Foundations on Deep Alluvial Soils

Technical Report Prepared for the Canterbury Earthquakes Royal Commission

August 2011

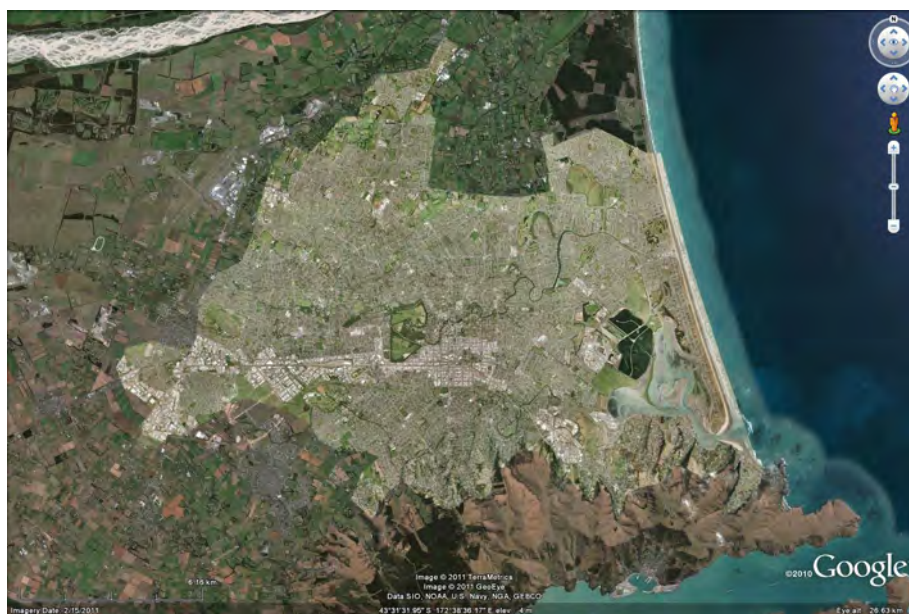
Figure 1. The City of Christchurch (Google Earth, 2011)

The City of Christchurch is located on deep alluvial soils of the Canterbury Plains, except for its southern edge, which is located on the slopes of the Port Hills of Banks Peninsula, the eroded remnant of the extinct Lyttelton Volcano. The river floodplain, Pacific coastline, and the Port Hills are the dominant geomorphic features of the Christchurch urban area (Figure 1).

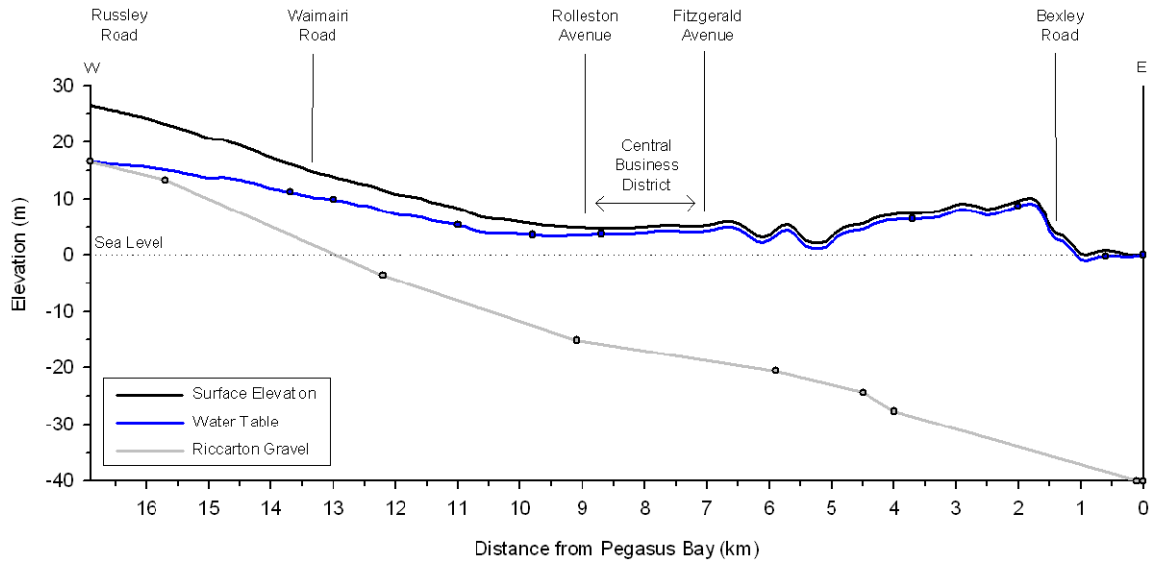
(a) East-West cross section aligned with Bealey Avenue

(b) East-West cross section aligned with Moorhouse Avenue

Figure 3. East-West cross sections indicating the thickness of surface soils or depth to the Riccarton Gravel along the directions of: (a) Bealey Avenue, and (b) Moorhouse Avenue; ground elevation derived from a Landcare Research 15m-resolution Digital Elevation Model (Landcare Research, 2011); depth to water table and Riccarton Gravel interpolated from contour data (circles) from Brown and Weeber (1992)

thickness of the surface soils or depth to the Riccarton Gravel is indicated in Figure 3 along two east-west cross sections aligning with the Bealey Avenue and Moorhouse Avenue respectively. The thickness of the surface alluvial soils is smallest at the west edge of the city (approximately 10 m thick) and increases towards the coast where the thickness of the Christchurch formation reaches about 40 m. Within the CBD, the thickness of the alluvial soils is approximately 20 m to 25 m.

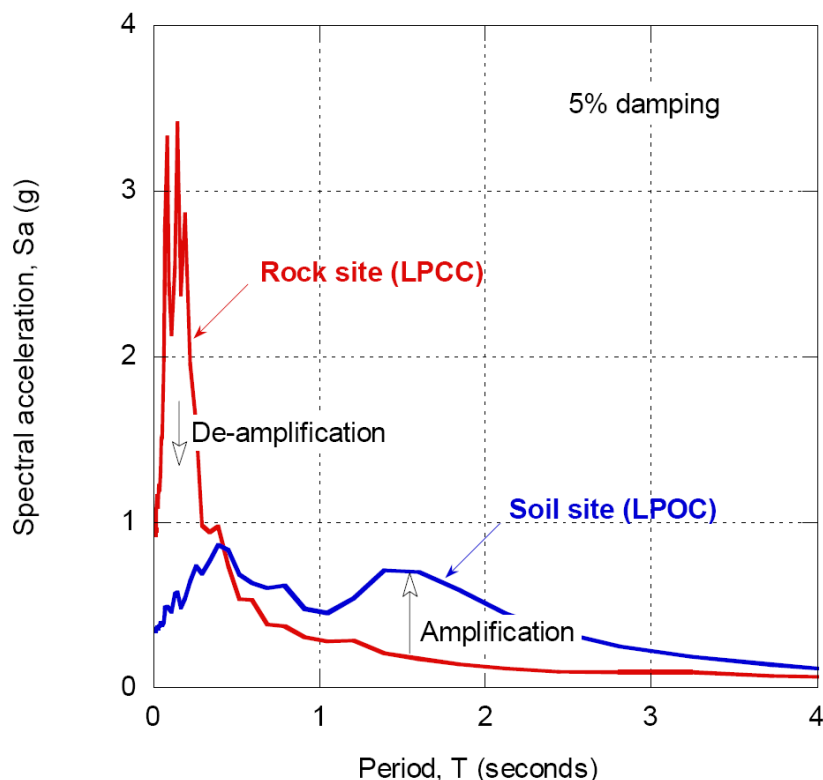
Figure 12. Acceleration response spectra recorded on rock (LPCC) and soil (LPOC) in Lyttelton during the 22 February earthquake illustrating typical effects of alluvial soils on response spectra (5% damped, elastic spectra)

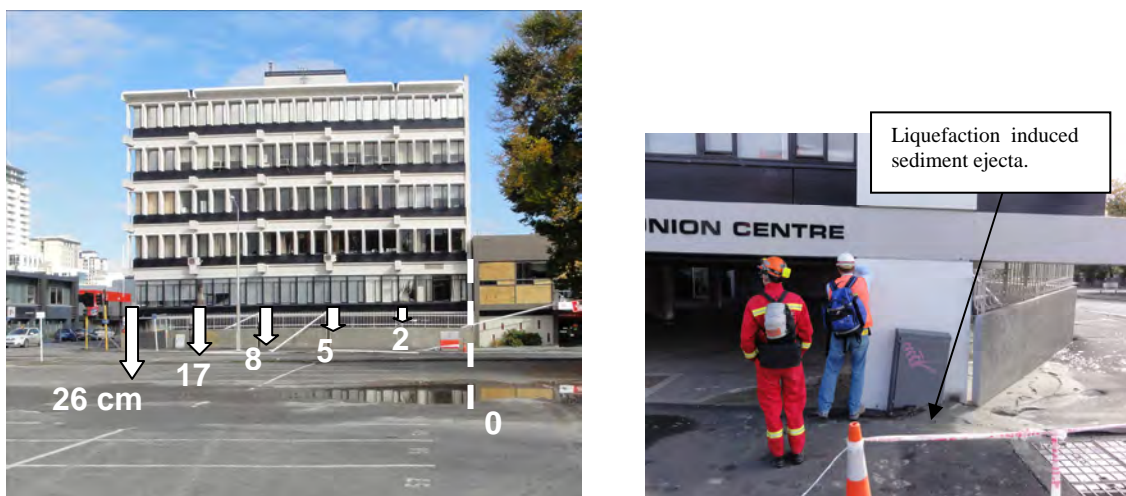
Figure 16. Liquefaction-induced differential settlement of a six storey building

Figure 16, shows a six storey building at the same location (which faces the weak liquefied area to the left in the photo). This building is also on shallow foundations comprised of isolated footings with tie beams and perimeter grade beam. Differential settlements are indicated in the figure relative to the right-most column which is used as a reference. The differential settlement of the southeast corner (the left-most column in the figure) was approximately 26 cm. Again, effects of liquefaction were the most severe at the southeast corner of the building and gradually diminished throughout the footprint of the building towards north leading to substantial differential settlements and pronounced structural deformations. Both these buildings were considered uneconomic to repair and were (will be) demolished in the months following the 22 February 2011 earthquake. Other multi-storey buildings also suffered this type of damage, which in many cases was exacerbated by the 13 June 2011 earthquakes.

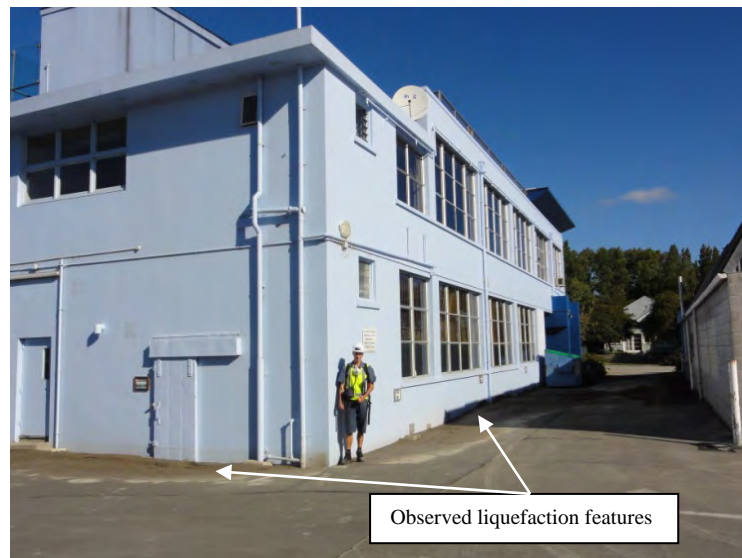
Figure 17. Punching settlement of a building in liquefied soils

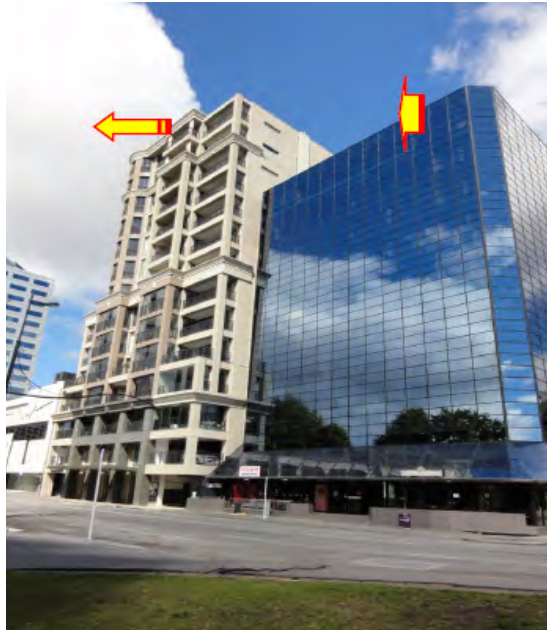
Figure 18. Residual tilts of adjacent buildings

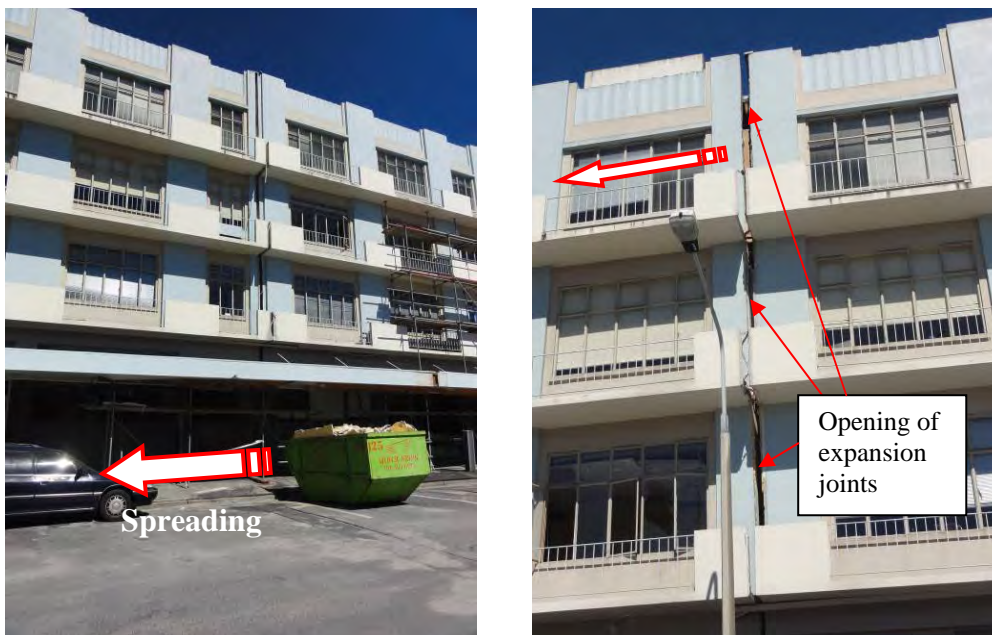
Figure 20. Stretching of foundations due to lateral spreading resulting in opening of the expansion joints

In areas affected by lateral spreading, the horizontal stretching of the ground adversely affected several buildings causing damage to the foundations and superstructure, lateral movements and tilt of buildings. The effects of spreading within the CBD were localized, but quite damaging to buildings and services within the affected zone. Typical stretching of the foundations resulting in damage of the structure (opening of expansion joints) is shown in Figure 20.

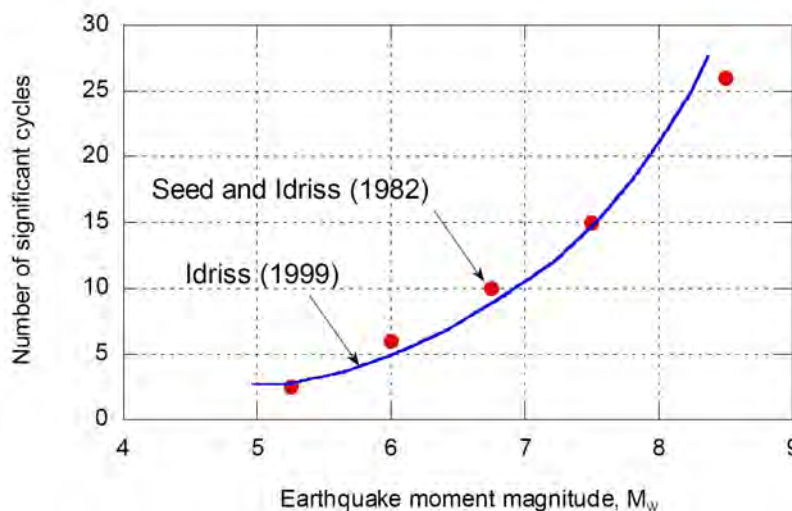
Figure 21. Relationship between the number of significant cycles and earthquake magnitude (M_w) (reproduced from Idriss and Boulanger, 2008)

Figure 21 depicts such a relationship between the earthquake magnitude (M_w) and the number of significant cycles of shaking (N_C). It suggests for example that, on average, a magnitude $M_w=7.5$ earthquake has 15 significant cycles. A large magnitude $M_w=8.0$ earthquake has 22 cycles while a magnitude $M_w=6.0$ has only 5 significant cycles. It simply reflects the fact that the size of the earthquake magnitude is related to the size of the fault rupture and hence the duration of shaking. Using this simple concept, we can examine the potential impact on Christchurch, and the CBD in particular, of a magnitude $M_w=8.0$ earthquake generated by the Alpine Fault, and compare it to the liquefaction induced in the 22 February 2011 earthquake. The calculations summarised below are preliminary and specific to triggering of liquefaction and should be restricted to such use only.

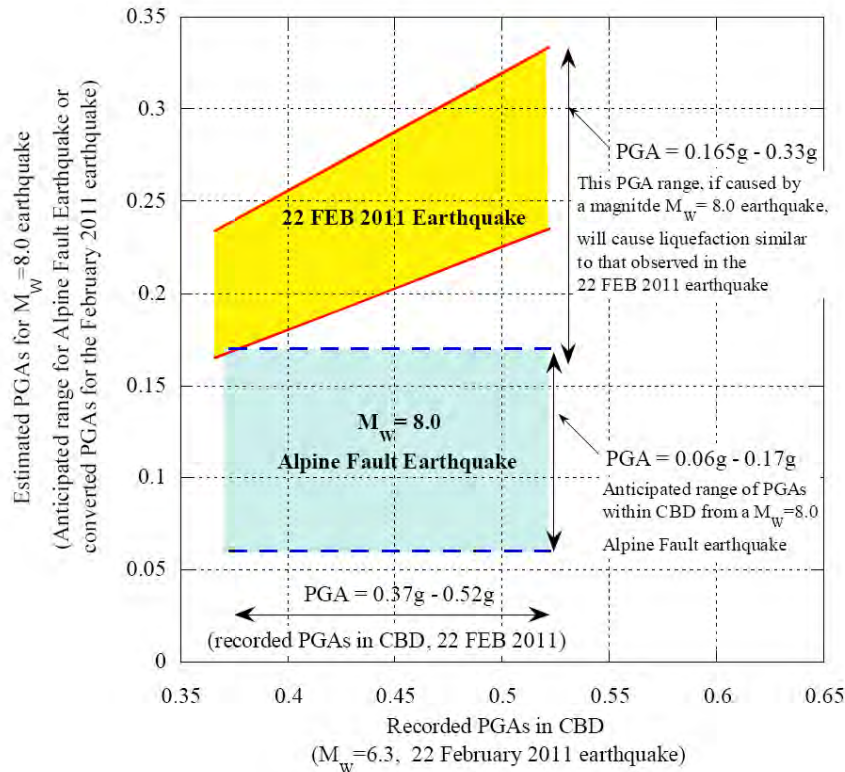
Figure 22. Comparison of anticipated range of PGAs within CBD from a $M_w=8$ Alpine Fault event (blue zone) and range of PGAs from an $M_w=8$ event causing liquefaction similar to the 22 February 2011 earthquake (yellow zone)

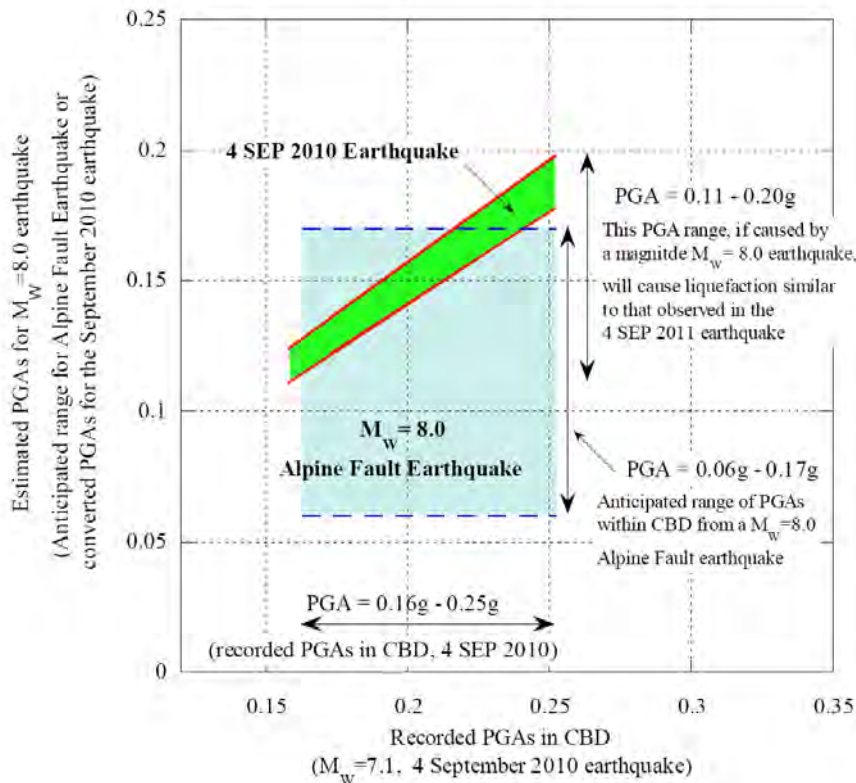
Figure 23. Comparison of anticipated range of PGAs within CBD from a $M_w=8$ Alpine Fault event (blue zone) and range of PGAs from an $M_w=8$ event causing liquefaction similar to the 4 September 2010 earthquake (green zone)
