# The performance of unreinforced masonry buildings in the 2010/2011 Canterbury earthquakes

Jason Ingham

## Part 2: Observations following the 4 Sept 2011 earthquake

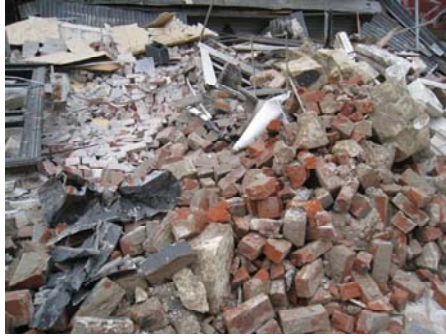
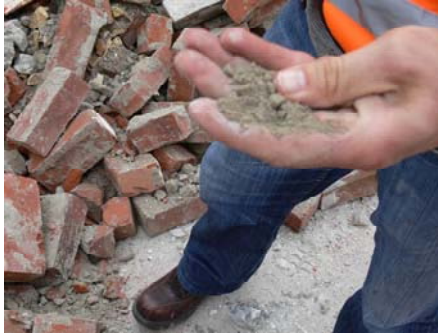
### Figure 3.3 Masonry rubble from collapsed wall

(a) Masonry rubble showing 'clean' bricks

(b) Weak mortar crumbles between fingers

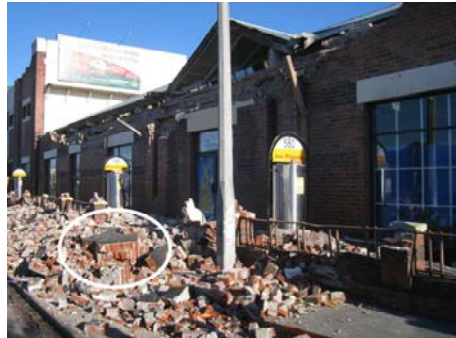
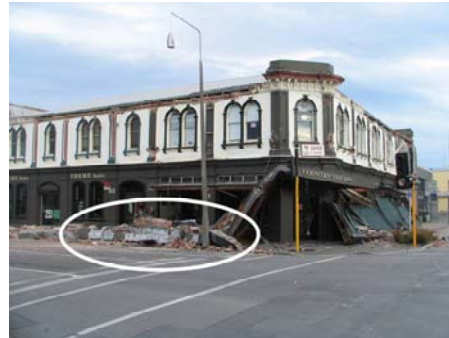
**Figure 3.4 Large sections of masonry intact after fall from buildings**

(a) Solid section of masonry gable

(b) Solid section of parapet

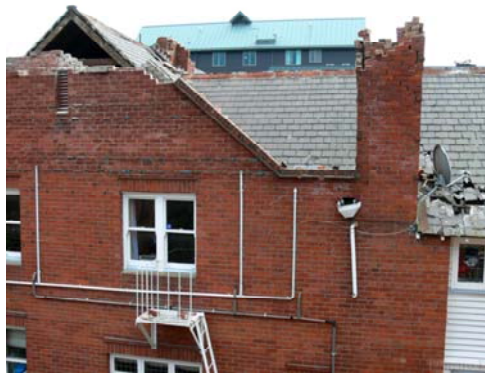
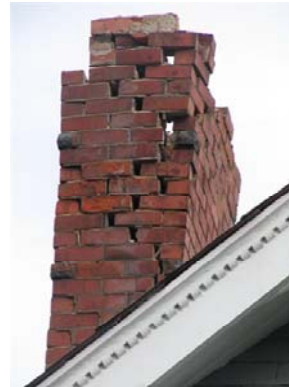
**Figure 3.6 Examples of chimney performance during the Darfield earthquake**

(a) Two damaged chimneys and gable wall

(b) Unstable damaged chimney

- Reported to have been 14,000 insurance claims for chimneys

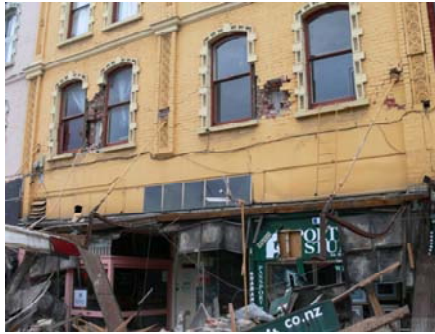
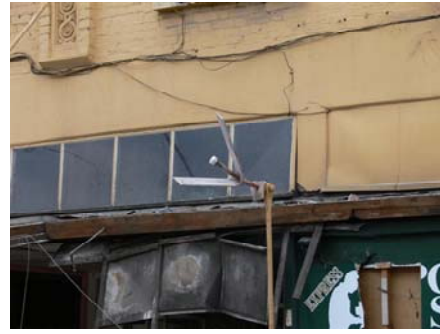
**Figure 3.9 Anchorage failure of awning brace due to parapet collapse**

(a) Anchorage failure

(b) Close-up of failed anchorage detail

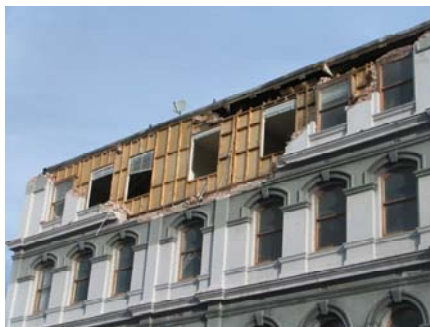
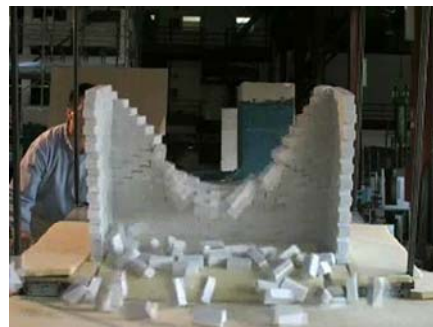
**Figure 3.11 Failure mechanism comparisons – observed earthquake damage versus experimental simulation**

(a) Wall damage at 140 Linchfield Street

(a) High speed photograph of a dry-stacked masonry wall failing during a tilt test

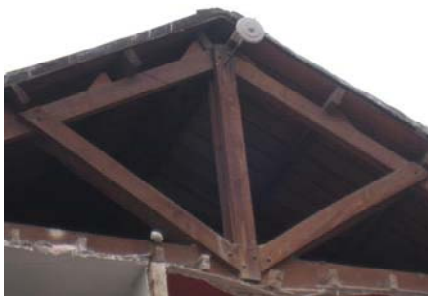
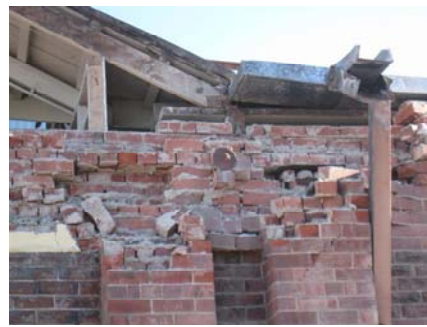
**Figure 3.13 Wall-to-diaphragm anchor details**

(a) Gable end wall failure despite anchor (see also Figure 13a).

(b) Wall anchor still intact (see also Figure 6a).

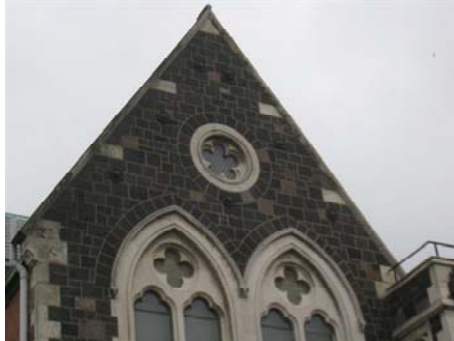
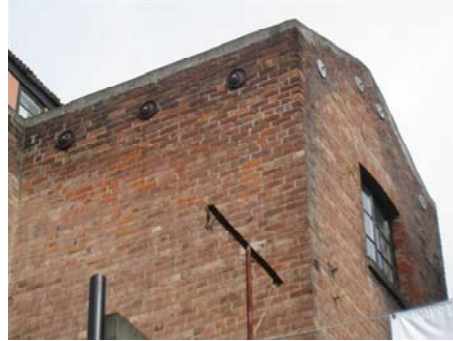
**Figure 3.14 Successful gable end wall and side wall anchorages**

(a) Arts centre building

(b) Arts centre building

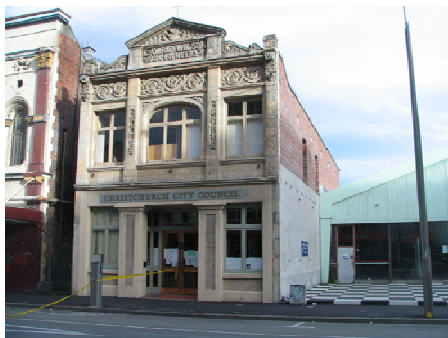
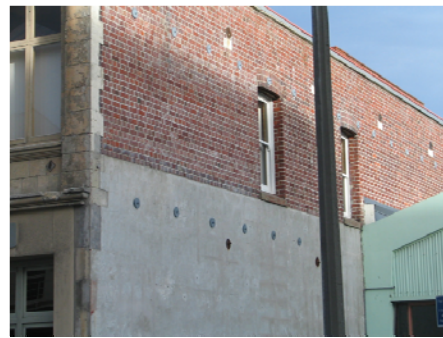
**Figure 3.15 Successful wall-floor and wall-roof diaphragm anchorages**

(a) Front elevation

(b) Side elevation

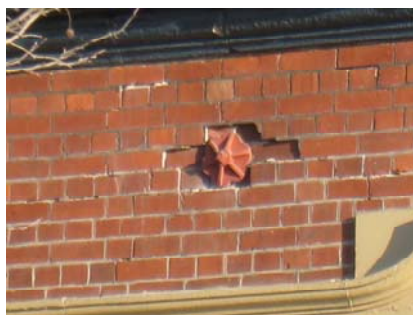
## Figure 3.18 Partial bed joint shear failure surrounding anchorage detail

(a) Wall-roof anchorage failure

(b) Gable end anchorage failure

- These 'partial failures' emphasise the effect of earthquake duration (being 10-15 sec). Greater duration would have led to far worse damage

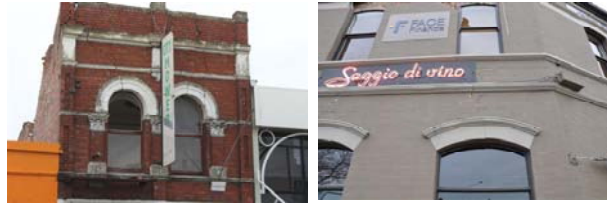
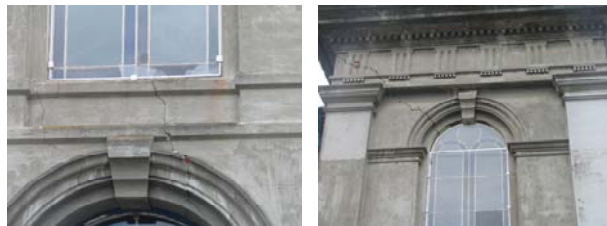
**Figure 3.16 Examples of in-plane wall damage above window openings**

(a) Extensive vertical cracking above window openings

(b) Vertical crack above window opening

(c) Vertical crack through spandrel

(d) Diagonal crack extending from window opening

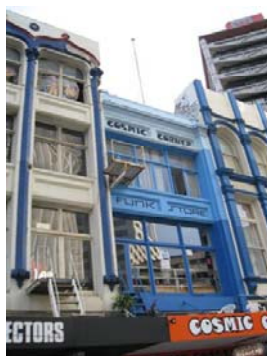
**Figure 3.22 Example of building pounding damage**

(a) Building overview

(b) Close-up of column

(c) Close-up of column

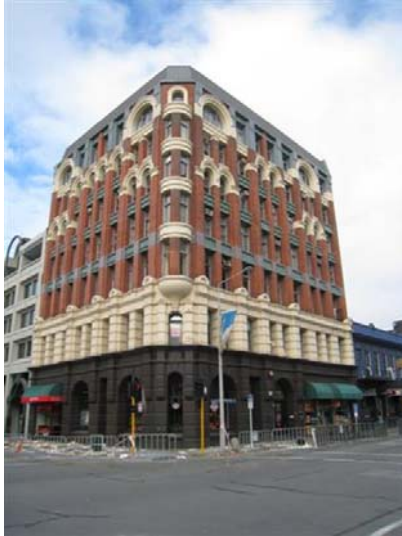
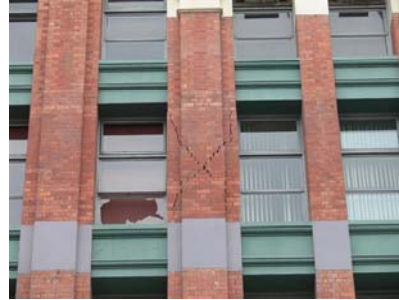
**Figure 3.23 Manchester Courts building**

(a) North wall piers, levels 3-4
