The performance of unreinforced masonry buildings in the 2010/2011 Canterbury earthquakes

Part 3: Earthquake failure modes and strengthening techniques for URM buildings

To clarify the types of failure modes and the range of techniques used in Christchurch to earthquake strengthen URM buildings

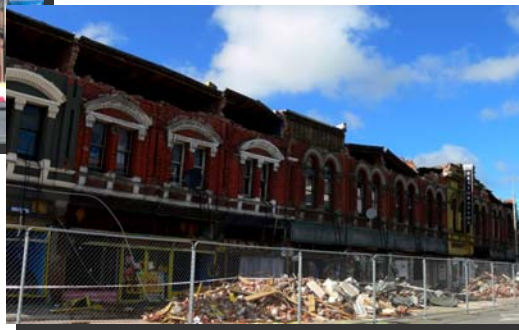
FEMA 306 classification of damage due to one-way bending failure (FEMA, 1999a)

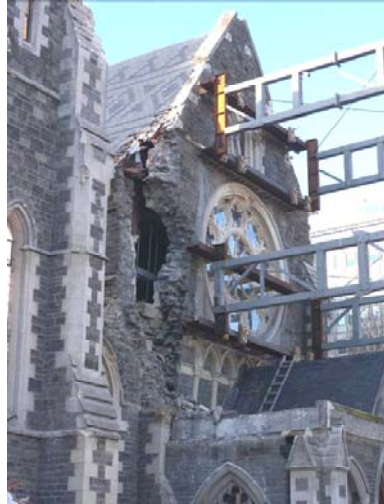
(a) unstable front wall

Figure 3.30 Christchurch Anglican Cathedral – front façade damage

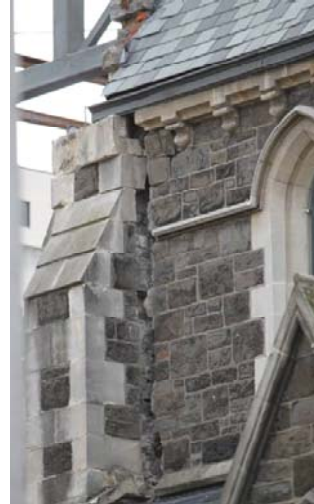
(b) return wall separation

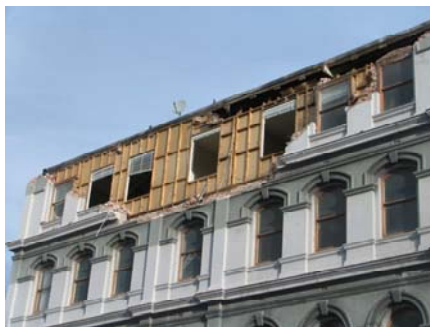
(a) Wall damage at 140 Linchfield Street

Figure 3.11 Failure mechanism comparisons – observed earthquake damage versus experimental simulation

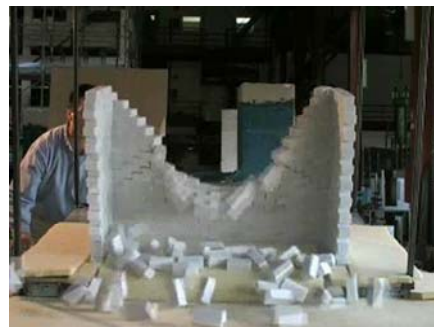
(a) High speed photograph of a dry-stacked masonry wall failing during a tilt test

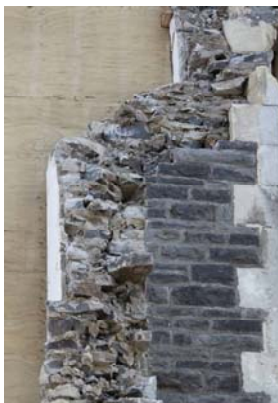
(a) Cramner Court - 3 leaves with rubble fill.

Figure 3.27 Representative examples of wall cross-sections for Christchurch stone masonry buildings

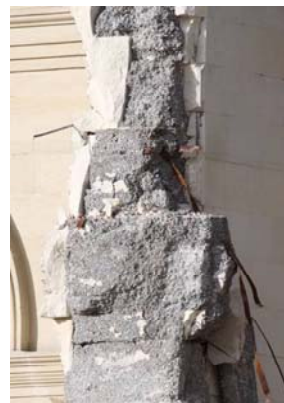
(b) Cathedral of the Blessed Sacrament - Oamaru stone with poured concrete.

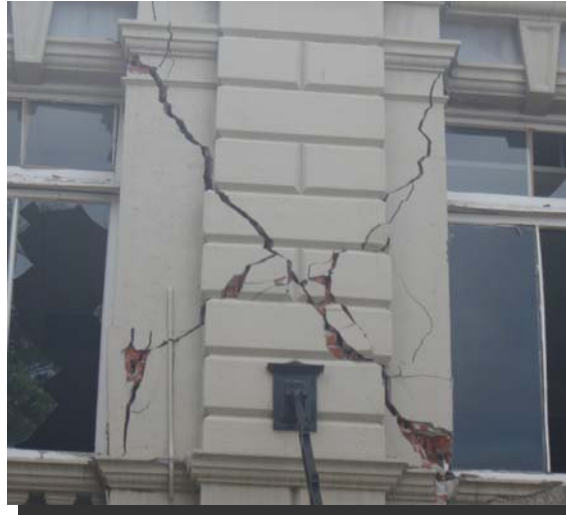
**Figure 3.34 Christchurch Anglican Cathedral -
diagonal cracks in the south façade piers**

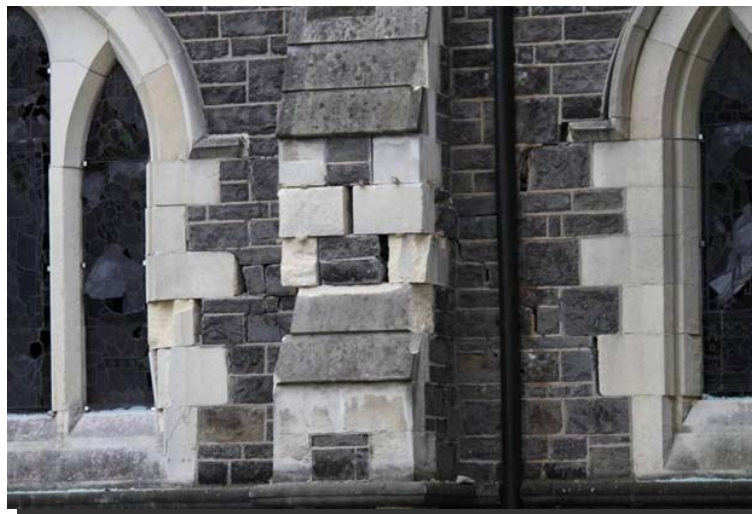
Spandrel failure

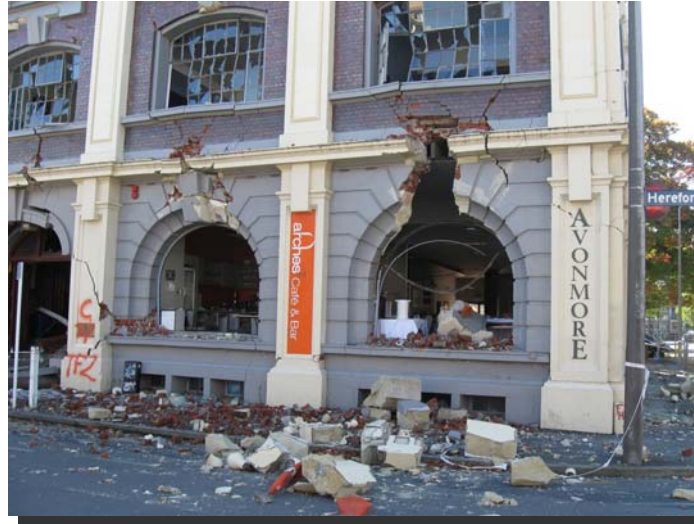
Diagonal tension failure and spandrel failure

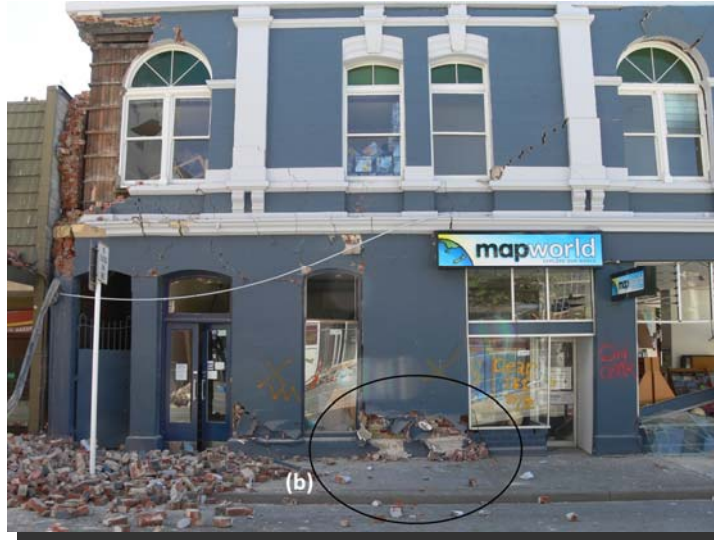
Toe crushing

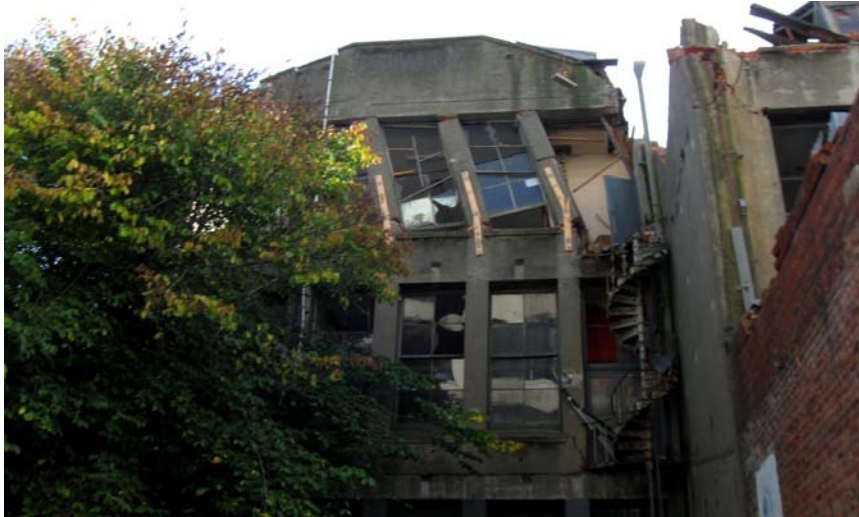
Bed joint sliding (due to pounding)

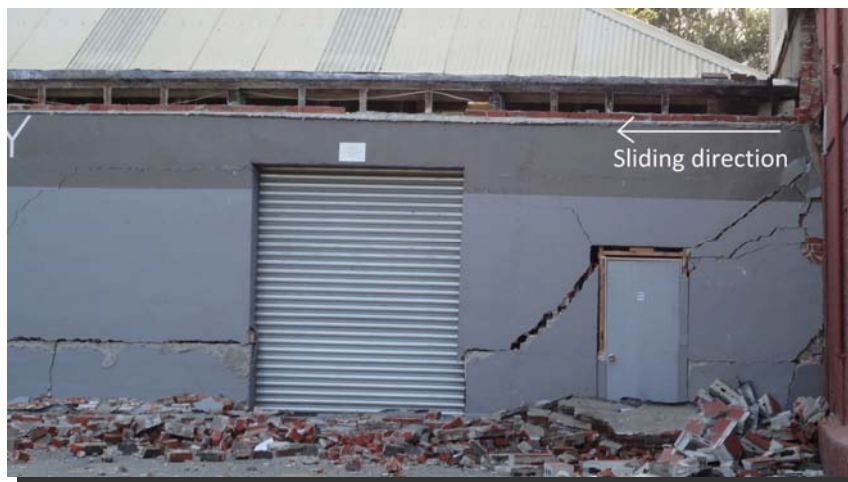
Bed joint sliding

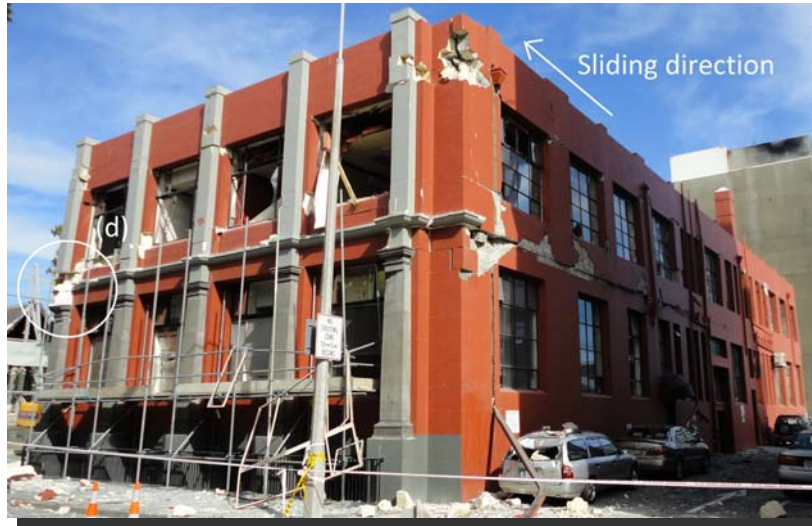
Bed joint sliding

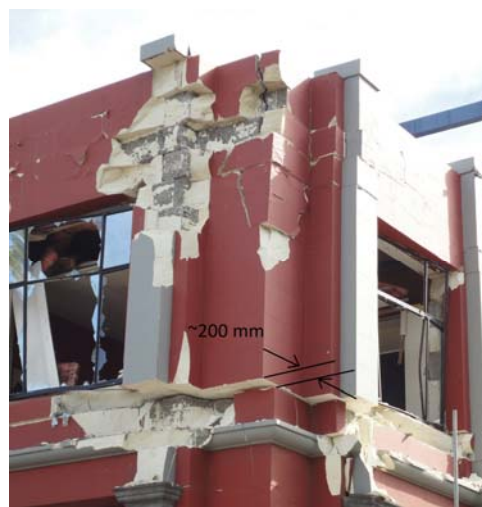
Building pounding

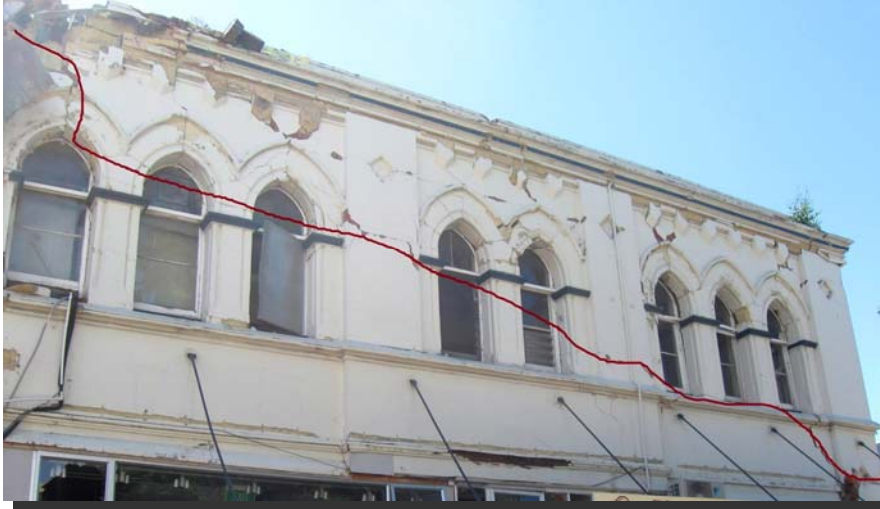
Building pounding

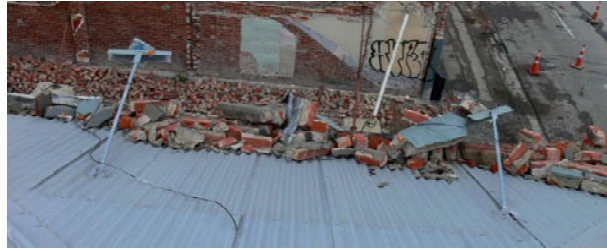
Failed parapet restraints

(a) Roof level view of failed parapet restraint

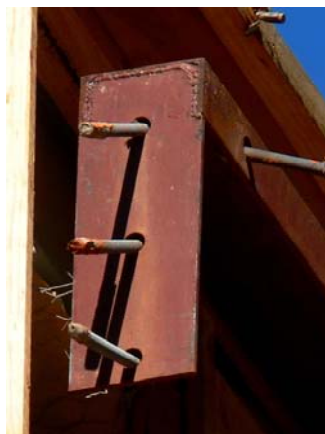
Figure 4.4 Examples showing failure of adhesive anchors

(a) Failure of a steel fixing due to anchor withdrawal

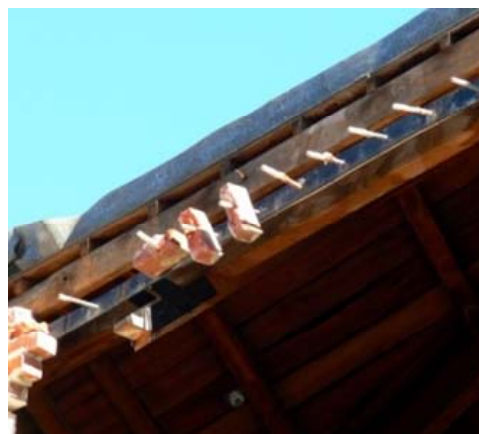
(b) Failure of a steel fixing due to both anchor withdrawal and brick detachment

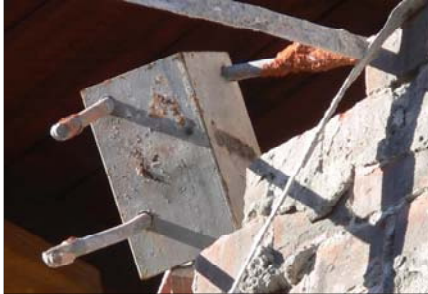
Figure 7.3 Adhesive anchors installation quality

(a) Poor installation of adhesive anchors

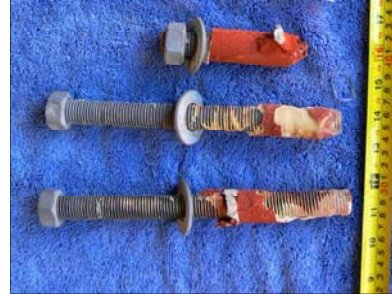
(b) Recovered adhesive anchors that performed inadequately

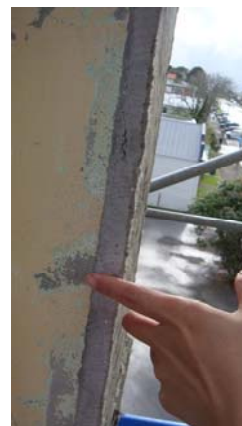
Figure 4.5 Examples of earthquake strengthened chimneys

(b) Fibre reinforced shotcrete applied to the exterior surface of a chimney

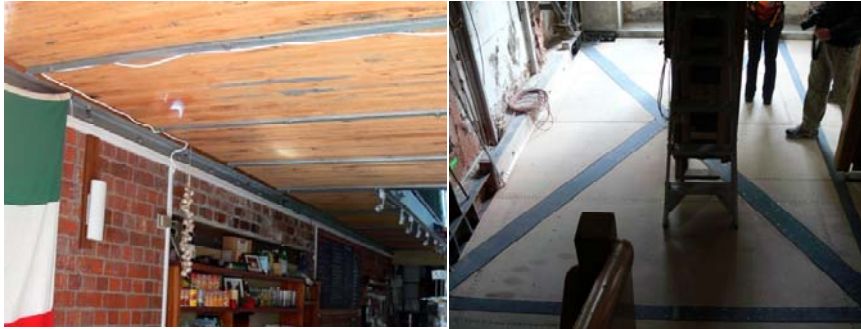
Figure 4.9 Examples of floor diaphragm stiffening

(a) Steel sections added to stiffen and secure the floor diaphragm

(b) Steel strapping for floor stiffening

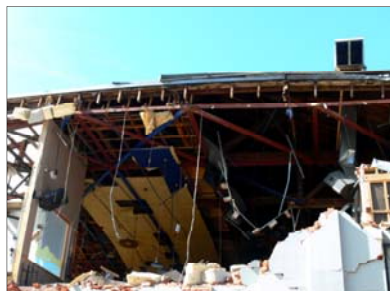
(a) Roof diaphragm improvement using steel brace frames

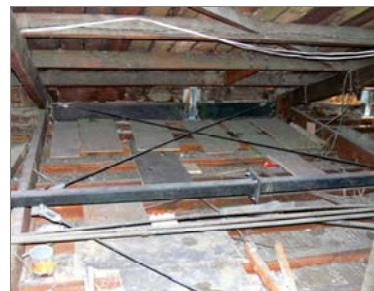
(b) Roof diaphragm improvement using steel braces

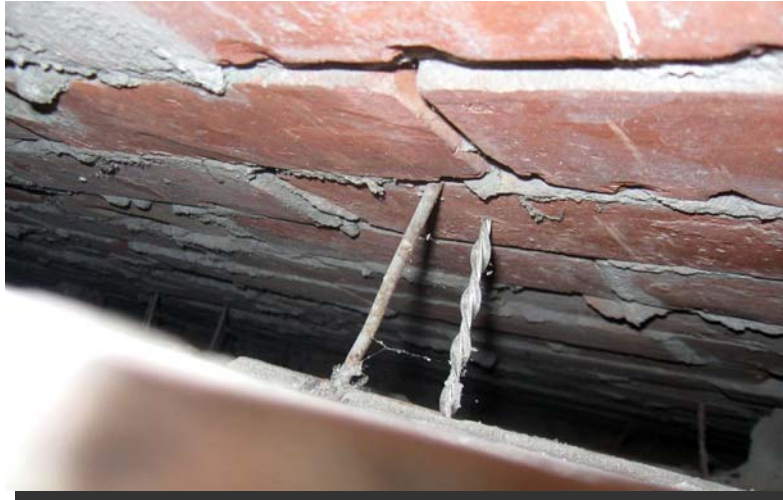
Install new cavity ties

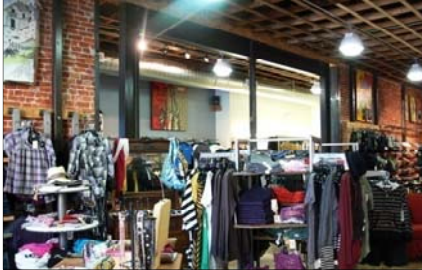
Figure 2.5 Addition of strong-backs for increased out-of-plane wall capacity

(a) Installation of steel moment frames and steel strong-backs, San Louis Obispo

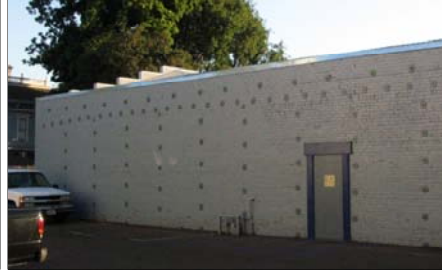
(b) Addition of internal strong-backs and extensive anchorage of masonry, San Louis Obispo

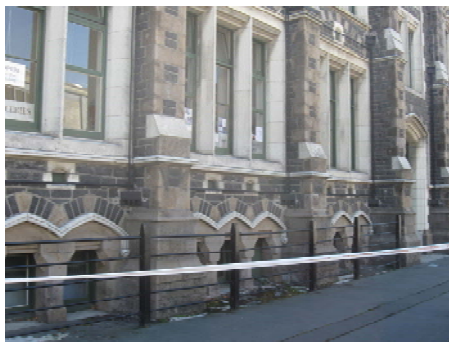
Figure 4.8 Post-tensioned seismic retrofits of URM buildings

(a) External post-tensioning used in the Christchurch Arts Centre (photo taken after 22 February 2011 earthquake)

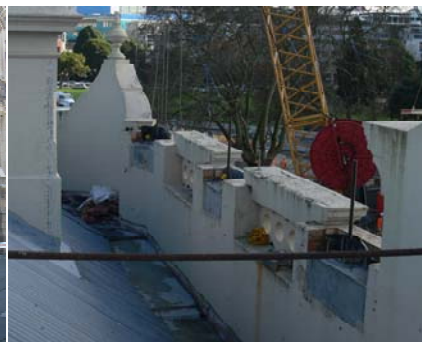
(b) Internal post-tensioning bars used in the Birdcage hotel, Auckland

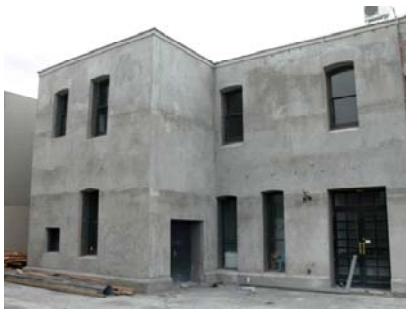
Figure 4.11 Examples of strengthened masonry shear walls

(a) Shotcrete applied to a former URM building

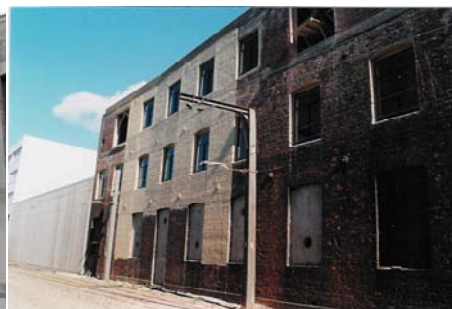
(b) Surface bonded FRP applied to the exterior of a URM wall

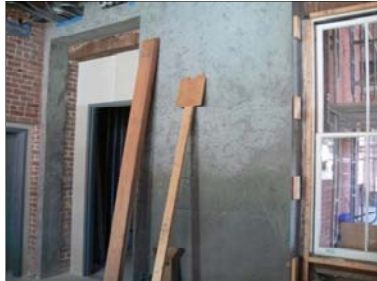
Figure 2.7 Shotcrete rehabilitation technique in San Francisco

(a) Internally applied shotcrete to a URM building located in San Francisco

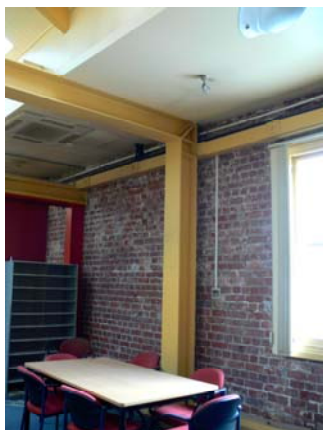
Figure 4.13 Internal moment frames installed as seismic retrofits

(a) Post-earthquake condition of a URM building having an internal steel frame retrofit

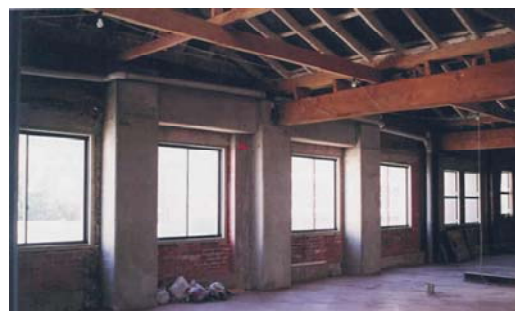
(b) Reinforced concrete moment frame retrofit

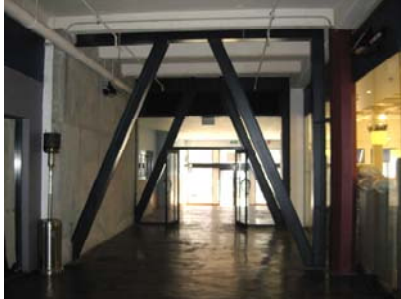
**Figure 4.14 Eccentrically braced steel frame retrofits
(photos courtesy of Dunning Thornton Consultants)**

(a) Eccentric bracing in a walkway

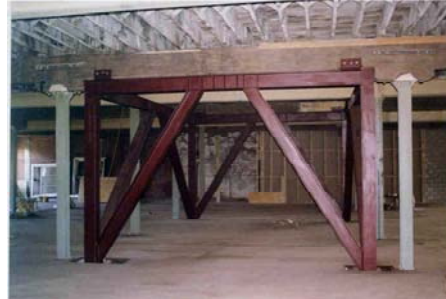
(b) Eccentrically braced core

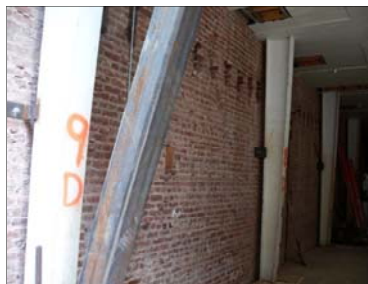
Figure 2.6 Addition of lateral resisting systems

(b) Steel moment frames used in a multi storey URM building in San Francisco
