Collapse of the Pyne Gould Corporation Building on 22nd February 2011

Investigation into the Collapse of the Pyne Gould Corporation Building on 22nd February 2011

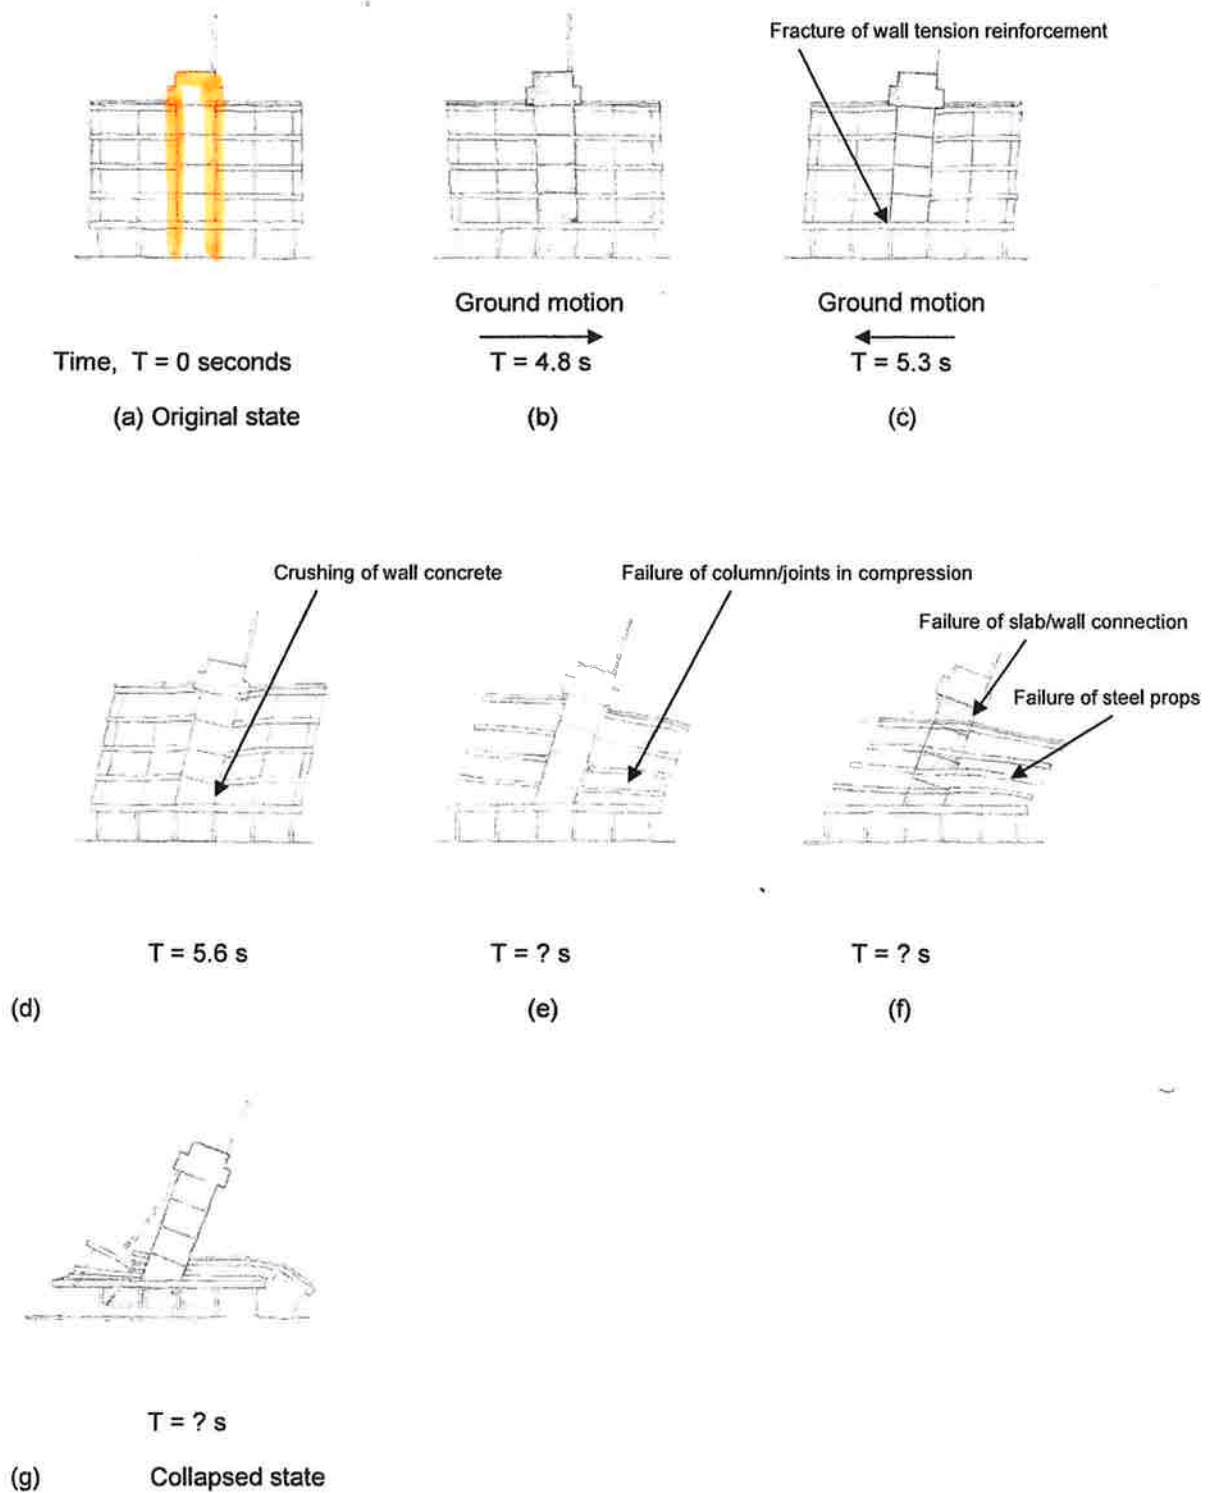
Figure 9.1 : Inferred Collapse Sequence
