**REPORT 107267-1 (v1.1)**

**PREPARED FOR ROYAL COMMISSION**

**NOVEMBER 2011**

## **MATERIALS TESTING IN BUILDINGS OF INTEREST**

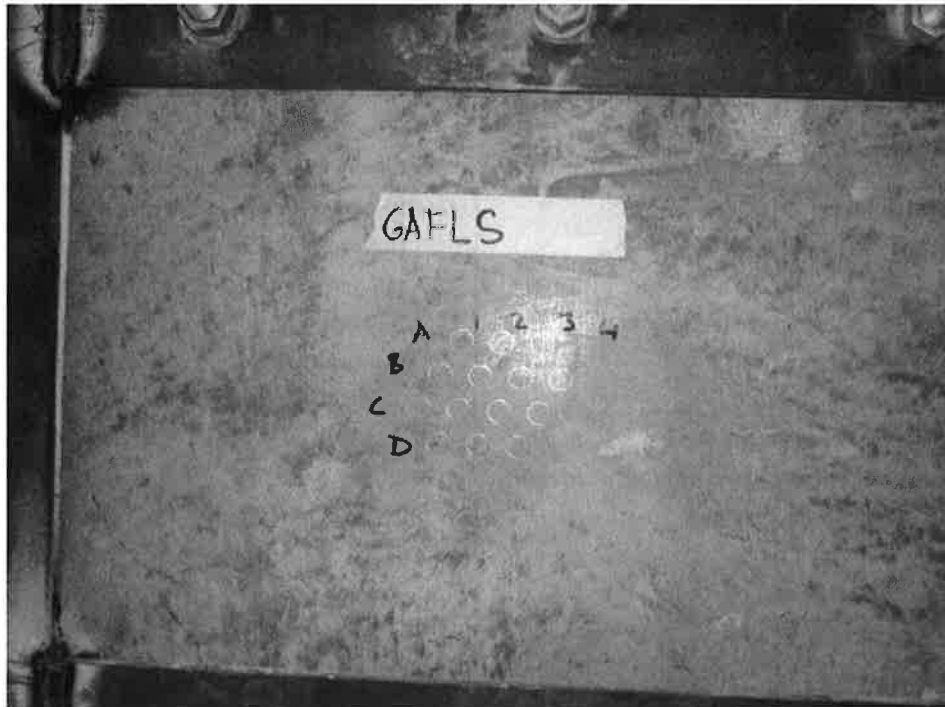
Figure 4 Schmidt Hammer test location GAFLS

location: <u>Front Wall - Left Side</u>				
	1	2	3	4
A	73	71.5	72	
B	67	73.5	77	72
C	72.5	72.5	71.5	70
D		60	70.5	72

Correct Average:	71.8
Cube Strength:	87.1 MPa
<b>Cylinder Strength, <math>f_c</math>:</b>	<b>70.0 MPa</b>

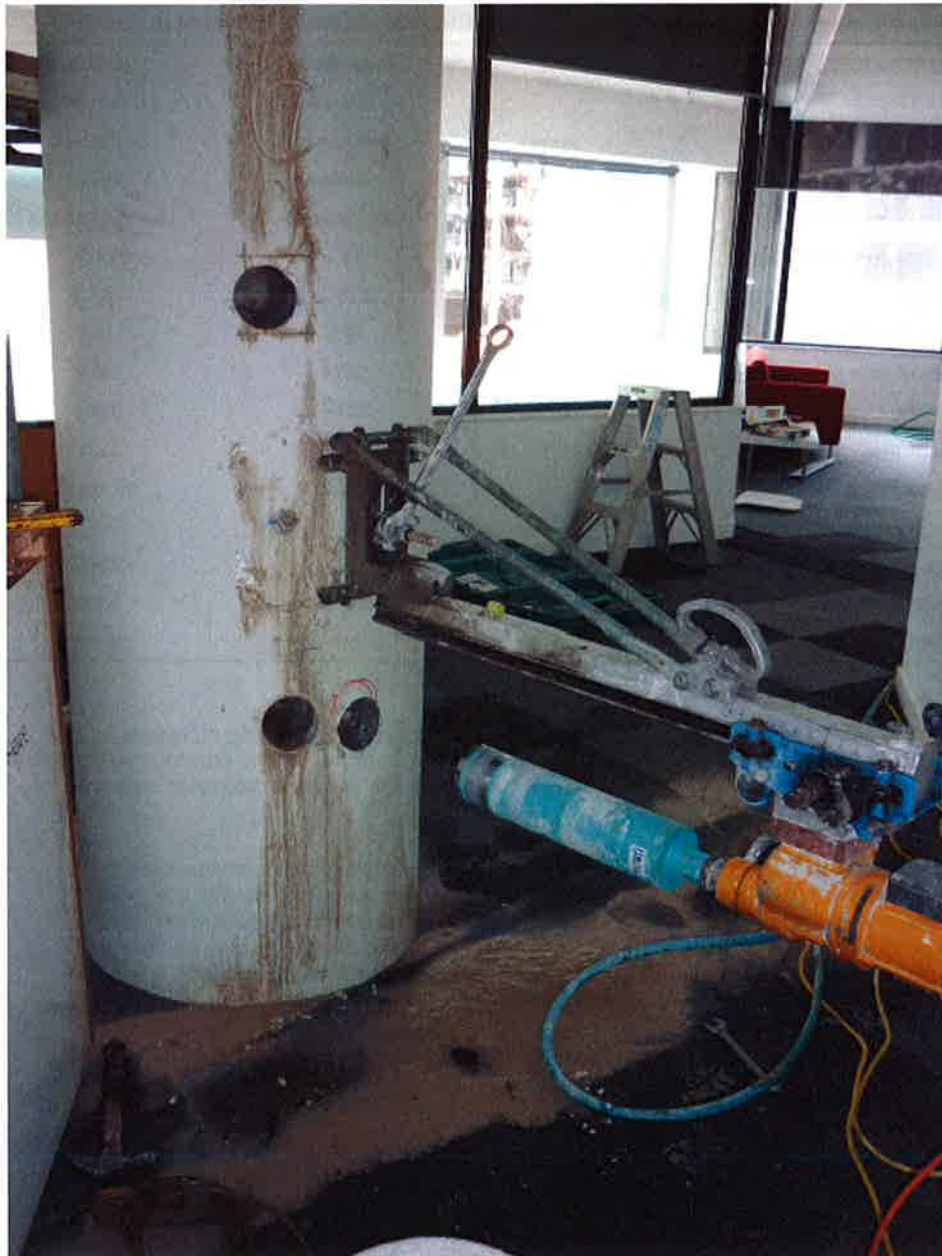
Figure 5 Core Drilling in concrete column

A series of 6 concrete cores were removed from the concrete elements, all of which were subjected to compression testing. Two of the cores were removed from precast beams, two from column elements, and the remaining two were extracted from the in-situ walls. The results from the physical testing on the cores are presented below.

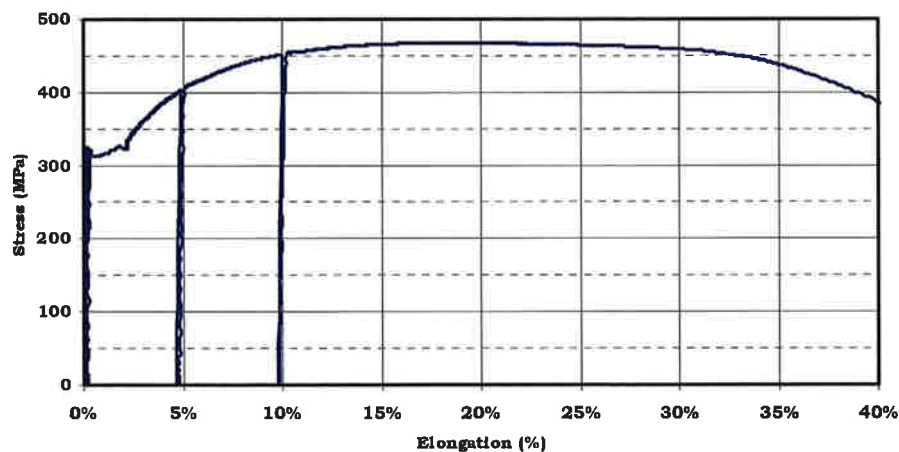
Figure 10 Materials Test Result for the Steel test coupons obtained from undamaged area in the Westpac Centre

The obtained stress-strain responses of the two undamaged steel samples are shown in *Figure 10* below. The steel samples were subjected to unidirectional cyclic tensile testing rather than cycles of reverse cyclic loading to near equal values of tensile and compressive strain. In the structural element, under imposed lateral loads the neutral axis is likely to have been located near the location of the reinforcing steel during the compression load cycle, and as such the steel would have been subjected to very small induced compressive strains. During the reverse loading cycle the steel located at or near a crack in the concrete section is likely to have been subjected to disproportionately larger tensile strains, thereby significantly skewing the strain profile experienced by the reinforcing steel into the tension domain. Due to the skewed strain profile, it is believed that the unidirectional cyclic tensile test provides an adequate representation of the strains induced in the steel during a seismic event.

a) Horizontal reinforcing bar sample

b) Vertical reinforcing steel sample

The steel samples had an average recorded yield stress ( $f_y$ ) of 320 MPa and an average maximum recorded stress ( $f_u$ ) of 472 MPa. The strain hardening ratio ( $f_u/f_y$ ) of the tested steel sample was defined as 1.475. This value of strain hardening ratio indicates that the steel has a good likelihood of spreading the zone of yield along the bar, a beneficial property for limiting the potential damage at a localised zone of damage in a reinforced concrete member. It also indicates that the steel has a high plastic hardness and therefore it likely to provide suitable variation in Leeb hardness values for various levels of imposed strain.
