Canterbury Earthquakes Royal Commission

New Technologies in Timber Buildings

Professor Andy Buchanan University of Canterbury

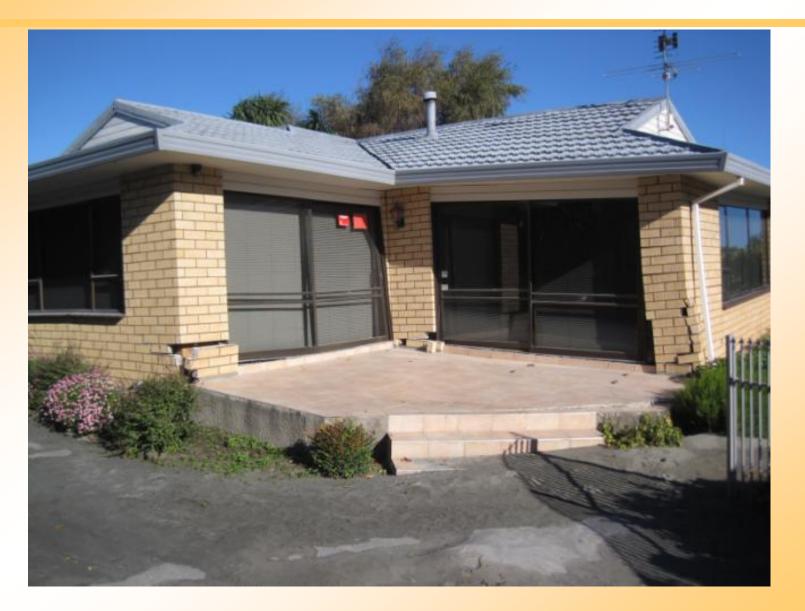
Liquefaction damage

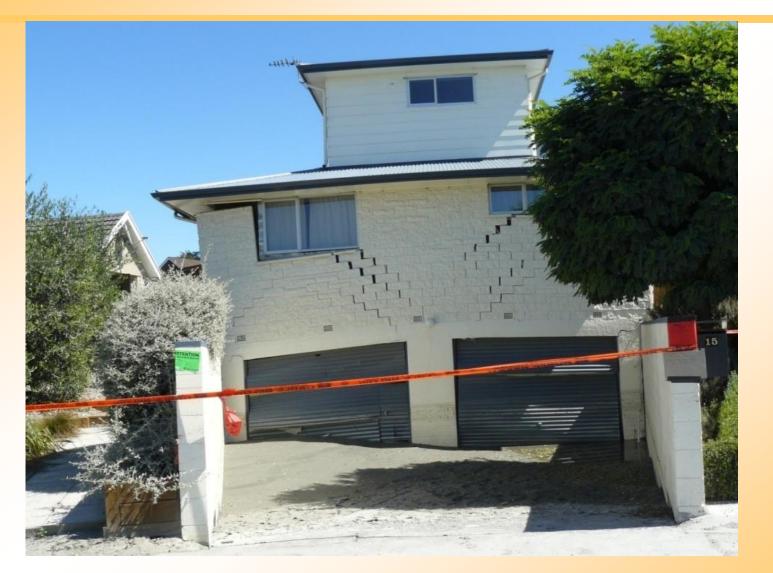
Differential settlement

Differential settlement, veneer damage, timber structure OK

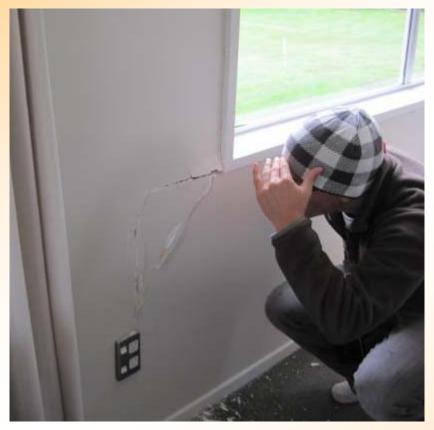
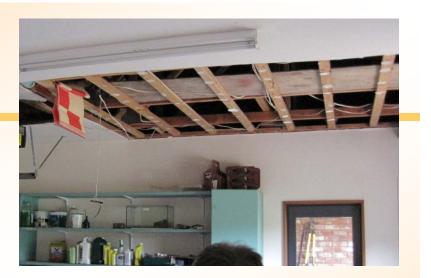
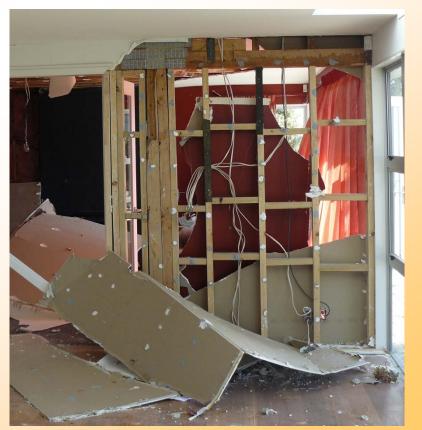
Internal linings

Gib plasterboard

Provided bracing for most houses

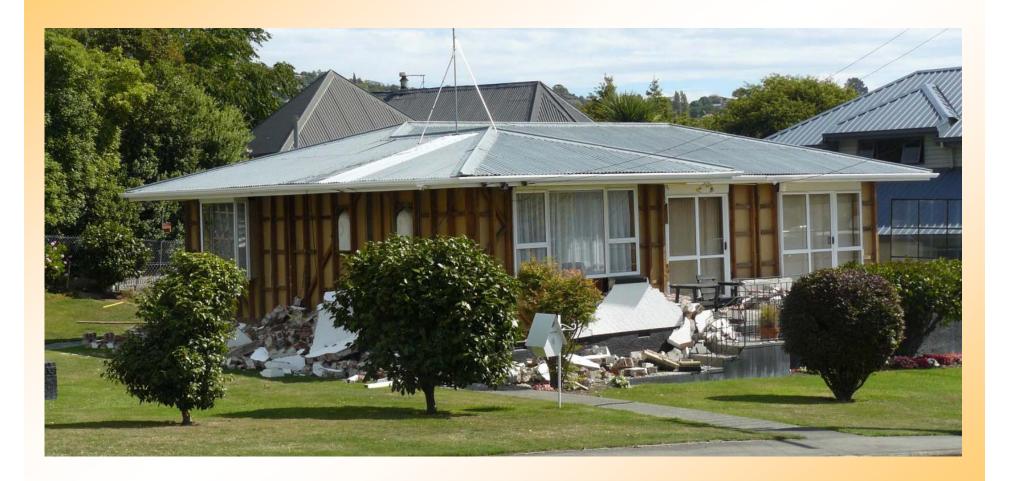
Veneer failure

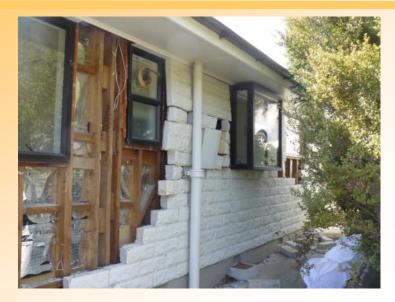
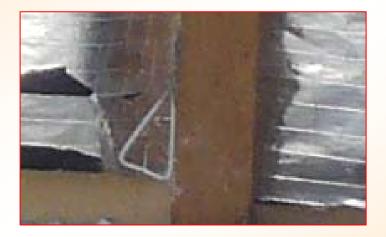
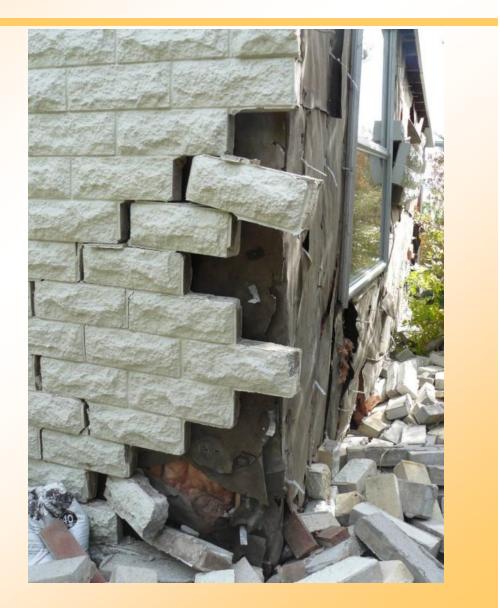
Veneer ties

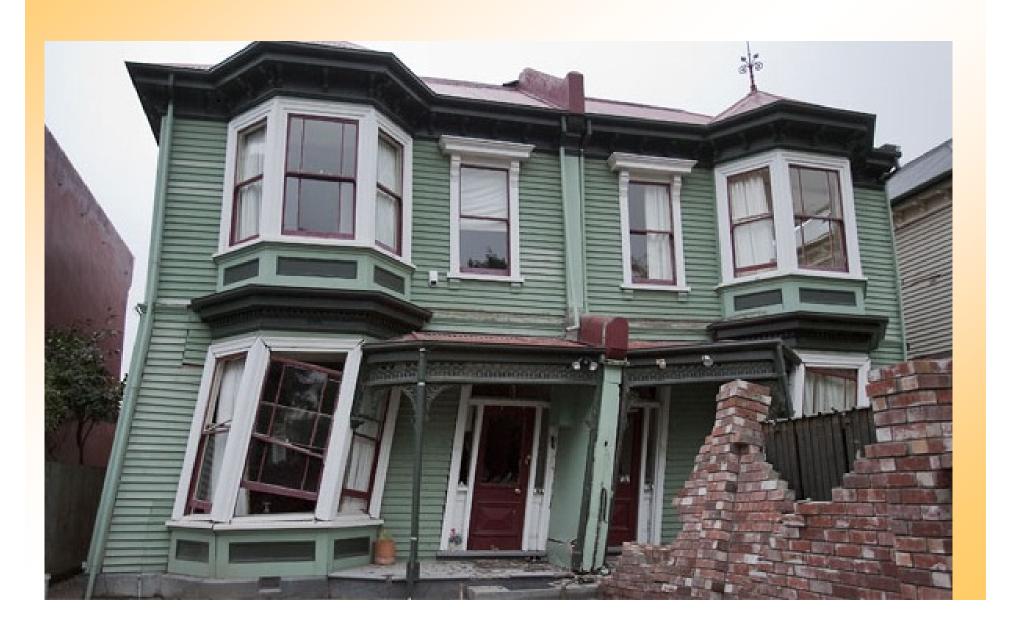
Wall bracing failures

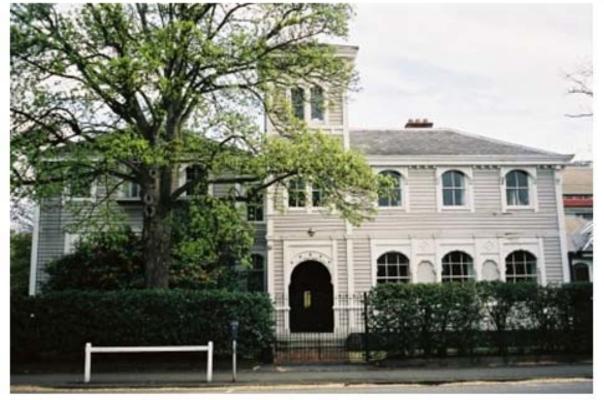
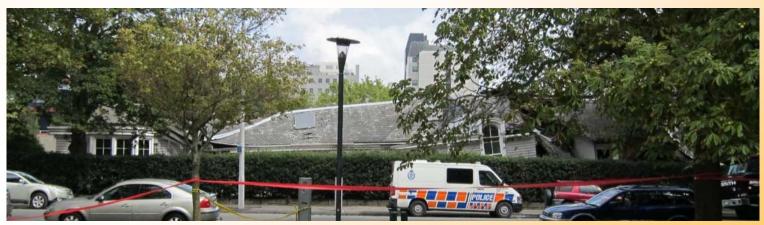
Old timber building collapse

Before

After

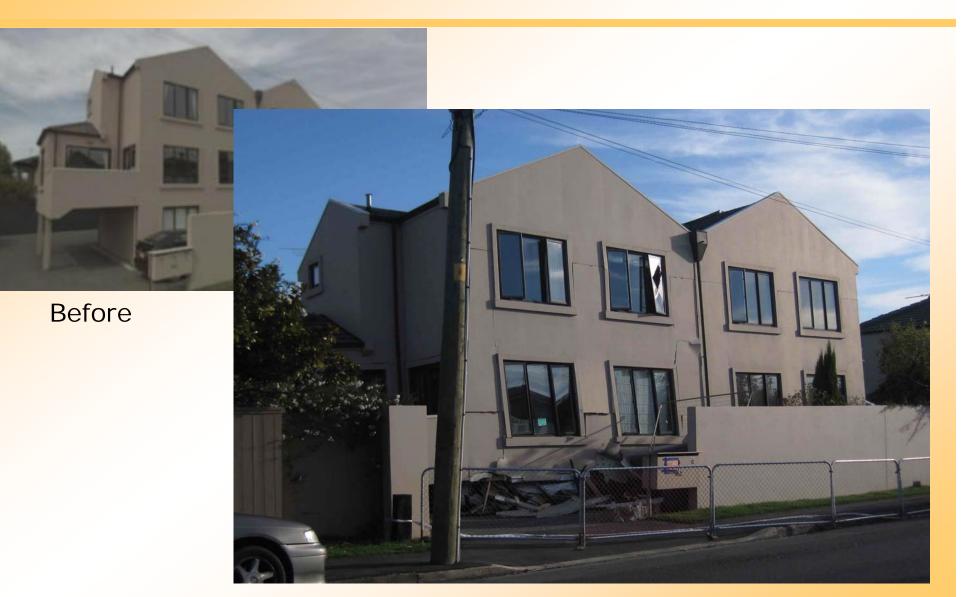
Soft storey collapse

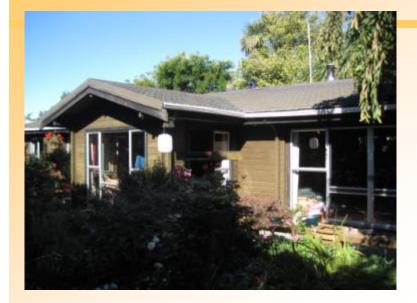
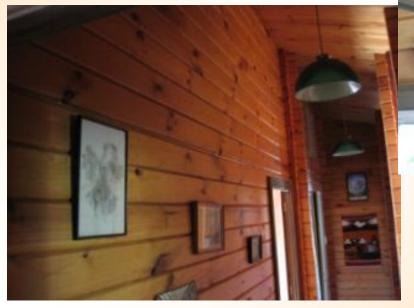
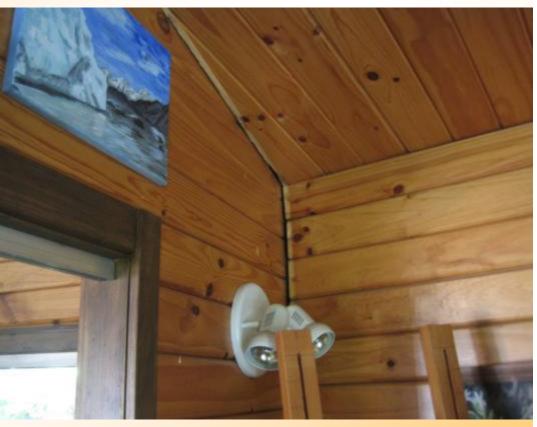
Solid wood houses

Good performance despite differential slab movement

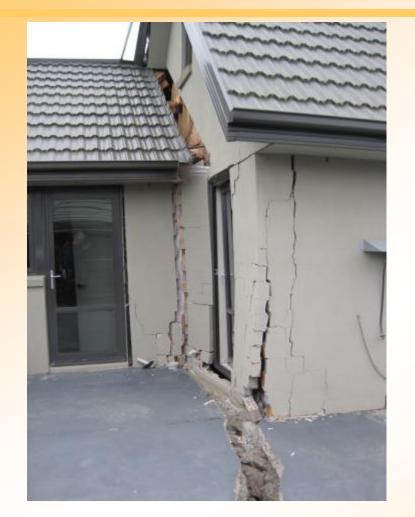
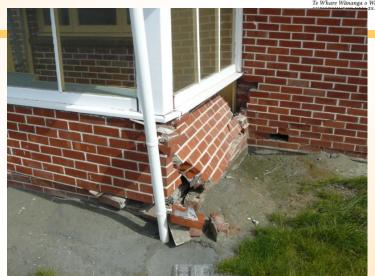
Concrete slab floors

Lateral spreading

Differential sinking

No reinforcing

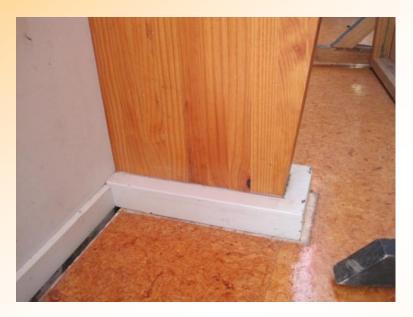
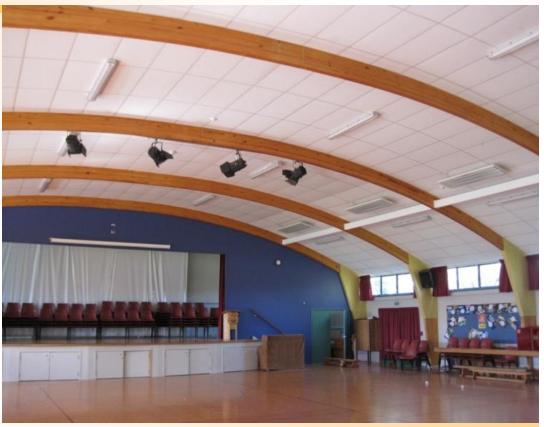
Most performed very well

Lateral spreading of portal bases

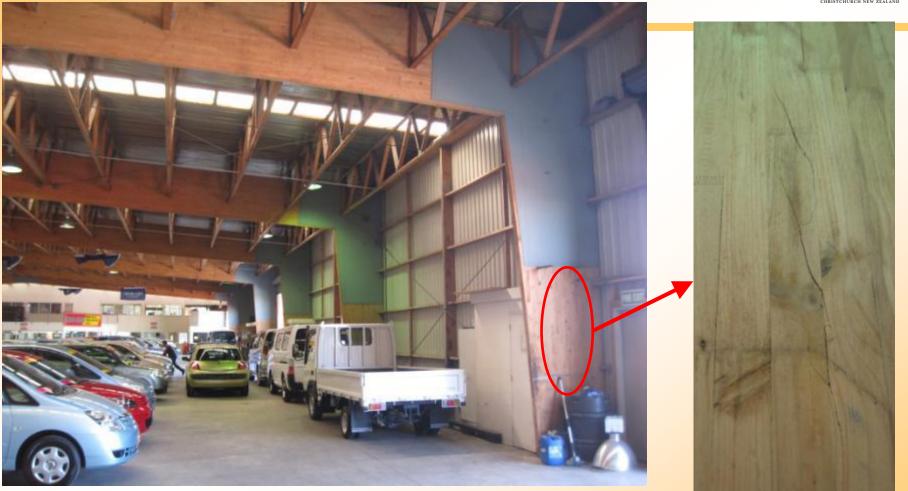
Shear cracks in column

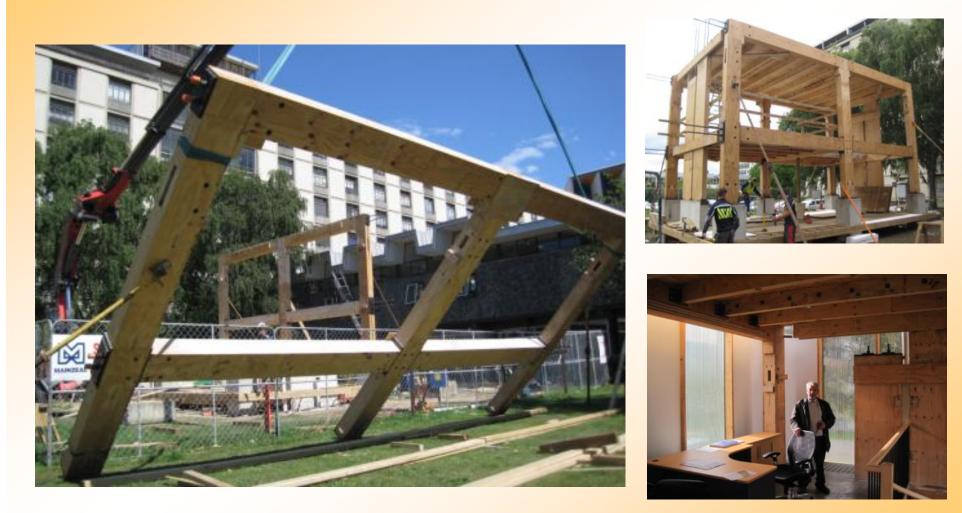
EXPAN building, UC campus No structural damage. Immediate occupancy.

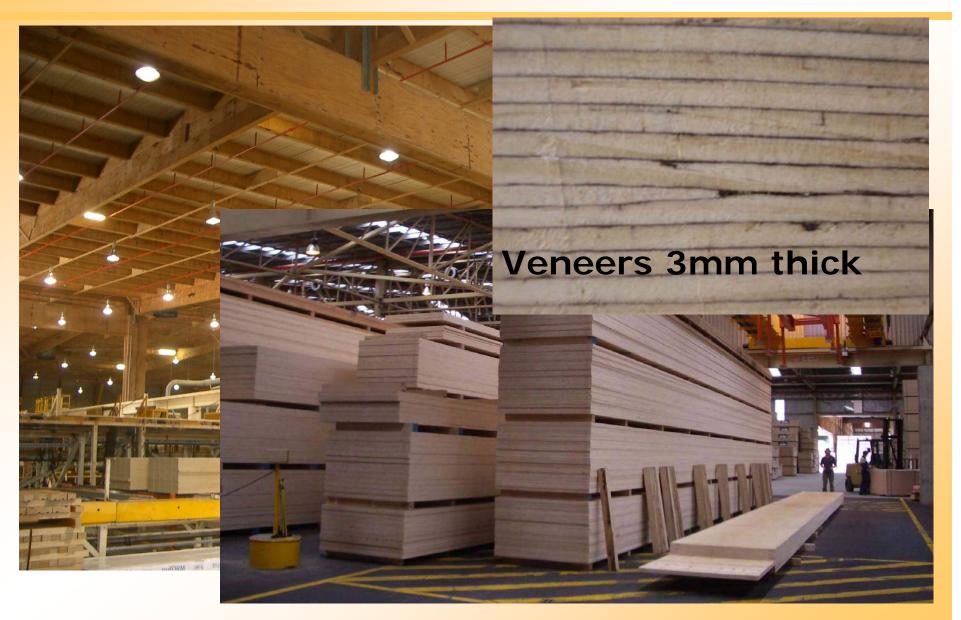
LVL - Laminated veneer lumber

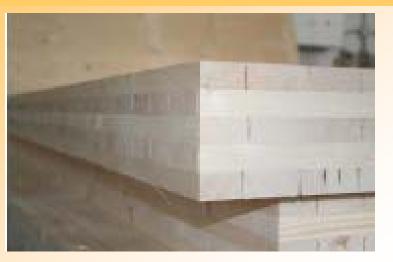
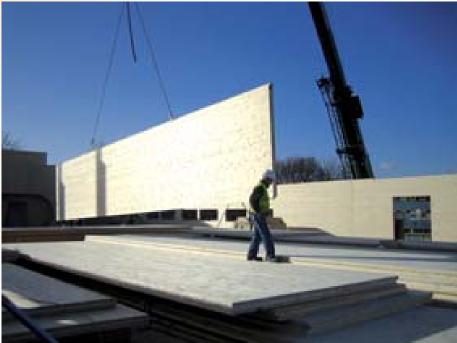
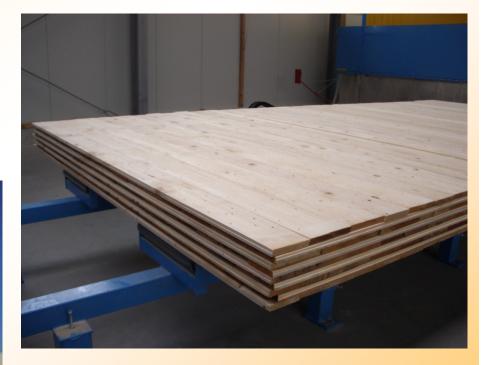
CLT - Cross laminated timber

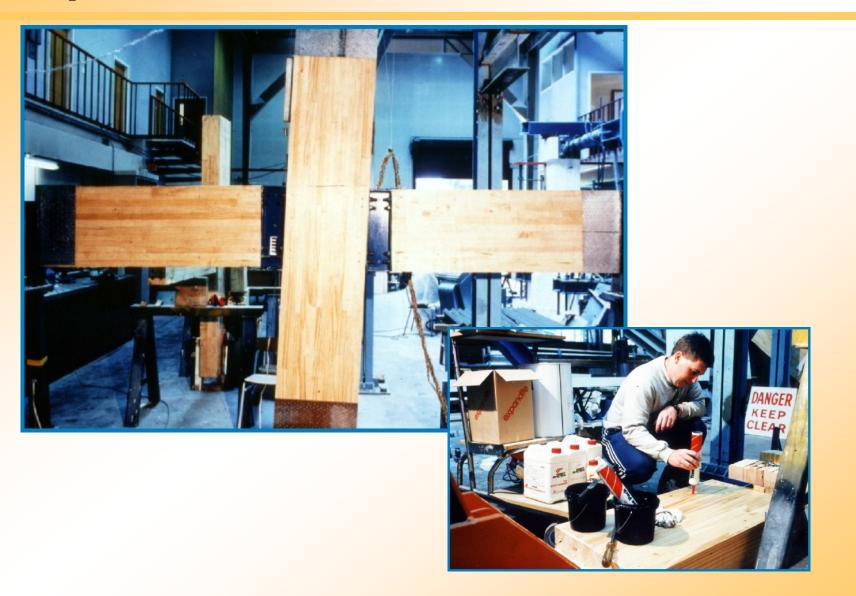
Epoxied steel rods

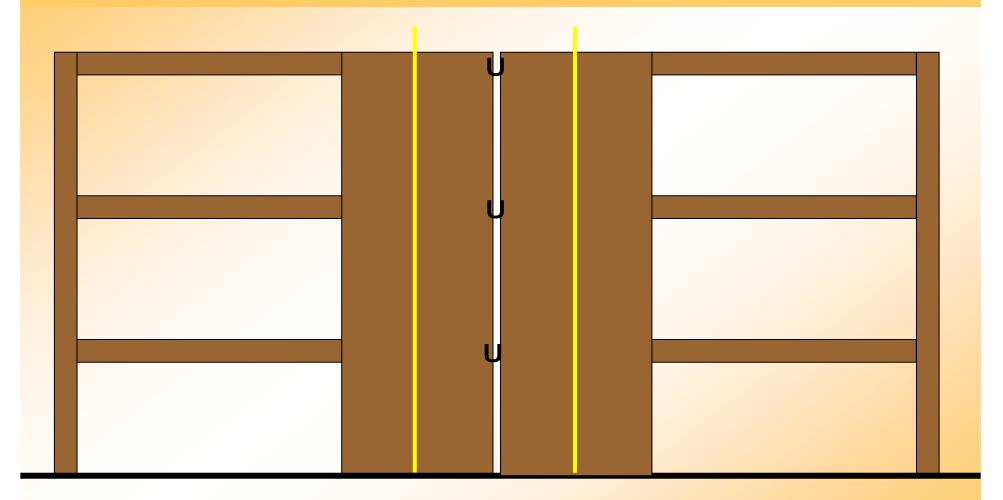
Post-tensioned timber walls

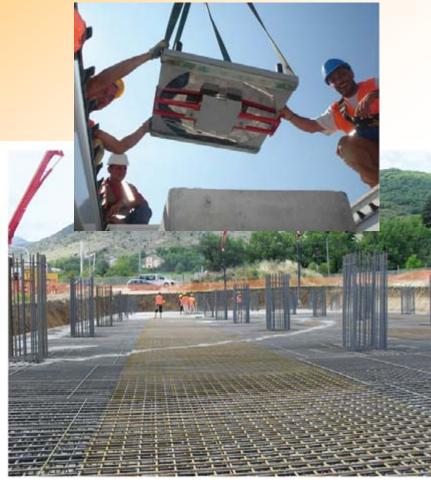
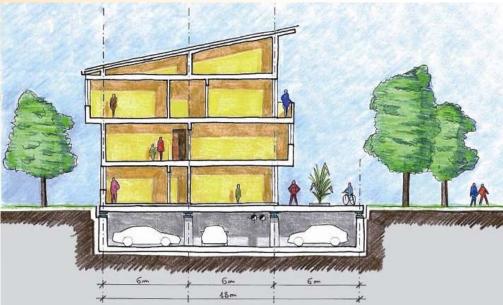
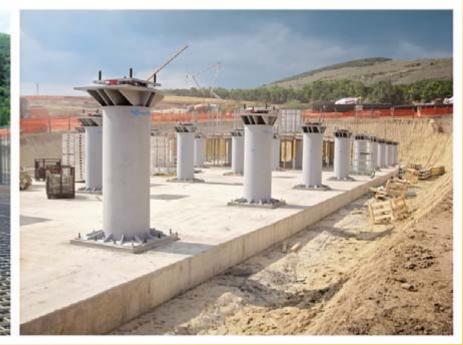
Base isolation

L'Aquila, Italy. 2009

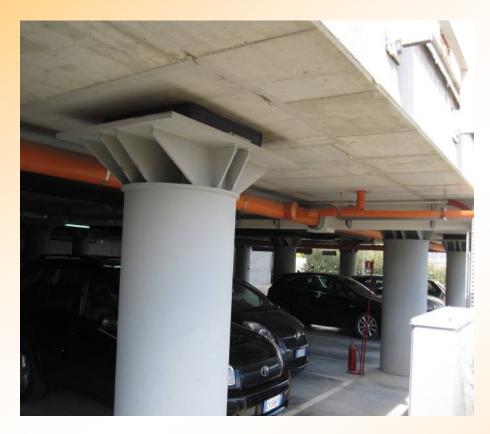
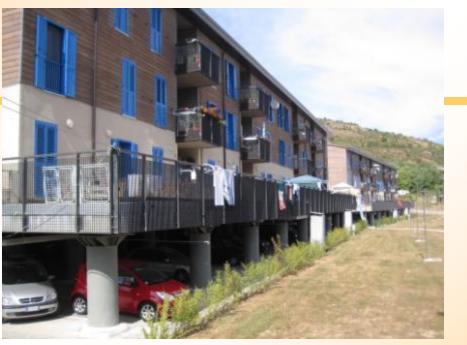
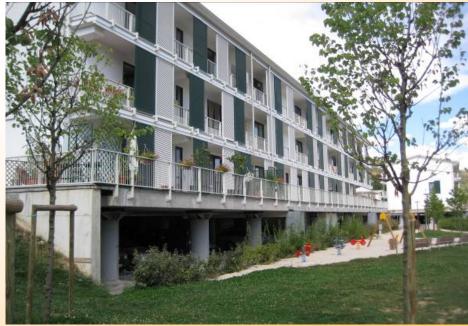
Base isolation

L'Aquila, Italy. 2009

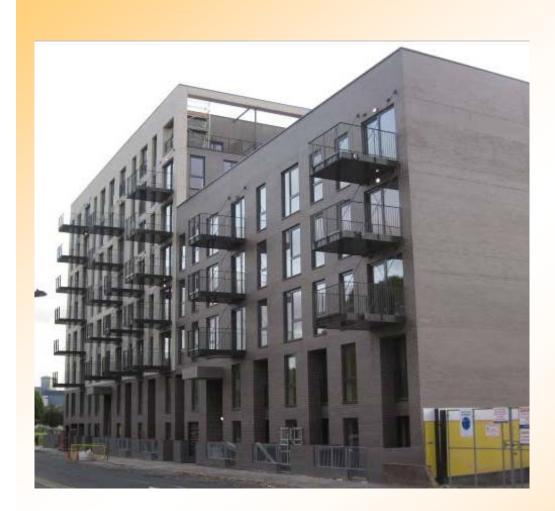
CLT buildings

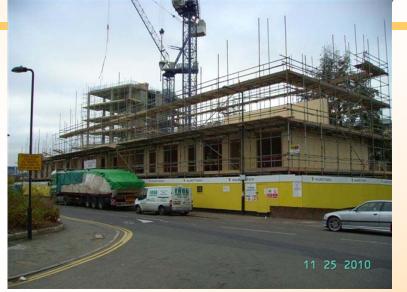
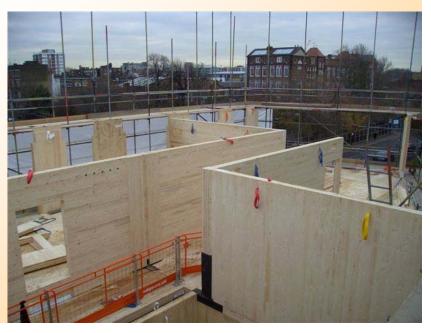
7 storey CLT building, London

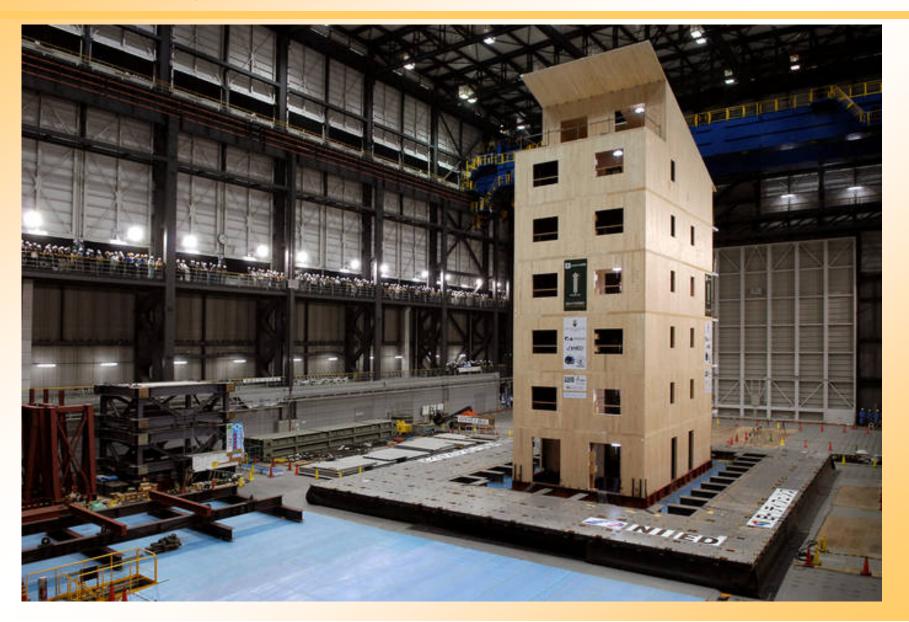
7 storey CLT shake test

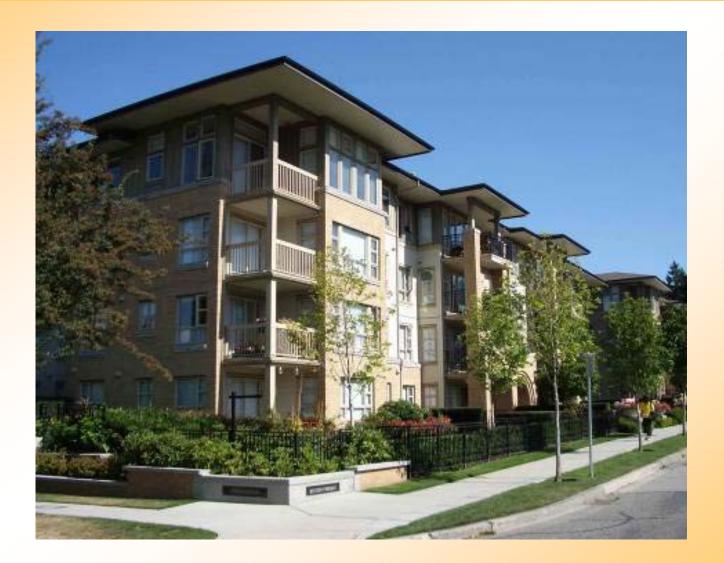
Light timber frame

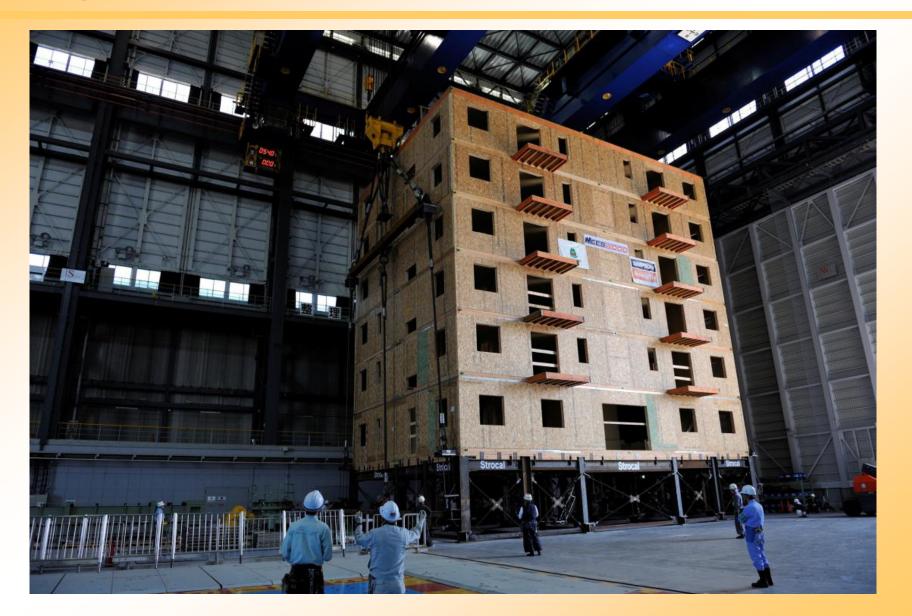
Light timber frame test

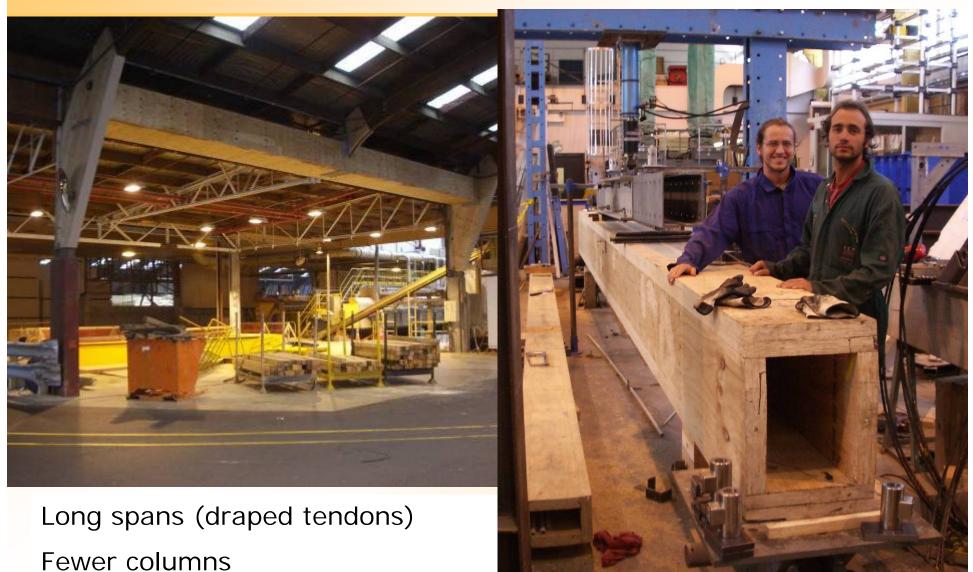
Post-tensioned beams

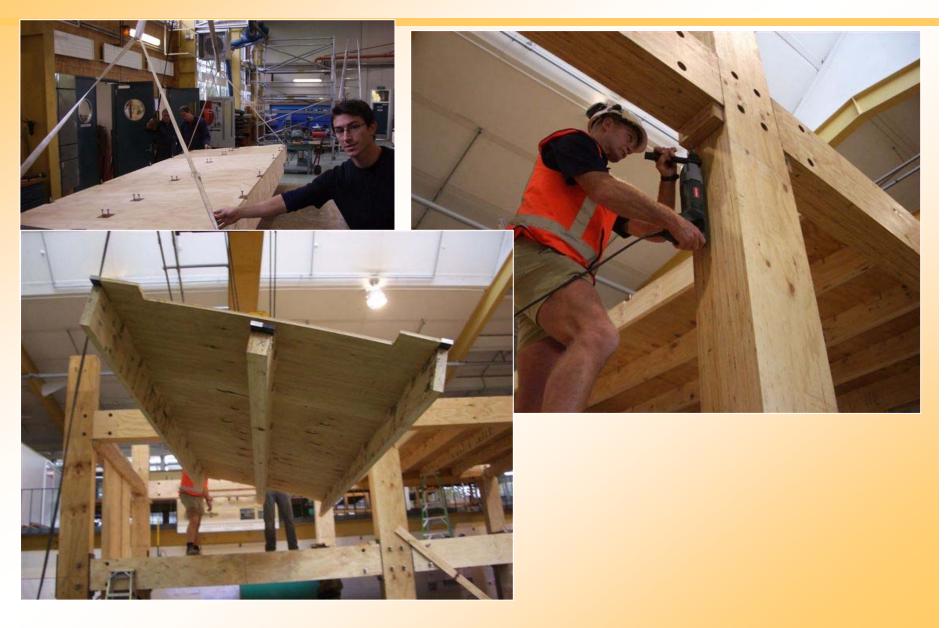
Post-tensioned timber building

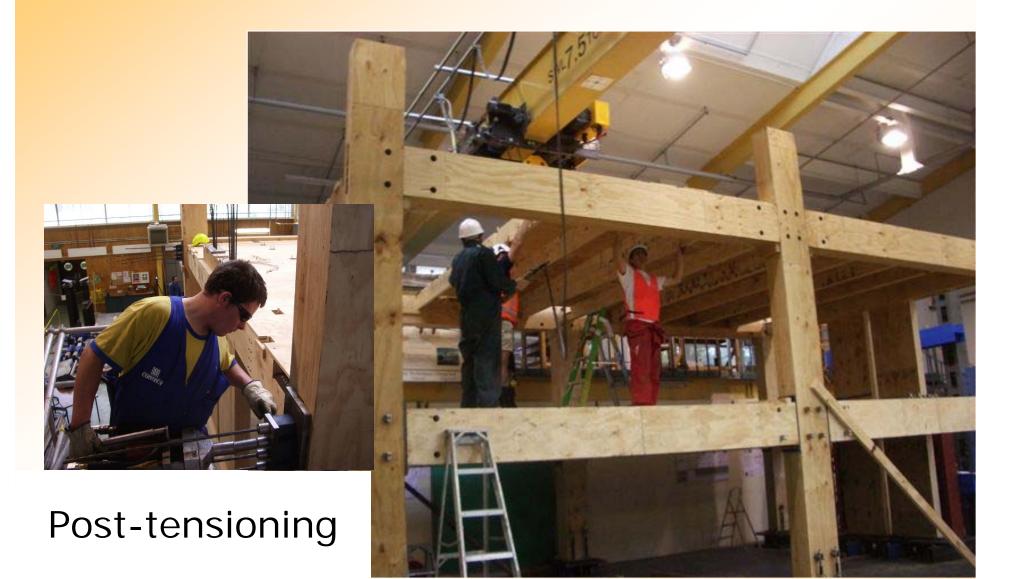
Post-tensioned timber building

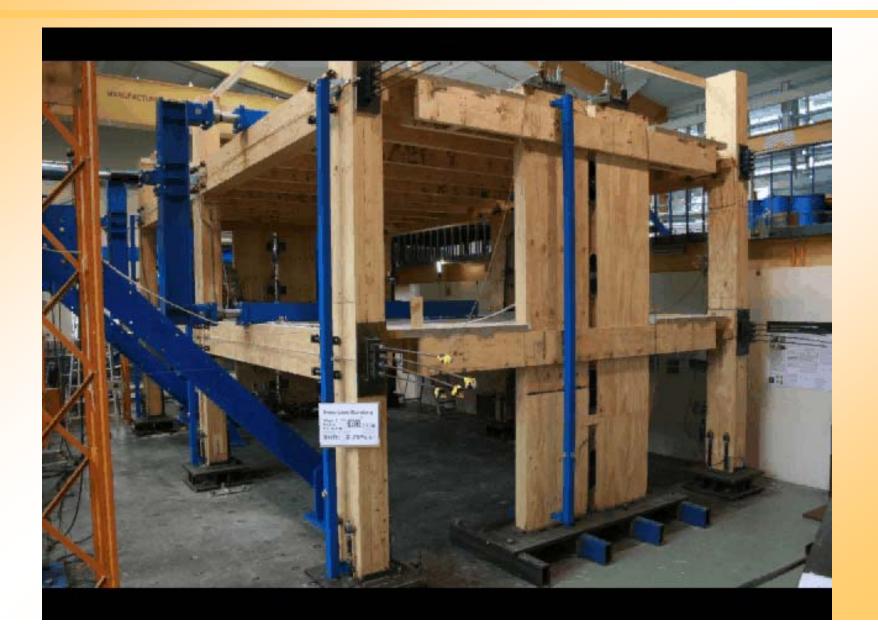
Post-tensioned timber

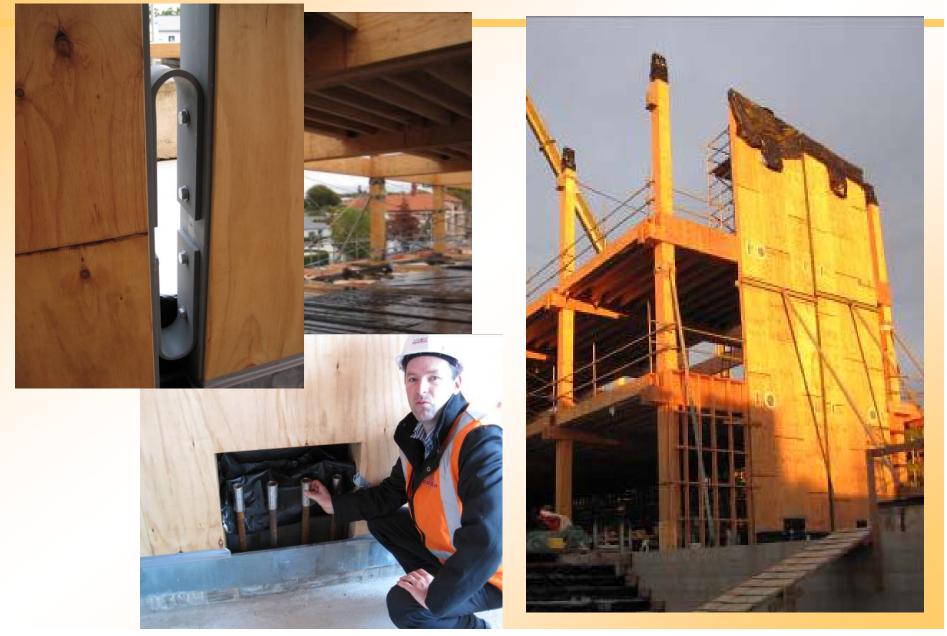
Post-tensioned timber walls

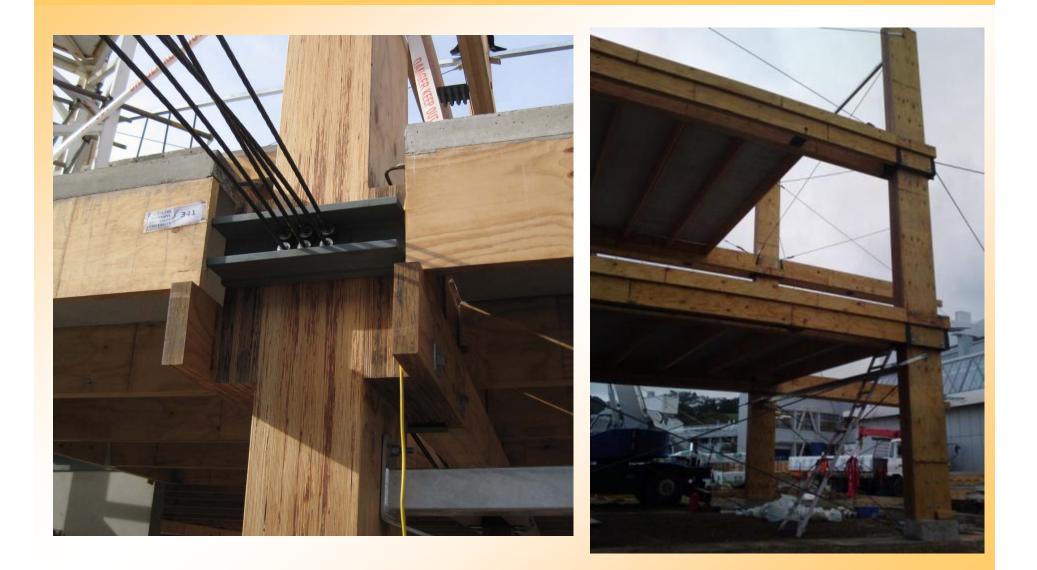
Post-tensioned timber frames

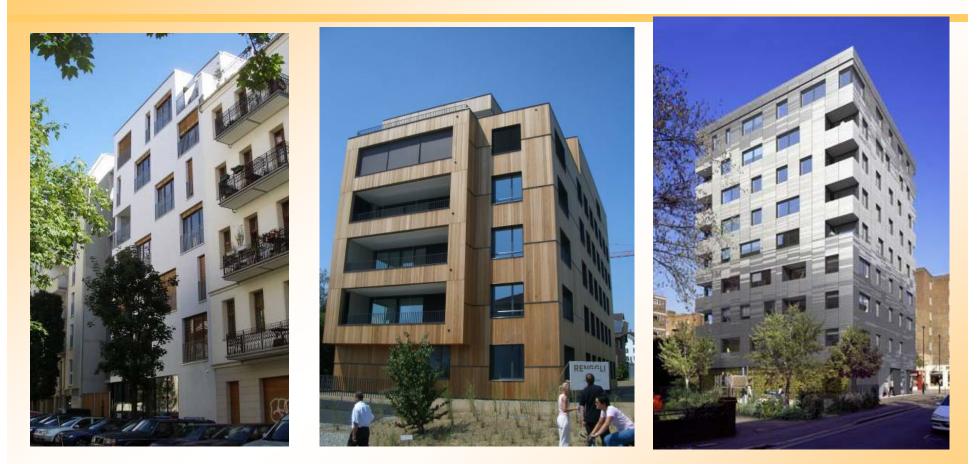
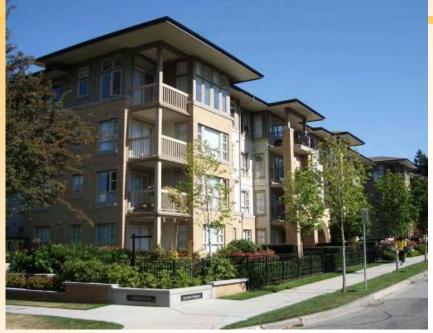
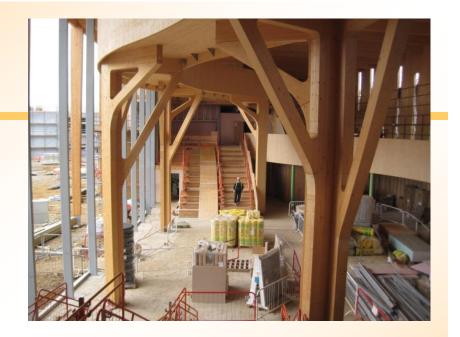
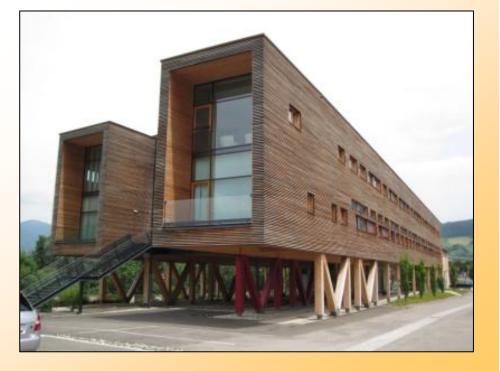
7 storeys – Berlin (Glulam)

6 storeys – Switzerland (Light timber frame)

9 storeys – London (CLT panels)
