Under **THE COMMISSIONS OF INQUIRY ACT 1908**  
In the matter of the **CANTERBURY EARTHQUAKES ROYAL COMMISSION  
OF INQUIRY INTO THE COLLAPSE OF THE CTV  
BUILDING**

**STATEMENT OF EVIDENCE OF DOUGLAS ALEXANDER LATHAM**

**Concrete sampling**

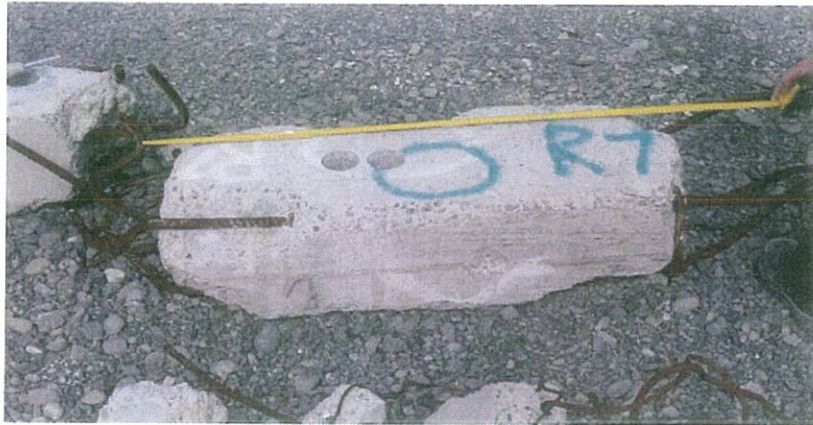
## Photo of column:

<b>Column identifier:</b>	R7
Date of sampling:	21/03/2012
Sampled by:	DL
Weather:	Fine
Location in building:	400x300 column, Grid A, level unknown
Design concrete strength:	25-35 Mpa
Nominal aggregate size:	19mm

<b>Sample identifier:</b>	R7
Begin coring:	10:22am
Finish coring:	10:48am
Ends cut:	Not cut
Diameter of core:	145mm approx
Length of core:	260+70mm approx
Bagged and sealed:	11:32am
Notes:	Sample broken due to pre-existing crack in concrete

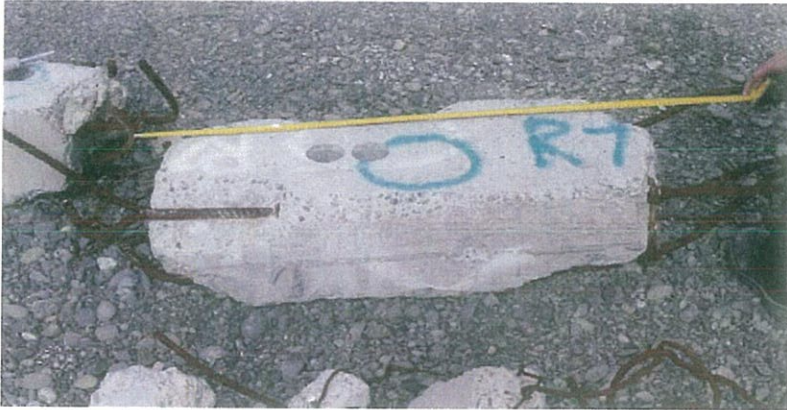
<b>Column identifier:</b>	R7
Date of testing:	20/03/2012
Time of testing:	12:50pm
Tested by:	DL/CU
Weather:	Fine
Air temperature:	12-15°C
Location of sample in building:	400x300 column, Grid A, level unknown
Design concrete strength:	25-35 Mpa
Nominal aggregate size:	19mm
Form material:	Unknown
Curing conditions:	Unknown
Rebound Hammer type:	NDT James Instruments
Serial number:	86431
Last calibrated:	18/04/2011
Orientation of testing:	Vertical, downwards
<b>Photo of column:</b>

<b>Test area (refer photo above):</b>	Centre
Surface condition:	Unground
<b>Hammer rebound readings:</b>	46
	48
Note:	45
Readings in brackets represent	51
samples greater than +/- 6	43
outside the average of the 10	46
readings. These have not been	48
included in the average below	51
	49
	49
<b>Average hammer rebound:</b>	47.6
Testing was carried out in accordance with ASTM C805

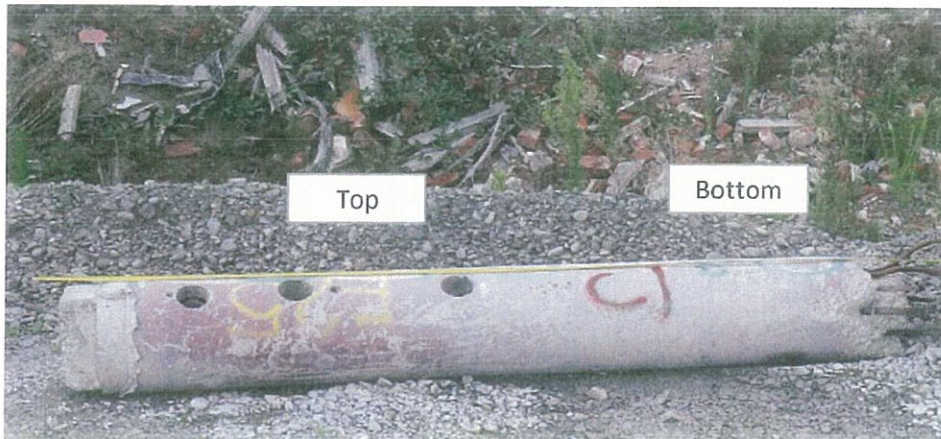
## Photo of column:

<b>Column identifier:</b>	<b>C1</b>
Date of sampling:	20/03/2012
Sampled by:	DL/CU
Weather:	Fine
Location in building:	400 diameter column, Level 6, plan location unknown
Design concrete strength:	25 Mpa
Nominal aggregate size:	19mm

<b>Sample identifier:</b>	<b>C1-T</b>	<b>C1-B</b>
Begin coring:	12:34pm	12:59pm
Finish coring:	12:47pm	1:29pm
Ends cut:	Not cut	Not cut
Diameter of core:	145mm approx	145mm approx
Length of core:	130+210mm approx	120+220mm approx
Bagged and sealed:	1:35pm	2:18pm
Notes:	Sample broken due to pre-existing crack in concrete	Sample broken due to pre-existing crack in concrete

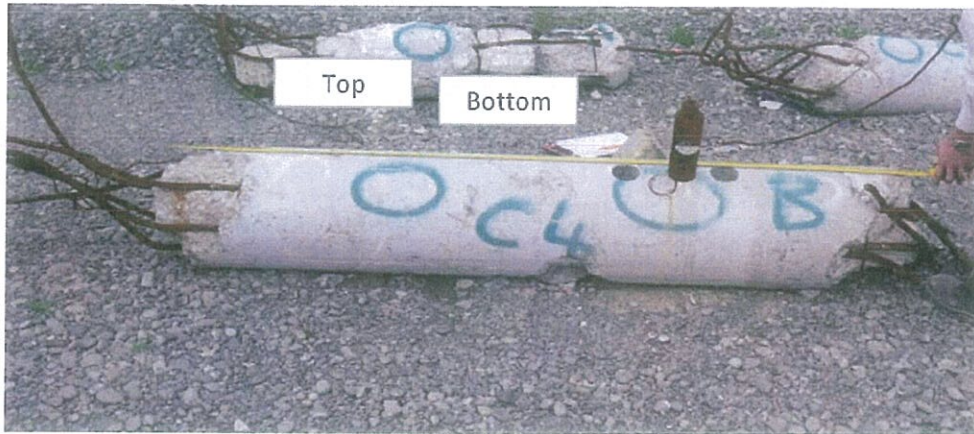
## Photo of column:

<b>Column identifier:</b>	C4
Date of sampling:	20/03/2012
Sampled by:	DL/CU
Weather:	Fine
Location in building:	400 diameter column, location unknown
Design concrete strength:	25-35 Mpa
Nominal aggregate size:	19mm

Sample identifier:	C4-T	C4-B
Begin coring:	2:11pm	1:36pm
Finish coring:	2:49pm	2:04pm
Ends cut:	Not cut	Not cut
Diameter of core:	145mm approx	145mm approx
Length of core:	200+140mm approx	230mm approx
Bagged and sealed:	3:45pm	2:45pm
Notes:	Sample broken due to pre-existing crack in concrete	Sample broken due to pre-existing crack in concrete

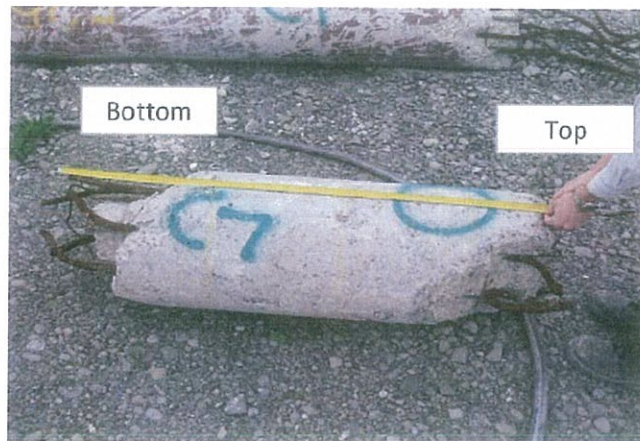
**Photo of column:**

**Column identifier:** C7  
**Date of sampling:** 20/03/2012  
**Sampled by:** DL/CU  
**Weather:** Fine  
**Location in building:** 400 diameter column, location unknown  
**Design concrete strength:** 25-35 Mpa  
**Nominal aggregate size:** 19mm

<b>Sample identifier:</b>	<b>C7-B</b>	<b>C7-T</b>
Begin coring:	11:16am	10:52am
Finish coring:	11:27am	11:05am
Ends cut:	11:32am	11:15am
Diameter of core:	145mm approx	145mm approx
Length of core:	290mm approx	295mm approx
Bagged and sealed:	12:17pm	11:54am
Notes:

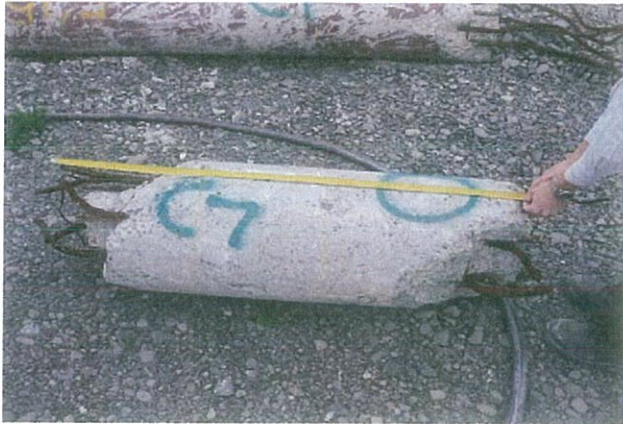
<b>Column identifier:</b>	C7
Date of testing:	20/03/2012
Time of testing:	9:26am
Tested by:	DL/CU
Weather:	Fine
Air temperature:	12-15°C
Location of sample in building:	400 diameter column, location unknown
Design concrete strength:	25-35 Mpa
Nominal aggregate size:	19mm
Form material:	Unknown
Curing conditions:	Unknown
Rebound Hammer type:	NDT James Instruments
Serial number:	86431
Last calibrated:	18/04/2011
Orientation of testing:	Vertical, downwards
<b>Photo of column:</b>

<b>Test area (refer photo above):</b>	Centre
Surface condition:	Unground
<b>Hammer rebound readings:</b>	(52)
	44
Note:	43
Readings in brackets represent	48
samples greater than +/- 6	44
outside the average of the 10	43
readings. These have not been	46
included in the average below	40
	42
	50
<b>Average hammer rebound:</b>	44.4
Testing was carried out in accordance with ASTM C805

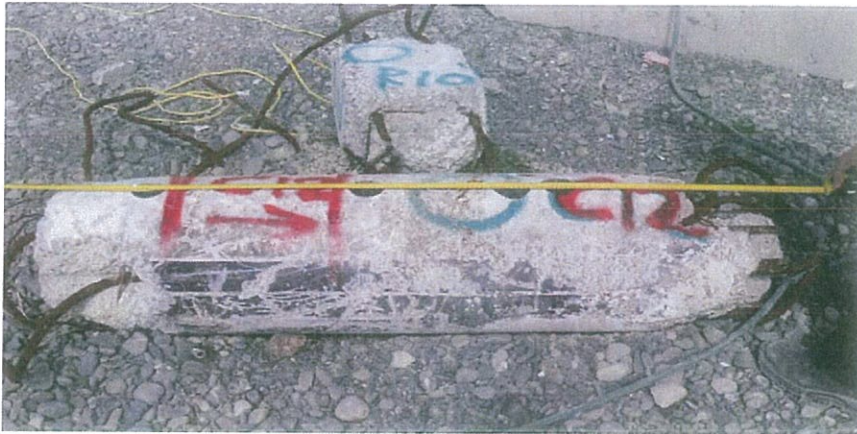
**Photo of column:**

<b>Column identifier:</b>	C12
Date of sampling:	21/03/2012
Sampled by:	DL
Weather:	Fine
Location in building:	400 diameter column, location unknown
Design concrete strength:	25-35 Mpa
Nominal aggregate size:	19mm

<b>Sample identifier:</b>	C12
Begin coring:	9:22am
Finish coring:	9:38am
Ends cut:	Not cut
Diameter of core:	145mm approx
Length of core:	160+120+40mm approx
Bagged and sealed:	10:23am
Notes:	Sample broken due to pre-existing crack in concrete

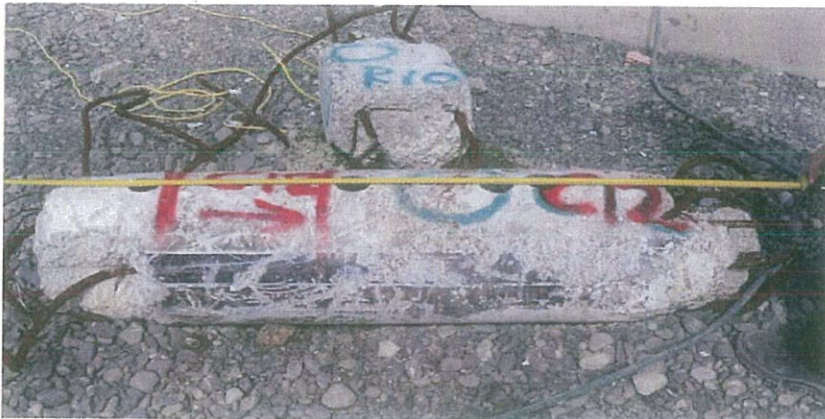
**Photo of column:**

<b>Column identifier:</b>	C12
Date of testing:	20/03/2012
Time of testing:	2:19pm
Tested by:	DL/CU
Weather:	Fine
Air temperature:	12-15°C
Location of sample in building:	400 diameter column, location unknown
Design concrete strength:	25-35 Mpa
Nominal aggregate size:	19mm
Form material:	Unknown
Curing conditions:	Unknown
Rebound Hammer type:	NDT James Instruments
Serial number:	86431
Last calibrated:	18/04/2011
Orientation of testing:	Vertical, downwards

<b>Test area (refer photo above):</b>	Centre
Surface condition:	Unground
<b>Hammer rebound readings:</b>	47
	44
Note:	44
Readings in brackets represent	44
samples greater than +/- 6	46
outside the average of the 10	48
readings. These have not been	46
included in the average below	47
	52
	51
<b>Average hammer rebound:</b>	46.9
