CTV Building Drag Bar Capacity Assessment

Prepared for Canterbury Earthquakes Royal Commission

By Beca Infrastructure Ltd (Beca)

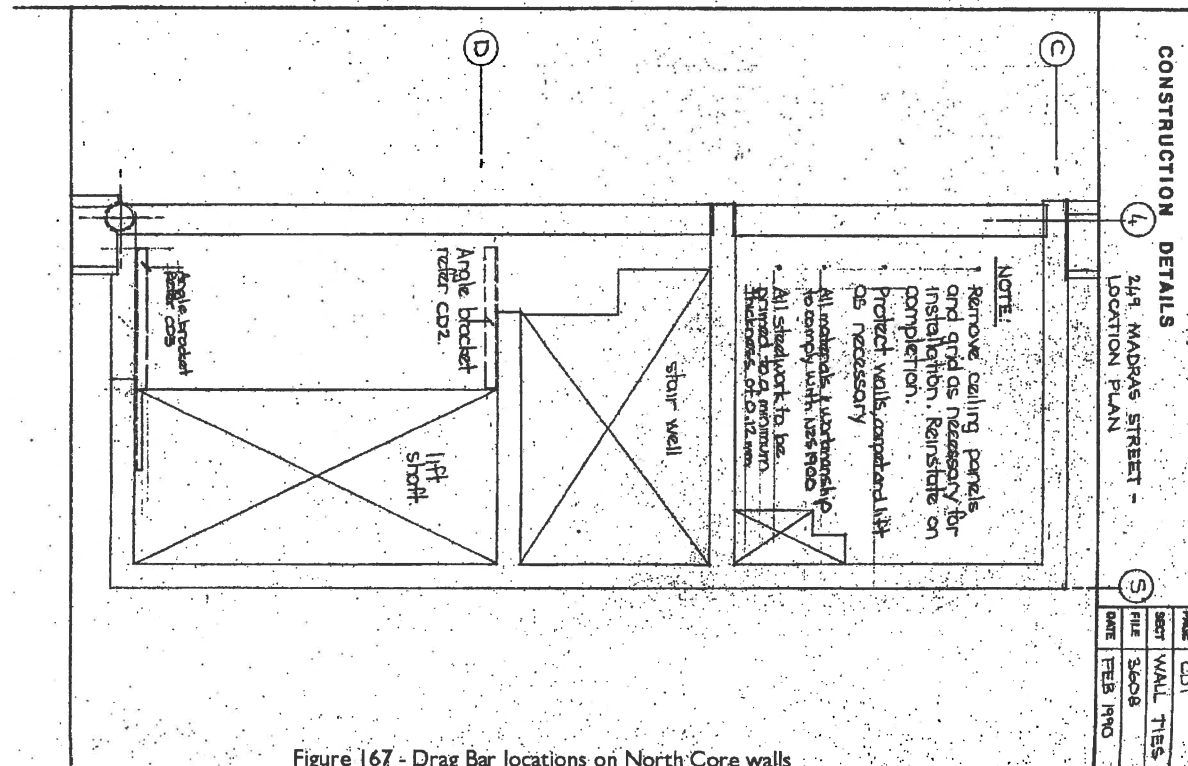
Figure 167 - Drag Bar locations on North Core walls

The CTV building 'drag bars' connected the floors at Levels 4, 5 and 6 to the North Core walls on Lines D and D/E. The drag bars were retrofitted to the building in 1990 and consist of steel angles fixed to the floor slab and walls using Chemset type bonded anchors (steel studs adhesive fixed into holes drilled in the concrete).

- Drag bar and anchor details as shown in Figures 167 and 168 of the Collapse Report (reproduced in Figures 1 and 2 of this report)
- Slab and wall dimensions and reinforcement as shown on Drawings S11, S15 and S16 contained in Appendix L of the Collapse Report
- Concrete strength for slab and walls of 25 MPa
- Reinforcement grades of 380 MPa for H bars and 485 MPa for 664 mesh
- Hi-bond decking 0.75mm BMT, 550 MPa yield
- Drag bar steelwork (steel angle section and RHS) 250 MPa yield, 400 MPa UTS
- Chemset studs Grade 5.8, 520 MPa UTS, 145mm embedment in slab and walls
- Ultimate anchor bond strength of 10 MPa, based on back calculation from Ramset capacities

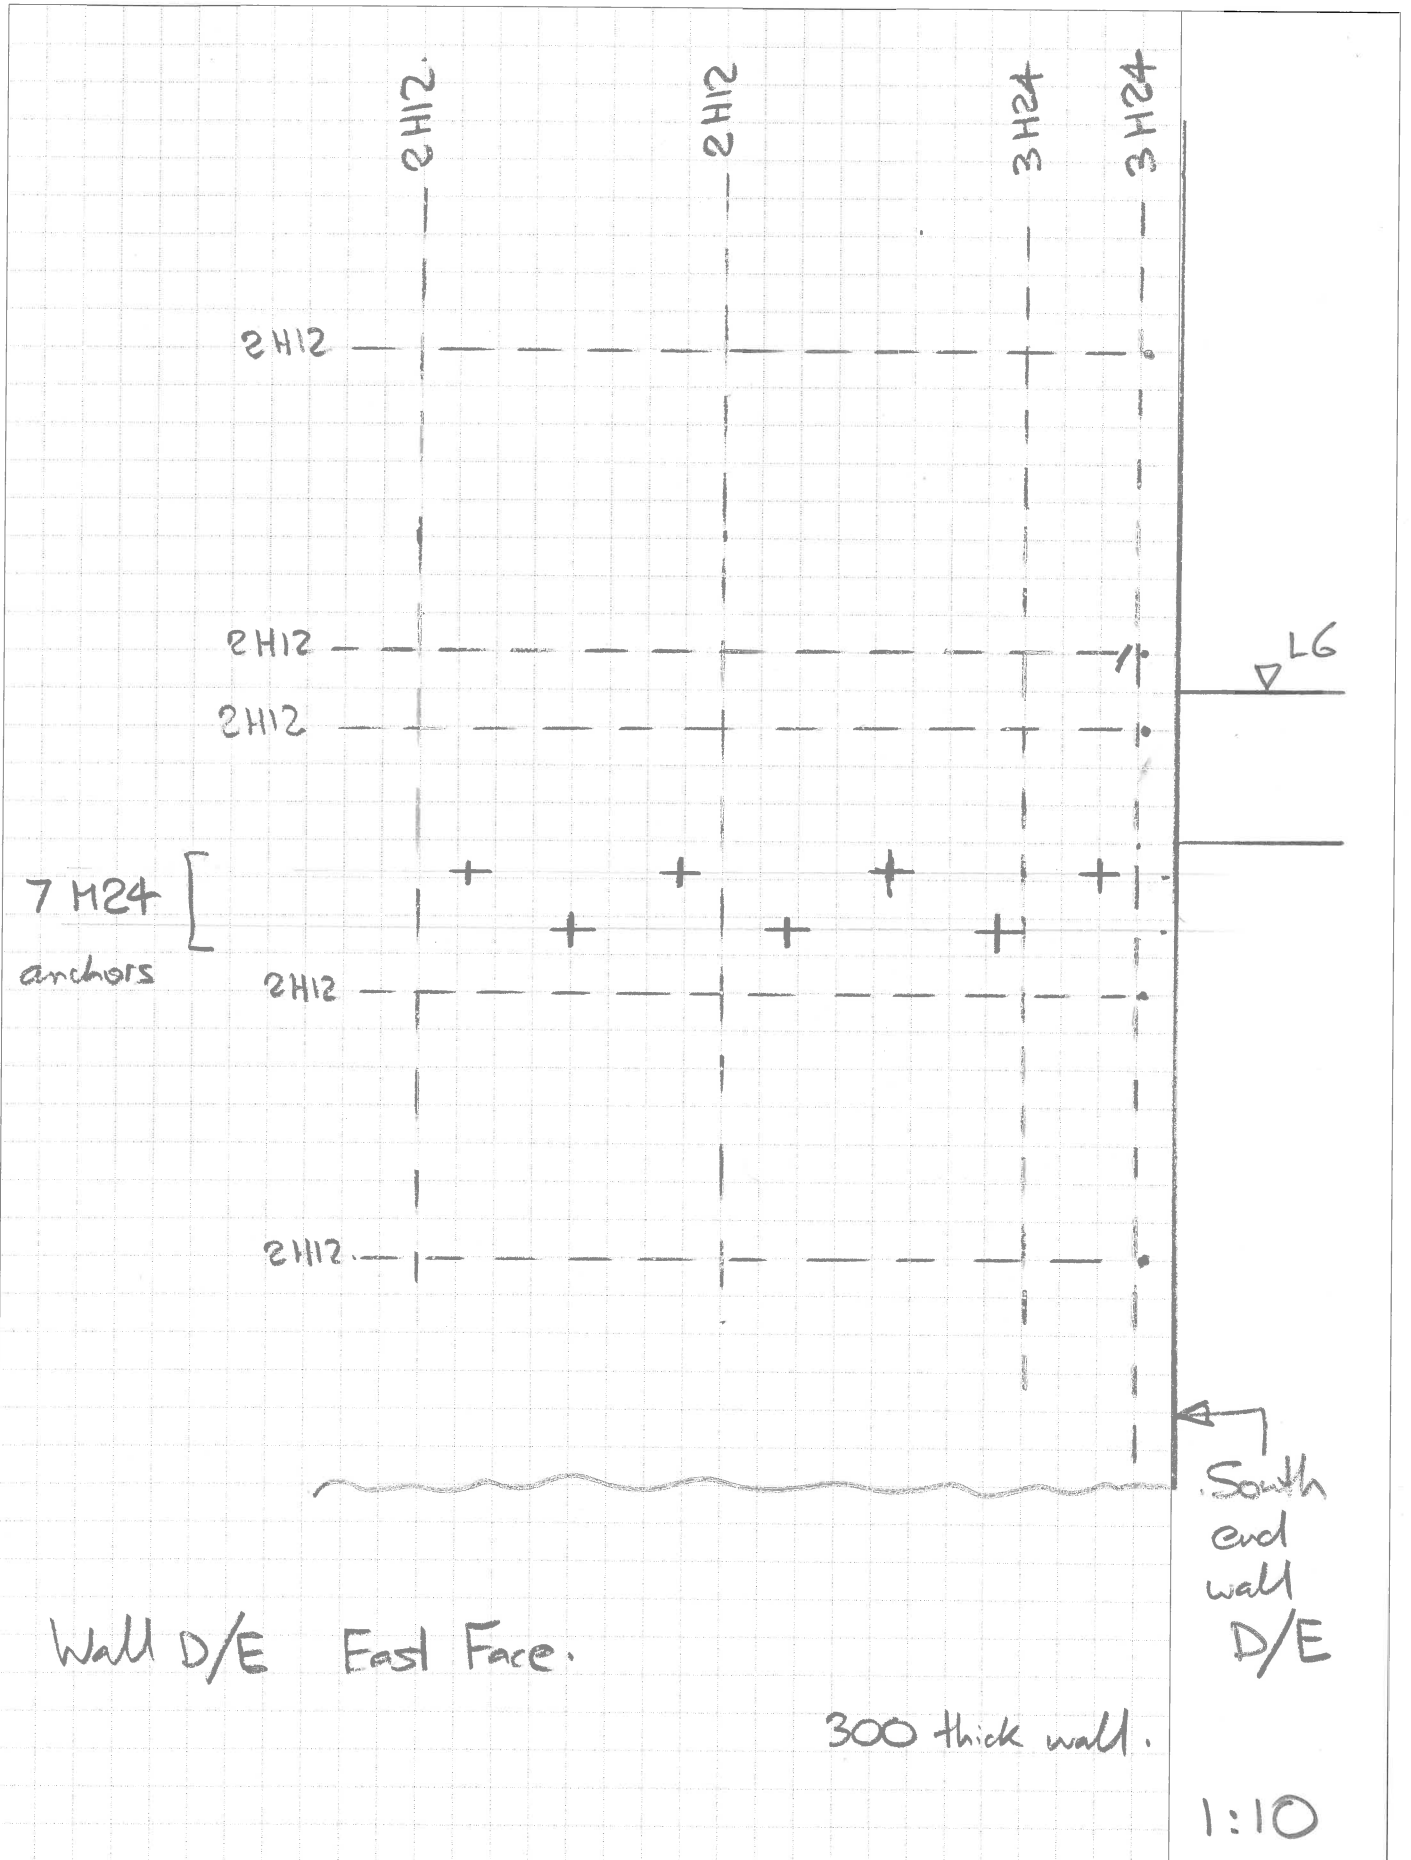
Job Number _____ Date 27/5/12
 Job Name CERC Assessment
 Subject CTV Drag Bars - Wall Anchors
 By ARD Page No _____ of _____

Information relevant to each different anchor group at Level 6 is summarised in the sketches shown in Figures 3, 4 and 5.

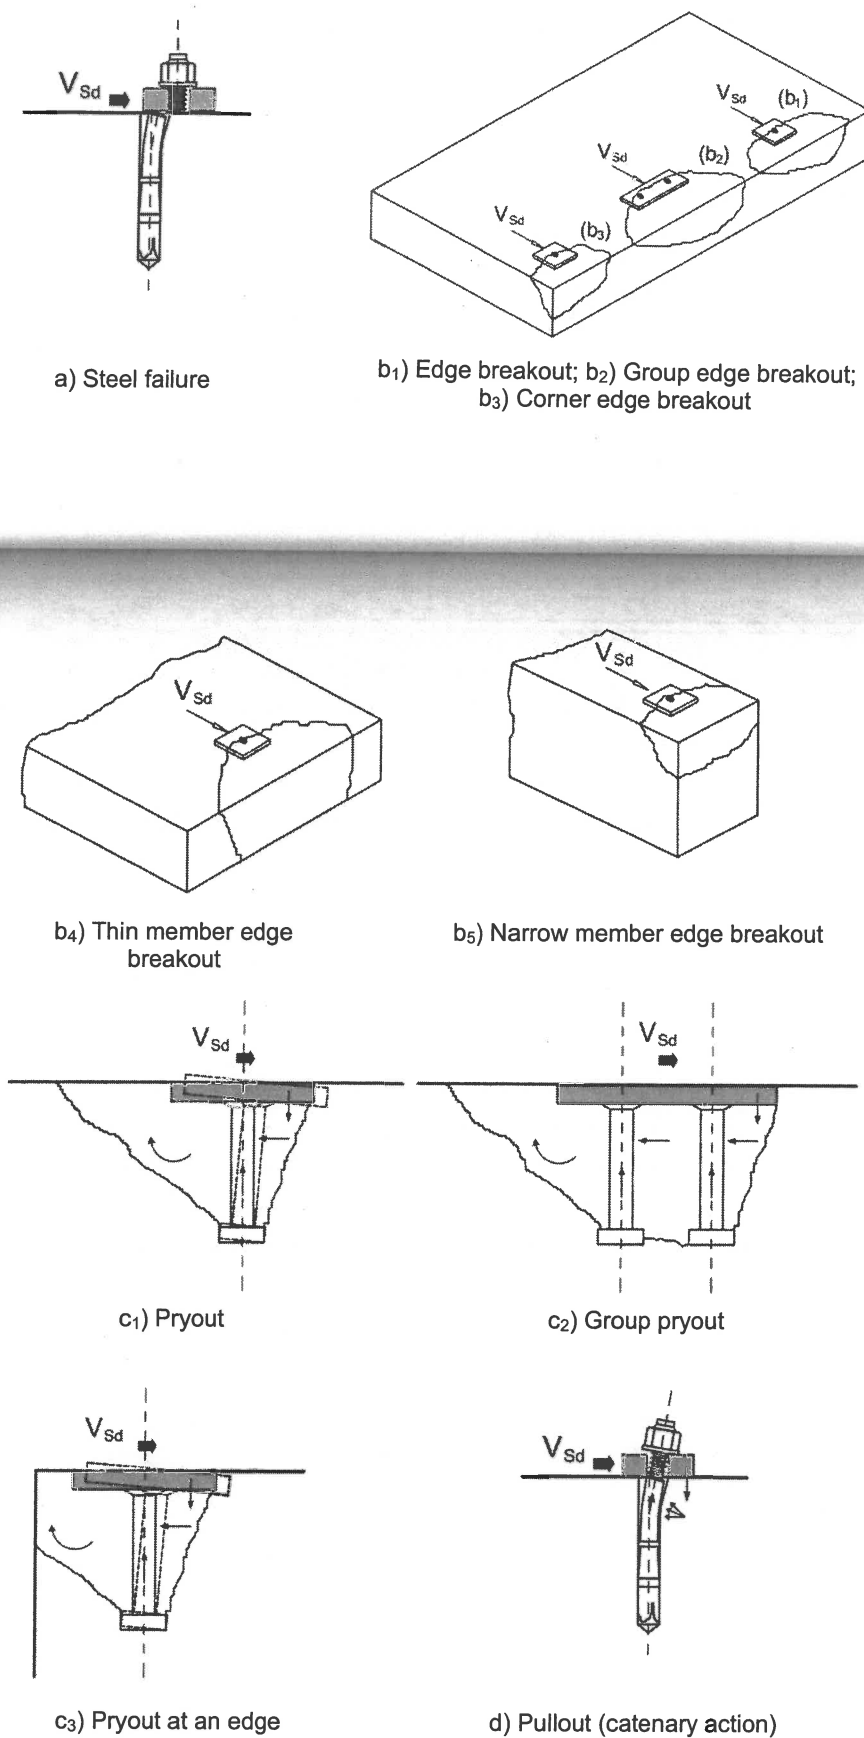
Figure 3.2-2: Failure modes associated with shear loading

FIB 58 describes and assists capacity assessment for the following shear load failure modes (refer Figure 6):

- Steel failure (shear failure of anchor stud)
- Pryout (of concrete cone)
- Pullout (of anchor)
- Edge breakout (in direction of loading or perpendicular to direction of loading)

Concrete edge failure mode is characterised by the formation of a cone-shaped fracture surface originating at the anchor shaft and radiating towards the concrete edge.

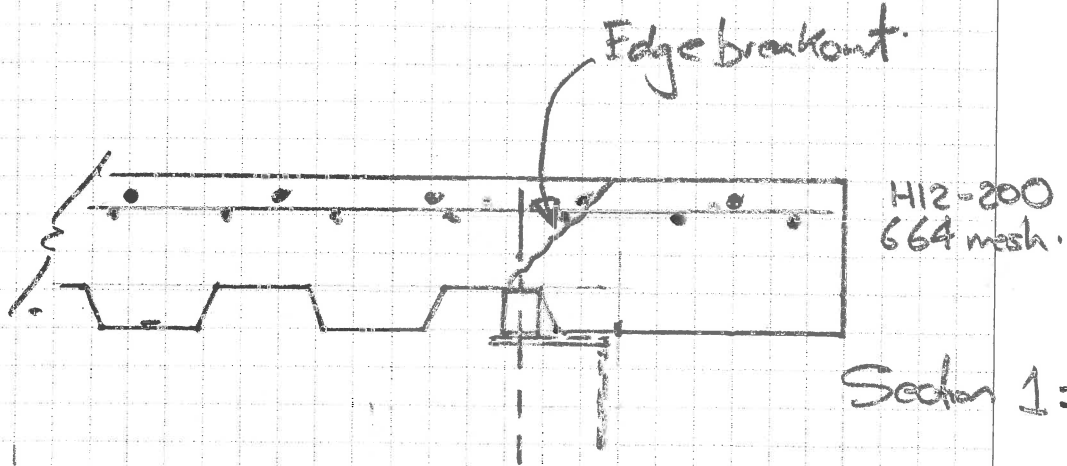
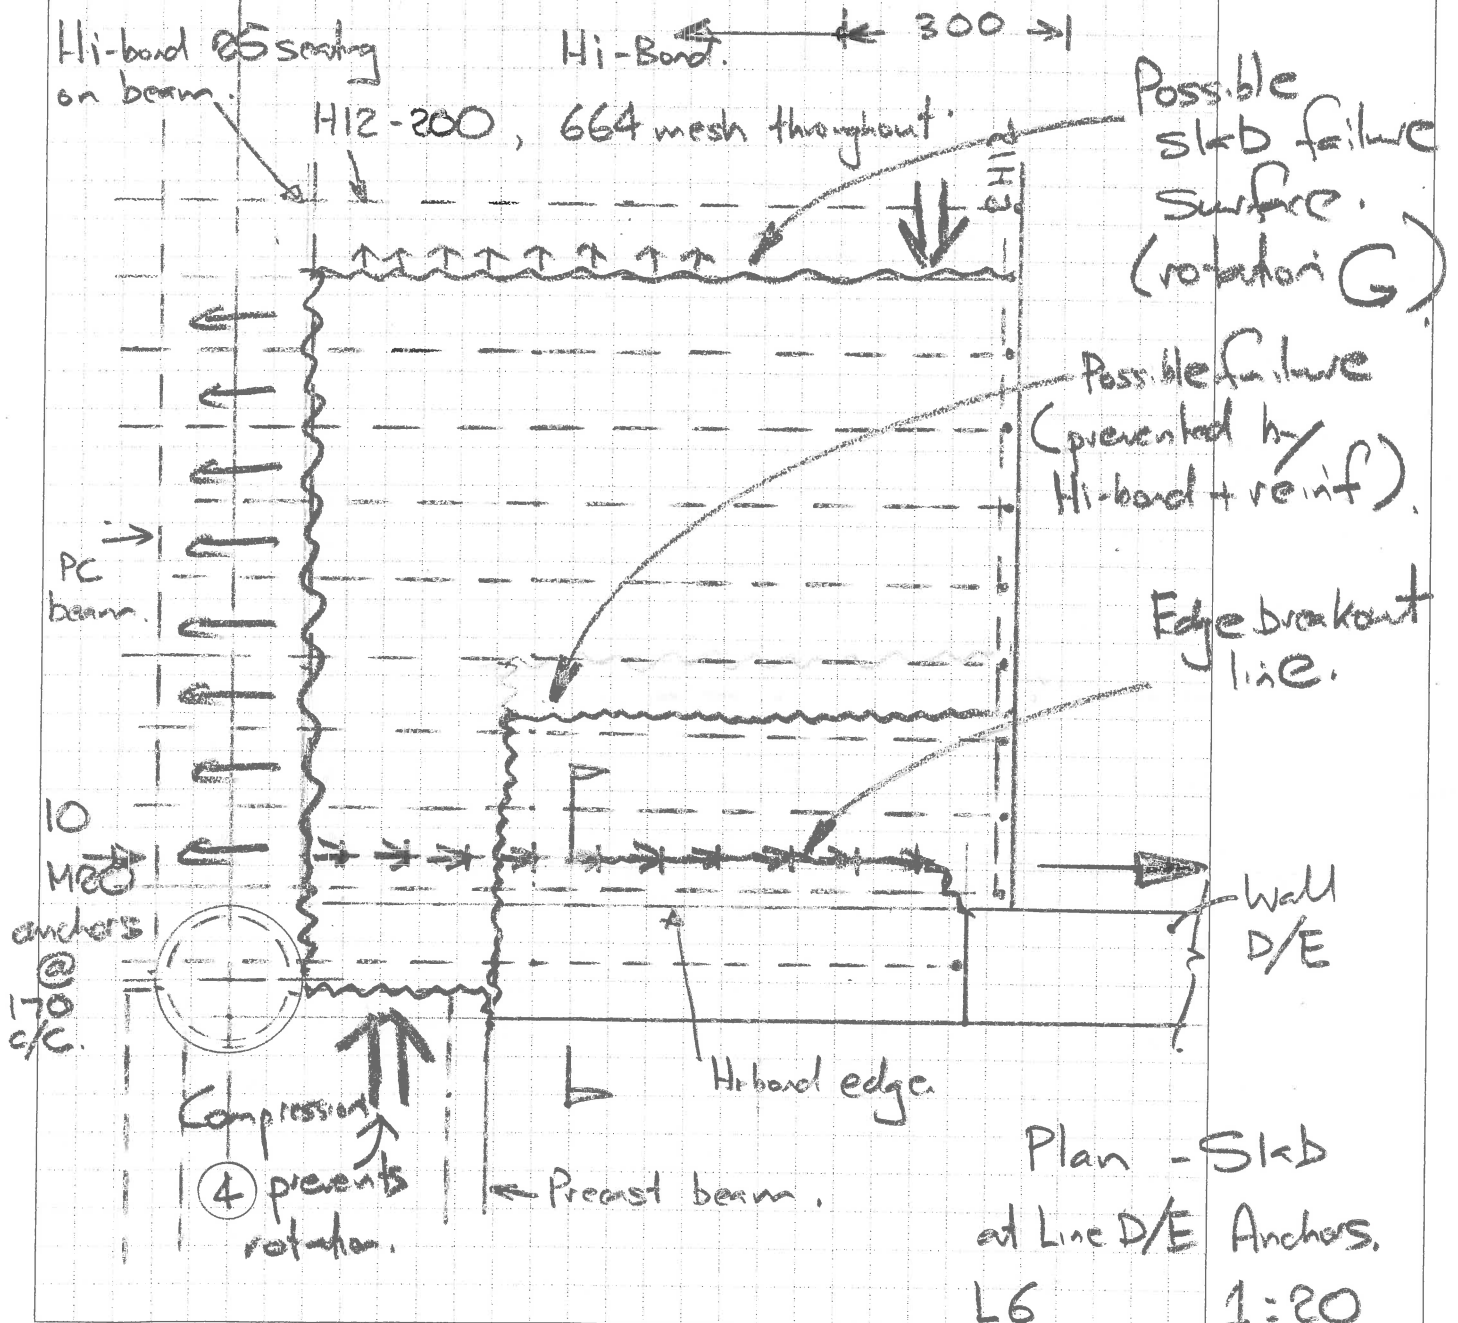
Job Number _____ Date 27/5/12
 Job Name CERC Assessment
 Subject CTV Day Bas - Line D/E Slab Anchors
 By ARD Page No _____ of _____

However, the capacity of the line of anchors (refer Figure 9) is limited by edge breakout perpendicular to the direction of loading, especially for those anchors closest to the wall. We understand that there was no reinforcement linking the slab edge thickening to the wall and thus little preventing an edge breakout failure of the form indicted on Figure 9. The reinforcing mesh (as detailed) appears too high in the slab to offer fully effective restraint to this failure, and so the calculated edge breakout capacity of 32 kN per anchor has been adopted for the anchors closer to the wall. This breakout can be assumed to occur at a group load of 320 kN.

Because of the proximity of the free edge, the potential exists at this anchor group for a slab tensile failure to occur, either (a) along the line where the Hi-Bond is seated on the Grid 4 beam or (b) parallel with the outside face of the large Grid 4 beam to the east of the column. These are indicated on Figure 9.
