REPORT 108880 (v1.0)

PREPARED FOR ROYAL COMMISSION

OCTOBER 2012

**INVESTIGATION INTO THE INFLUENCE
OF STRAIN-AGING ON THE SEISMIC
PERFORMANCE OF THE REINFORCING
STEEL FROM THE CTV BUILDING**

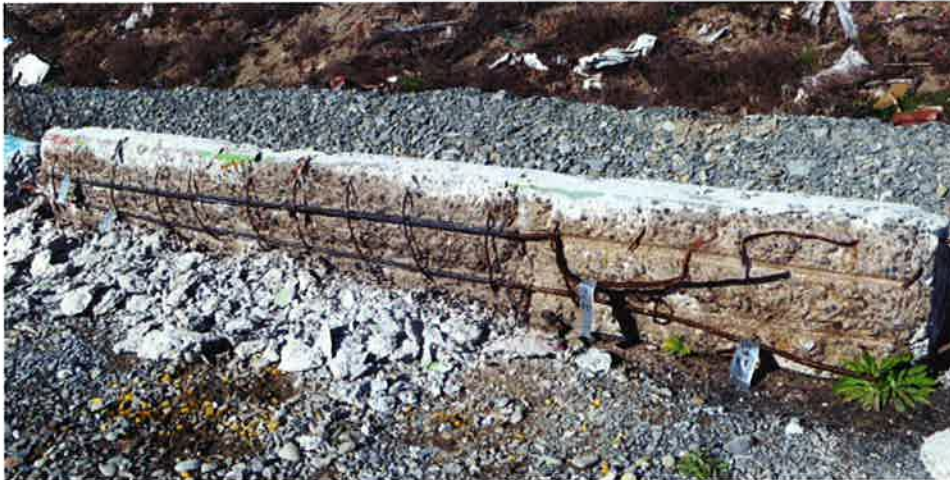
Reinforcing bar samples were obtained from an intact column element. Care was taken to collect the samples from zones in the column that had no visually apparent cracks.

Figure 1 Example of Column element suitable for sample extraction.

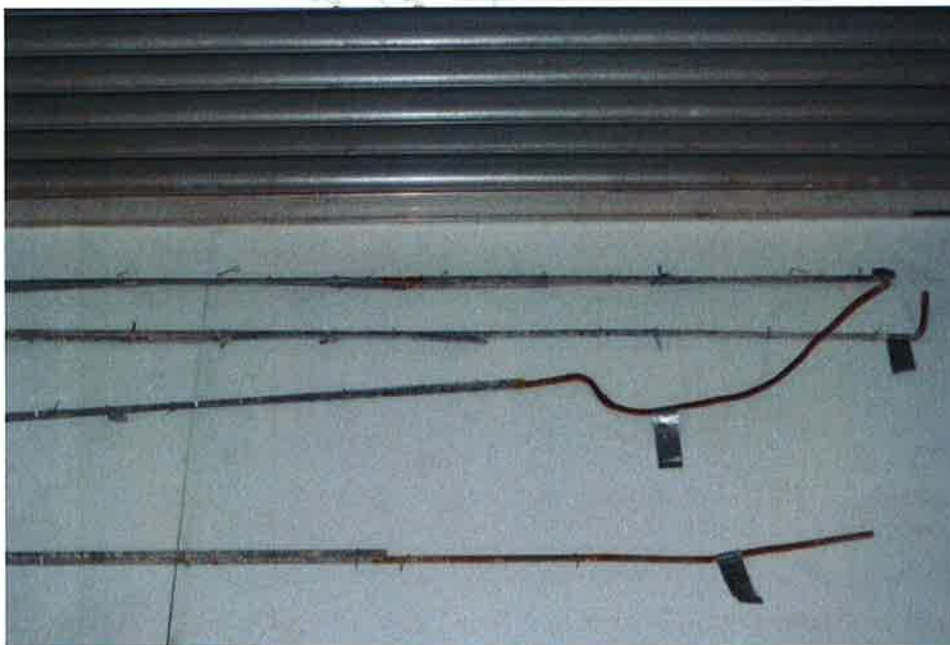
Figure 2 Unprepared 12 mm diameter reinforcing bar samples.

In total, 60 test samples were obtained for testing, the majority obtained from the column element and remaining samples from the suspended floor. All samples were a minimum of 600 mm long and cut into two sections to form the pair of matched samples prior to testing.

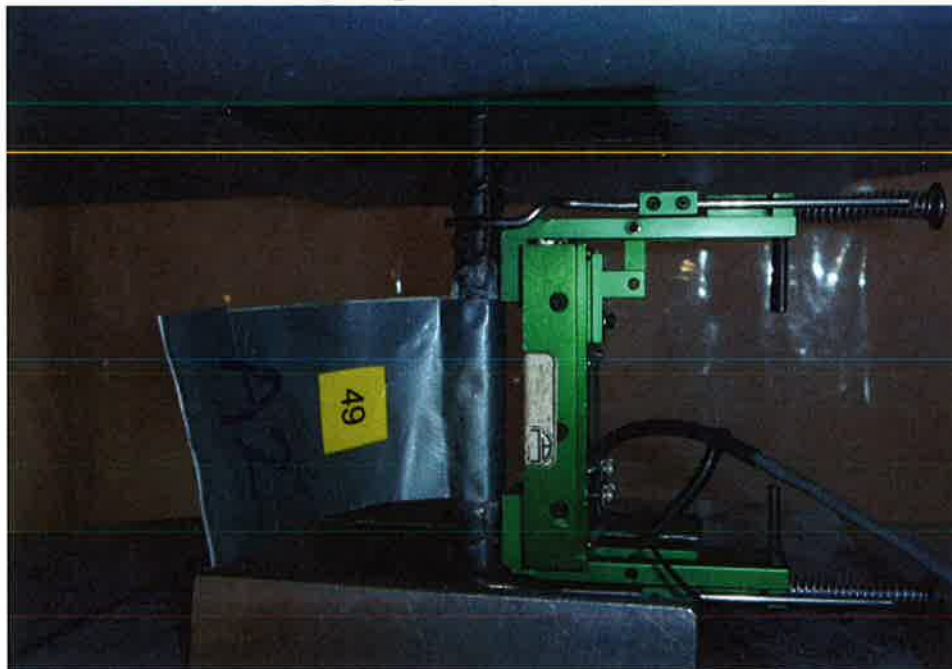
Figure 4 Testing of 12 mm diameter control bar from a column element

A EN ISO 7500-1:2004 Class 1 calibrated UH600 Shimazu servo-controlled Universal Test Machine (UTM) with a 600 kN capacity was used to undertake all laboratory based materials testing. The UTM has a maximum stroke of 250 mm and a maximum table velocity of 150 mm/min. Applied loads to the test specimen were recorded directly using the internal measurement transducer of the Shimazu control system.

Steel Elongation was recorded using a strain gauge based digital extensometer with a gauge length of 50 mm. The extensometer is calibrated to ISO 9513-1999, with a reported Class 1 accuracy.

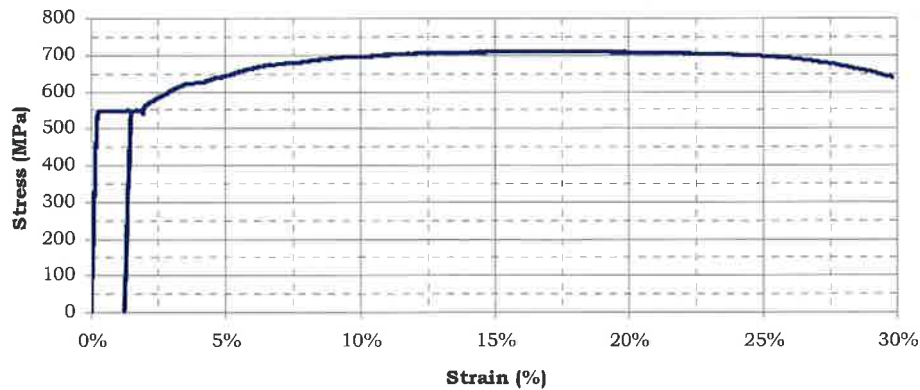
Figure 5 Representative Materials Stress-strain response

The derived lower 5th percentile material properties are presented in Table 2. The derivation of results was obtained assuming a normal distribution. A representative stress-strain response from the material is presented in Figure 5.

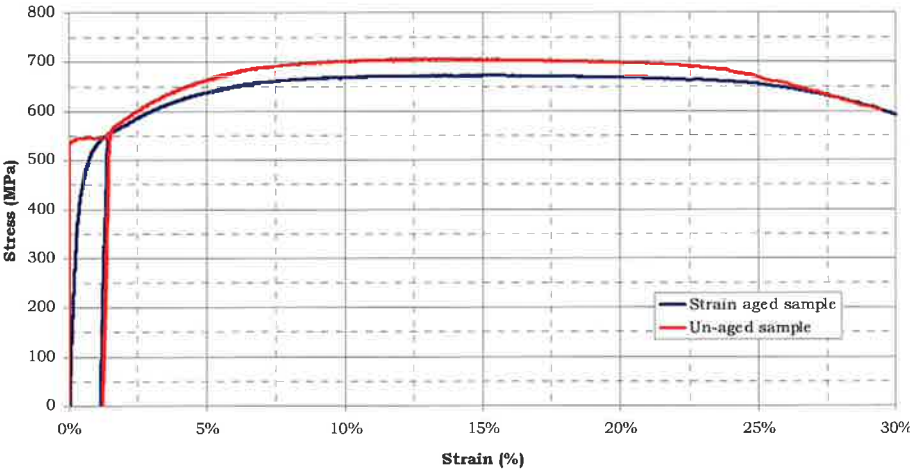
Figure 6 Materials Stress-strain response for 1.5% pre-strain and 30 days aging

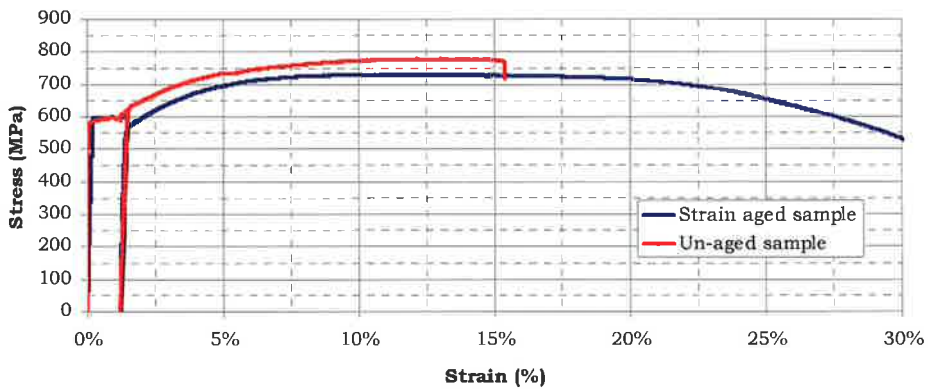
Figure 9 Materials Stress-strain response for 1.5% pre-strain and 60 days aging

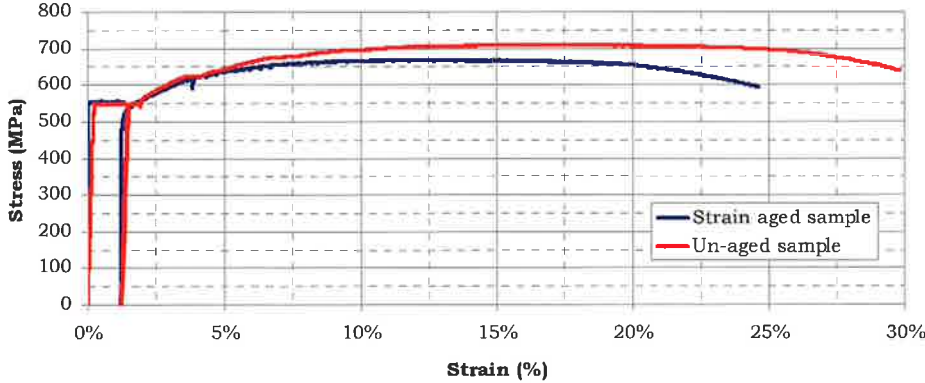
Figure 11 Materials Stress-strain response for 1.5% pre-strain and 60 days aging

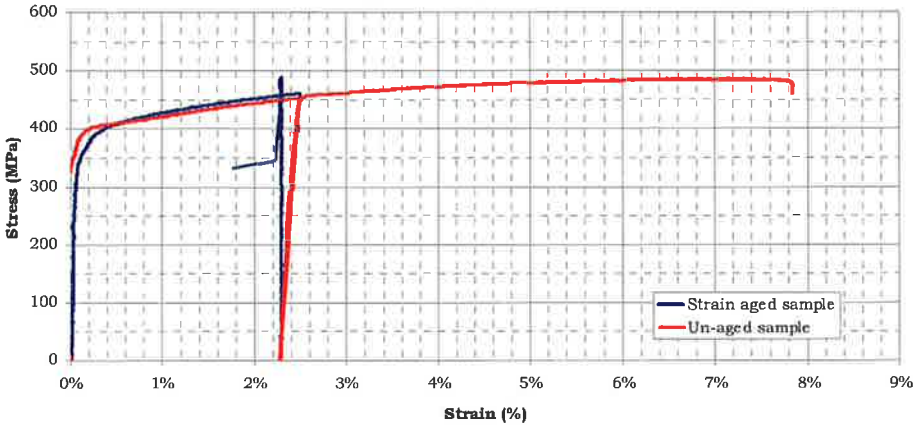
Figure 12 Materials Stress-strain response for 2.5% pre-strain and 30 days aging

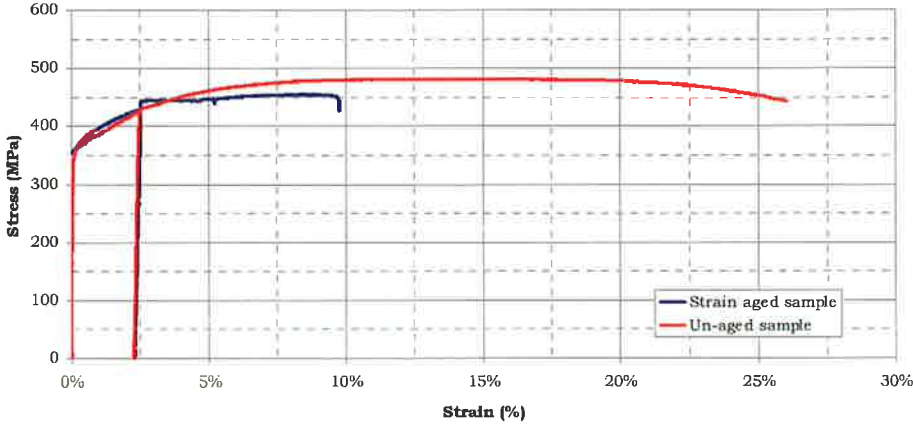
Figure 13 Materials Stress-strain response for 2.5% pre-strain and 30 days aging

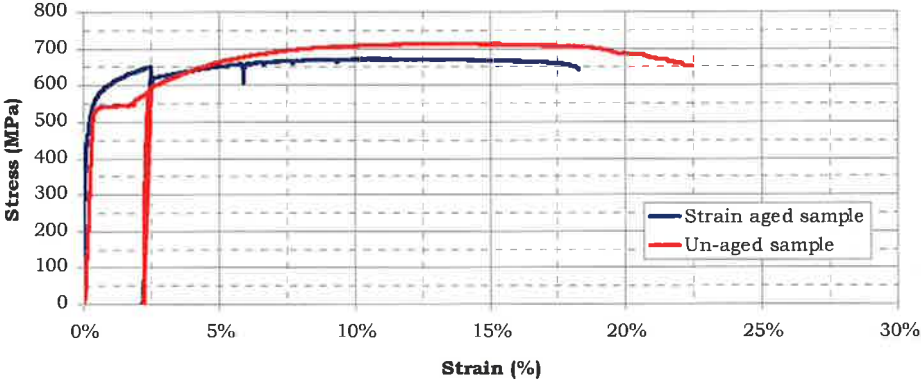
Figure 16 Materials Stress-strain response for 2.5% pre-strain and 60 days aging

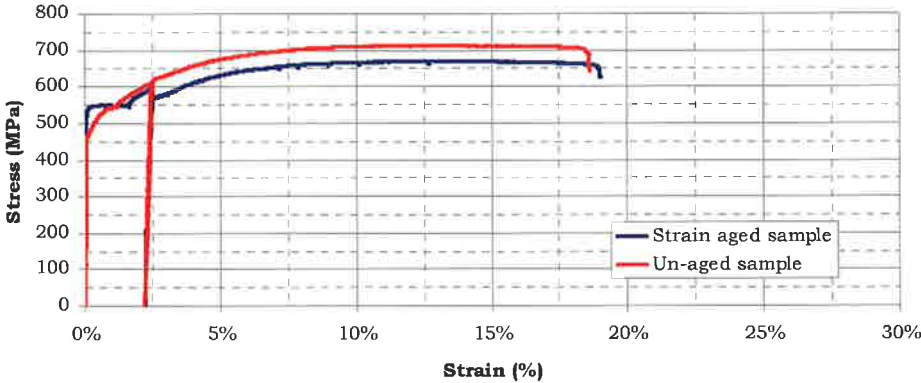
Figure 17 Materials Stress-strain response for 2.5% pre-strain and 60 days aging

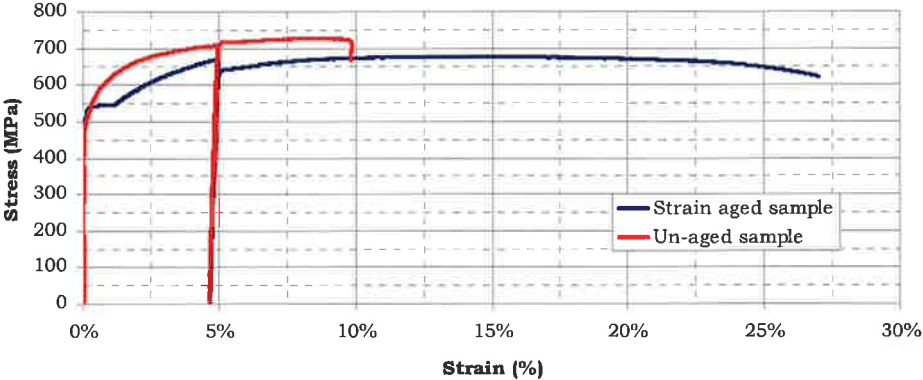
Figure 22 Materials Stress-strain response for 5.0% pre-strain and 60 days aging

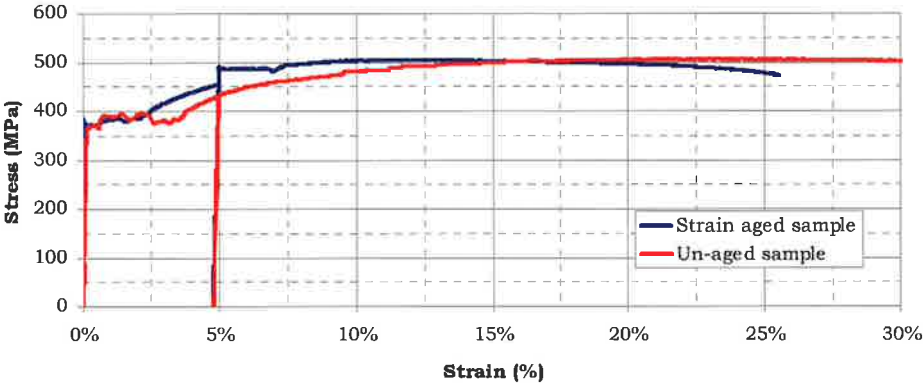
Figure 23 Materials Stress-strain response for 5.0% pre-strain and 60 days aging
