# CTV Building Collapse Investigation

# How and Why?

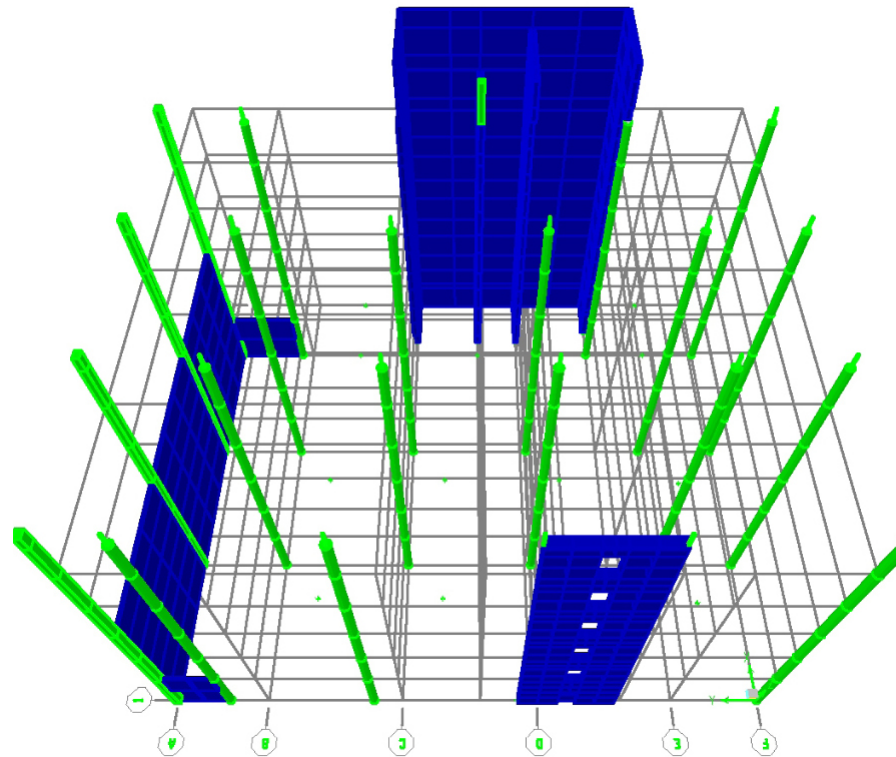
# Walls and Columns

- Unroughened concrete construction joints
- Susceptible to progressive collapse
- Masonry wall not isolated as required
- Panels to columns gap insufficient
- Low strength concrete
- Low concrete confinement in columns
- Fragile slab / beam/ beam column joints
