CTV Building: Site Examination and Materials Tests

For: Department of Building and Housing

21st July 2011

DBH 110329 CTV Building: Site Examination and Materials Tests (Interim)

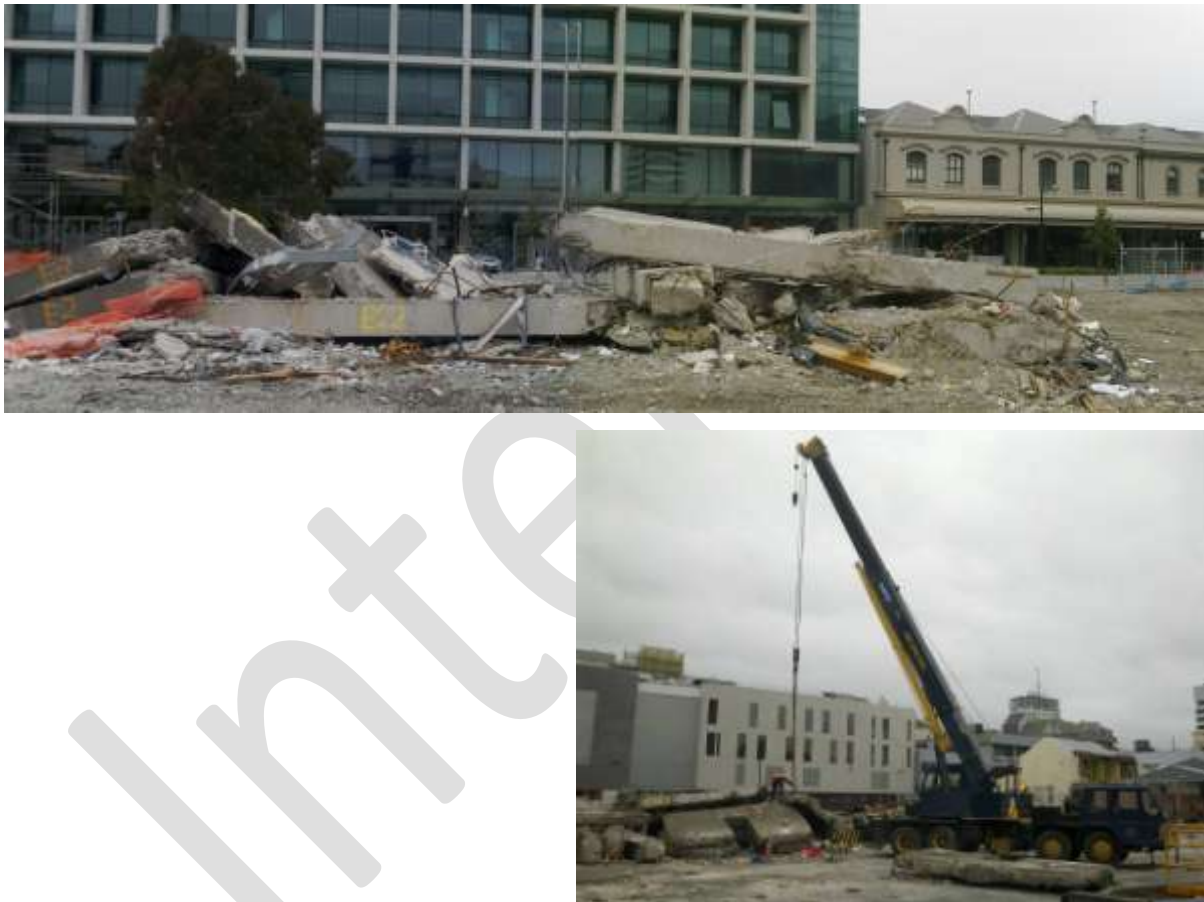
The examination of structural remnants was undertaken by the author and DBH Structural Engineer, Graeme Lawrence on Saturday 12th March, 2011 (Figure 1). It was then visited again with Ashley Smith of Structuresmith Ltd on 5th April, 2011.

Figure 1 USAR structural debris pile on CTV site (top to bottom) a) At start of site examination; b) Crane used to move debris remnants for examination

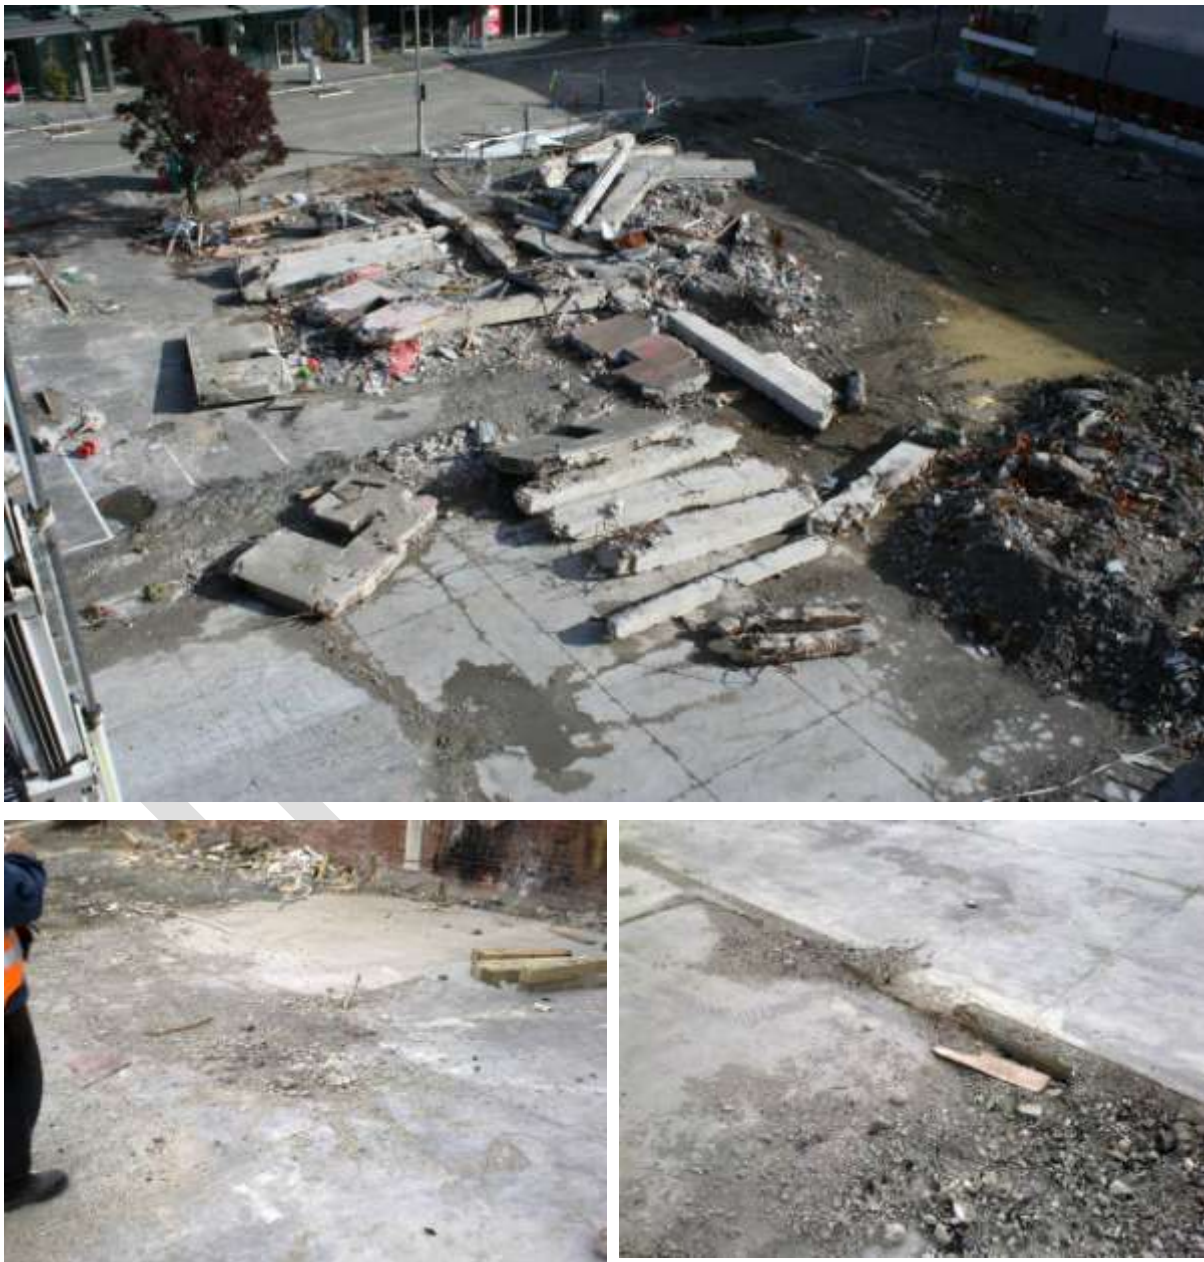
The ground floor slab had a concrete overlay that measured on average 89 mm thick over the eastern half of the floor (Table 5). This ramped up from the original slab adjacent to the lift core (Figure 2).

The slab appeared to be in reasonable condition and there weren't any obvious heave or localised damage at column or shear wall locations. A levels and positional survey was undertaken to check for settlement and lift core rotation and is reported in Section 5.

Figure 2 Ground floor Level 1 slab on grade (clockwise from top) a) View from Fire Service snorkel of debris and western portion of Level 1 slab on grade. b) Slab in northwest corner with column reinforcing protruding; c) Ramp formed in concrete overlay in front of Line 4 lift core walls.

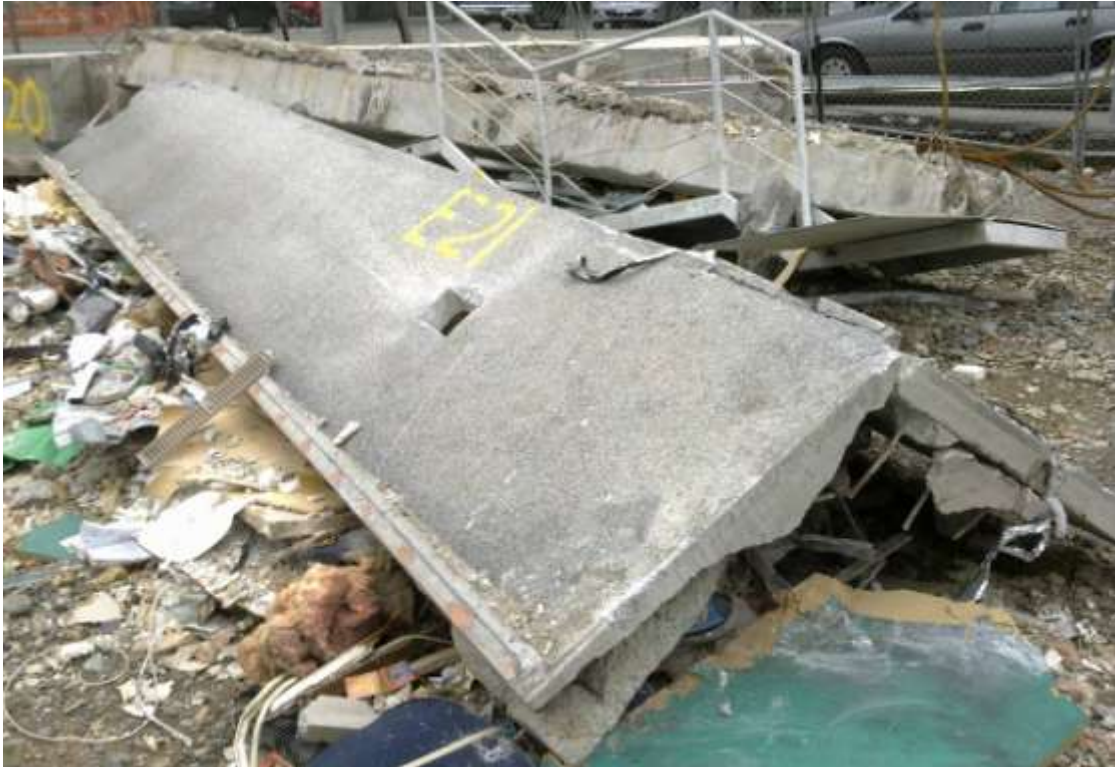
Figure 3 Pre-cast spandrel panel Item E21 (DENG Dwg S25 (Figure 65))

The pre-cast spandrel panels may have had some influence on the mid-height failures by inducing short column effects (Figure 3 and Figure 65). The 400 mm diameter columns that suffered the mid-height failures may therefore have been from Grids 1, 4 and F like Item 33.

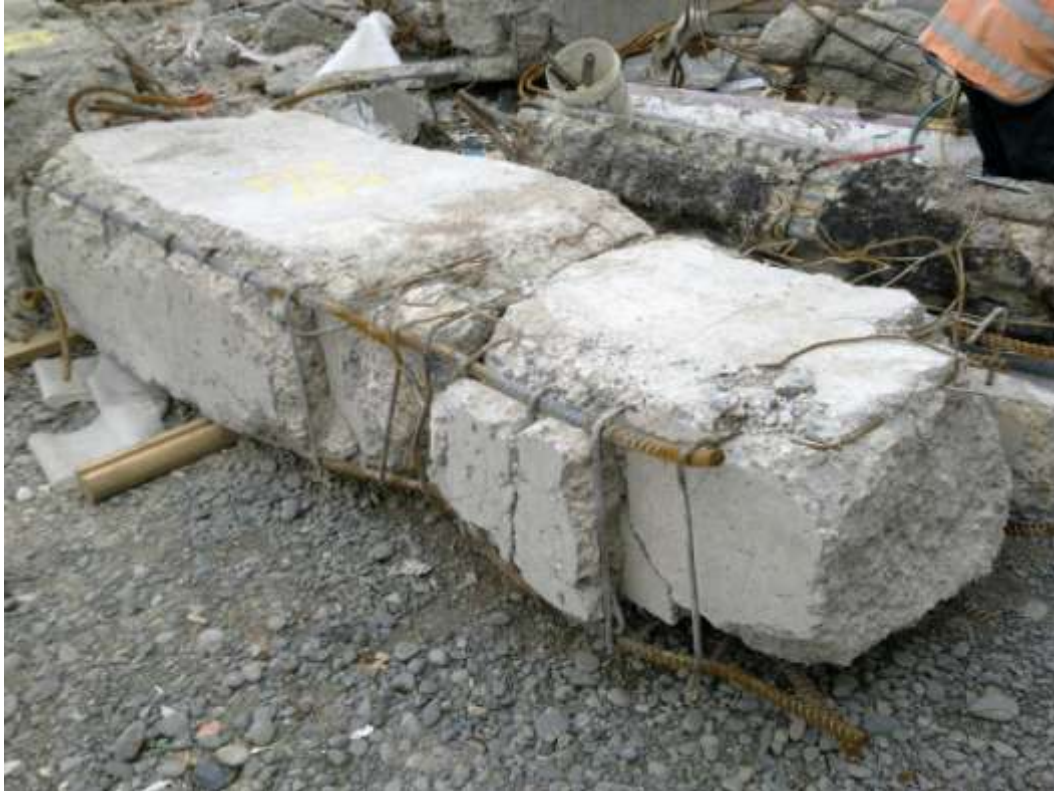
Figure 4 Edge shell beam Item E6 showing unreinforced concrete infill and smooth interface between shell beam and in-fill. The DENG Specification Precast Concrete cl 3.12 required roughened interface surfaces (Figure 71).

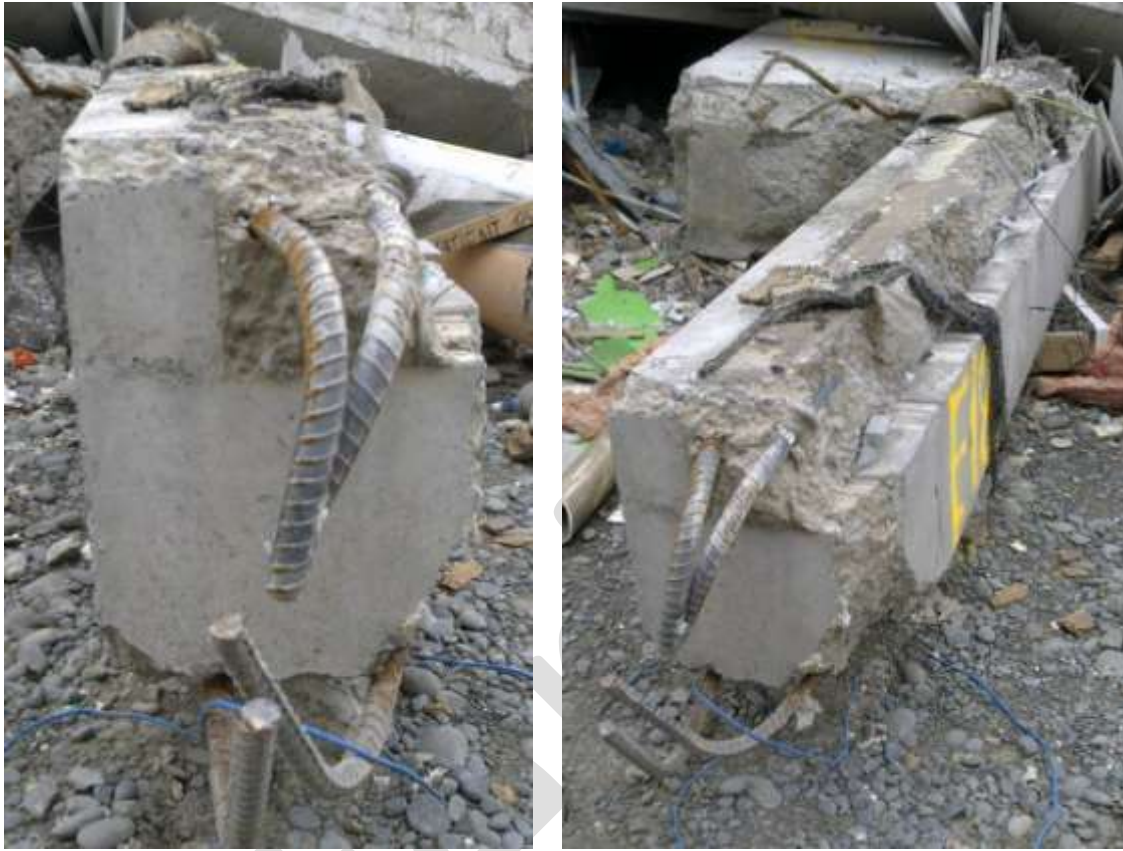
Figure 11 Item E18 Pre-cast edge beam north-west corner (DENG B22 Dwg S18 (Figure 59)) (from left to right) a) Smooth form finish at attachment to column 4A (DENG Detail 1 Dwg S19 (Figure 63)); b) No starters from pre-cast beam into slab to prevent the Hi-bond slab pulling away (DENG Section 4 Dwg S15 (Figure 58))

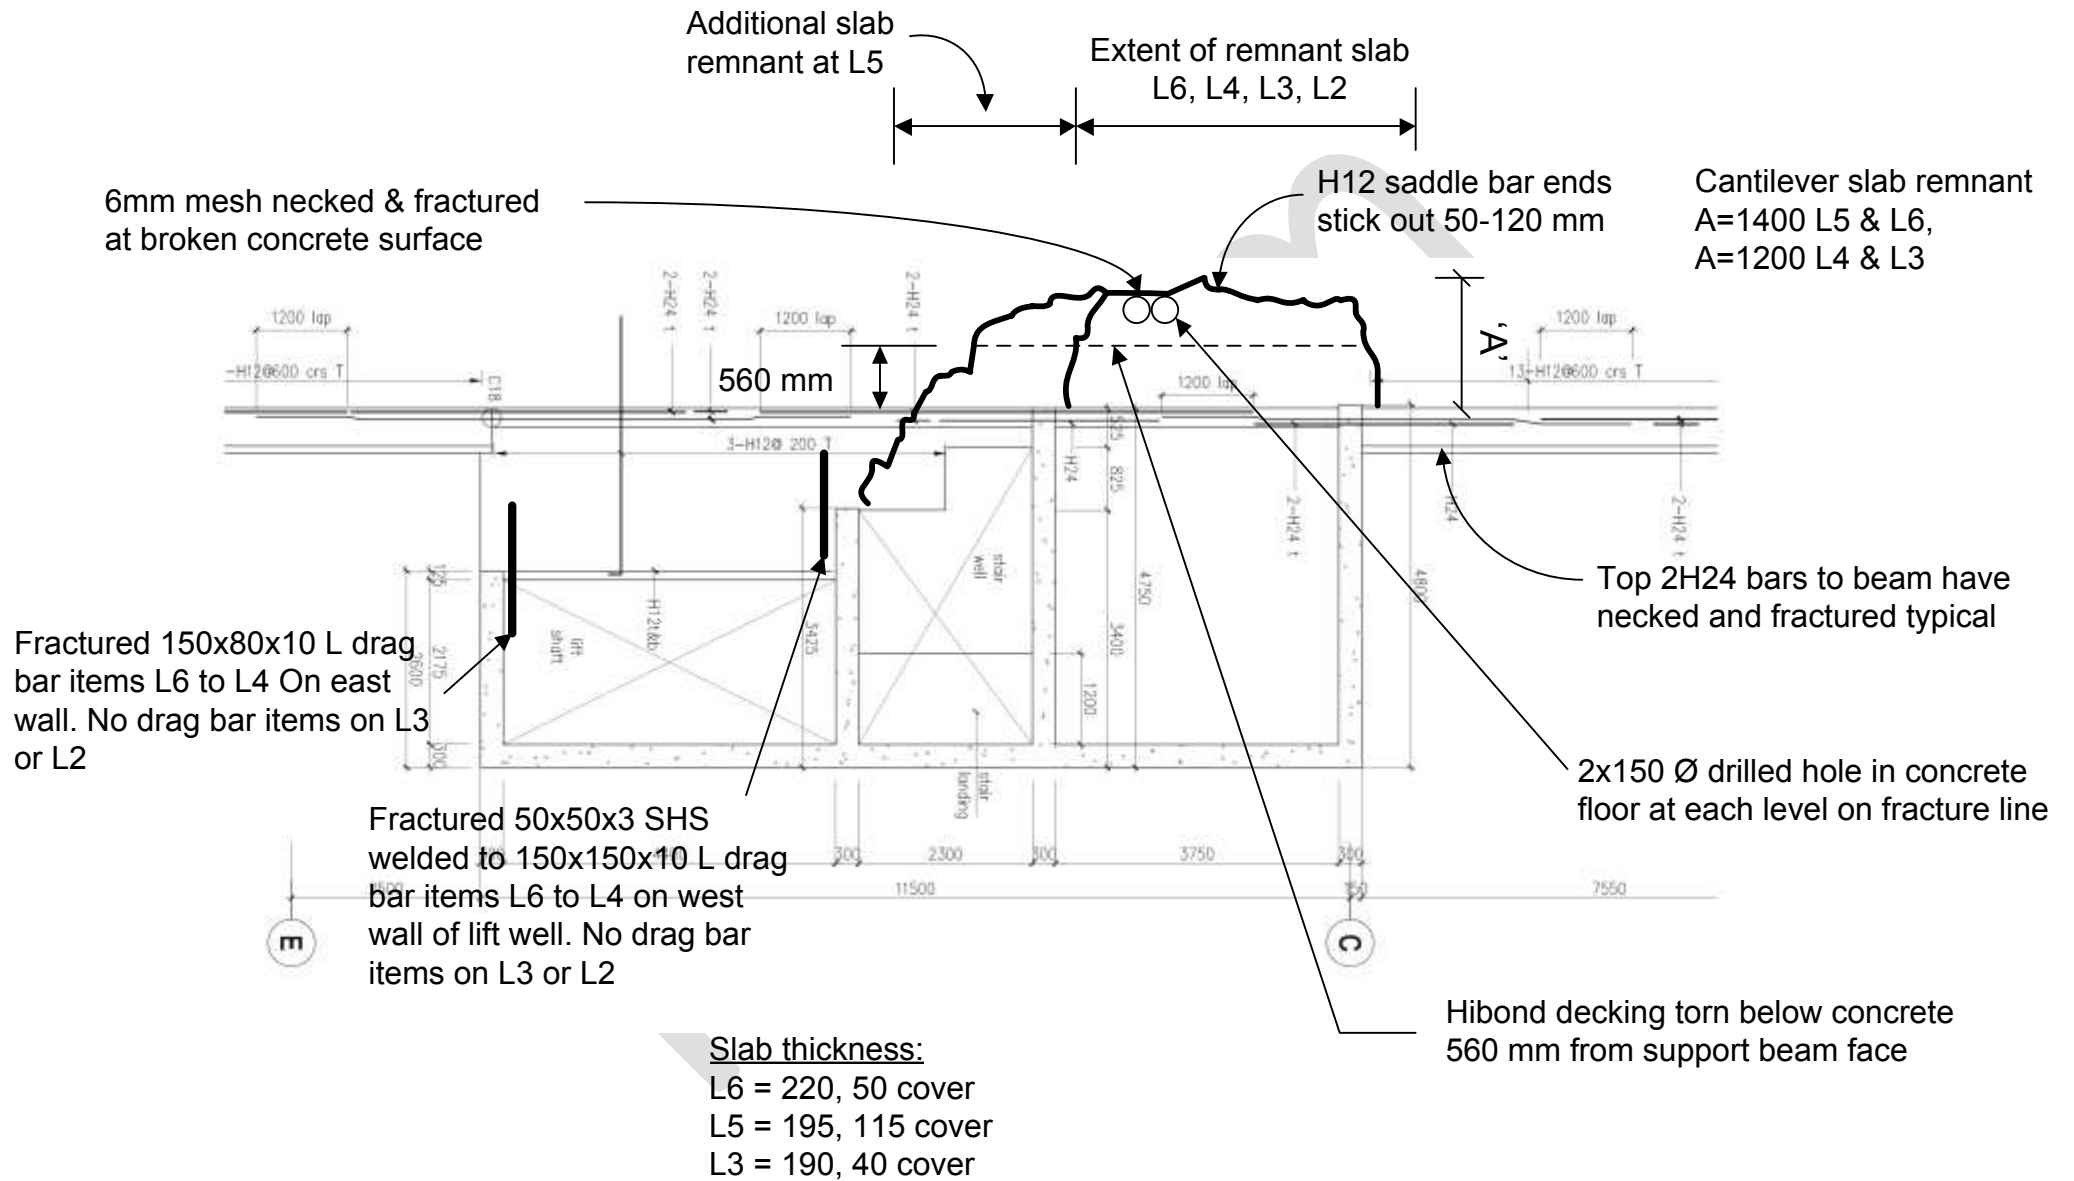
Figure 25 Extent of remaining slab at time of site examination. Portions of the slab had been removed during deconstruction for safety reasons.

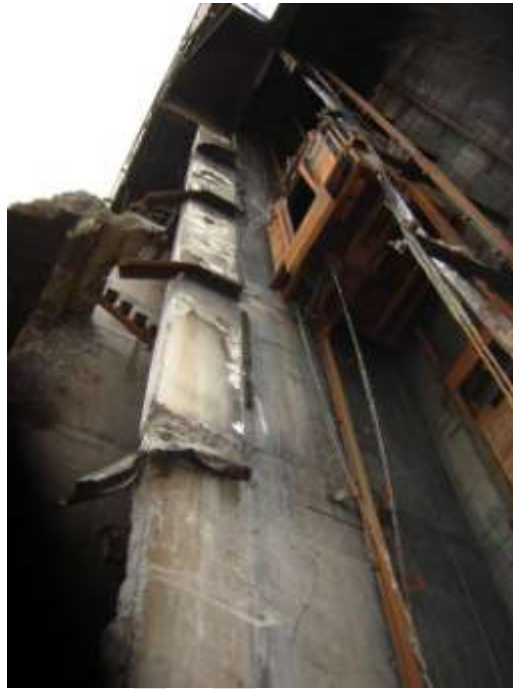
Drag bar items had been bolted through the slab and into the shear walls at Levels 4, 5 and 6 after the original construction had been completed (Figure 26).

The Hi-bond floor slab at Level 4, 5 and 6 had additional drag bars connecting it to the north-south wing walls, on either side of the lift well, sometime after the original construction was completed. Bolts had been bolted through the slab and epoxy grout inserted to fill the gap between the bolts and the hole drilled into the slab as can be seen in Figure 29 to Figure 32.

Figure 26 Drag bar connections at Levels 6, 5 and 4 on lift well west wing wall on Grid D. No drag bar at Level 3 or 2 (Figure 25)

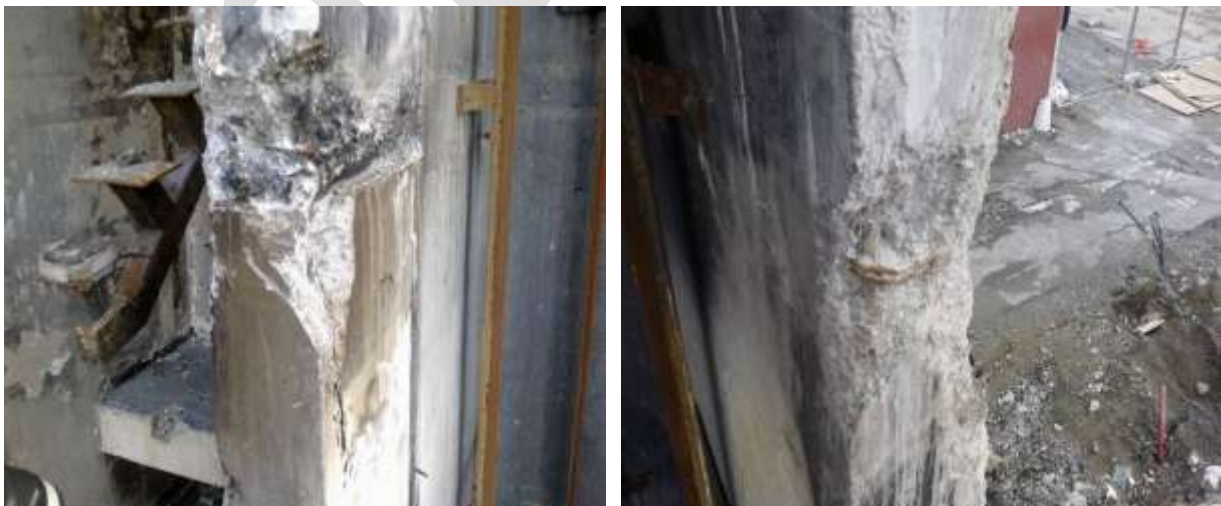
A 20mm hole was found in the west wing wall D where a reinforcing bar has pulled out (Figure 27).

Figure 27 Level 2 Lift Well Wing Walls Grid D and D.5 (left to right) a) 20 mm hole in end where a reinforcing bar has pulled out of wall. 200 mm thick construction joints in wall at slab level. b) No reinforcing steel attachment into the east wing wall at Level 2

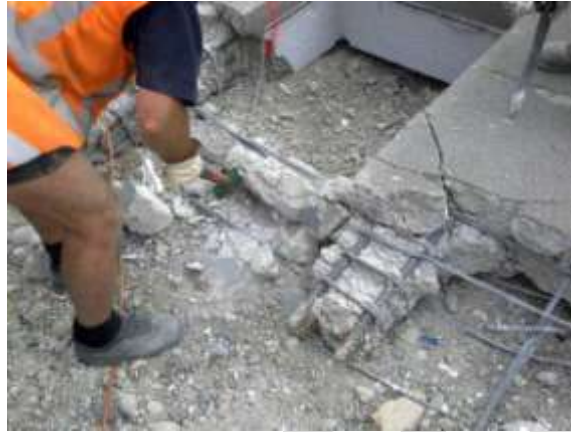
Figure 34 Line 1 Wall Item E1 H16 bars from masonry door infill.

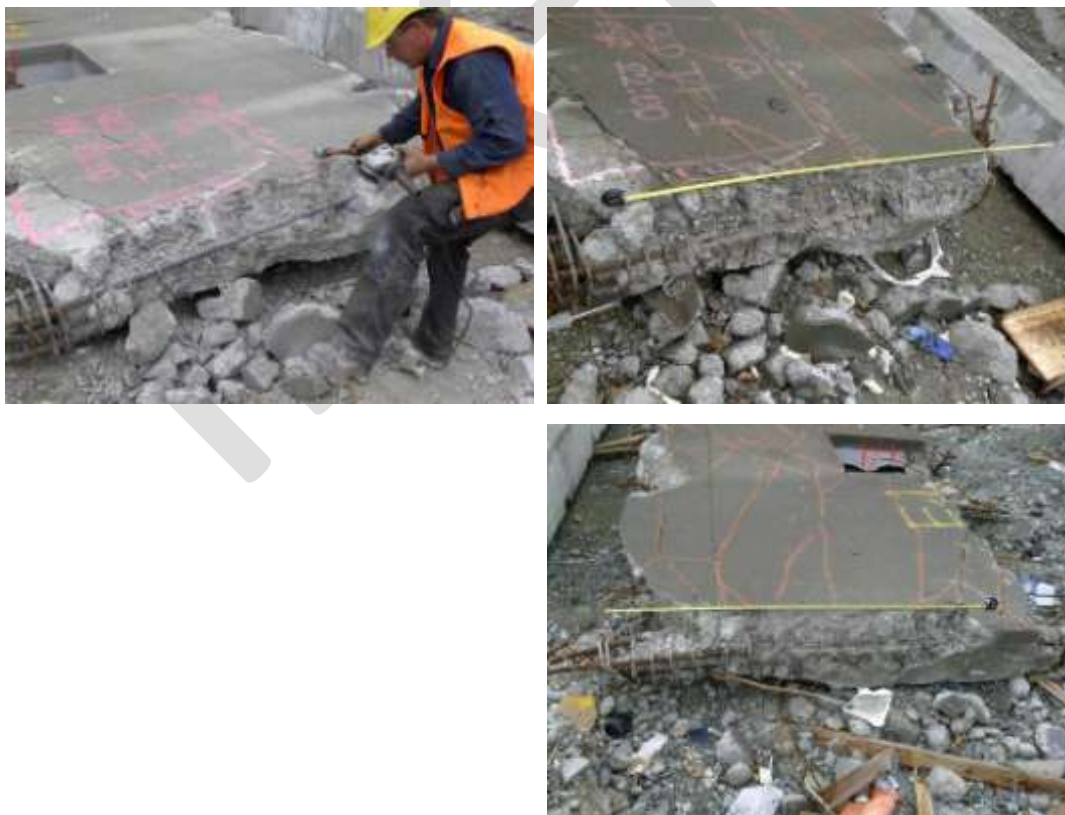
Figure 35 H28 from east and west end of Line 1 wall Item E1 (clockwise from top left) a) H28 about to be cut from east end (E1E); b) Top of 1000 mm long E1E sample 1300 mm from top of L2 slab; c) Top of 1000 mm long E1W sample from west end 750 mm from top of L2 slab. Coupling beam depth was 1700 mm.

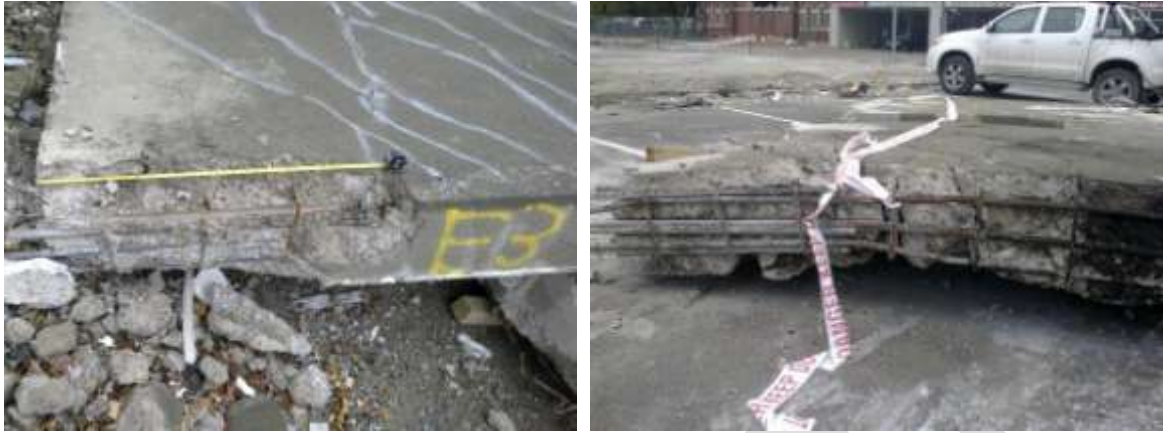
Figure 36 Locations of H24 reinforcing bar samples (left to right) a) East end of Line 1 wall item E3, one cut from lower 1050 mm of wall; b) Two lapping bars from lower E3 wall item taken from east end of wall item E4

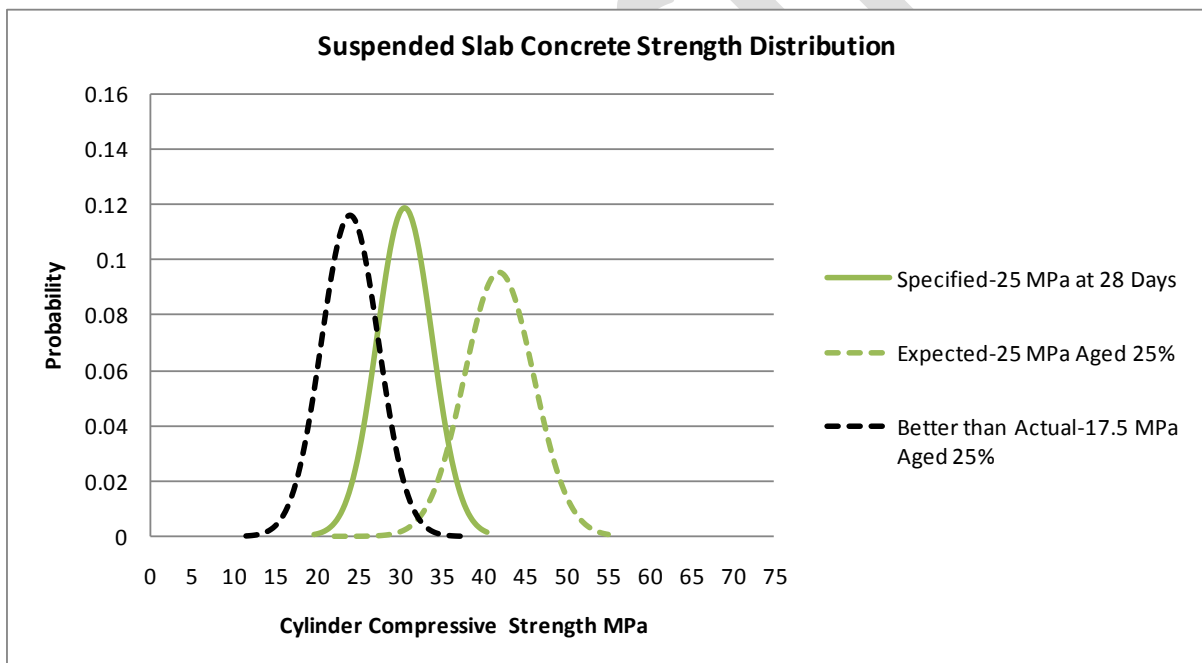
In conclusion, on the basis of 25% strength-aging at the time of the tests, the suspended slab concrete would not have complied with the requirements of concrete with the specified 28 day strength of 25 MPa.

It is also did not comply with the requirements for concrete with 28 day strength of 17.5 MPa with an acceptable level of confidence (Figure 37).

Figure 37 Suspended slab concrete properties

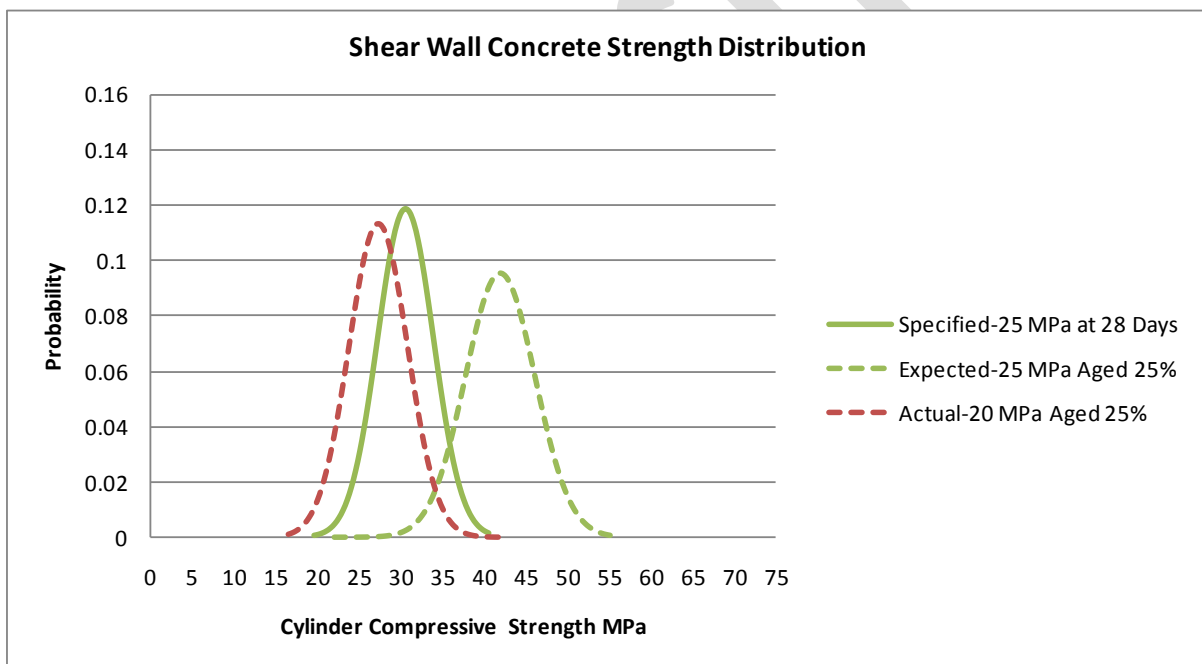
In conclusion on the basis of 25% strength–aging at the time of the tests, the shear wall concrete would not have complied with the requirements of concrete with the specified 28 day strength of 25 MPa with an acceptable level of confidence.

However it would have complied with the requirements for concrete with 28 day concrete strength of 20 MPa with an acceptable level of confidence (Figure 38).

Figure 38 Shear Wall Concrete Properties

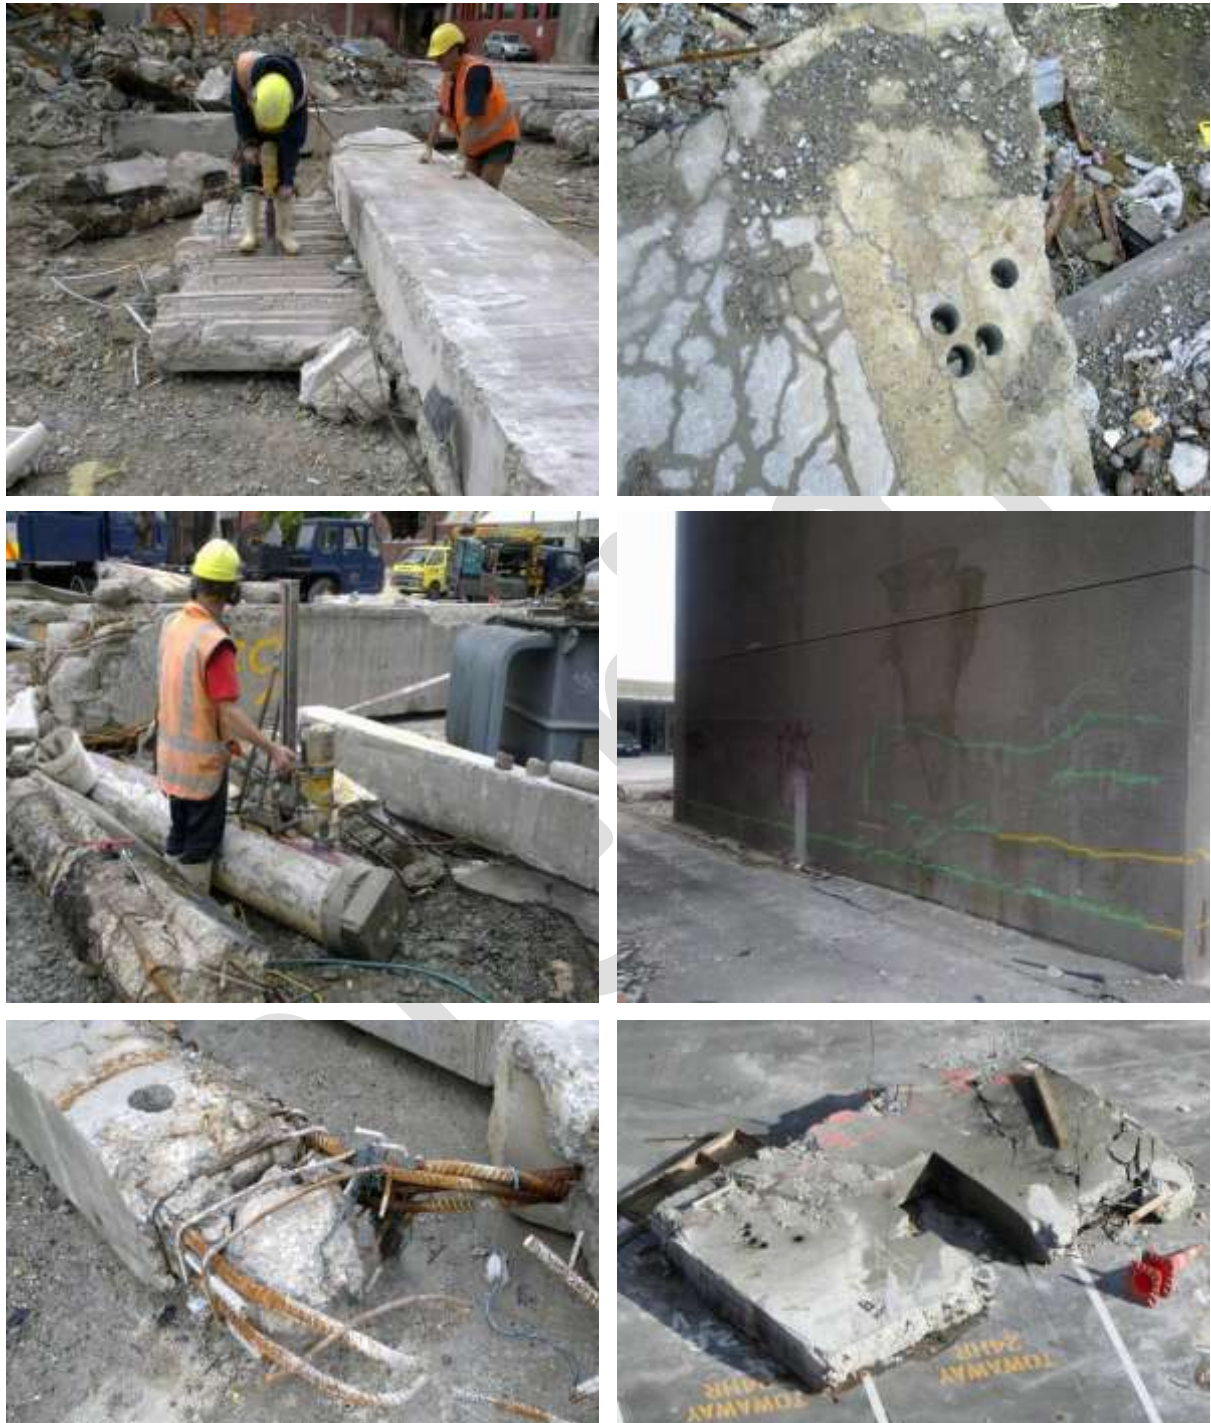
Concrete cores were extracted from suspended slabs in two locations (Item E14 and E23); the Line 5 shear wall at Level 1; the Line 1 shear wall between Level 4 and 5 (Item E4) ; the 400 mm diameter column between Level 6 and 7 (Item E25) (Figure 39); and the Level 1 column C18 stub (Figure 40).

Figure 39 Concrete core locations (clockwise from top left) a) Slab cores from Item E23; b) Slab cores from Item E14; c) Line 5 wall cores at Level 1 centre stair well area; d) Line 1 wall cores from Item E4 Level 4 to Level 5 in west pier; e) Pre-cast log beam core in side; f) 400 mm Diameter Column E25 Level 6 to roof cores.

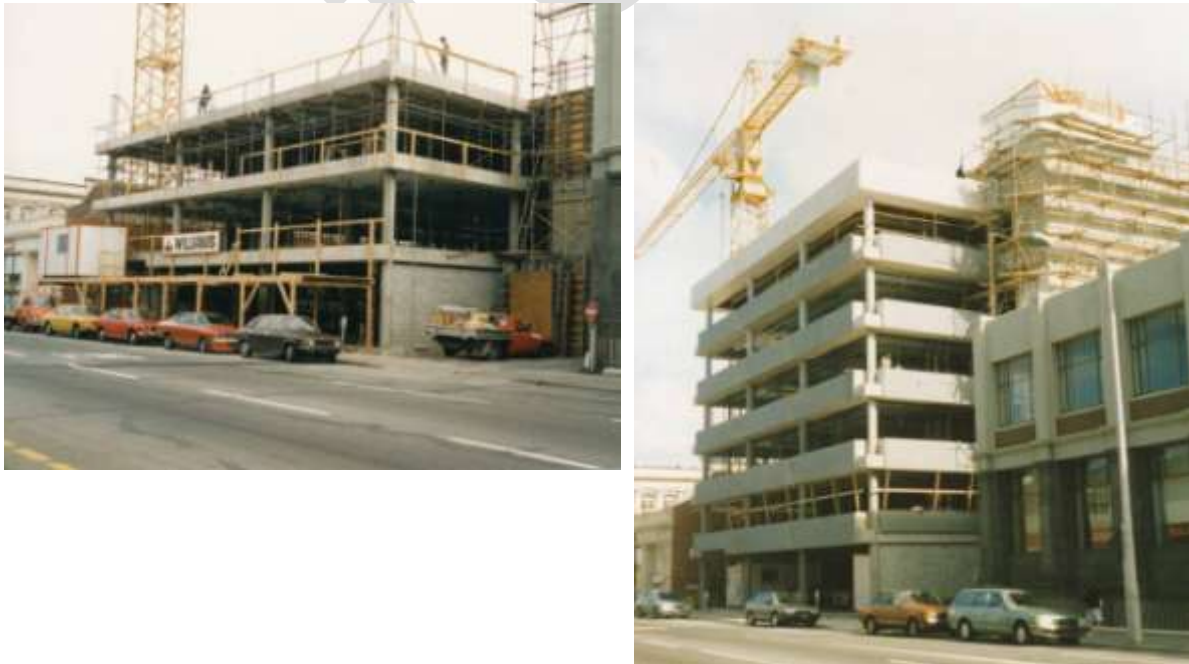
Figure 41 CTV Building under construction (left to right) a) May 1987 with floors cast up to Level 4; b) October 1987 with roof on and pre-cast spandrel panels attached; Columns C21 to C23 had not been built at that time in the northeast corner closest to camera.

The specified concrete strength for these Level 1 columns was 35 MPa at 28 days according to the Specification. However the inferred strengths show that the concrete used was consistent with 17.5 MPa 28 day strength concrete aged by 25% (Table 4 and Table 6). Photos, taken by a member of the public during construction, show that these columns were not cast at the same time as the other Level 1 columns (Figure 41).

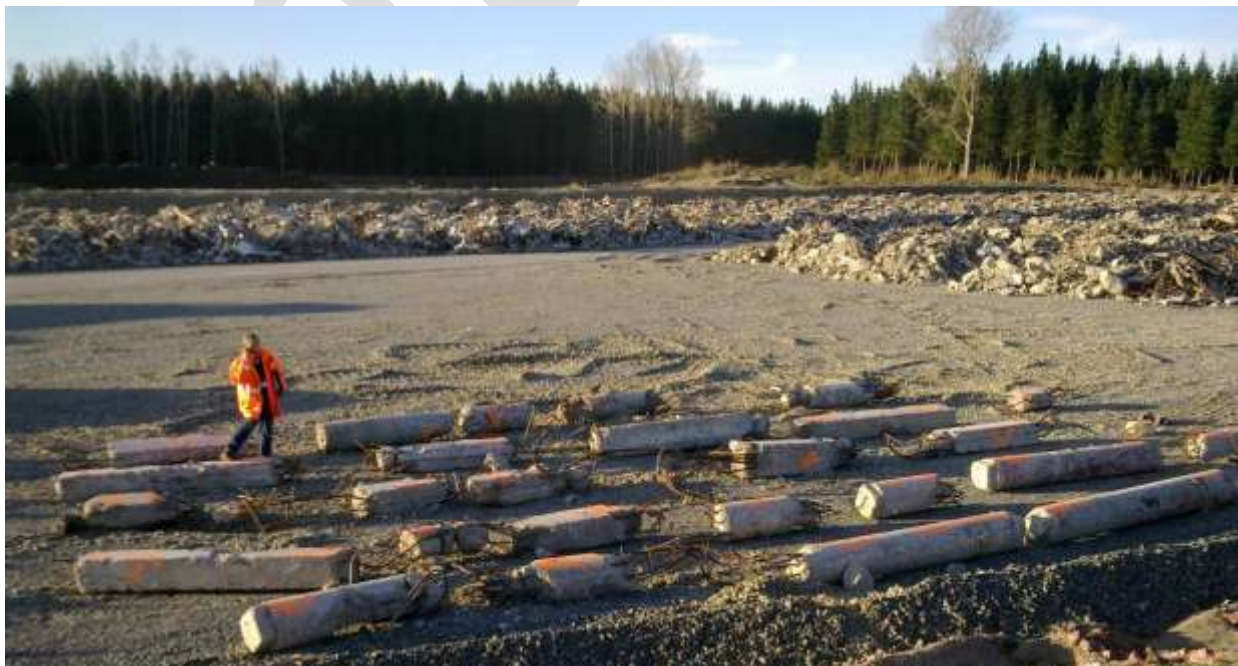
Thirteen 400 mm diameter and twelve 400 x 300 mm rectangular concrete column remnants were extracted from the CTV debris located in the specially designated area at the Burwood Eco landfill (Figure 42).

Figure 42 CTV Columns remnants extracted from the Burwood Landfill CTV debris (at right) for Schmidt Hammer testing and coring. Full height and partial height remnants can be seen.

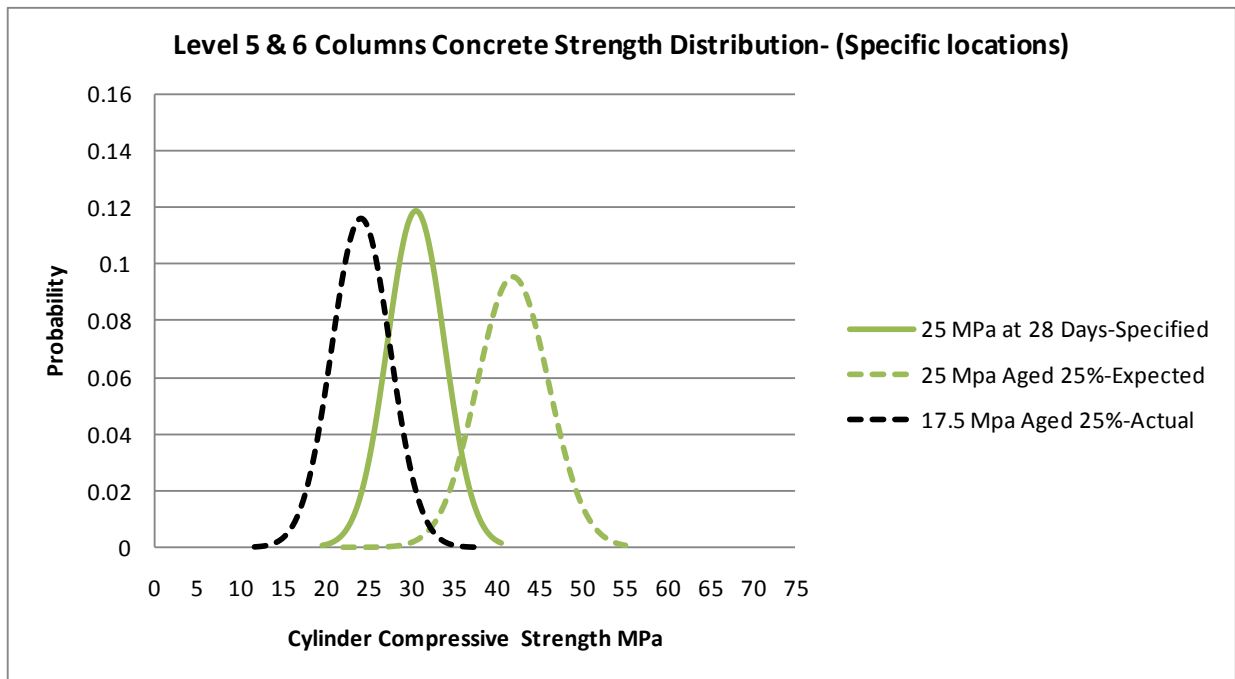
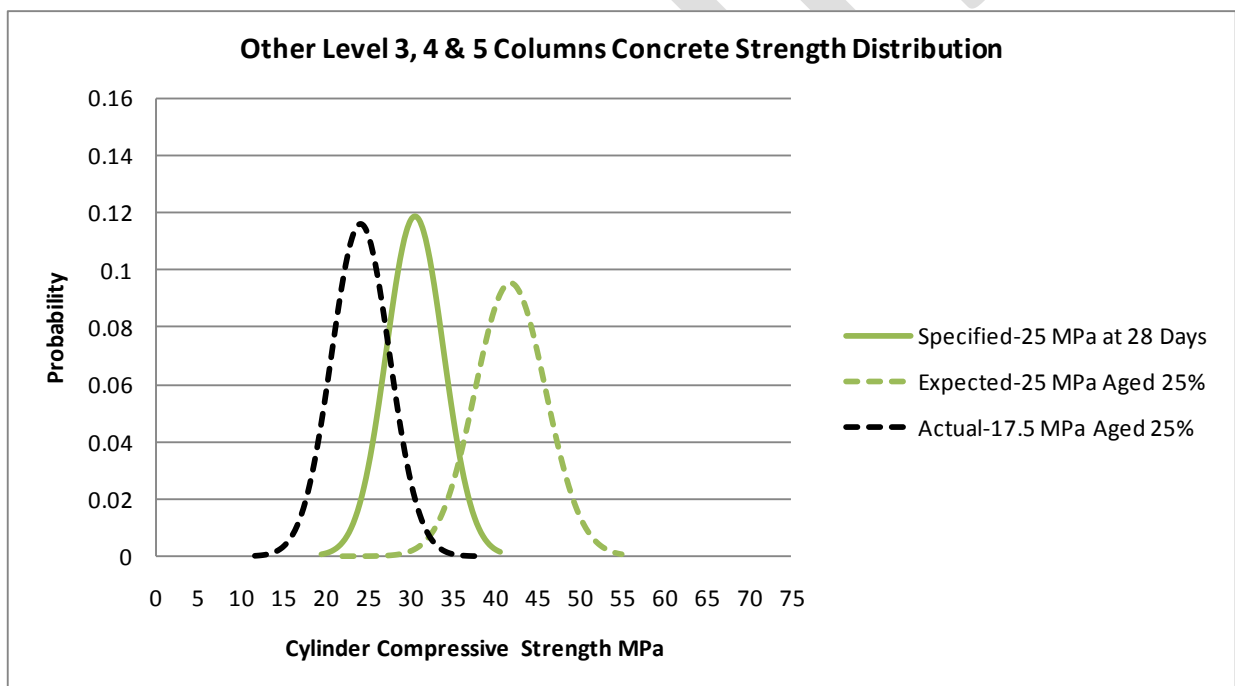
Column remnants that could not be specifically identified as being from Level 5 or 6 had a sample mean of 29.1 MPa which is greater than the lower 5% confidence limit of 26.2 MPa for concrete with specified 28 day strength of 17.5 MPa aged by 25% (Figure 44). This excluded the Level 1 entry column remnants C2 and C10, and the higher strength column remnants C4, R7 and R10.

Figure 44 Level 3 to 6 Concrete Column Properties (From Top) a) Specific Level 5 and 6 columns; b) Other Level 3, 4 and 5 columns

In conclusion, on the basis of 25% strength-aging at the time of the tests, the columns from Level 5 and 6 would not have complied with the specified requirements for concrete with a specified strength of 25 MPa at 28 days with an acceptable level of confidence. However they would have complied with requirements for concrete with specified 28 day strength of 17.5 MPa with an acceptable level of confidence (Figure 44).

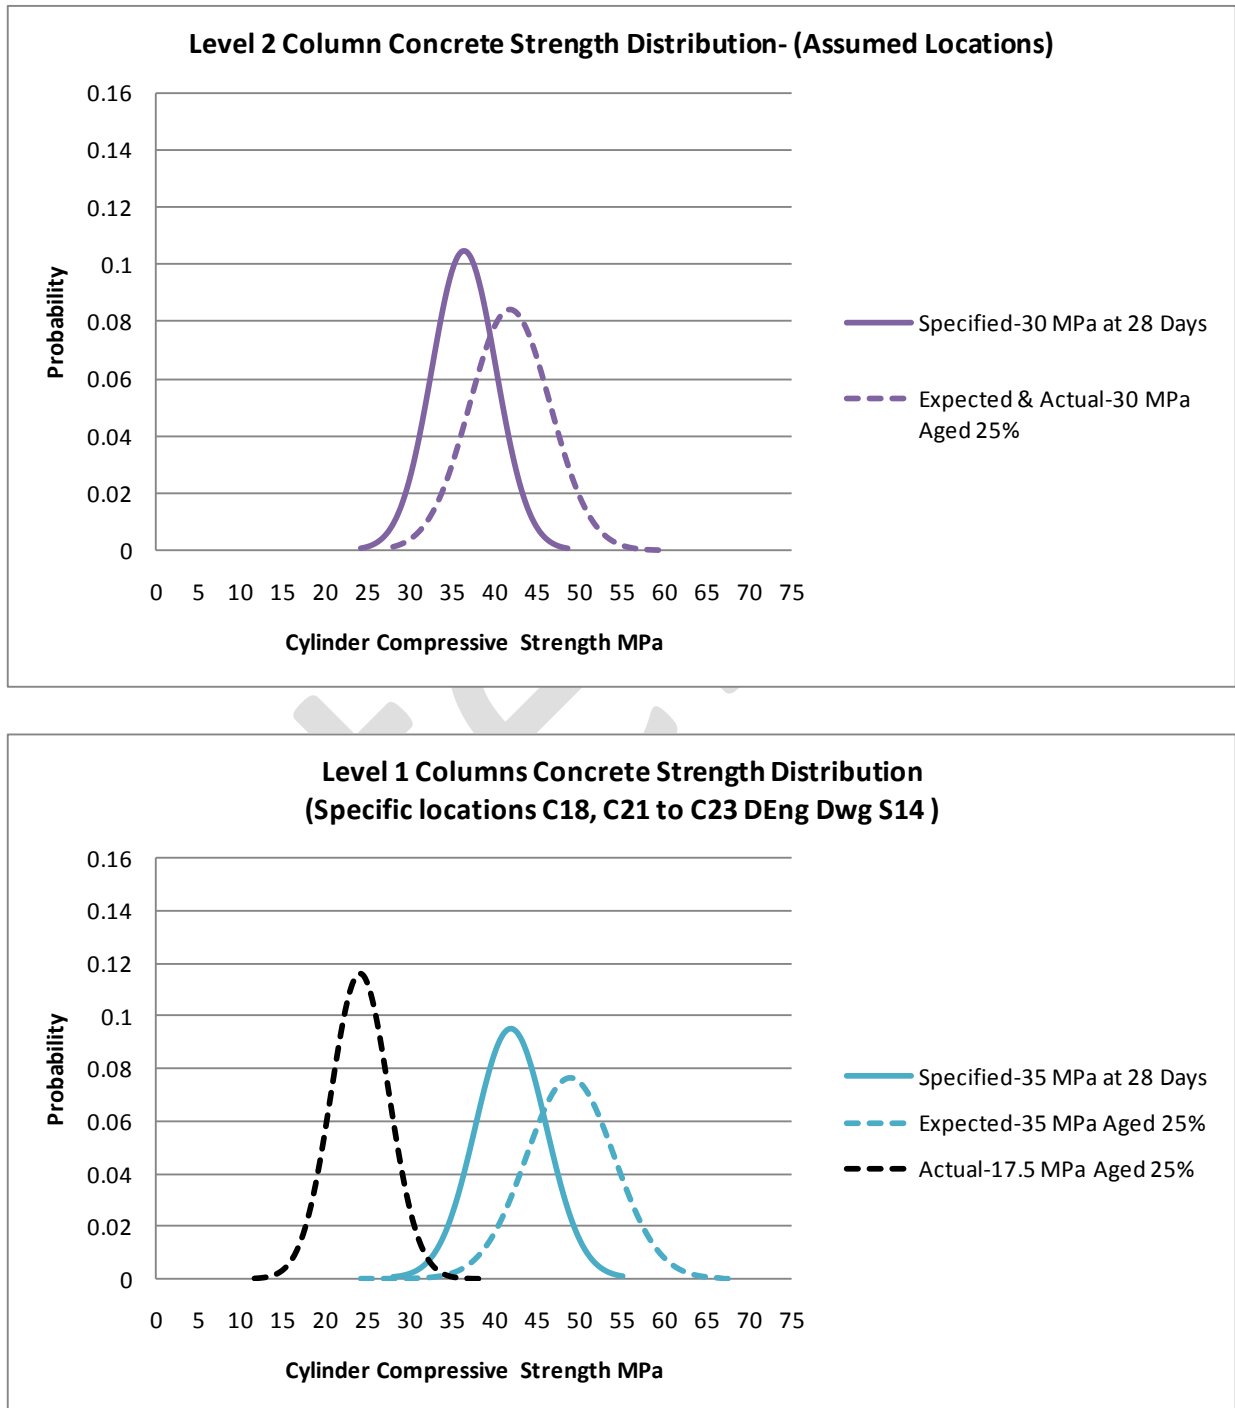
At some level, possibly Level 2, the concrete in the columns may have complied with the specified requirements of concrete with specified 28 day strength of 30 MPa at 28 days aged by 25% based on cores in C4, R6 and R7 and hammer tests of R10 (Figure 45).

Figure 45 Level 1 and 2 Concrete Column Properties (From Top) a) Assumed Level 2 columns; b) Specific Level 1 columns

The Burwood tests showed some concrete with properties consistent with 28 day strength of 30 MPa aged by 25% (Figure 45).

However core tests on the 400 mm square column stub at the CTV site on Line 4 adjacent to the lift core (C18) (Figure 40), found low quality concrete with strengths not achieving that of concrete with 28 day strength of 17.5 MPa and aged 25%, when 35 MPa at 28 days had been specified (Figure 45).

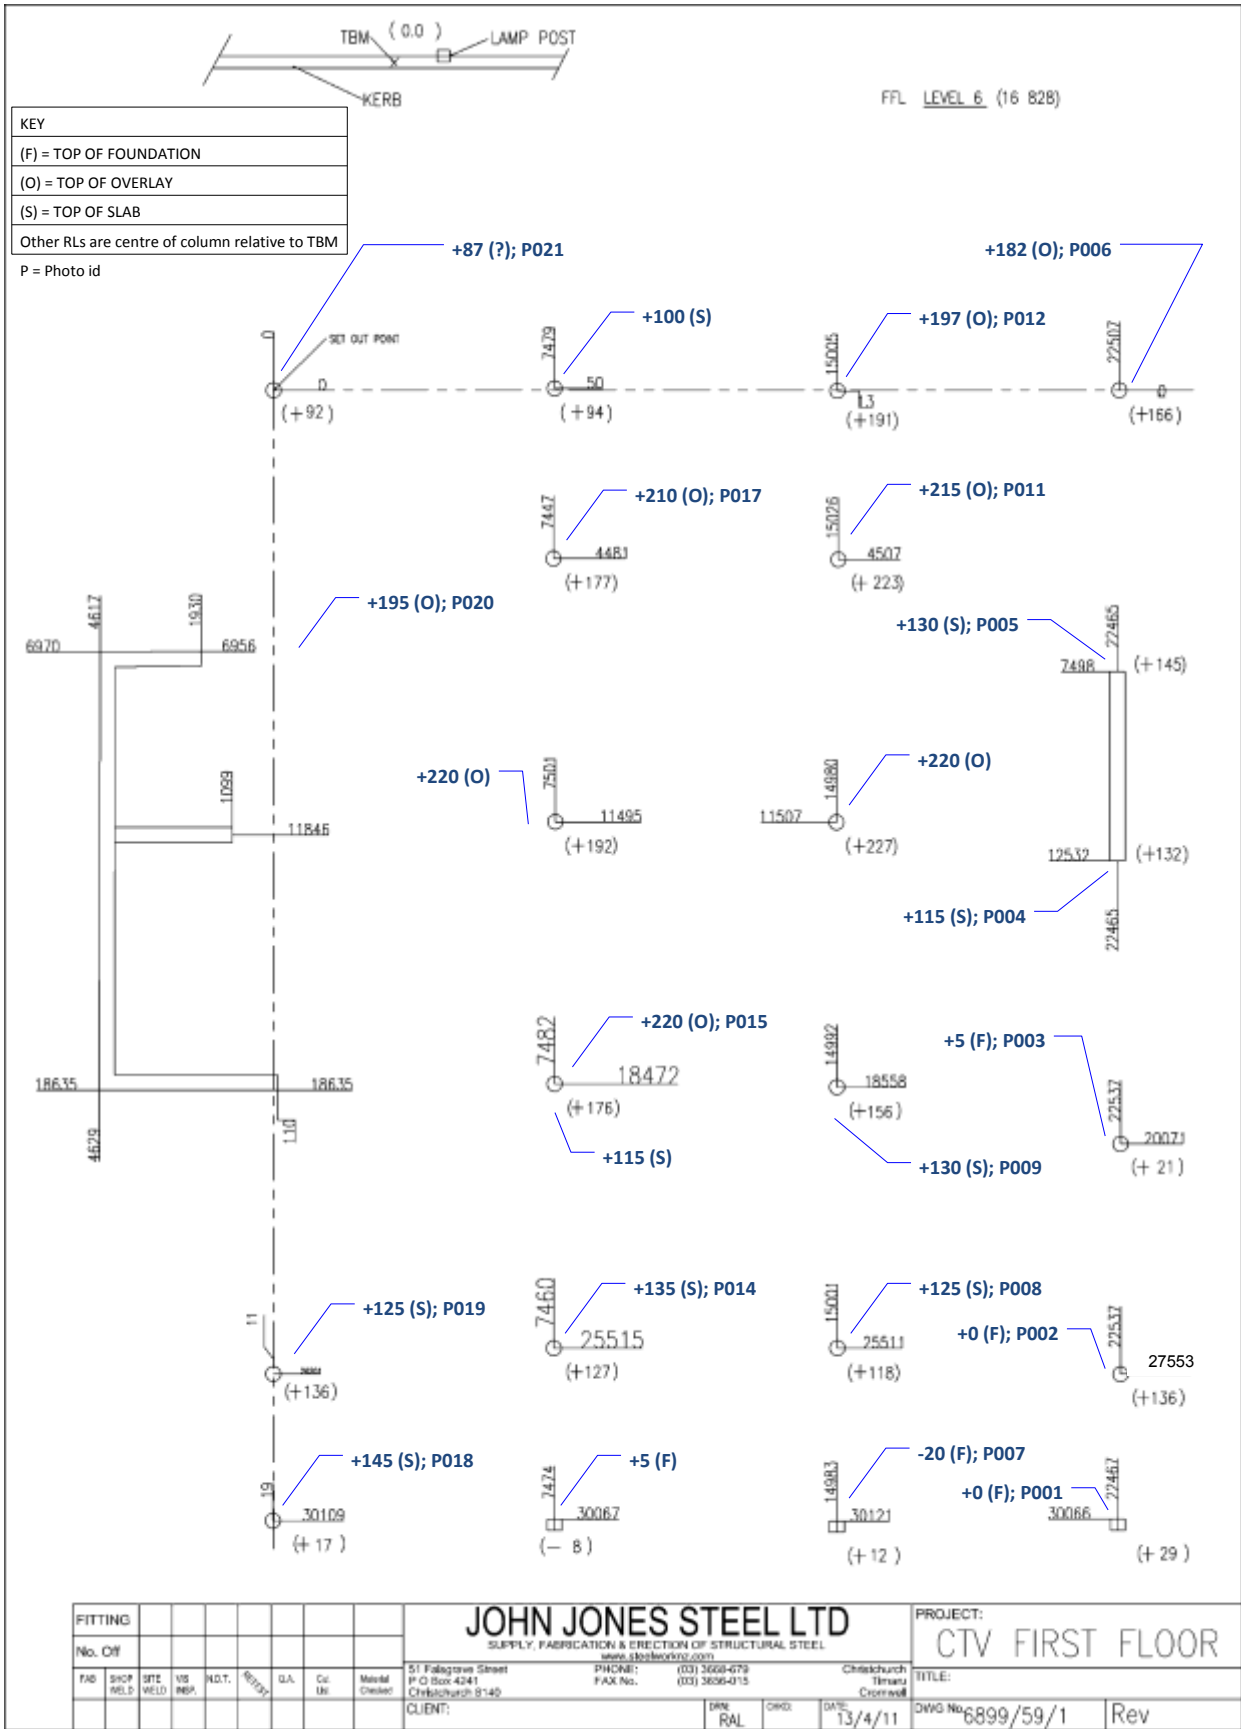
Figure 51 JJS Dwg 1: Locations and levels at centres of demolished columns, annotated with levels on adjacent concrete identified as 100mm overlay (O), 125mm slab (S) or foundation beam (F). Photo locations are designated P###.

Shots were initially taken on 14th April, 2010 to the approximate centres of the demolished remains of the concrete columns (Figure 51).

The JJ Steel drawings have been annotated to identify whether the levels were taken on the foundation beams, slab or slab overlay (Figure 50 and Figure 51).
