CTV Building: Site Examination and Materials Tests

For: Department of Building and Housing

21st July 2011

DBH 110329 CTV Building: Site Examination and Materials Tests (Interim)

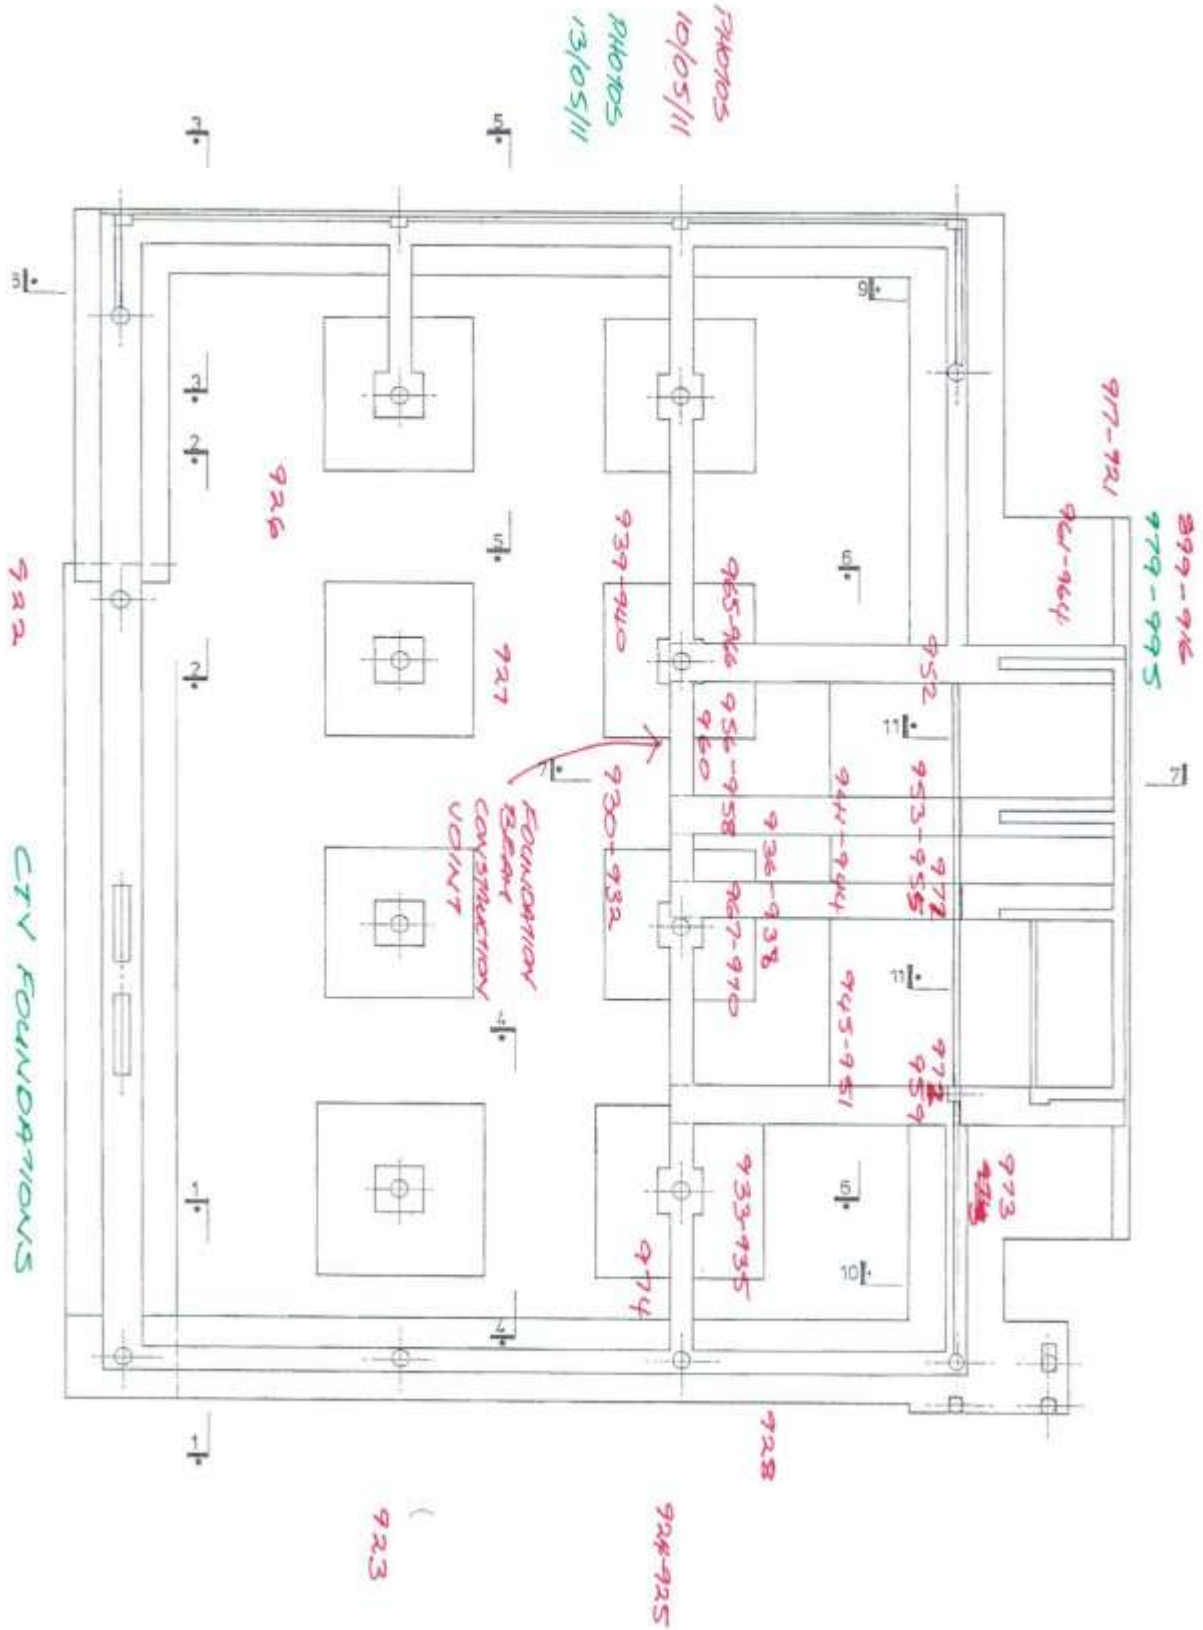
Figure 52 Locations of photos taken during foundation inspections on 10th and 13th May, 2011 (CERA)

The slab was removed and a pit dug adjacent to the northwest corner of the core walls (Grid C/5) on 10th May 2011, to look for damage in the foundation beams around the lift core area and signs of liquefaction (Figure 52).

The following are notes for the photos during the inspection by a CERA engineer in Figure 53. The location at which the photos were taken is shown in Figure 52.

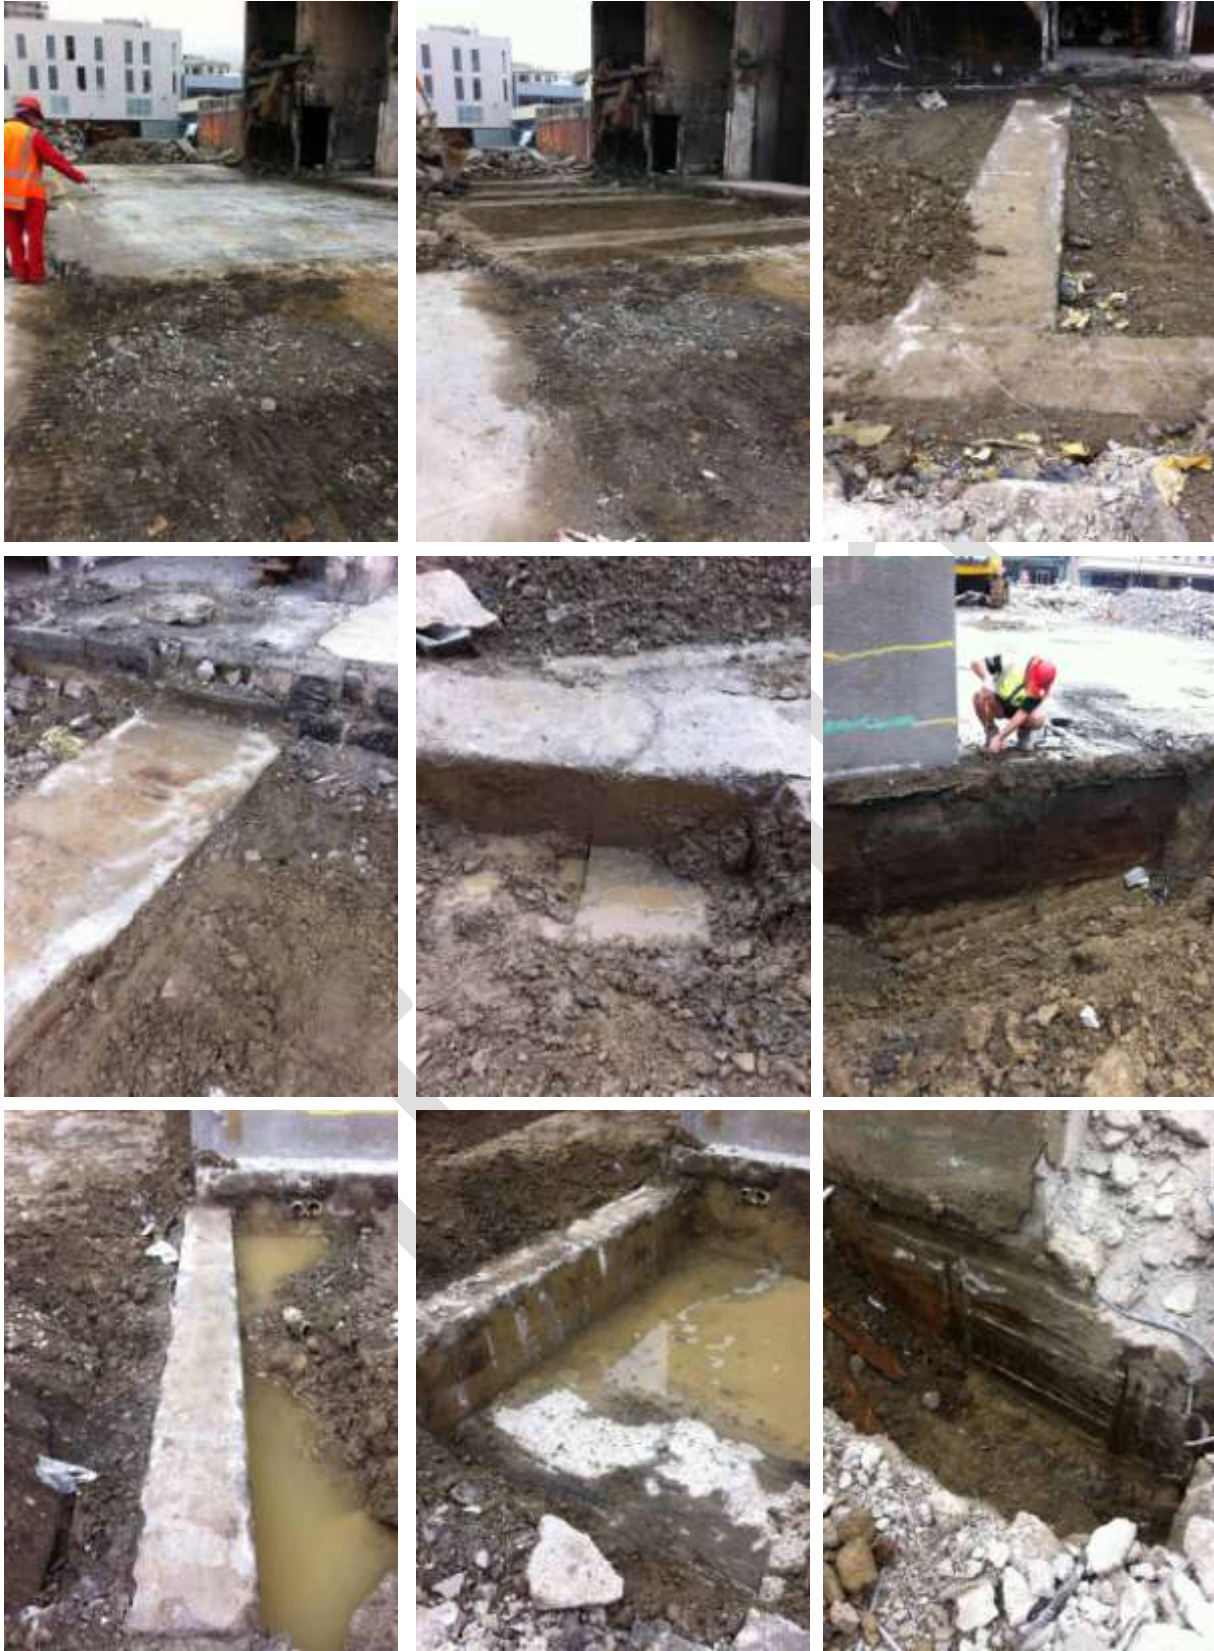
P919 : Excavated south side of the finger beam showing the base slab. Water entered from a broken pipe in the side of the tower foundation. The base slab is about 650 below top of the beam.

P993 : North side of the excavation at the northwest corner showing side of the finger beam shown in P903 after demolition of the core. The rotted boxing timber in P903 on the side of the footing has been removed.

Figure 53 Foundation Inspection (From left to right in rows from top) a) P947; b) P948; c) P968; d) P971; e) P960; f) P903; g) P964; h) P919; i) P993

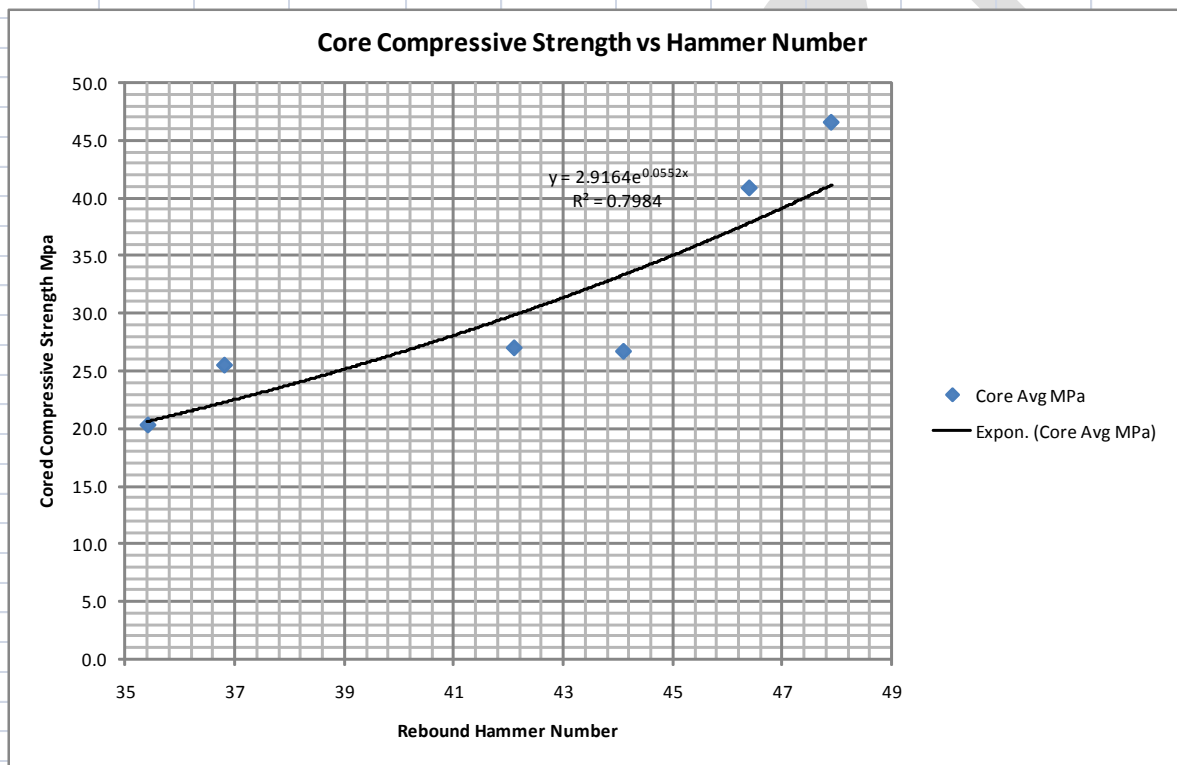
Two cores were subsequently extracted and tested from each of five column test locations that had average hammer numbers approximately equal to the mean, and 1 and 2 standard deviations either side of the mean (Jones 2011). This was to allow a relationship to be developed between the compressive test results for the cores and the hammer numbers in accordance with the requirements of ASTM C805 (Figure 54).

The compressive strengths at each location were inferred using the strength vs hammer number relationship developed by correlating the cored test results at 6 locations with the rebound hammer numbers in accordance with the ASTM C805 (Figure 54).

Figure 54 Strength vs Hammer Number relationship derived for columns cored and hammered per ASTM C805

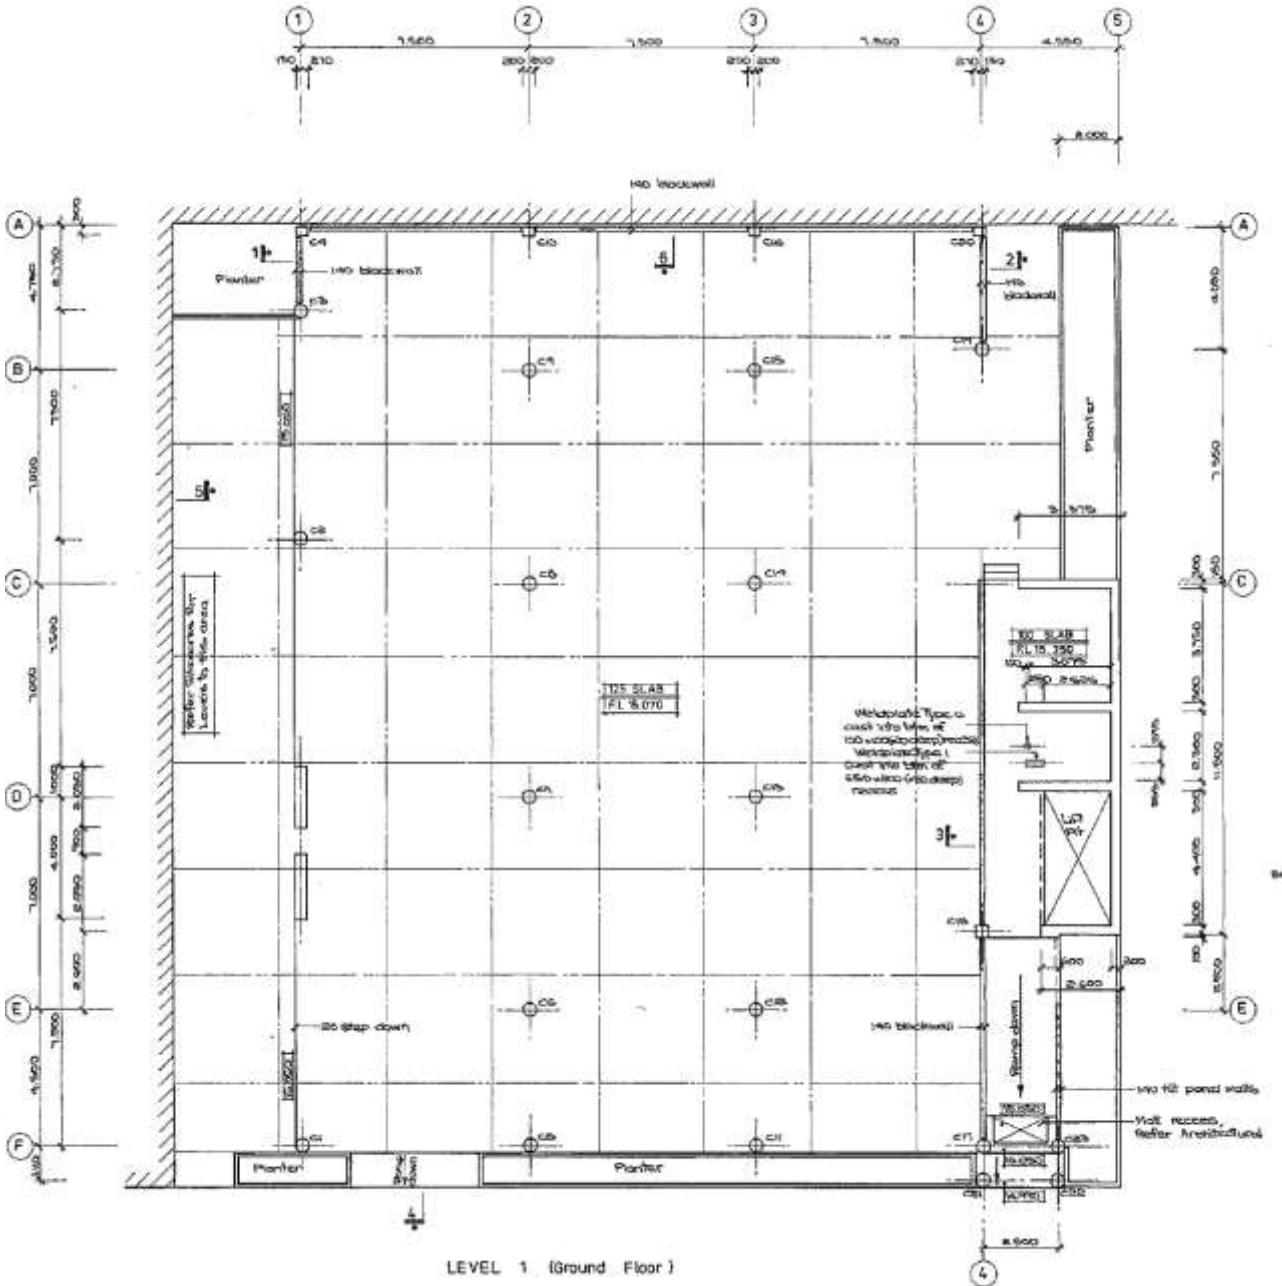
Figure 56 Level 1 ground floor slab layout (extract DENG Dwg S9)

The average RL of top of slab, which was cast directly on the top surface of the foundation beams was $+120$ mm with sample standard deviation of 12 mm from 12 shots. The nominal thickness of the slab specified was 125 mm cast to Finished Floor Level of 15.070 m (DENG Dwg S9 (Figure 56)). The average slab thickness calculated from the difference in the average RL of the slab and the foundation beams was 117 mm.

Average compressive strength from the six cores tested for the Level 1 square column C18 (DENG Dwg S9 (Figure 56) and S14 (Figure 60 and Figure 61)) was 16.0 MPa, with a minimum of 11.0 and maximum of 25.1 MPa.

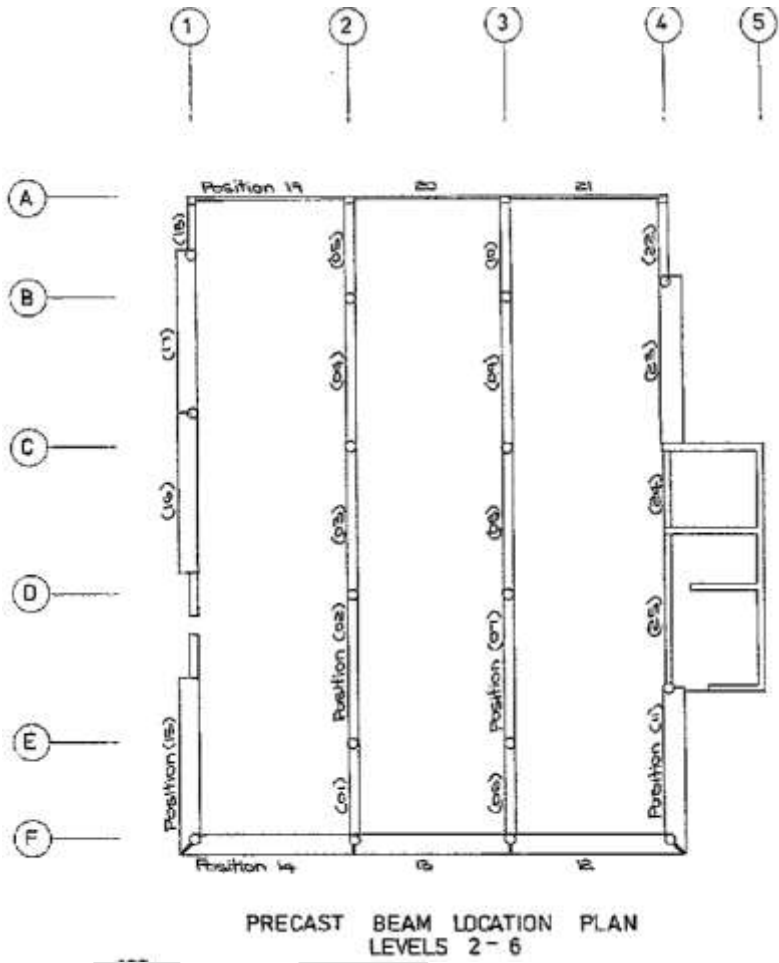
Figure 59 Precast beam layout drawings (Extract DENG Dwg S18)

Smooth mortar construction joints rather than roughened at junctions with pre-cast shell beams B15 and B16 (Figure 59).

Figure 22 Line 4 Core Walls Level 4 slab remnants (top to bottom) a) Connection of shell beam to wall with two fractured H24 top bars and two de-bonded top bars. No bottom bars from shell beam embedded in wall but imprints from bars evident (DENG B23 Dwg S18 (Figure 59), Detail 5 S19 (Figure 64)), corresponding to the bent back bottom steel in shell beam Item E23 (Figure 6). b) Fractured vertical face of slab at stairwell wall, with fractured slab support beam (DENG B25 Dwg S18 (Figure 59)) top bar and charred fracture surface. c) Torn Hi-bond sheeting de-bonded from slab but still fixed in at pre-cast beam support.

Figure 23 Line 4 Core Walls Level 3 slab remnants (clockwise from top left) a) Connection of shell beam to wall with two fractured H24 top bars and two de-bonded top bars. No bottom bars from shell beam embedded in wall but imprints from bars evident (DENG B23 Dwg S18 (Figure 59), Detail 5 S19 (Figure 64)), corresponding to the bent back bottom steel in shell beam Item E23 (Figure 6). b) Ash on slab. Cored holes at fractured edge. c) Torn Hi-bond sheeting de-bonded from slab but still fixed in at pre-cast beam support (DENG B24 Dwg S18 (Figure 59)). d) Hi-bond deck and slab from below supported on beam B24

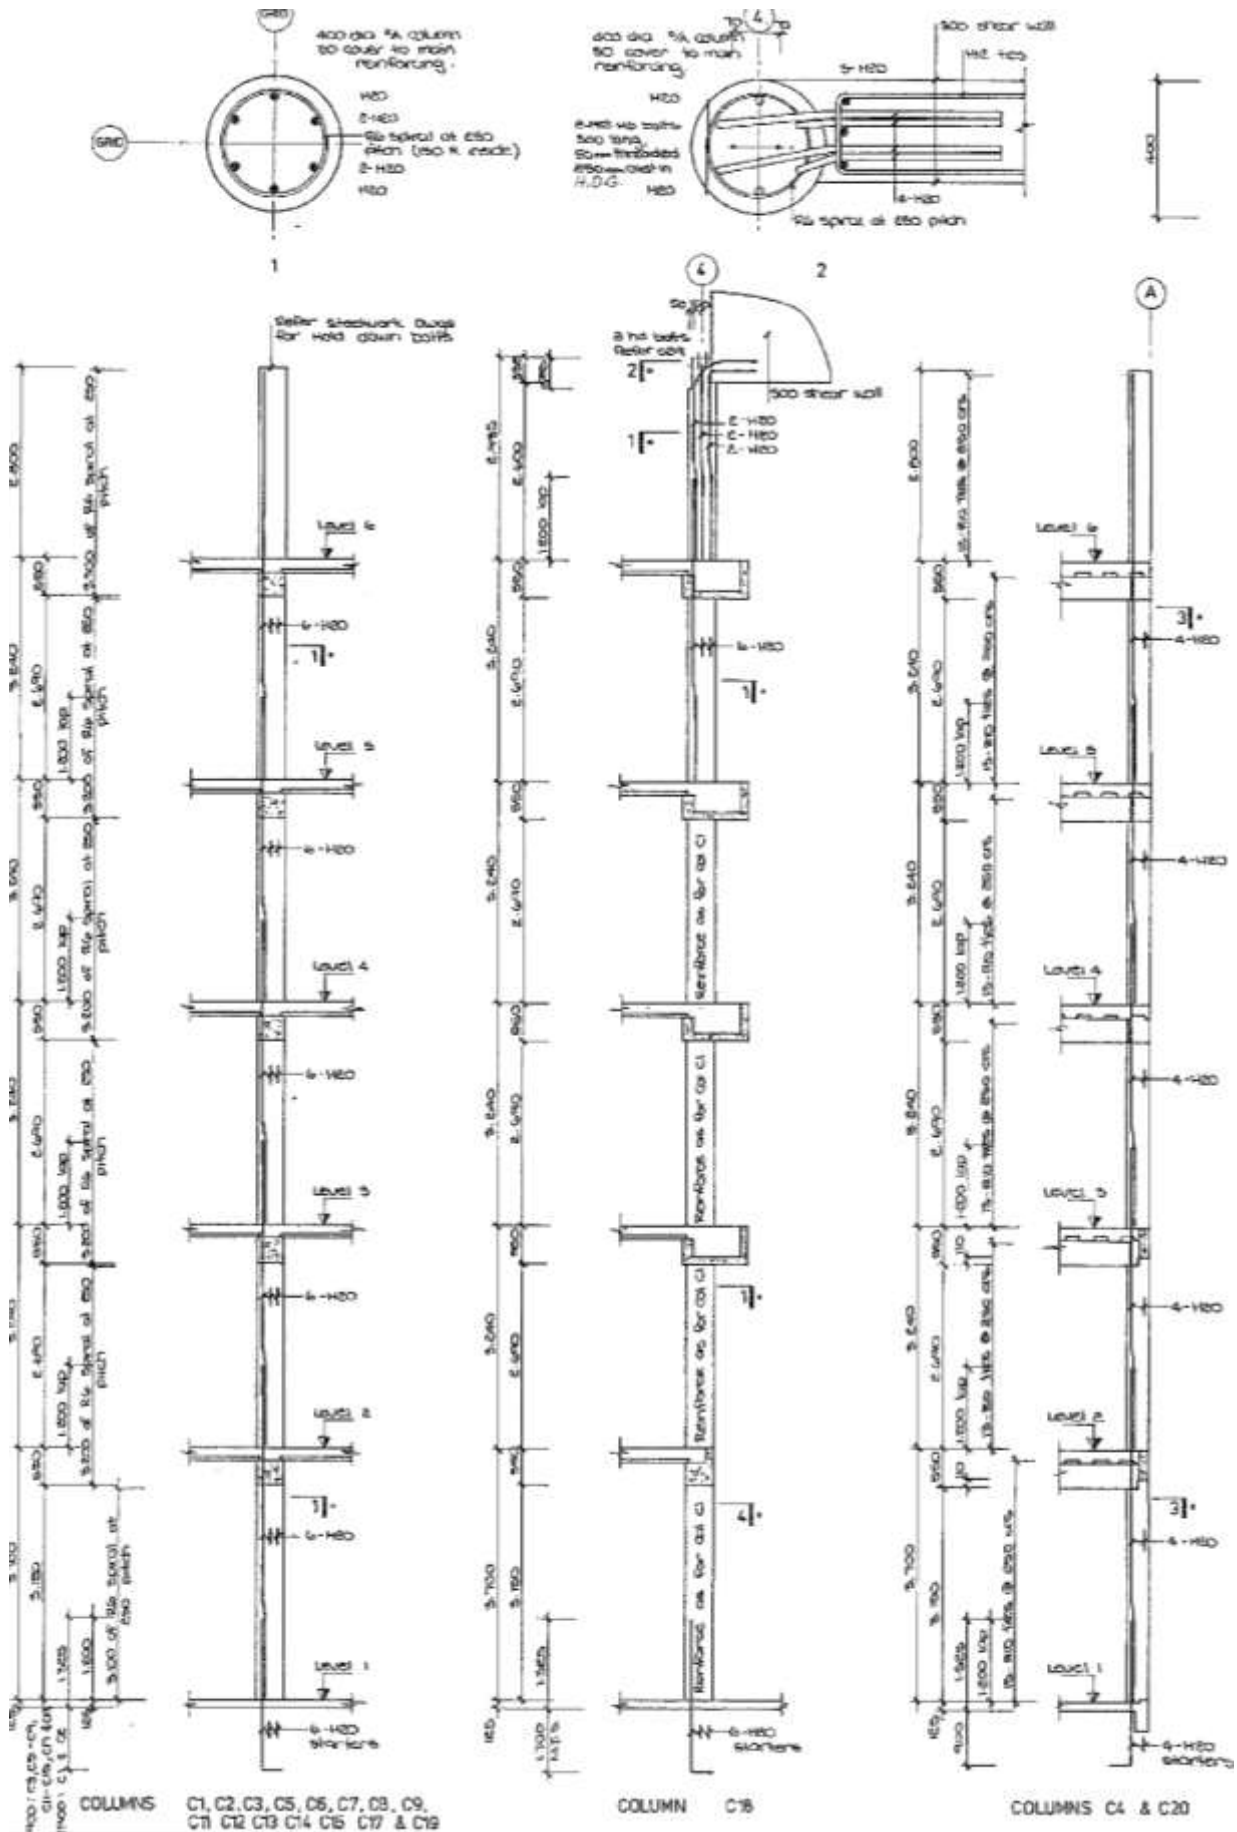
Figure 61 Columns (Extract DENG Dwg S14)

Figure 33 Lift Well Wing Wall D.5: Column C18 Connection (DENG Dwg S14 (Figure 61)); 3 x 20 to 24 mm diameter holes can be seen where reinforcing bars from column have pulled out. The drawing shows that 4-H20 bars were required to be bent in to the wall.

Circular column remnants test Items C7, C8, C9, C11, C12 and C13 had flexural hinging zones at their bases around the lapping bars and hinging failure similar to that seen in Item 33 which was a perimeter column (Figure 46 and Figure 8). In that case spear head style shear or flexural hinging commenced approximately 1350 mm above the base and terminated at around 1600 mm. This appears to coincide with the end of the column lap bars which were specified to be 1200mm long (DENG Dwg S14 Figure 61).

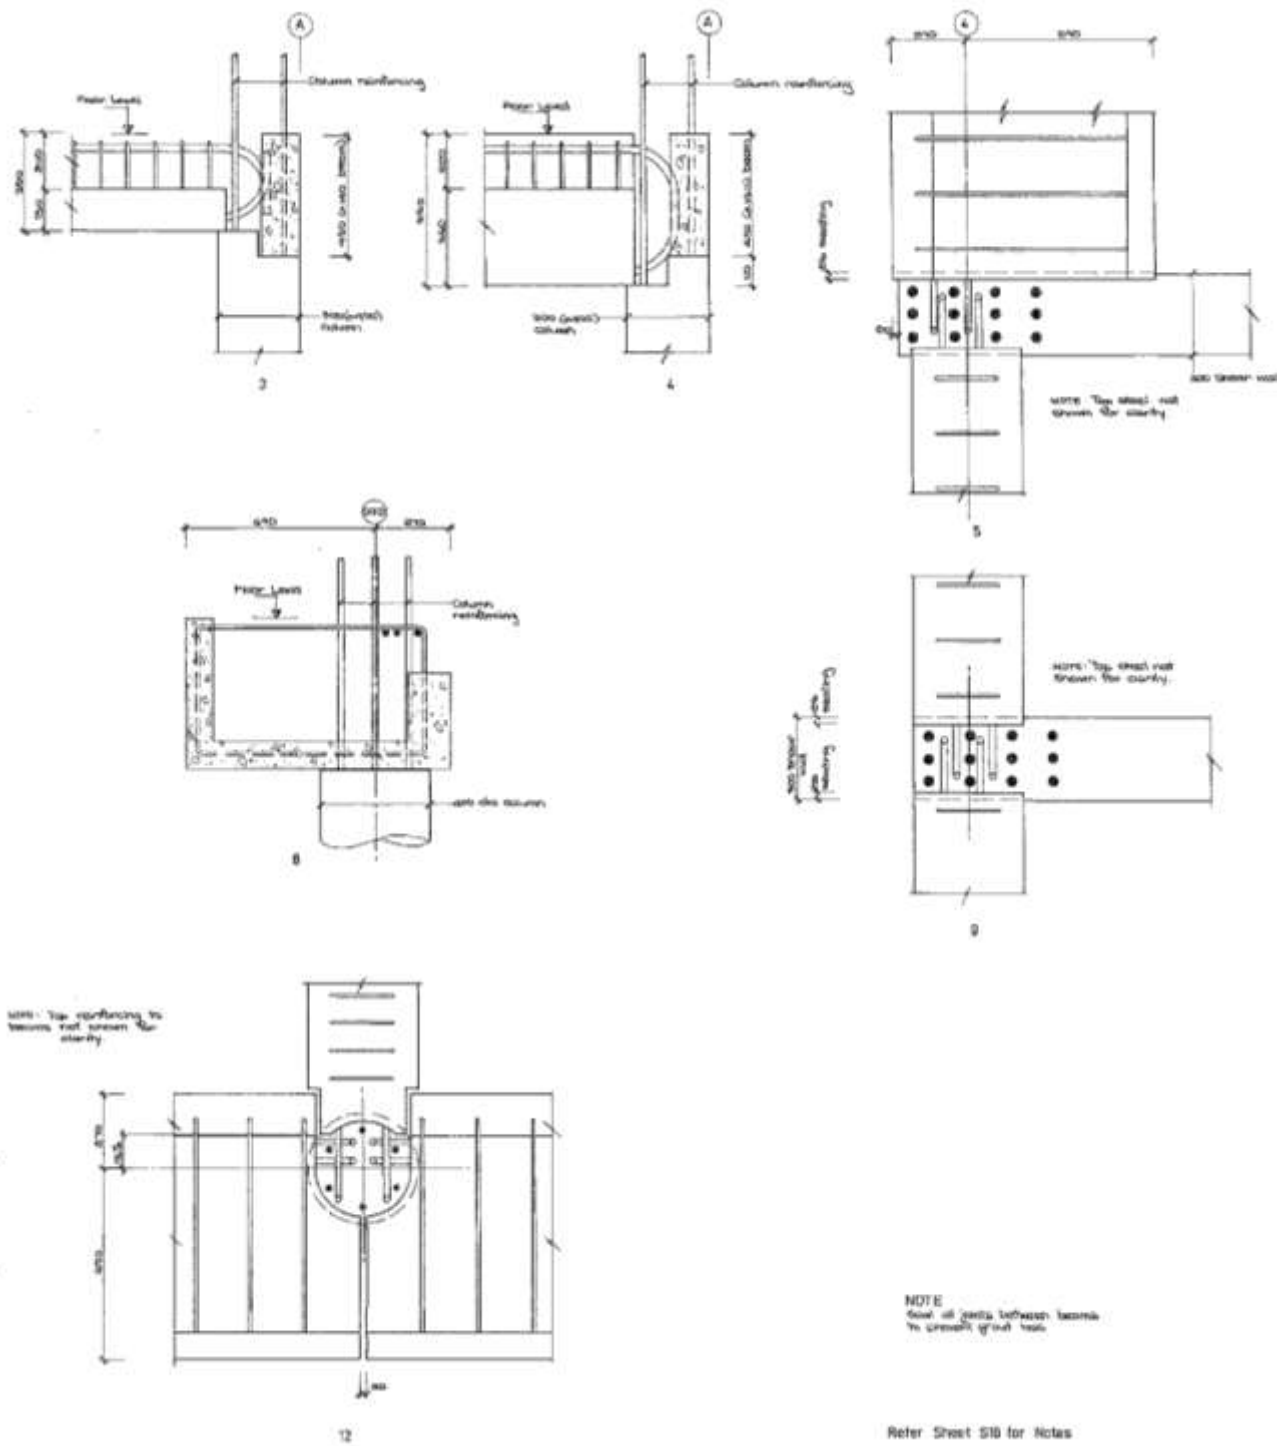
Figure 64 Beam-Column Joints (Extract DENG Dwg S19)

Figure 24 Line 4 Core Walls Level 2 slab remnants (clockwise from top left) a) Slab edge broken back during de-construction adjacent to stairwell wall; b) Broken back slab with H12 saddle bars exposed. Masonry wall with separation along top course; c) Switch room under Level 2 slab; d) Connection of shell beam to wall with two fractured H24 top bars and one de-bonded top bars. Bottom bars from shell beam have been embedded in wall as specified (DENG B23 Dwg S18 (Figure 59), Detail 5 S19 (Figure 64)). Some diagonal beam-wall joint zone shear cracking can be seen in the wall end.

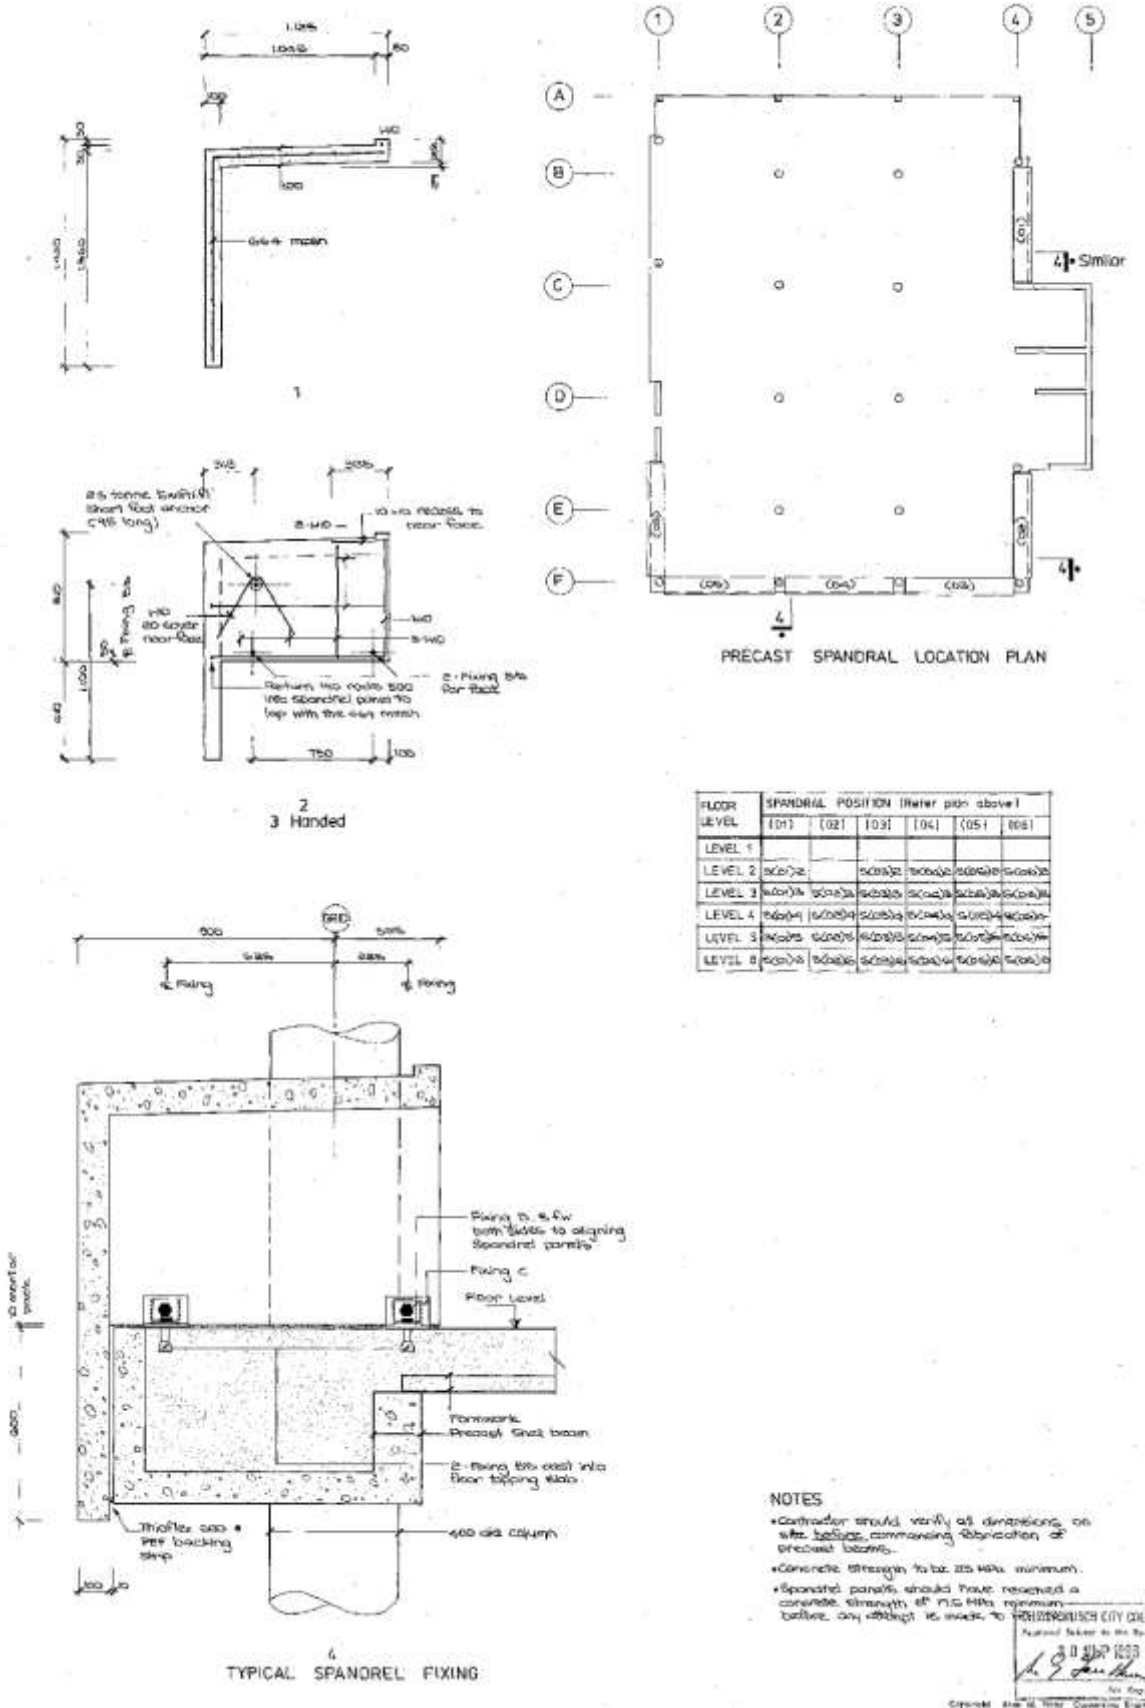
Figure 65 Pre-cast spandrel panels (Extract from DENG Drawing S25)

Figure 3 Pre-cast spandrel panel Item E21 (DENG Dwg S25 (Figure 65))

The pre-cast spandrel panels may have had some influence on the mid-height failures by inducing short column effects (Figure 3 and Figure 65). The 400 mm diameter columns that suffered the mid-height failures may therefore have been from Grids 1, 4 and F like Item 33.
