CTV BUILDING COLLAPSE INVESTIGATION  
FOR CEBPTI PANEL  
FOR DEPARTMENT OF BUILDING AND HOUSING  
11TH AUGUST

Report Title: CTV Building Collapse Investigation  
Report Number: DBH 110628

Report Issue Date: 15<sup>th</sup> August 2011  
Report Issue Status: Draft

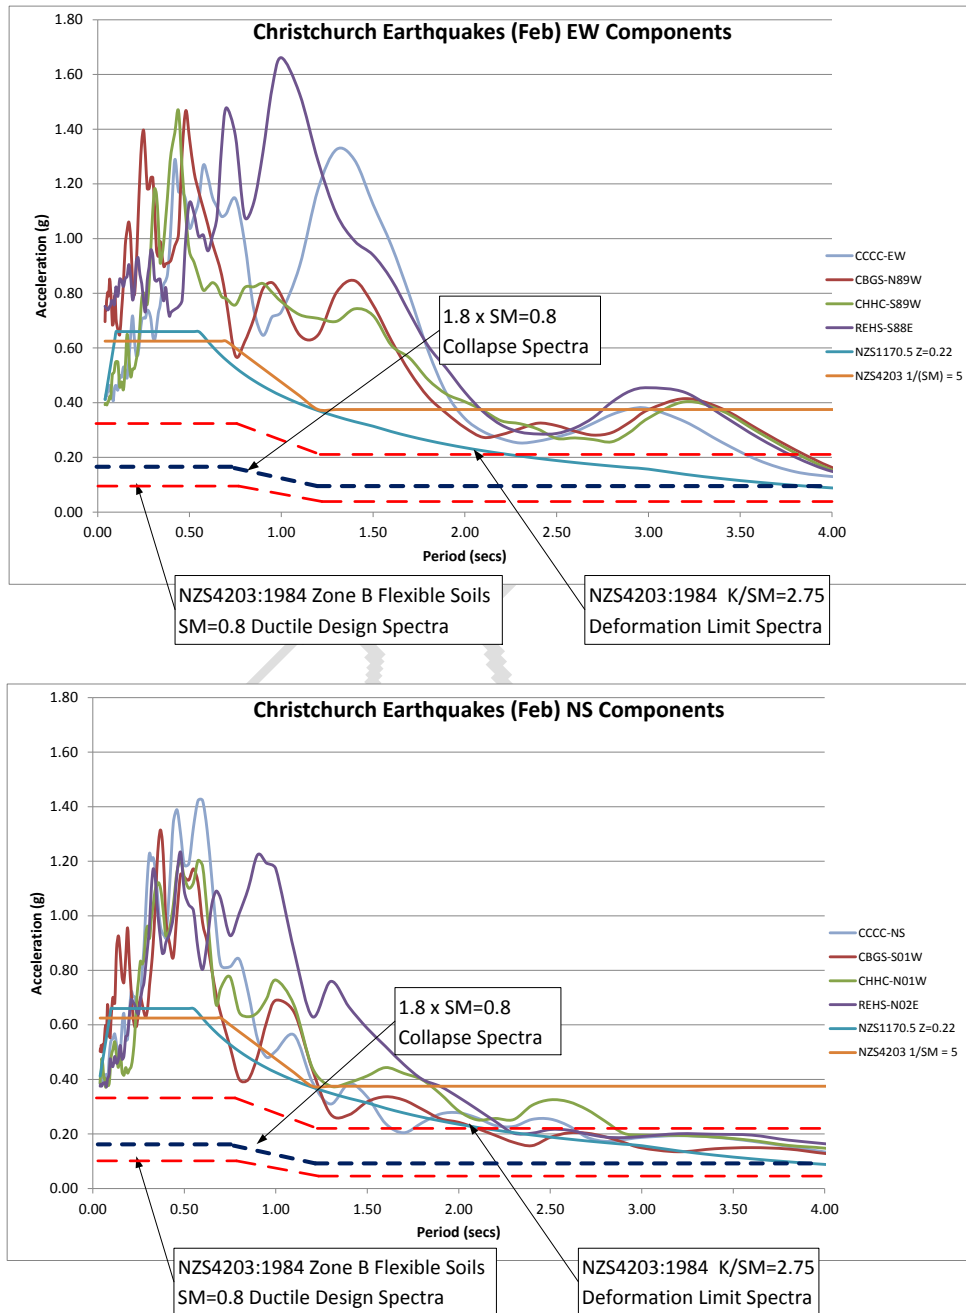
Figure 6 Response spectra for the after-shock of 22<sup>nd</sup> February, 2011. The ductile and fully elastic response spectra from NZS 4203:1984 and NZS 1170.5:2003 are superimposed.

A comparison of the  $SM=0.8$  design spectra relative to the records in each event (Figure 4 to Figure 6), indicates that major structural damage and even collapse should have occurred in all the events.

Figure 6 shows response spectra plots from the four nearby recording stations for the 22<sup>nd</sup> February 2011 after-shock and the relevant design spectra. The 1.8 x SM=0.8 scaled design spectra at which the collapse is calculated to have initiated is shown as the collapse spectra.

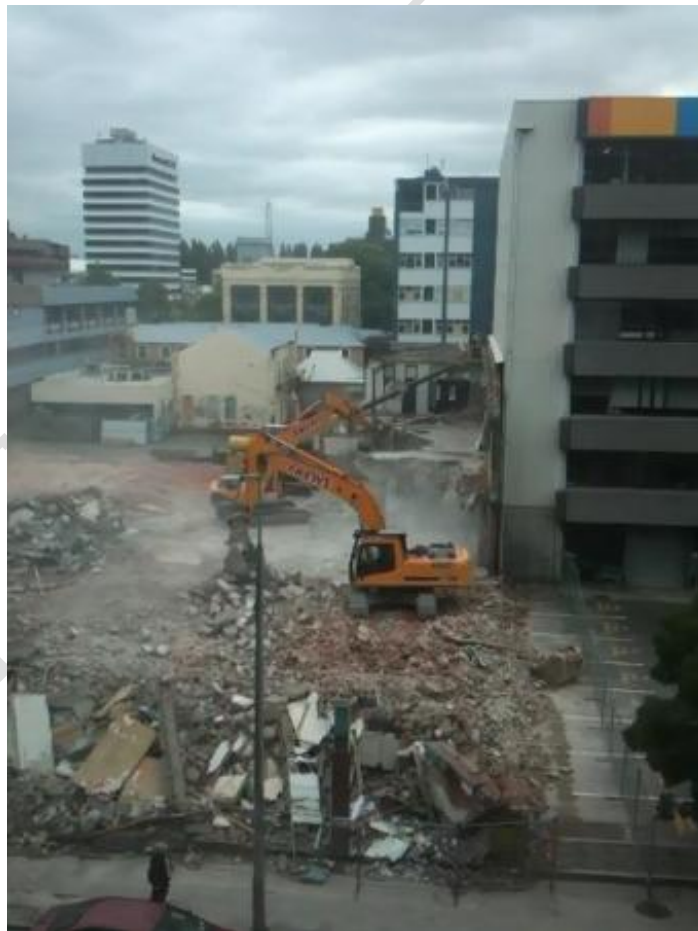
Figure 12 Heavy machinery demolishing a reinforced concrete building adjacent to the CTV Building after the 4<sup>th</sup> September, 2010 earthquake.

Heavy machinery with pneumatic pokers and pincers, and drop hammers, were used to break it up (Figure 12). This caused ongoing and disturbing vibrations to occupants in the CTV building.

It is considered however that no structural damage was caused by the demolition sufficient to affect the earthquake resistance of the CTV Building.

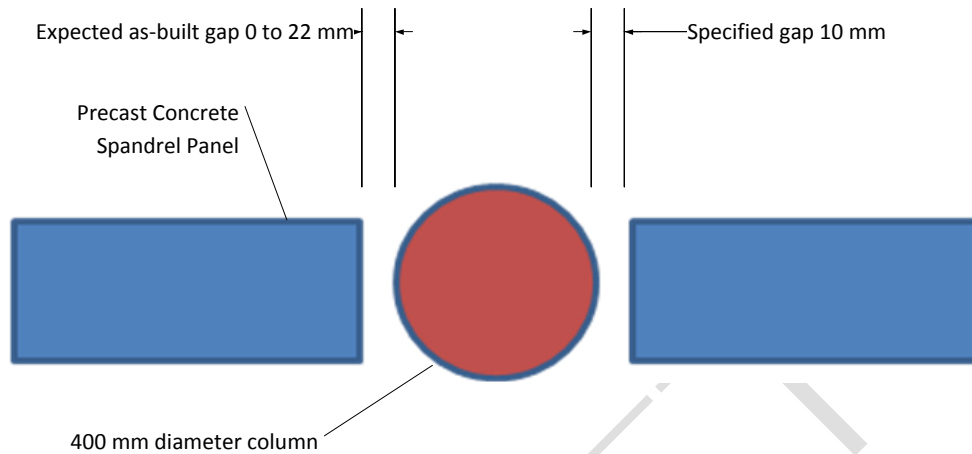
Figure 14 expected as-built gaps between spandrel panels and columns based on BS 5605:1990 combinations of tolerances

The actual as-built gap either side of the columns is expected to have ranged between 0 and 22 mm based on the guidelines for assessing combined construction tolerances BS 5606:1990 (Figure 14). This combines the 10 mm off-grid location tolerance of the column; 5 mm oversize allowance on column radius; and half of the 6 mm length tolerance on the precast panels, set in the Specification and the Concrete Construction Standard NZS3109:1987:

Other columns would have had a greater gap and been able to develop a hinge at the top and bottom of the column before engaging with the spandrel panels and developing a third hinge forming a localised collapse mechanism. This is seen in the perimeter column remnant E33 (Figure 70).

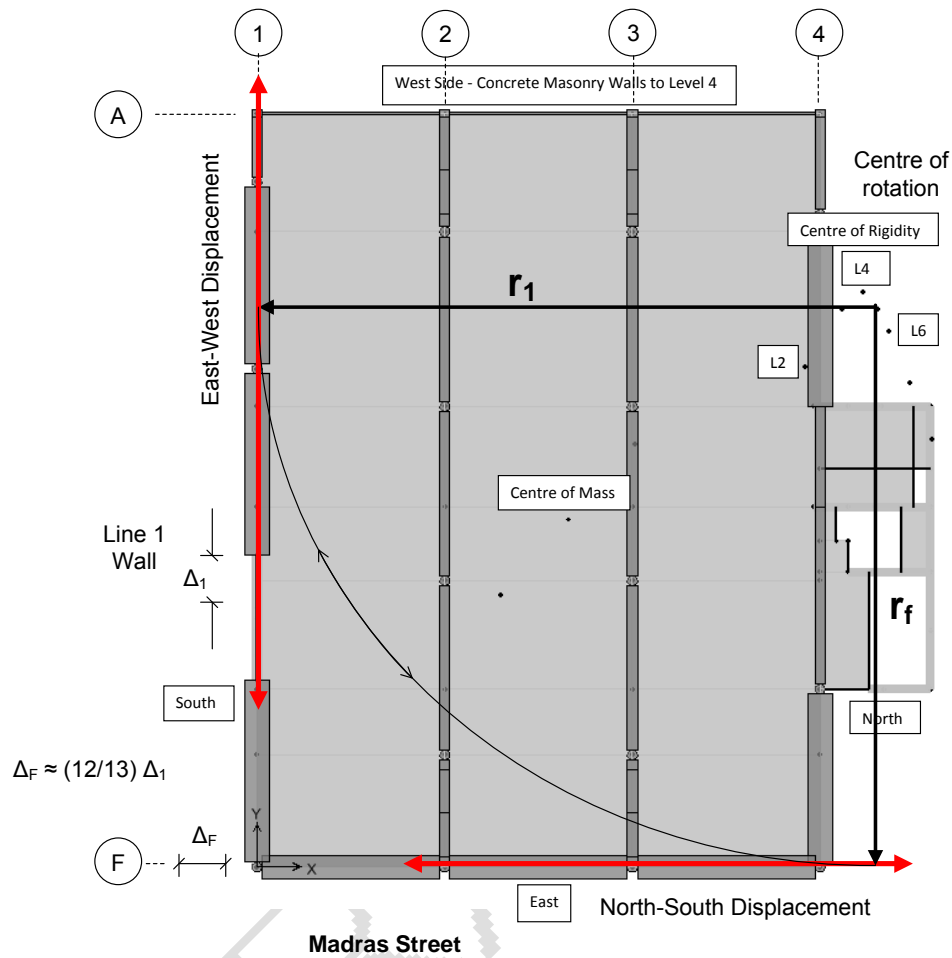
Figure 15 Torsional behaviour of the building increased above Level 4

Due to the highly torsional response of the structure the displacements along Grid F are similar to the displacements along Grid I in the orthogonal direction (Figure 15).

No cracking was evident in the west panel which should have borne half of the shear demand on the wall at that level. Below Level 4 the cracking damage became much lighter and strongly uni-directional. Horizontal construction joints above and below the slab levels in the Line 1 shear wall were found to be typically un-roughened and smooth. The 3D analysis showed a significant reduction in the shear in the Line 1 wall below Level 4 due to the masonry wall on Grid A adding significant torsional restraint to the structure below that level.

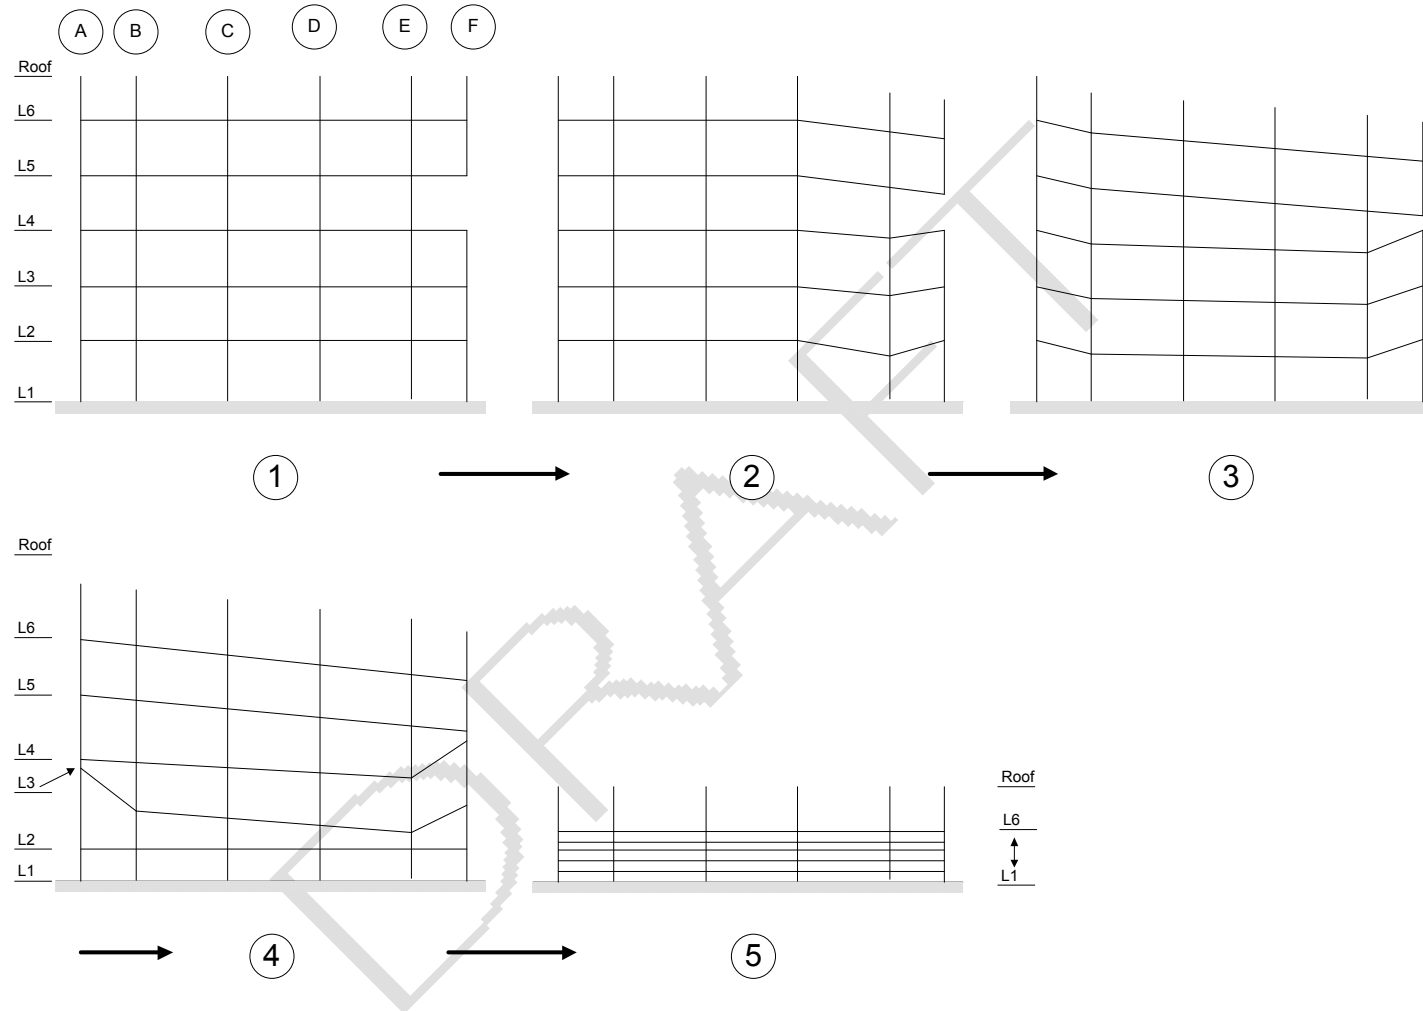
Figure 19 Line 2 collapse development sequence following column collapse initiation on Line F

Once columns on Grid F at level 4 began to collapse the collapse would quickly spread west through the structure as the next line of columns between level 4 and 5 gained additional tributary areas to support and collapsed in compression (Figure 19).

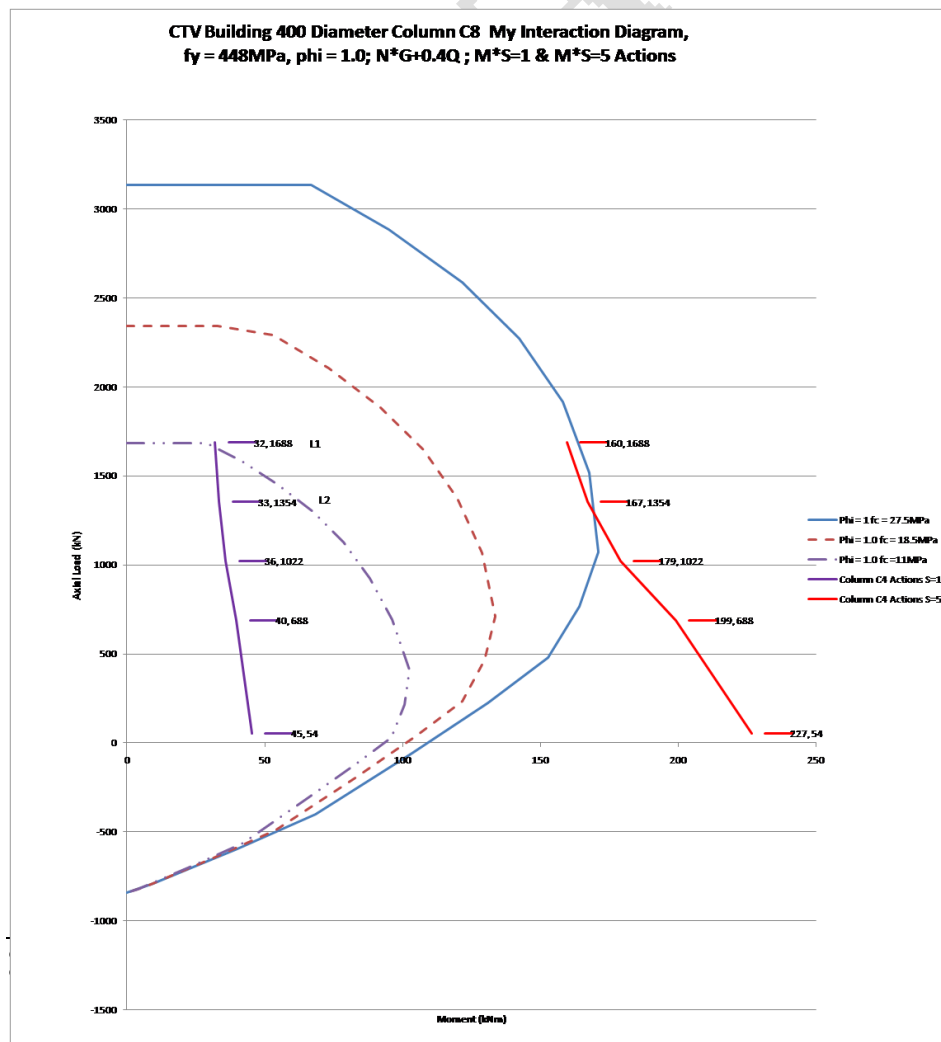
Figure 21 C8 (Grids C/2) column interaction curve used tested material properties and displacement compatibility actions for S=1 and S-5. Collapse is most likely where the load demand line breaches the 18.5 MPa average concrete strength interaction curve at around s-3 to 3.5 displacements.

maintain their integrity under gravity loads. They would have been operating near the upper limits of their theoretical axial capacity and could sustain only small amounts of lateral displacement from earthquake motion before collapsing (Figure 21).

The 'non-seismic' detailing of reinforcement in the columns (small diameter ties and spiral at wide spacings) offered little in the way of confinement or shear strength. This meant that the columns had little ability to maintain integrity once axial compressive damage began to initiate in the lower floor columns.

In summary this collapse mechanism is a credible option that can't be totally discounted, but depends on the Level 1 and Level 2 columns having concrete strengths consistent with 17.5 MPa at 28 days and aged by 25% rather than the specified 35 MPa and 30 MPa at 28 days respectively.

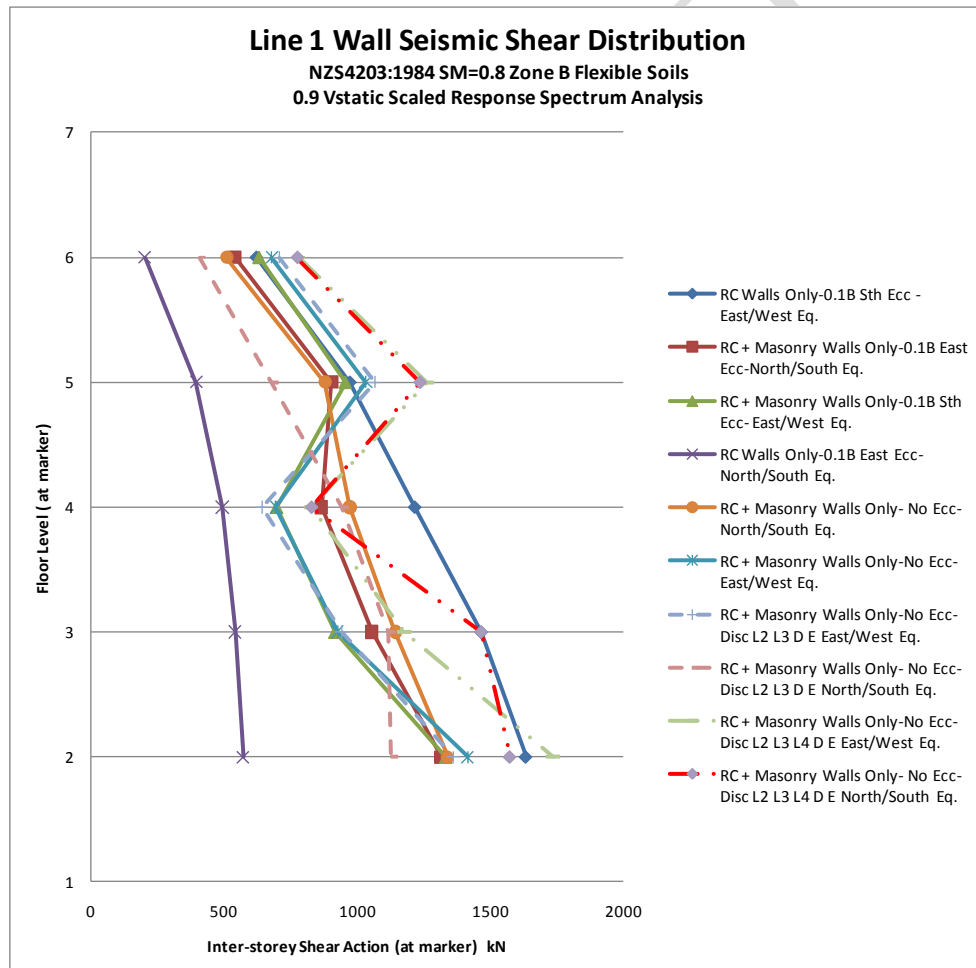
Figure 24 Line 1 Shear Wall shear action distribution

Analysis undertaken neglecting the Line A wall, leads to inter-storey shear design actions that adequately envelopes the design actions assuming the worst case East/West and North/South seismic events (Figure 24).

This was because the east/west event dominated the design when the masonry infill wall on Grid A was excluded. For north/south events with no Grid A masonry the actions on the Line 1 wall are 35% of those for the east/west event.

The frame was then analysed with those diaphragm connections removed and the demand versus capacity ratios calculated. This showed that the Line 1 and 5 shear walls picked up additional shear to compensate for the loss of diaphragm connections at level 2 and 3 (Figure 24 and Figure 25).

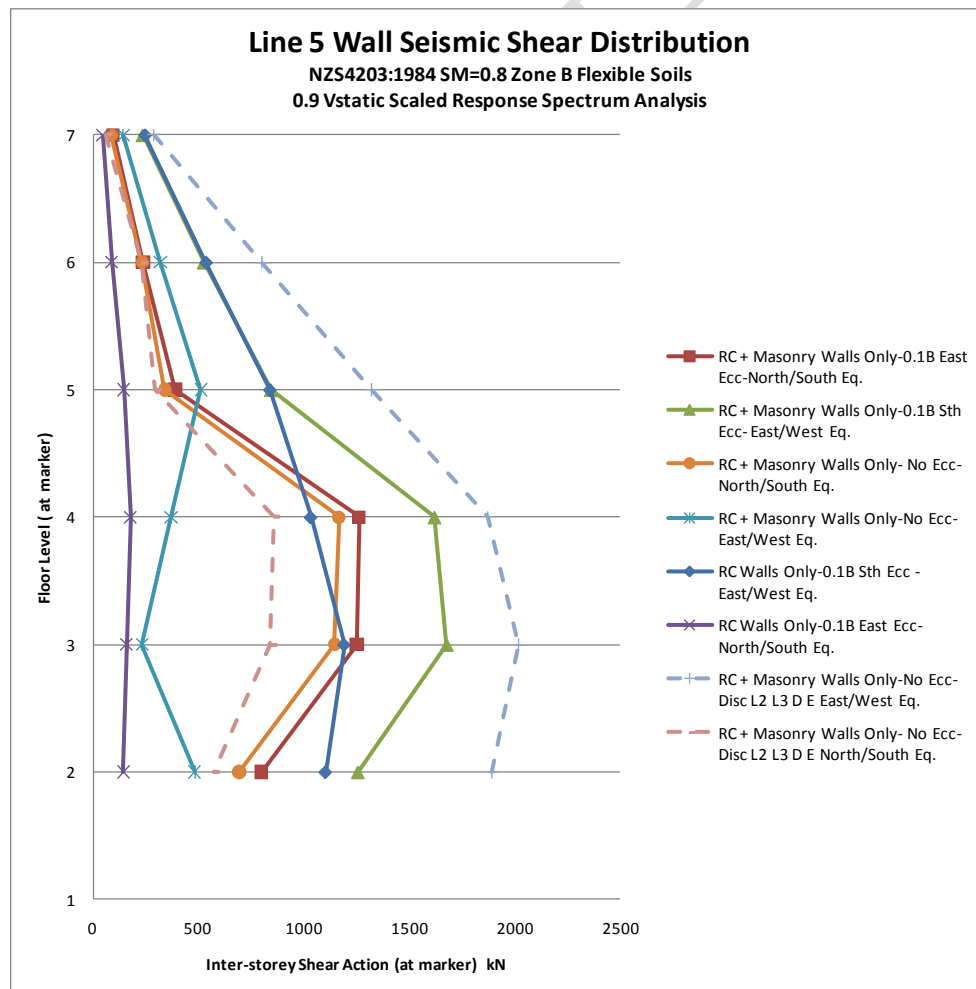
Figure 25 Line 5 Shear Wall shear action distribution

Disconnection of the floor diaphragm to walls D and E at levels 2 and 3 increased the shear actions on the Line 5 wall, as the couple between it and the Line 1 wall picked up the additional torsional actions.(Figure 25) .

It only suffered hairline diagonal shear cracking near the base in the earthquakes and after-shocks (Hyland 2011).

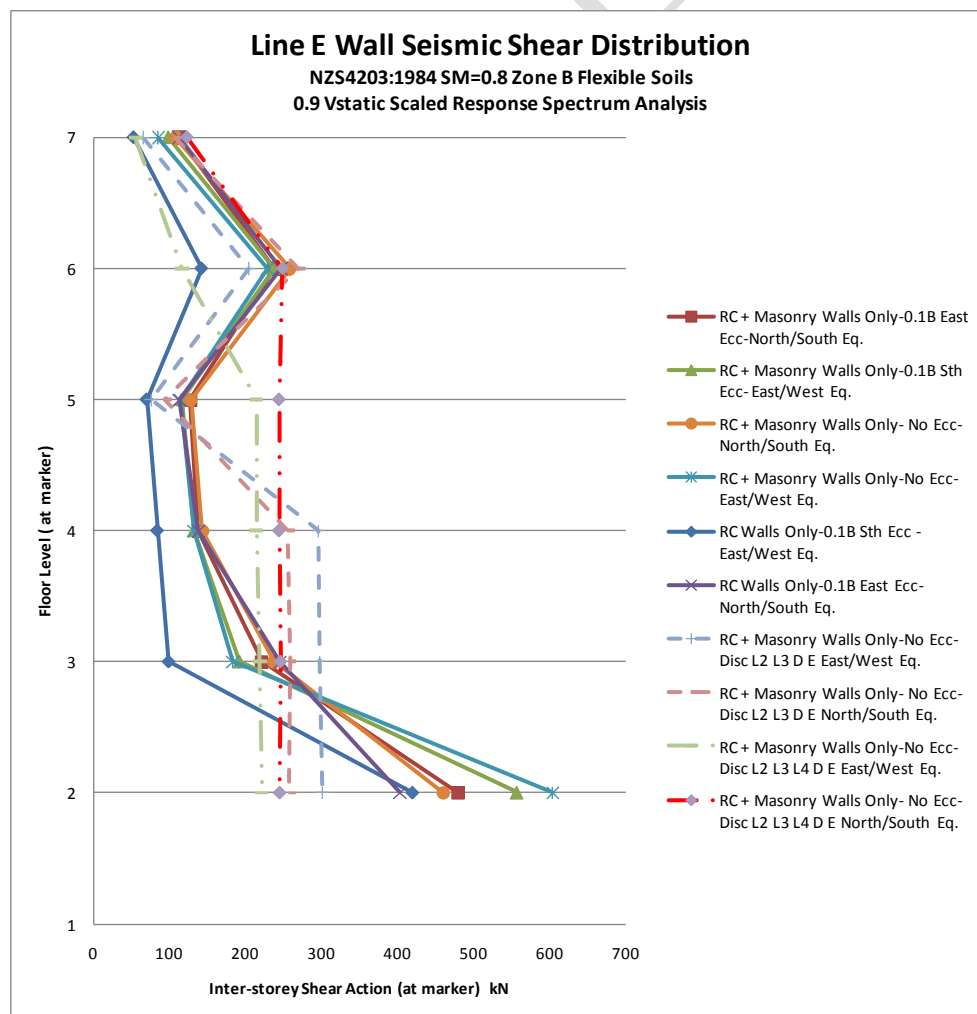
Figure 34 Line E Wall seismic shear distribution

Disconnection of the floor diaphragm to walls D and E at levels 2 and 3 increased the shear actions at level 4 of the Line E wall, Subsequent disconnection of the diaphragm at Level 4 increased the shear action between Level 5 and 4 (Figure 34).

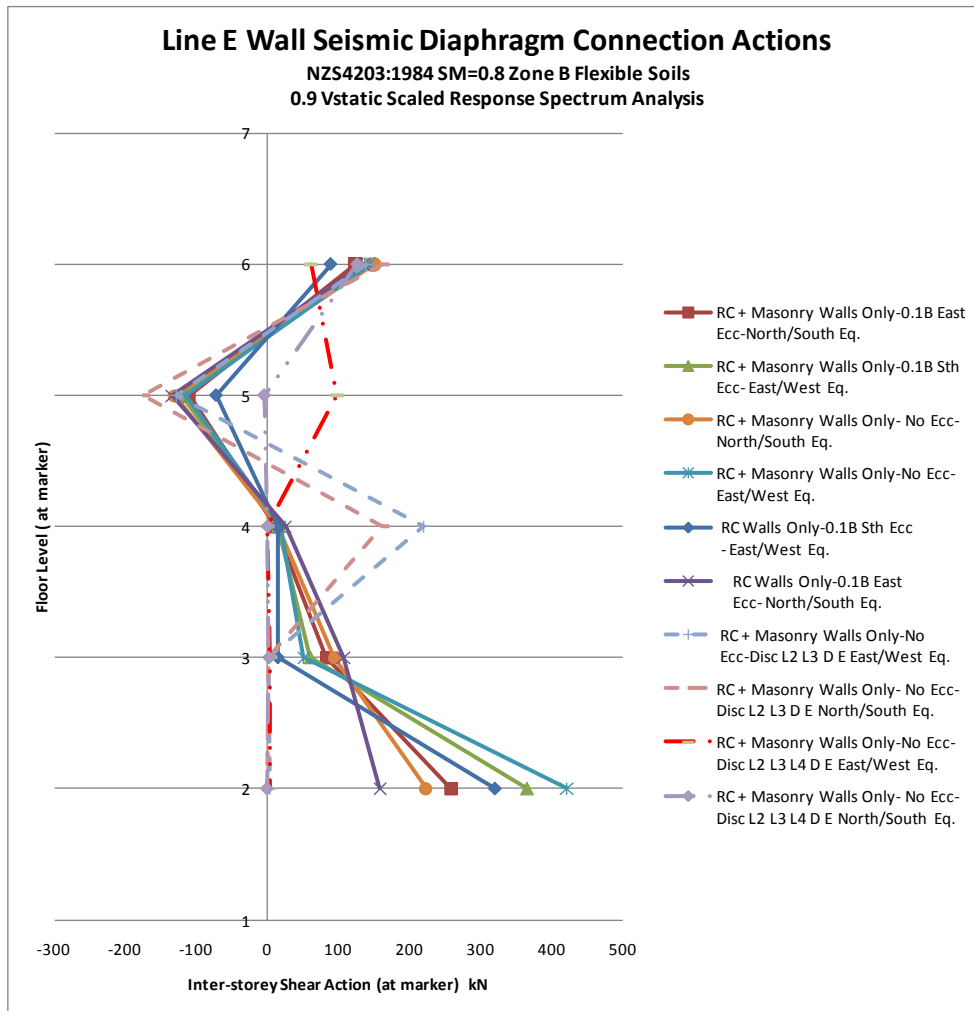
Figure 35 Line E Wall seismic diaphragm connection actions

Diaphragm connection actions are greatest and Level 4 when there are no diaphragm connections at level 2 and 3. When the connection at Level 4 is also removed the diaphragm connection action at Level 5 reduces (Figure 35).

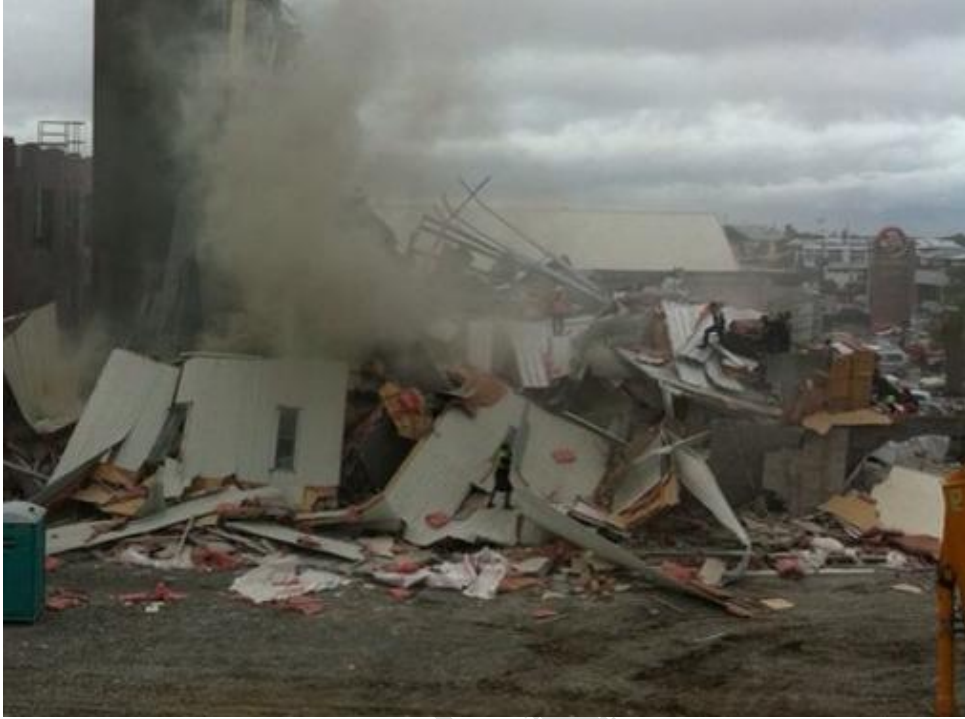
Liquefaction is not considered to have been a significant factor for this building. There was a report of some water or liquefaction on the west side of empty site adjacent at the west side after the earthquake. No liquefaction was observed adjacent to the building itself (Figure 39) or in the streets around the site at the south and east sides.

No liquefaction can be observed in photos in the immediate vicinity of the building after the collapse (Figure 39). However liquefaction was reported to have occurred near the neighbouring building near the Cashell Street roadway, on the adjacent site.

Figure 39 West side of building with lift core partially obscured by smoke, prior to heavy machinery removing debris

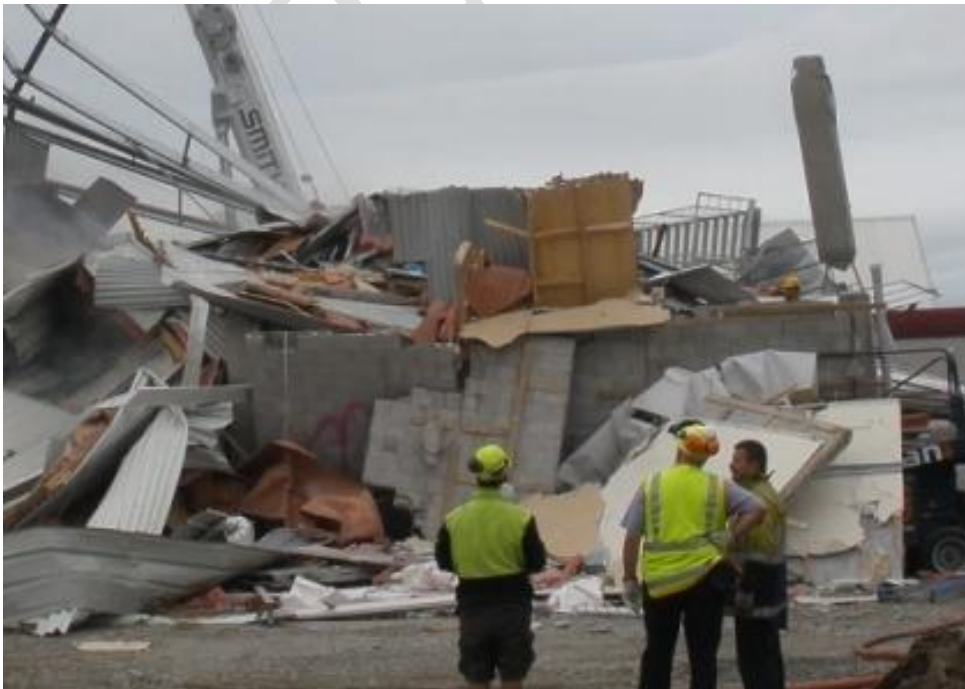
Figure 40 South west corner (Grid A/1) with corner column still standing. Collapsed work platform under wall panels.

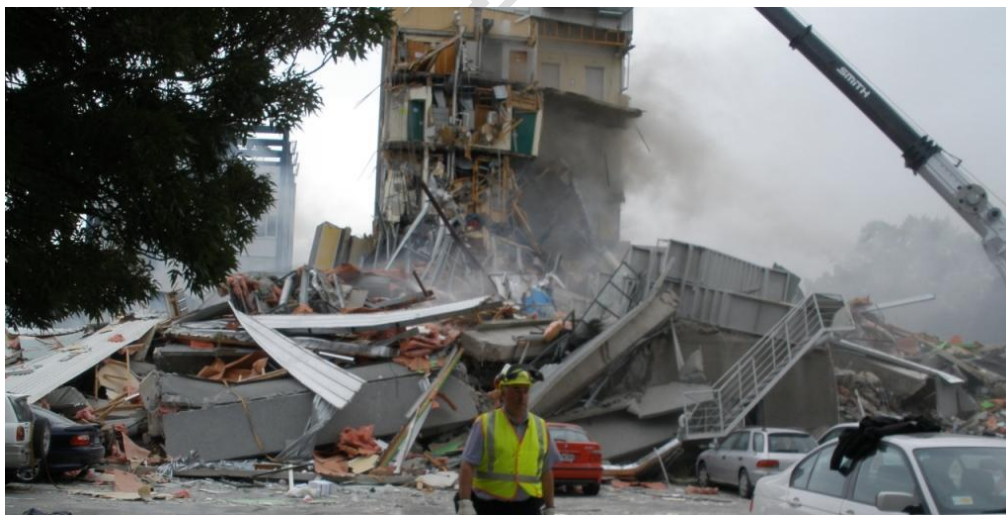
Figure 43 Western end of south face (Line 1). Collapsed Line shear wall with escape stair to the right.

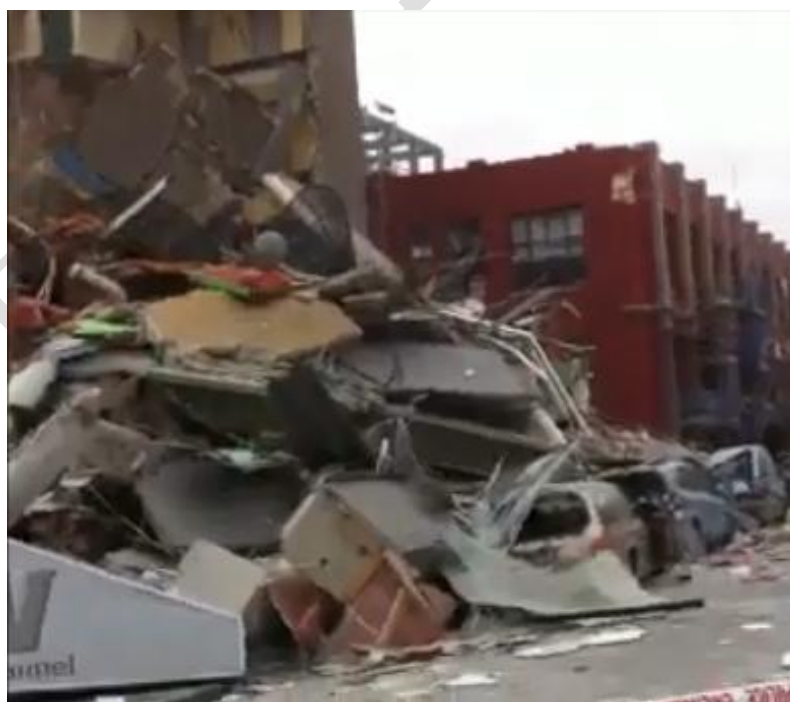
Figure 47 Madras St with precast spandrel panels fallen onto cars

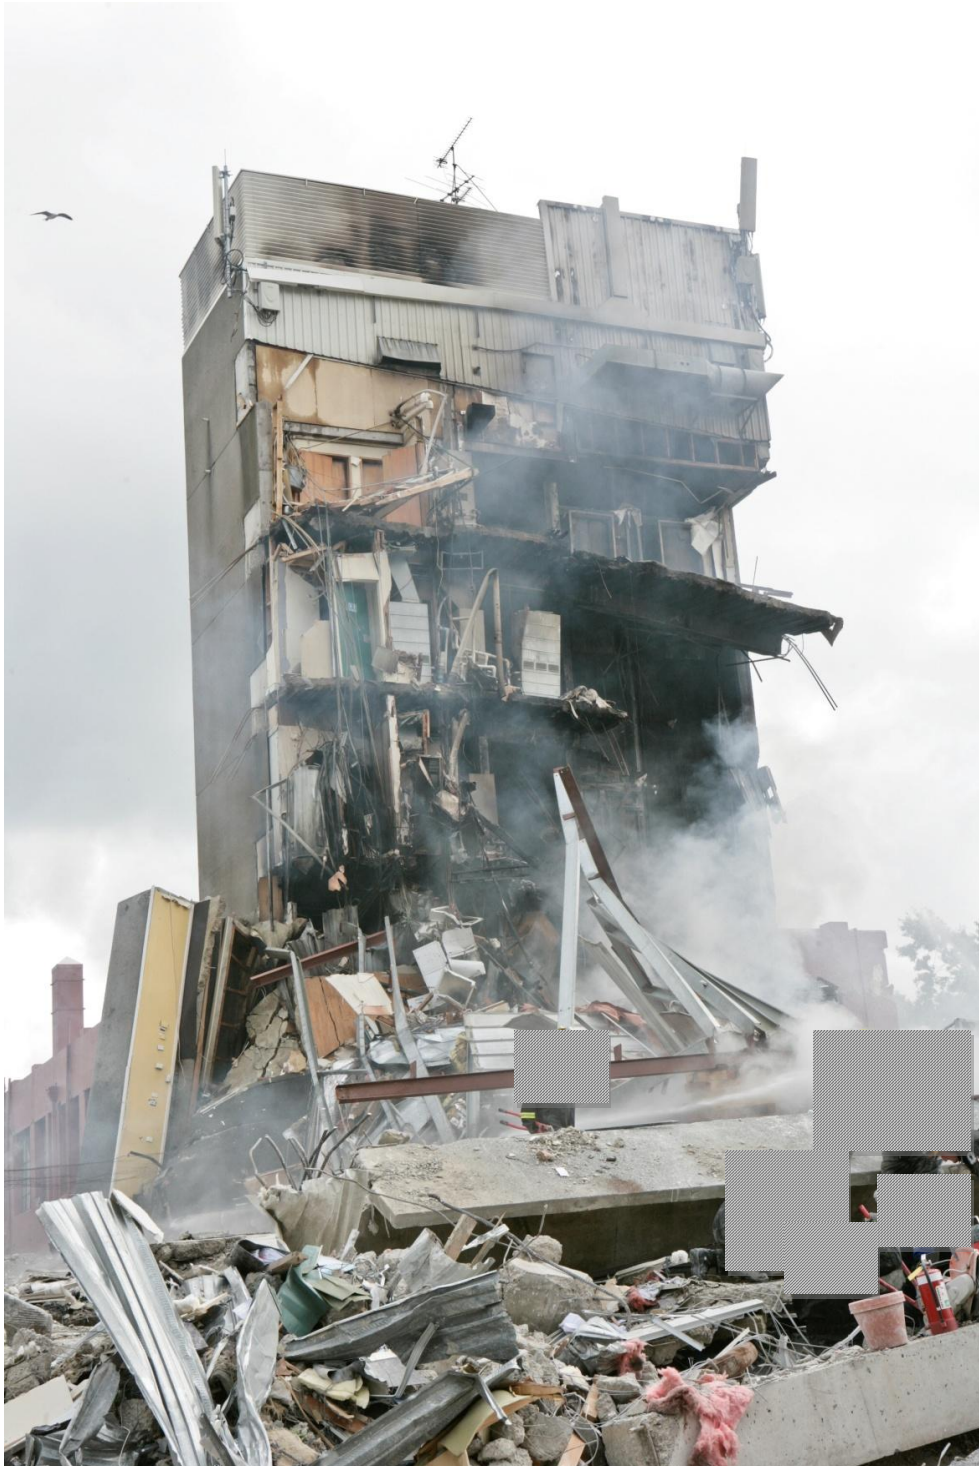
Figure 49 Spandrel panels and beams at Cashell Street Line 1 and on Line 4 in background standing vertical. Roof debris visible.

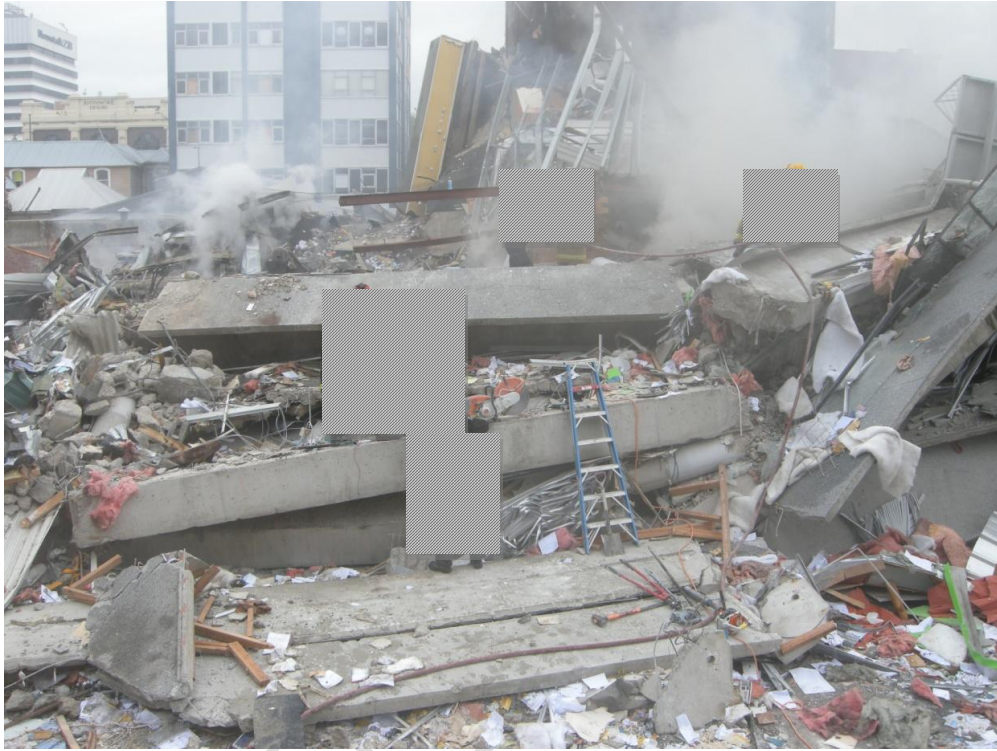
Figure 63 Concrete spandrel panels, perimeter beams and columns on Cashell Street face (Line 1 / B-D)

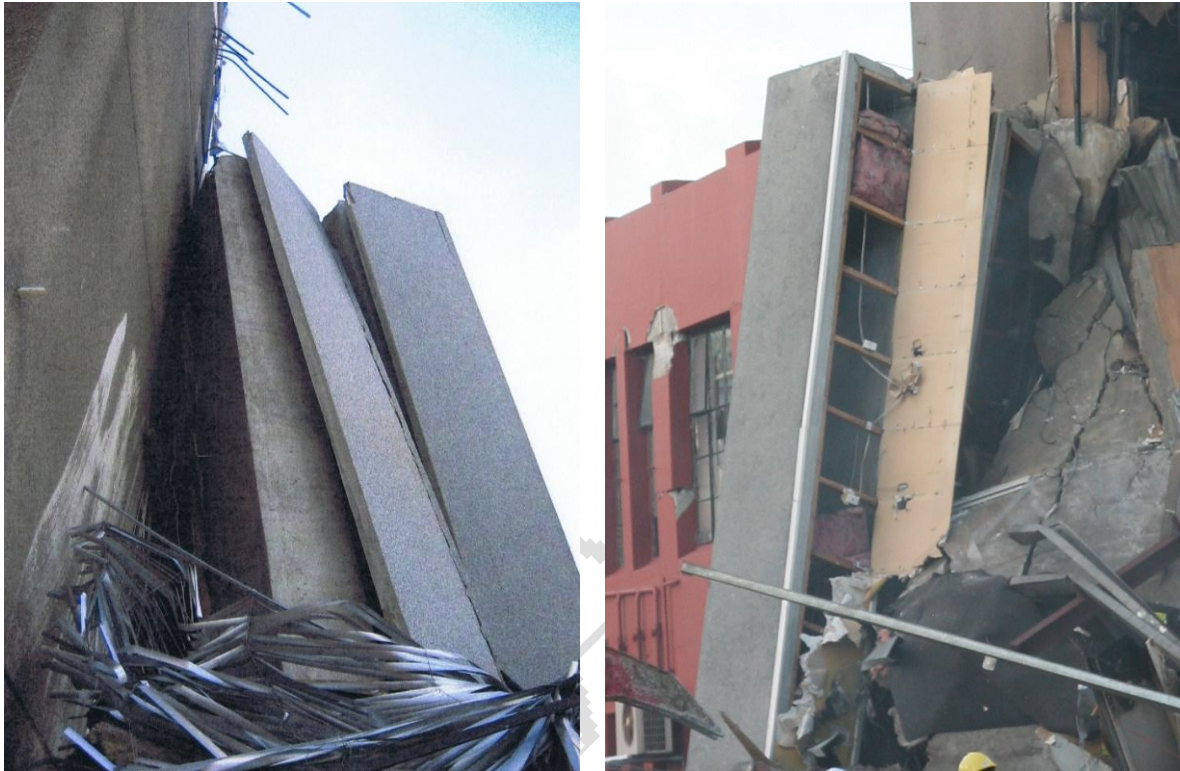
Figure 65 Line 4 / B-C spandrel panels against tower wall, showing (left to right) a) View from north face; b) View from west showing timber framing for wall linings

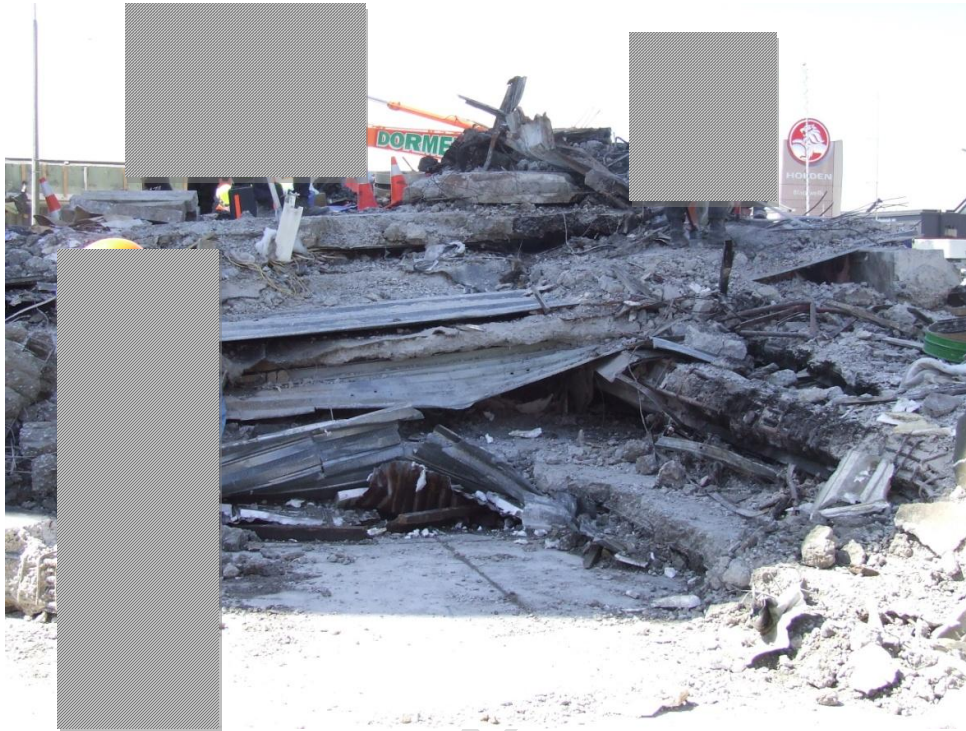
Figure 66 Line 2 beams laying rotated northwards

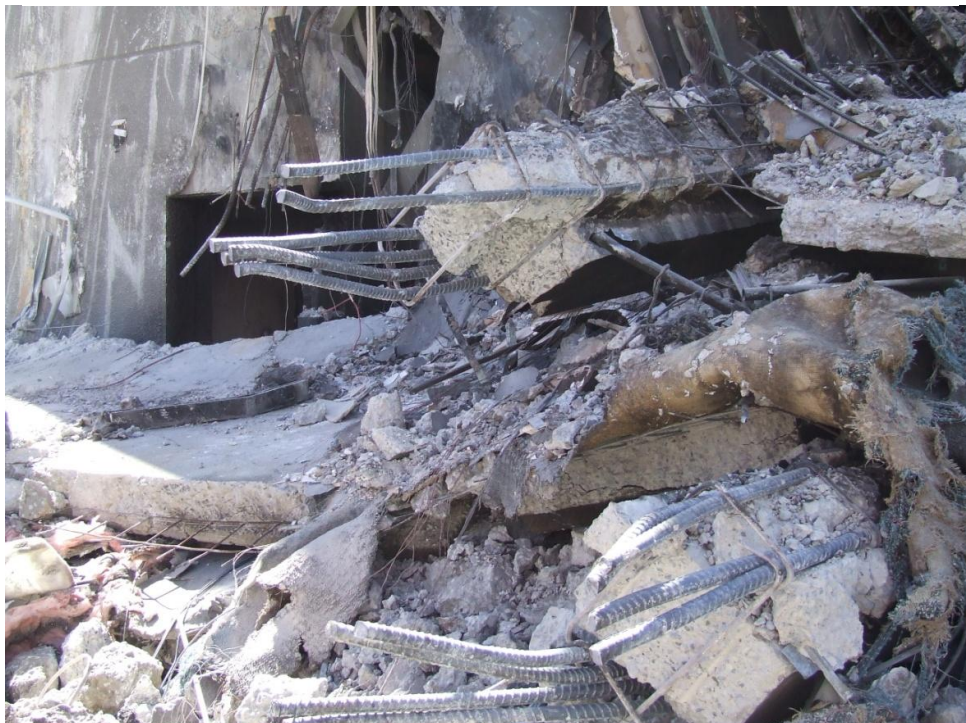
Figure 67 Line 3 beams lying rotated southwards

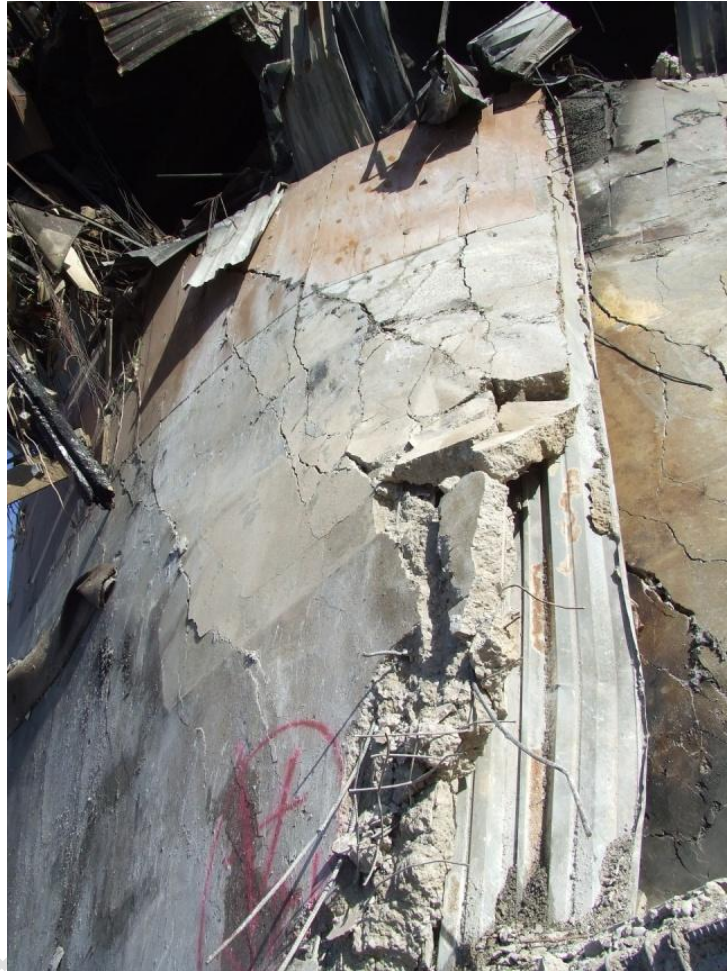
Figure 68 Lift core slab lying diagonally against the core

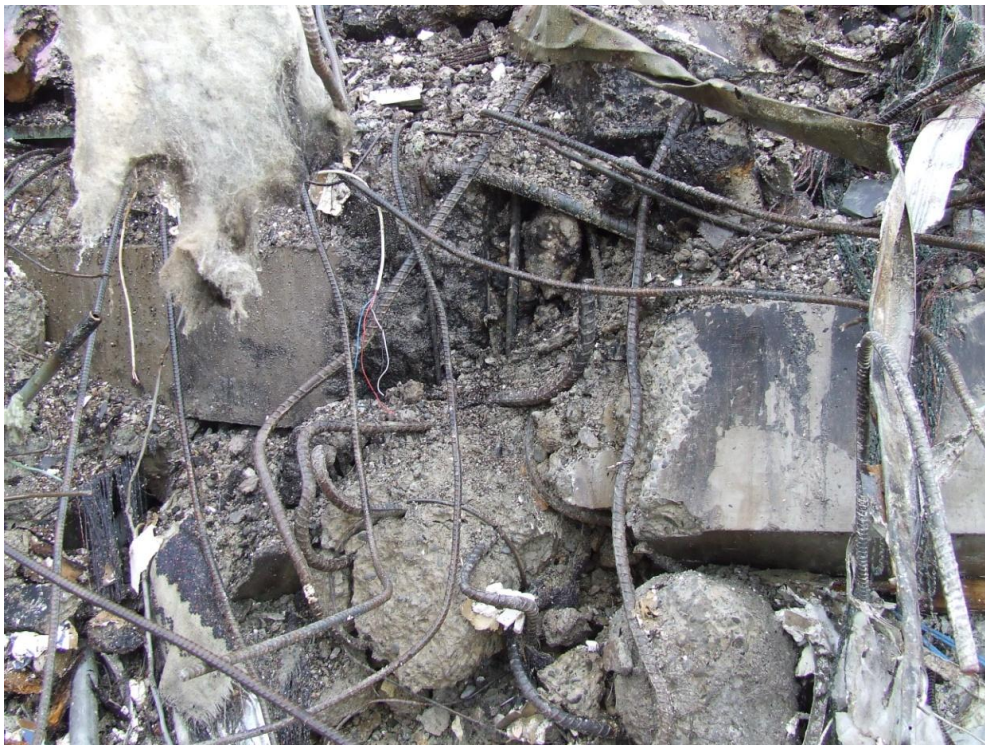
Figure 71 Perimeter columns at beam-column joint with shell beam on right side

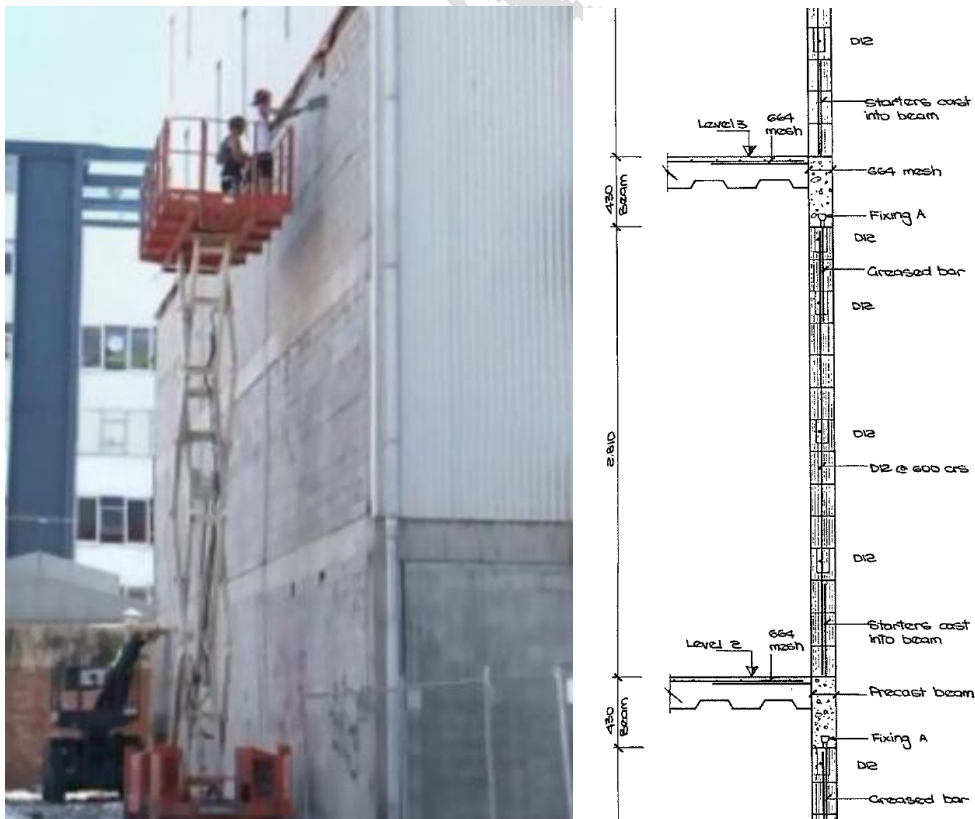
The design drawings show that it was intended that the Line A wall be fully grouted. Greased starter bars at 600 mm centres were fixed into the under-side of the precast beams along Grid A (Figure 77 DENG Dwg S9 section 6). There is a D12 horizontal bar shown in the top course of the infill masonry in Section 6 of S9, and a note on Dwg S17 requires Grade B masonry all cells filled so intention was to have it filled. Grade B masonry required observation by an engineer during construction, so it should have been grout filled as intended.

However no obvious vertical or horizontal gaps are evident on the West wall along Grid A.

Figure 77 West wall on Line A (left to right) : Being prepared for strapping and cladding a day or so before collapse on 22<sup>nd</sup> February; b) Connection of west wall block work into floor beams top and bottom (portion of DENG Dwg S9 Section 6).

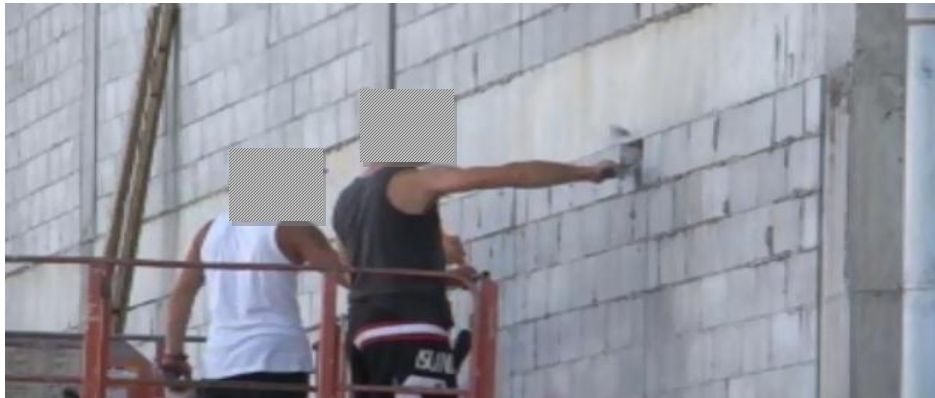
The workers were able to knock out the face of one top course block on the Level 1 portion of the wall with hammer blows which showed it was hollow ( ). They found that the wall wasn't fully grouted when they later drilled holes into it for timber strapping fixings. The rectangular columns sit out proud of the wall face by 20 mm or so.

Figure 78 Workers hammering face of top course block away on west wall near Line A / I corner column

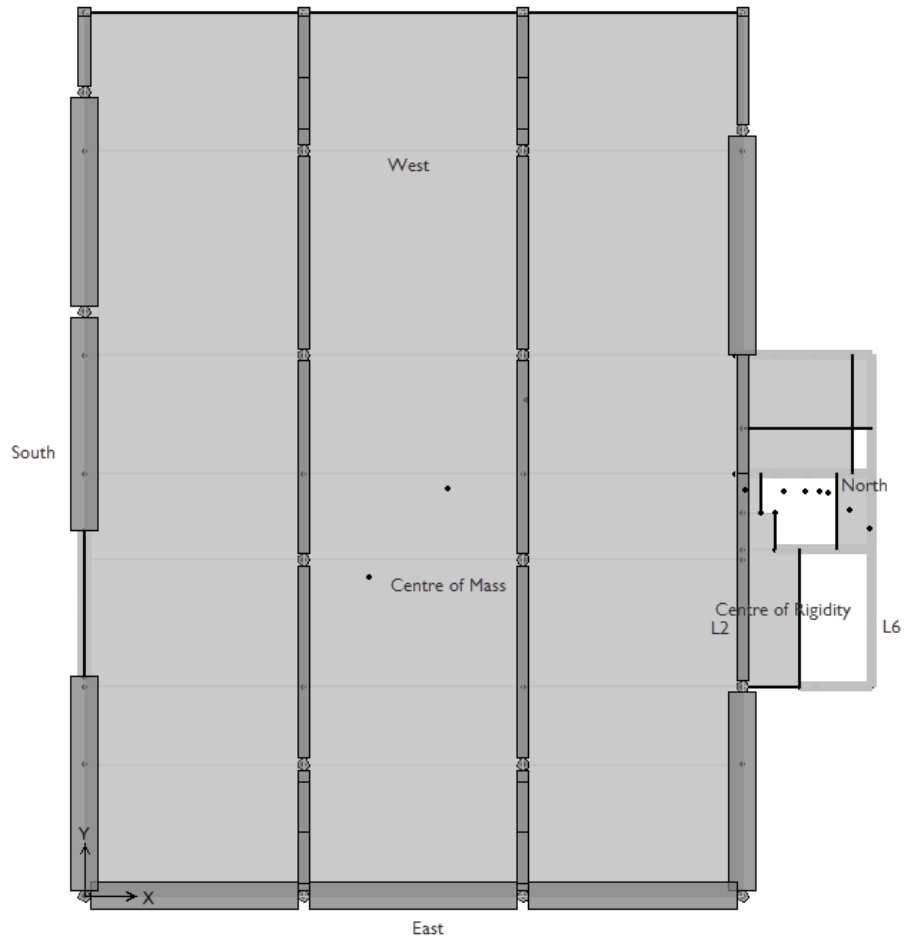
Figure 85 - Centre of Mass and Centres of Rigidity for each Floor (ETABS model 1a – Concrete Shear Walls only as seismic system)

Note – the centre of rigidity is close to the centre of mass in the east-west direction, but highly eccentric from the centre of mass in the north-south direction (towards the north).
