CTV BUILDING COLLAPSE INVESTIGATION  
FOR CEBPTI PANEL  
FOR DEPARTMENT OF BUILDING AND HOUSING  
11TH AUGUST

Report Title: CTV Building Collapse Investigation  
Report Number: DBH 110628

Report Issue Date: 15<sup>th</sup> August 2011  
Report Issue Status: Draft

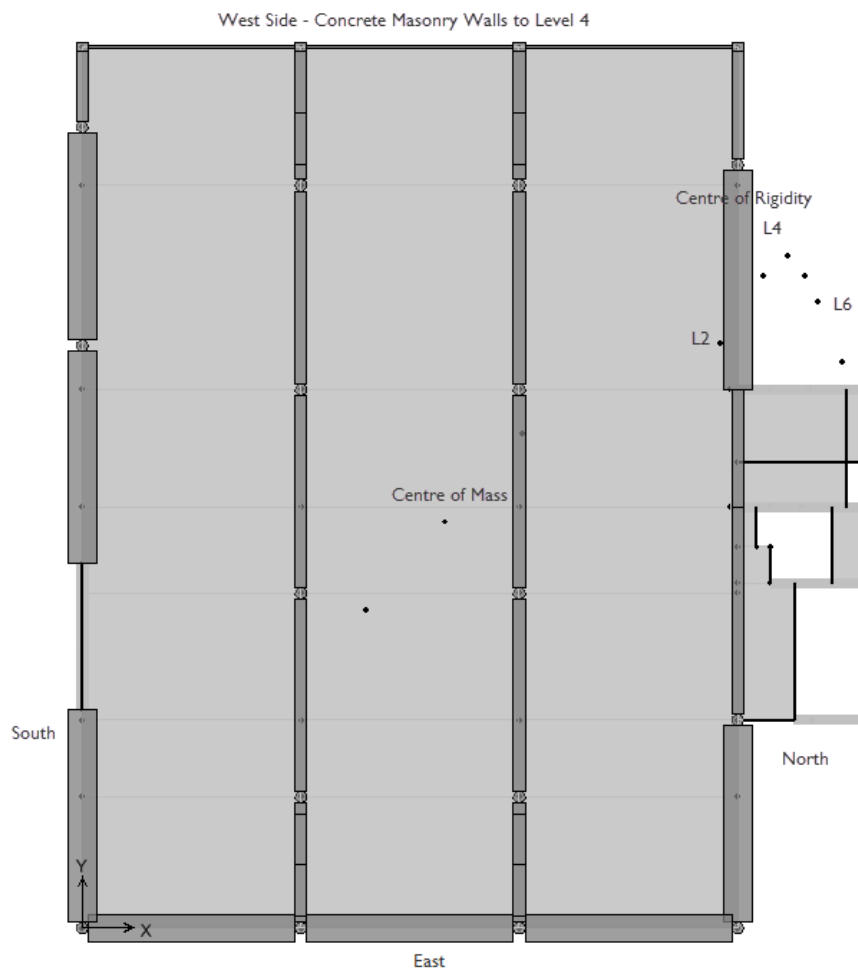
Figure 86 - Centre of Mass and Centres of Rigidity for each Floor (ETABS model 1b - Concrete Shear Walls and Concrete Masonry Walls as seismic system)

Note - the centre of rigidity is highly eccentric from the centre of mass in both directions, with a major vertical irregularity and transfer diaphragm being introduced at level 4 due to the participation of the west side masonry walls below that level.

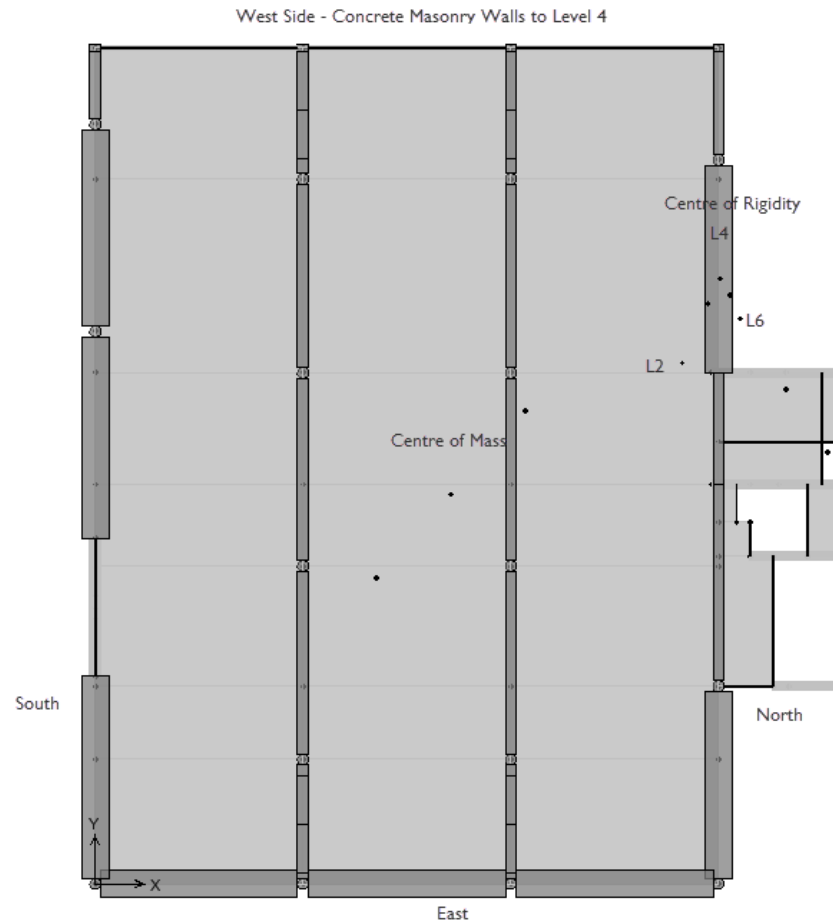
With the concrete frame also added, as in ETABS model 1c the situation is similar to that in 1b but the irregularities are moderated slightly by the action of the frame which is located more centrally than the walls.

Figure 87 - Centre of Mass and Centres of Rigidity for each Floor (ETABS model 1c - Concrete Shear Walls and Concrete Masonry Walls and Concrete Frame)

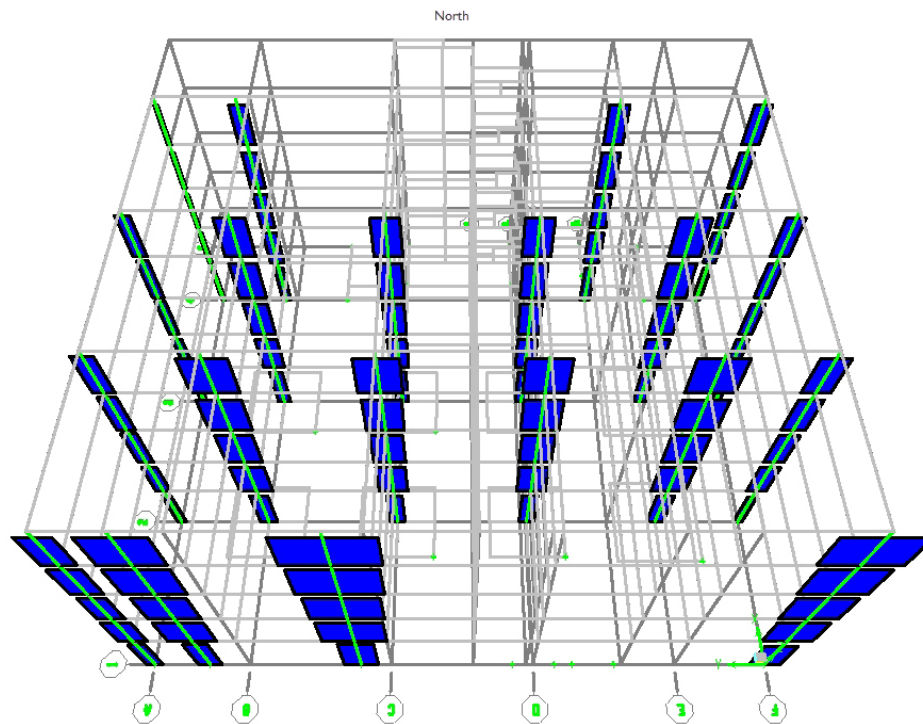
The effect of this torsional behaviour on the seismic displacements and column actions can be seen in the following plots of column shear forces for earthquake shaking in the east-west direction. Figure 88 **Error! Reference source not found.** is a plot of shear force on the east-west axis of the columns. It can be seen that columns nearer to the south side and nearer to the top of the building are subject to higher shear forces (and corresponding bending moments). This is because they are furthest from the centre of rigidity and so experience more seismic drift due to torsion, and because the frame takes a bigger proportion of the total storey shear compared with the walls nearer the top of the building.

Figure 88 - Plot of column shear force on east-west column axis for earthquake shaking in east-west direction

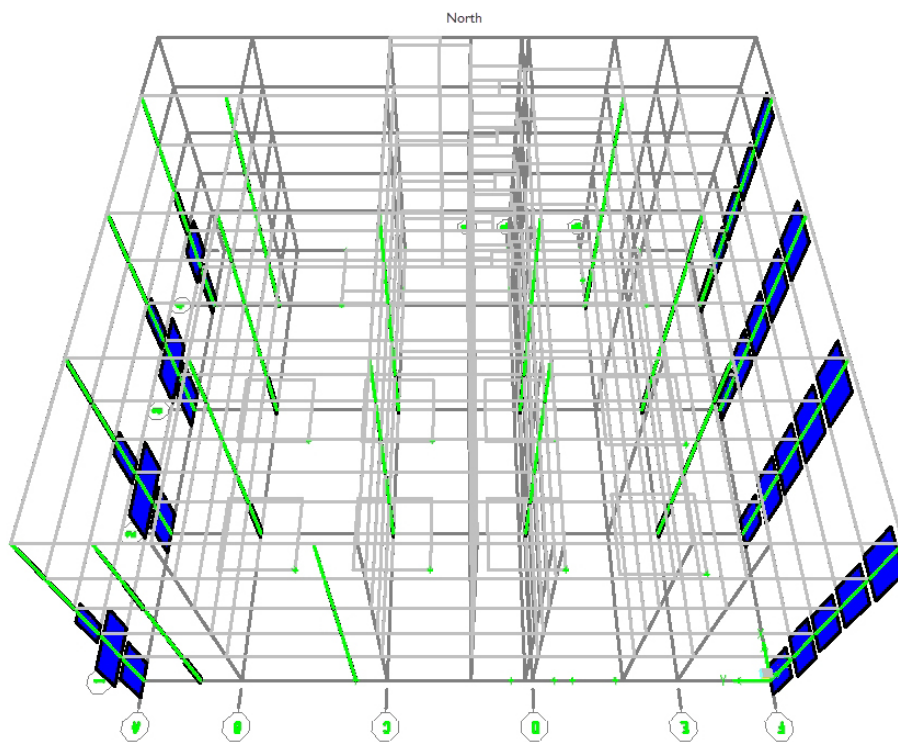
The columns shear forces at the west side should be ignored because they are due to interaction of the columns with the concrete masonry walls, an effect of the way the structure has been modelled rather than a real effect.

It can be seen that columns at the east side and nearer to the top of the building are subject to the highest shear forces (and corresponding bending moments). This is because they are furthest from the centre of rigidity and so experience more seismic drift due to torsion, and because the frame takes a bigger proportion of the total storey shear compared with the walls nearer the top of the building. The magnitude of the shear forces in this north-south direction are of a similar order to shear forces in the east-west direction, the direction of earthquake shaking modelled. The effects of torsion are therefore very significant. The columns at the east side of the building form part of a two-way moment frame and so they experience concurrent actions in both orthogonal directions.

Figure 89 - Plot of column shear force on north-south column axis for earthquake shaking in east-west direction

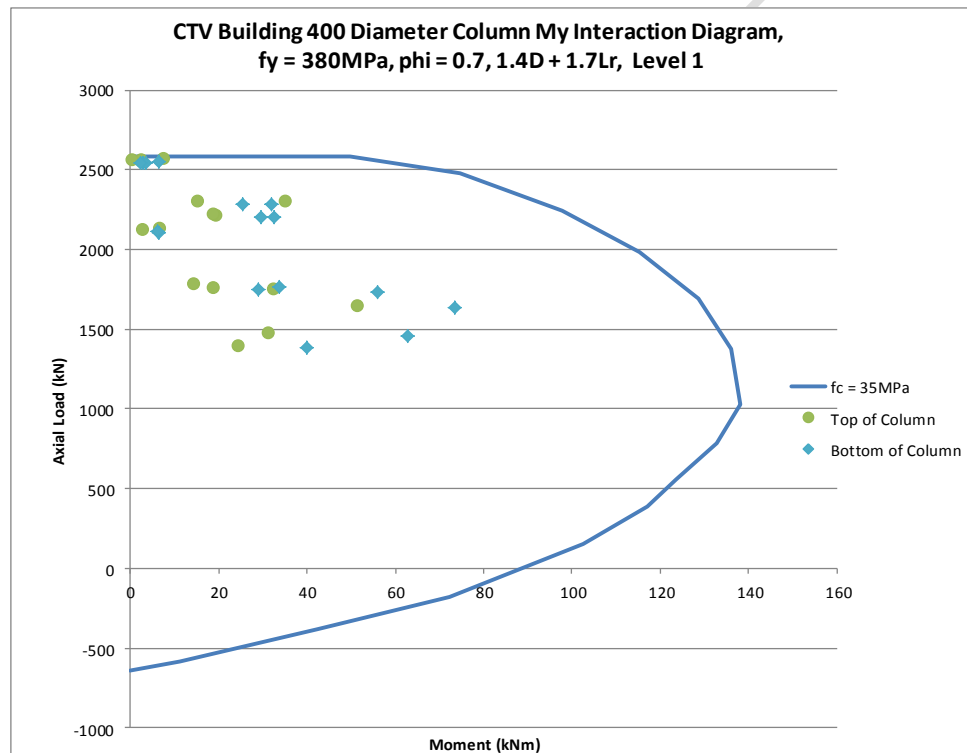
The internal columns at grid intersections C2, D2, C3 and D3, are all highly loaded under gravity actions. This is shown in

Concrete tests on the available column remnants showed lower strengths than expected. The actual concrete strengths for the most highly loaded columns are uncertain and so this remains as a potential initiator of the collapse, taking into account the additional demands that would have been placed on the internal columns during the earthquake.

Figure 90 - Column Chart for Factored Gravity Load 1.4D + 1.7Lr

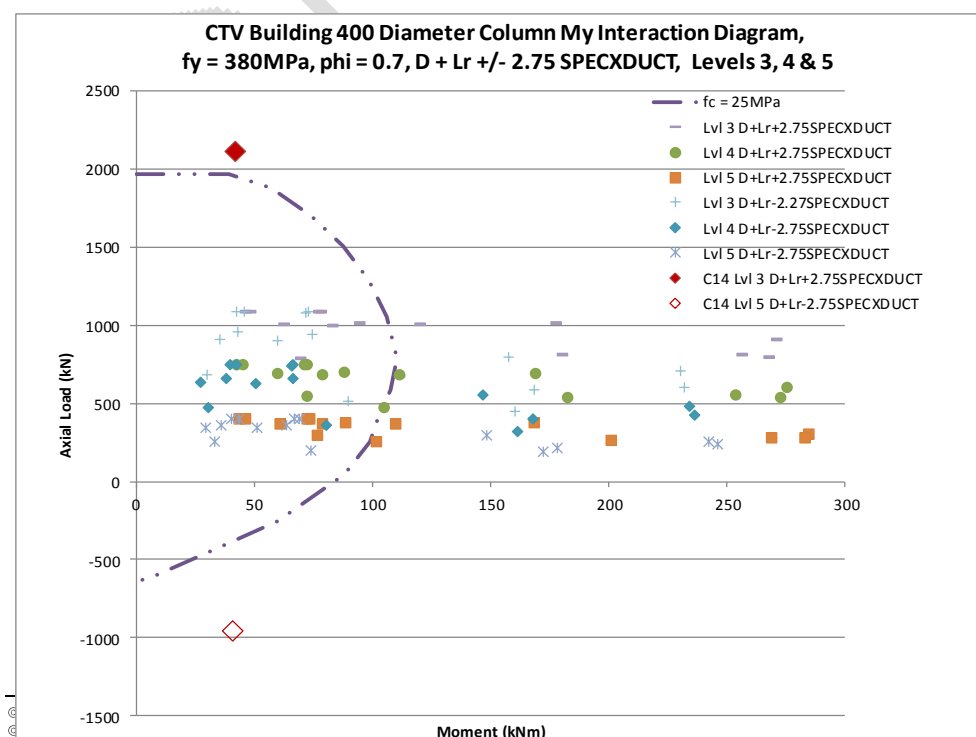
Analysis of the documented design undertaken as part of this investigation found that many of the columns were not able to maintain elastic behaviour under those specified deformations (Figure 91 and Figure 92), and had not been designed to meet the additional seismic requirements of the concrete structures standard.

Figure 91 and Figure 92 the perimeter columns on the south and east sides of the building experience higher seismic forces and so these are another focus.

The flexure and axial load charts below are for columns at Levels 3, 4 and 5 in the building, which have been shown above to be critical as far as seismic actions are concerned.

Figure 91 - Column Interaction Chart showing demands greater than elastic limits on columns with Standard NZ3101:192 Clauses 3.5.14(a) and (b) (for earthquake shaking in north-south direction)

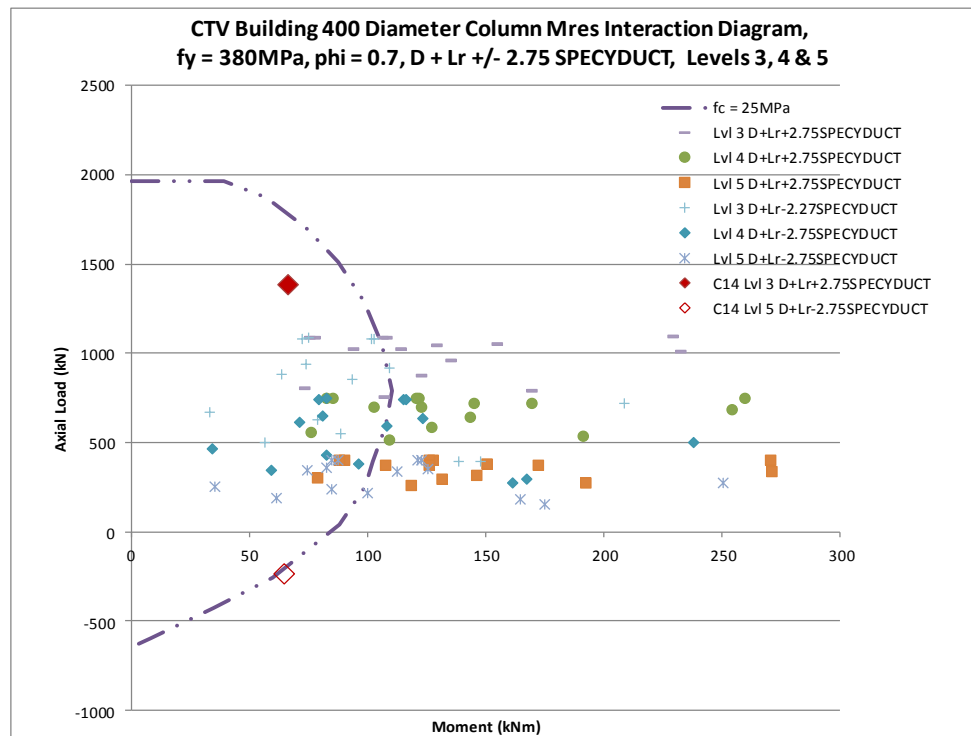
Figure 92 - Column Interaction Chart showing columns with demands greater than elastic limits under NZS3101:1982 Clauses 3.5.14(a) and (b) (for earthquake shaking in east-west direction)
