Report to the Royal Commission of Inquiry

The Performance of Unreinforced Masonry Buildings in the 2010/2011 Canterbury Earthquake Swarm

Associate Professor Jason M. Ingham

August, 2011

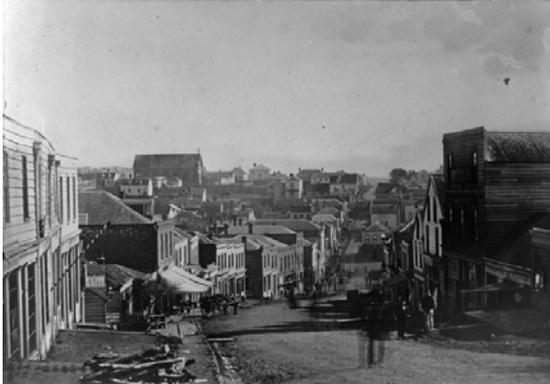
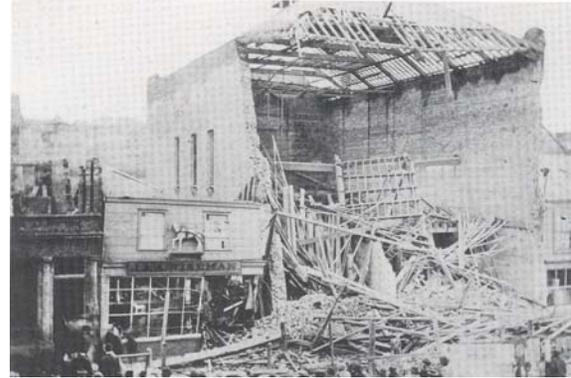
Figure 2.3 Transition from timber to masonry construction

- (a) Looking down Shortland Crescent, Auckland, ca. 1865. Construction is a mix of timber, brick masonry and stone masonry [Alexander Turnbull Library].
- (b) Collapse of a new masonry auction market building, Queen Street, 1865 [Alexander Turnbull Library]

Figure 2.3(a) shows Auckland at a time when the majority of buildings were constructed of timber, but a number of masonry buildings were becoming prominent. However Figure 2.3(b) shows that not all masonry buildings were well constructed. Hodgson (1992) reports that inferior materials and uncertain ground conditions were not uncommon in building projects of this period. Hodgson also reports that Auckland city went through a transformation during the 1870s when almost all timber buildings were replaced by masonry buildings. Figure 2.4 shows that by 1910 the central city was composed almost entirely of URM buildings.

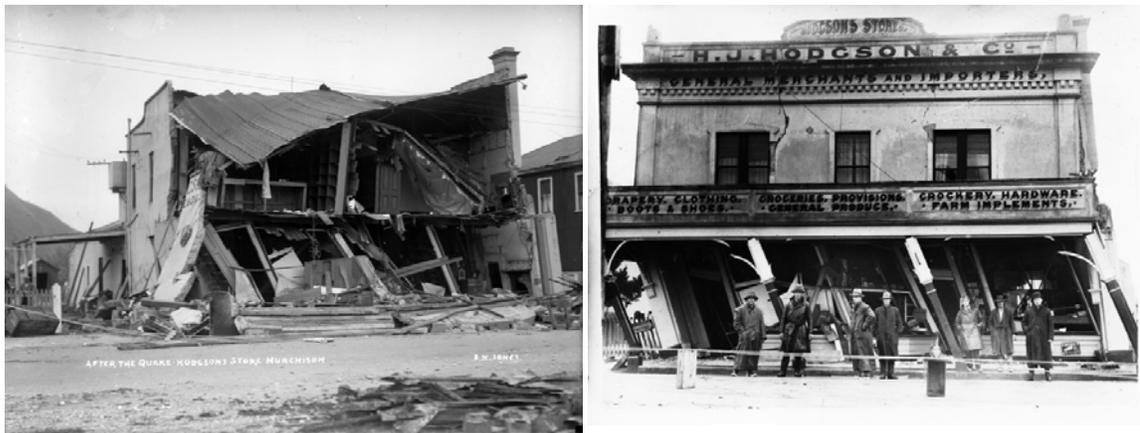
Figure 2.5 Damage to masonry buildings in the 1929 Murchison earthquake

- (a) General store damaged by the 1929 Murchison earthquake [Alexander Turnbull Library]
- (b) Damaged business premises after the earthquake of 17 June 1929 [Alexander Turnbull Library]

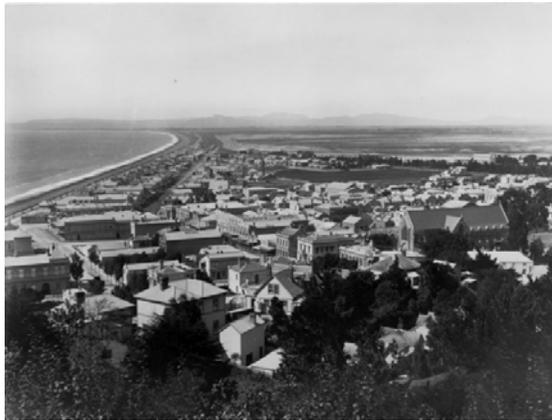
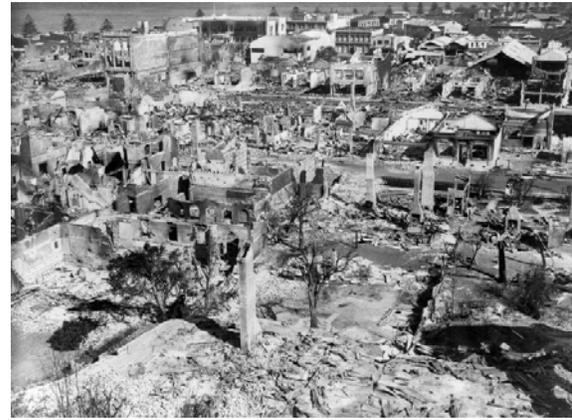
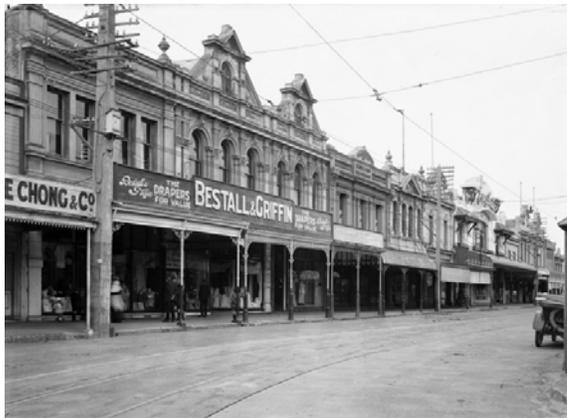
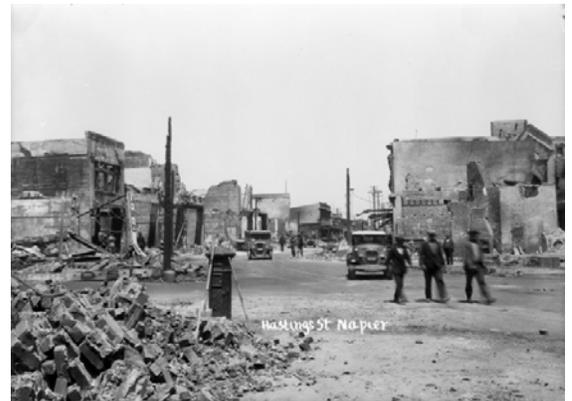
Figure 2.6 Damage to masonry buildings in the 1931 Hawke's Bay earthquake

(b) Overlooking Napier at the buildings ruined by the 1931 earthquake and the fires [Alexander Turnbull Library]

(d) View down Hastings Street, Napier after the earthquake 1931 [Alexander Turnbull Library]

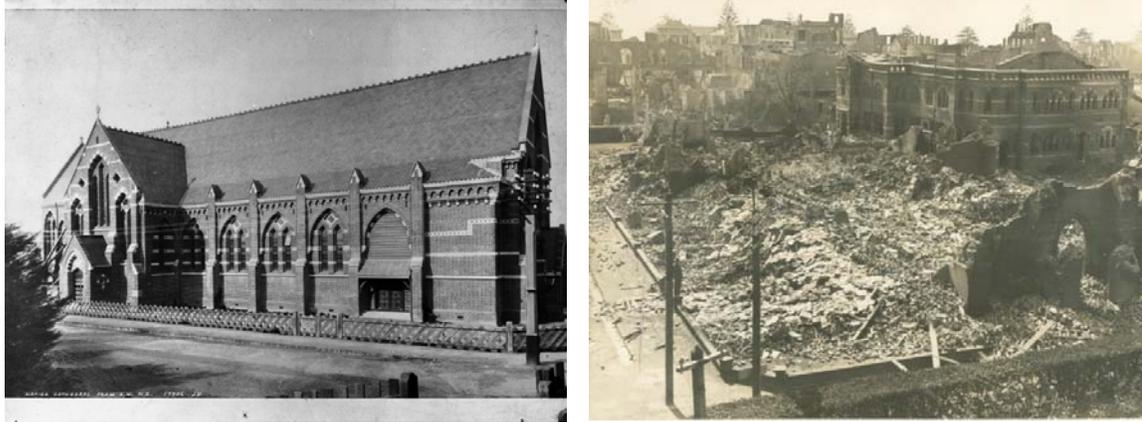
Figure 2.7 Napier Anglican Cathedral before and after the 1931 Hawke's Bay earthquake³

(a) St John's Anglican Cathedral in Napier, ca. 1885 [Alexander Turnbull Library] (b) Ruins of the Napier Anglican Cathedral after the 1931 Hawke's Bay earthquake [Alexander Turnbull Library]

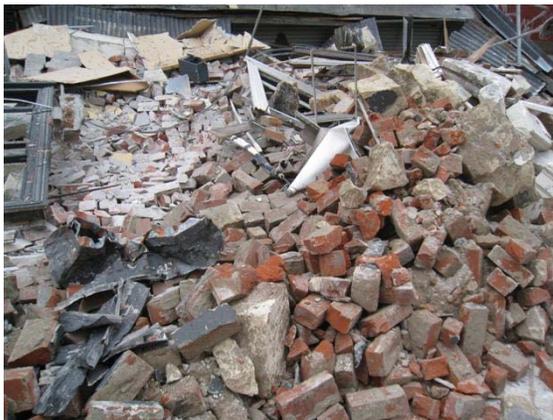
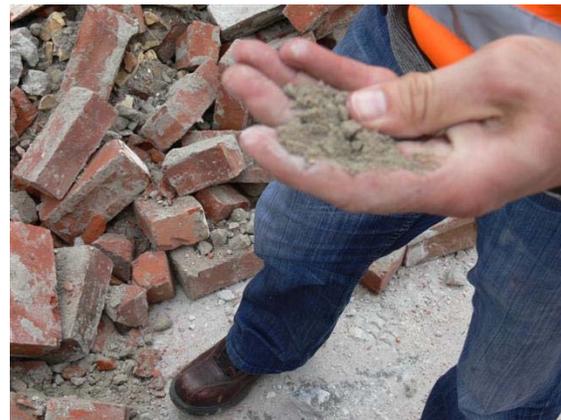
Figure 3.3 Masonry rubble from collapsed wall

The general observation from the debris of collapsed URM walls was that the kiln fired clay bricks were generally of sound condition, but that the mortar was in poor condition. In most cases the fallen debris had collapsed into individual bricks, rather than as larger chunks of masonry debris (refer to Figure 3.3(a)). When rubbing the mortar that was adhered to bricks it was routinely found that the mortar readily crumbled when subjected to finger pressure (refer Figure 3.3(b)), suggesting that the mortar compression strength was very low. However, it appears that superior mortar was often used in the ornate parapet above the centre of the wall facing the street, as this segment of the collapsed parapet often remained intact as the parapet collapsed (refer Figure 3.4).

(a) Masonry rubble showing 'clean' bricks

(b) Weak mortar crumbles between fingers

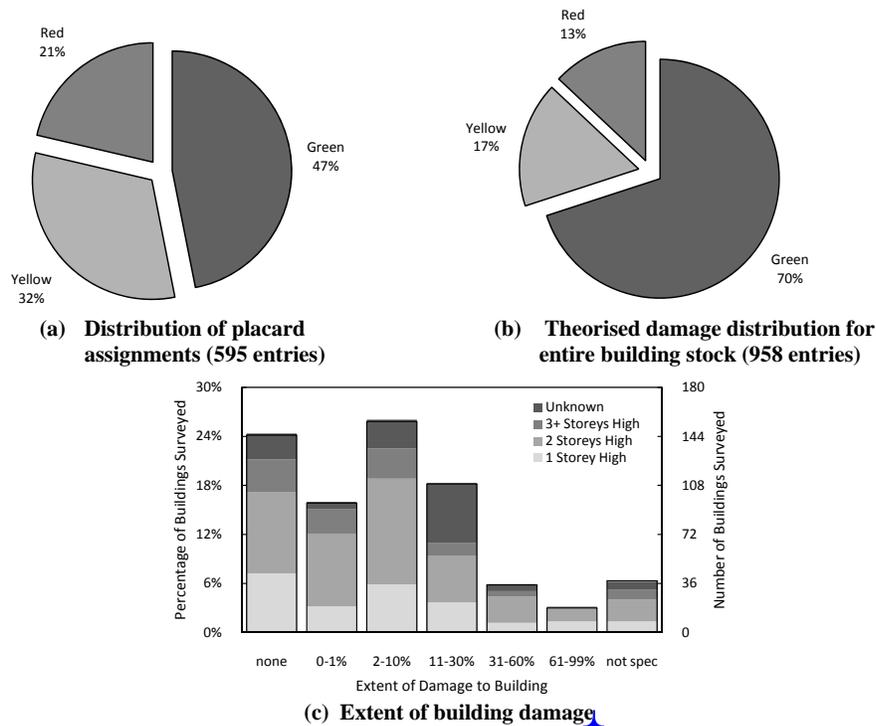
Figure 3.5 Damage statistics for the 4 September 2010 earthquake

The results of the damage assessment are reported in Figure 3.5. Figure 3.5(a) reports the ‘useability’ assignment of the 595 URM buildings assessed. In consultation with staff of Christchurch City Council it was assumed that the remainder of the URM buildings thought to exist in Christchurch probably had a green tag usability rating, and so a theorised damage distribution for the entire URM building stock of Christchurch is shown in Figure 3.5(b).

Figure 3.5(c) reports the level of damage in percentage terms for the 595 buildings that were surveyed by the Rapid Building Assessment teams. The values recorded by the teams for each building surveyed were simply estimates (excluding contents damage). Despite the known vulnerability of URM buildings to earthquake loading, 395 of the 595 buildings (66%) were rated as having 10% damage or less, with only 162 (34%) of the buildings assessed as having more than 10% damage. It was also possible to study the distribution of damage dependent on storey height (Figure 3.5(c)), with the data indicating no definitive trend and a comparatively uniform level of damage assigned to buildings in each height category.

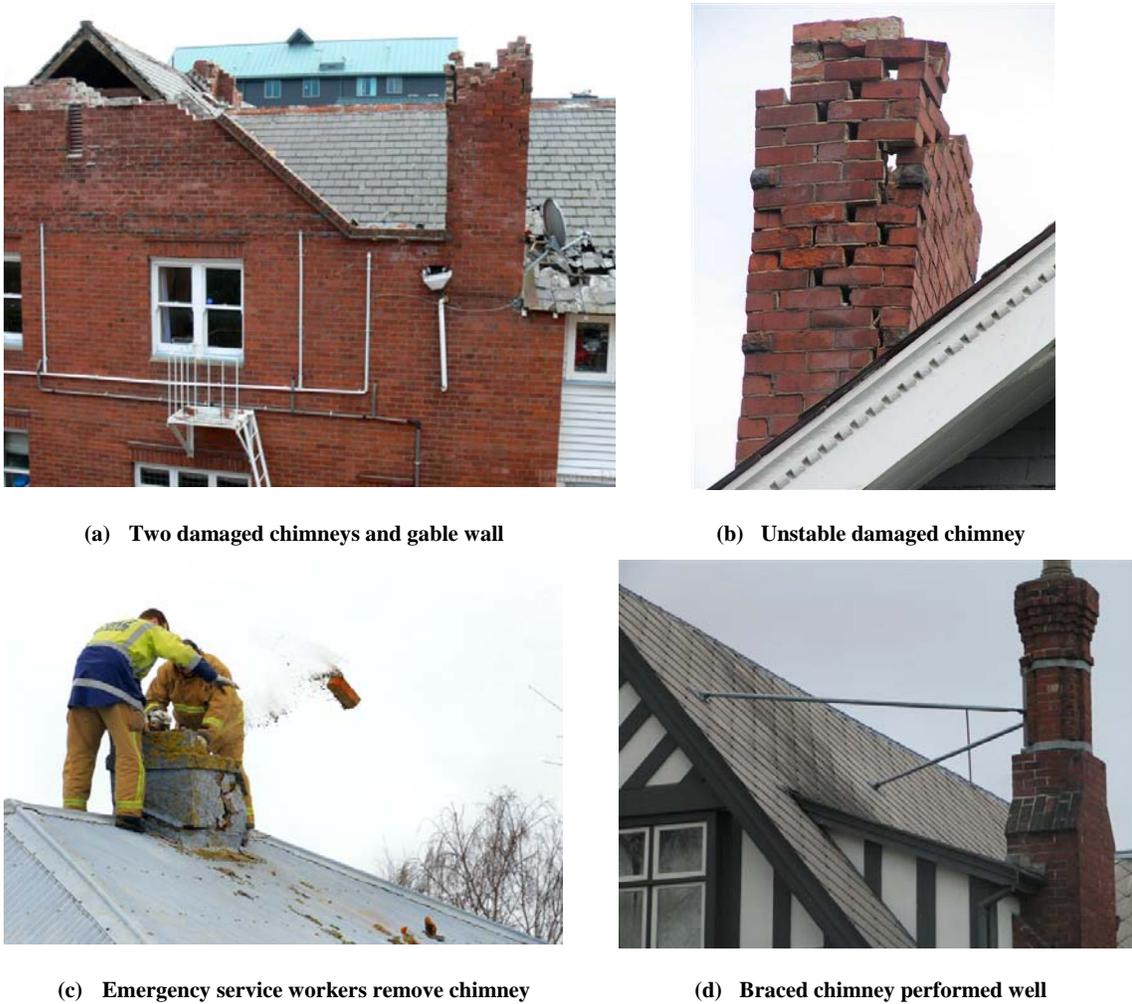
Figure 3.6 Examples of chimney performance during the Darfield earthquake

Unsupported or unreinforced brick chimneys performed poorly in the earthquake (Figure 3.6), with numerous chimney collapses occurring in domestic as well as small commercial buildings and some churches. Many examples of badly damaged chimneys that were precariously balanced on rooftops were also seen (Figure 3.6(b)) and it was reported that one week after the earthquake, 14,000 insurance claims involving chimney damage had been received, from a total of 50,000 claims (NewstalkZB, 2010). Emergency services personnel were in significant demand, being deployed to remove damaged chimneys in order to minimize further risk and eliminate these 'falling hazards' (Figure 3.6(c)). In contrast, Figure 3.6(d) shows an example of a braced chimney that performed well. Note that Figure 3.6(b) shows further evidence of the poor performance of mortar during the earthquake.

Chimneys contribute to the architectural form of a building and often help define its roofscape, and as such should be preserved if possible. The securing of chimneys is more complex than the securing of parapets and gables, but can usually be achieved by fixing them to the building diaphragms at each level and either strengthening the projecting portion or bracing it back to the roof structure with steel members similar to the methods used for parapet restraint, or fixing steel sections to the sides to provide flexural strength. A number of strengthening solutions are available for bonding to the surface of masonry elements and may be appropriate where the exterior has been plastered. Two such techniques used to strengthen chimneys are shown in Figure 4.5.

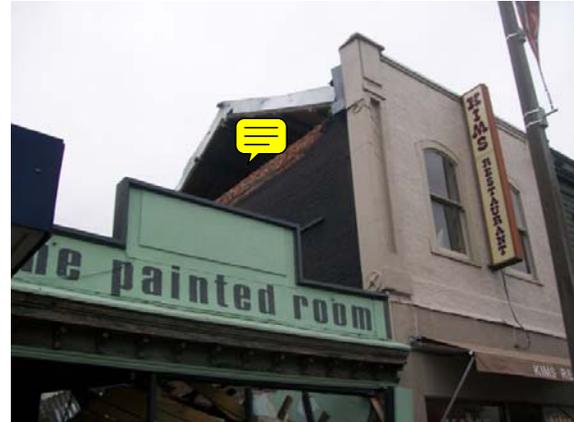
(b) 816 Colombo St

Many gable end wall failures were observed, often collapsing onto or through the roof of an adjacent building (refer to Figure 3.6(a) and Figure 3.7). However, there were also many gable ends that survived; many more than might have been expected, with the majority having some form of visible restraints that tied back to the roof structure. These examples are shown and discussed later (refer Figure 3.14 and Figure 3.15).

Figure 3.7 Examples of gable end wall failures

Gable end walls sit at the top of walls at the end of buildings with pitched-roofs (refer to Figure 3.7). If this triangular portion of the wall is not adequately attached to the roof, the gable end section of the wall will rock as a cantilever (similar to a chimney or parapet) and is similarly vulnerable to outward collapse. An example of a building that was undergoing gable wall retrofit at the time of the February Lyttelton earthquake is shown in Figure 4.1 where the retrofitted gable walls had survived whereas the one gable wall remaining to be anchored to the roof truss failed. Other examples of gable end walls that performed poorly in the Canterbury earthquakes are shown in Figure 3.7 whilst examples of URM buildings that performed adequately due to the presence of anchor plate connections between the gable wall and the roof structure are shown in Figure 3.14.

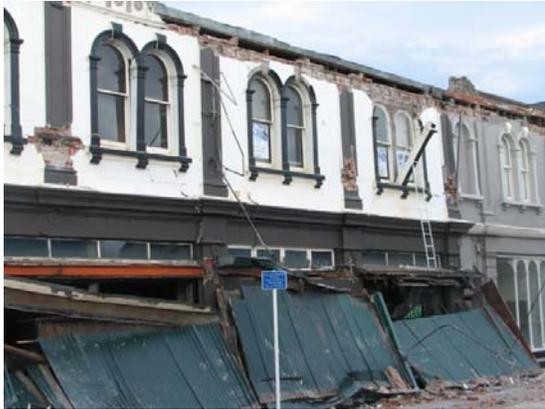
Numerous parapet failures were observed along both the building frontage and along their side walls. For several URM buildings located on the corners of intersections, the parapets collapsed on both perpendicular walls (refer Figure 3.8). Restraint of URM parapets against lateral loads has routinely been implemented since the 1940s, so whilst it is difficult to see these restraints unless roof access is available, it is believed that the majority of parapets that exhibited no damage in the earthquake were provided with suitable lateral restraint. In several cases, it appears that parapets were braced back to the perpendicular parapet, which proved unsuccessful.

(a) Multiple front wall parapet failures

Figure 3.8 Examples of typical parapet failures

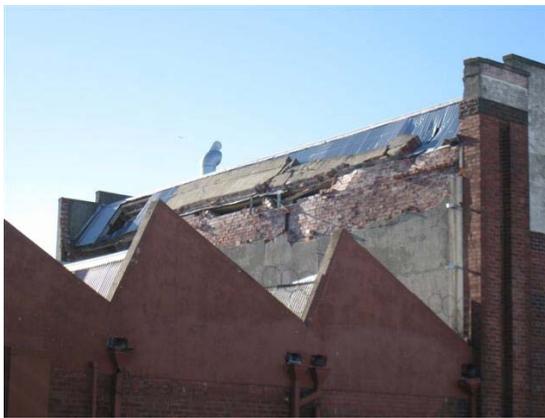
(c) Side wall parapet collapse onto roof.

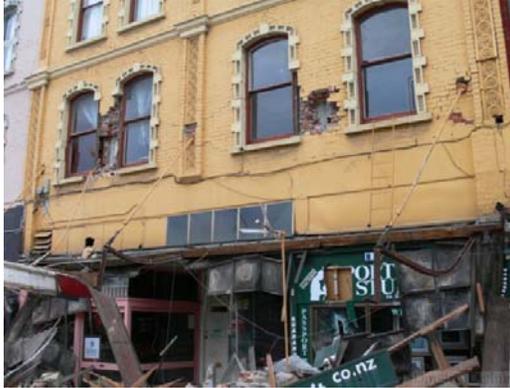
Falling parapets typically landed on awnings, resulting in an overloading of the braces that supported these awnings, leading to collapse. Most awning supports in Christchurch involved a tension rod tied back into the building through the front wall of the building. Many of these connections appear to consist of a long, roughly 25 mm diameter rod, with a rectangular steel plate (about 5 mm thick) at the wall end that is about 50 mm wide x 450 mm long and fastened to the rod and positioned either inside the brick wall or in the centre of a masonry pier or wall. In most cases the force on the rod exceeded the capacity of the masonry wall anchorage, causing a punching shear failure in the masonry wall identified by a crater in the masonry (refer Figure 3.9(a)).

(a) Anchorage failure

Figure 3.9 Anchorage failure of awning brace due to parapet collapse

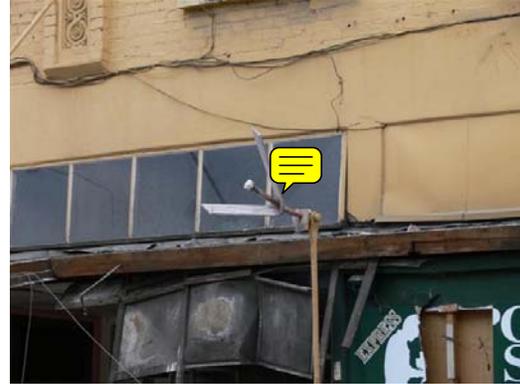
(b) Close-up of failed anchorage detail

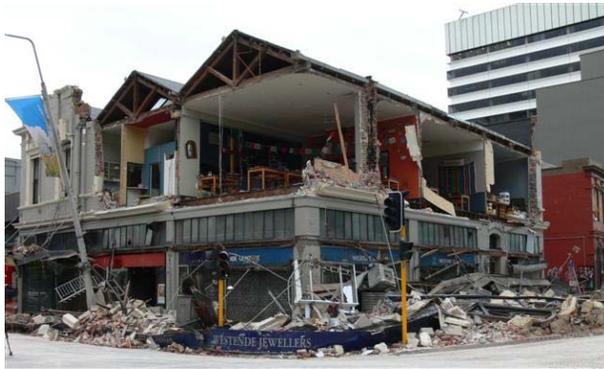
(a) Corner Worcester and Manchester streets

Out-of-plane wall failures were the first images to appear on television directly after the earthquake. Inspection of this damage typically indicated poor or no anchorage of the wall to its supporting timber diaphragm. Several examples of wall failure are shown below. Figure 3.10(a) shows a corner building that had walls fail in the out-of-plane direction in both perpendicular directions, on both sides of the corner. Figure 3.10(b) shows a 3-storey building where walls in the upper two stories suffered out-of-plane failures and Figure 3.10(c) shows similar damage for a 2-storey building. In all three of these instances, it appears that the walls were not carrying significant vertical gravity loads, other than their self weight, due to the fact that the remaining roof structures appeared to be mostly undamaged. In contrast, Figure 3.10(d) shows an out-of-plane failure of a side wall which was supporting the roof trusses prior to failure.

Figure 3.10 Examples of out-of-plane failures in solid masonry walls

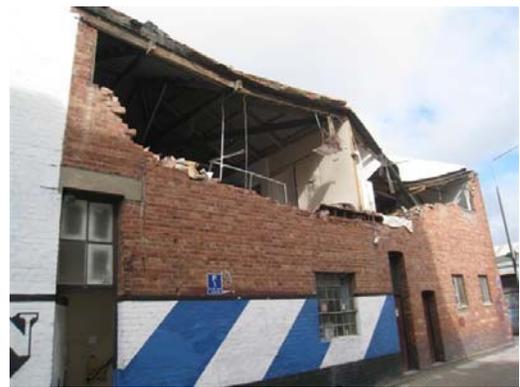
(d) Failure of long wall

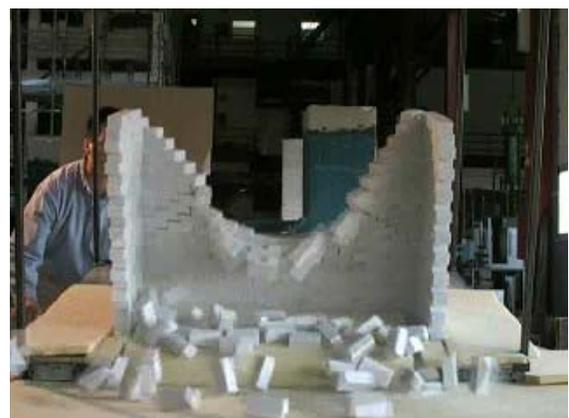
As shown in Figure 3.11, several examples of face load wall failure closely resembled observed damage in dry stack masonry experiments (Restrepo-Velez and Magenes, 2009), providing further support to the supposition that many of the wall failures were partly attributable to poor mortar strength.

(b) High speed photograph of a dry-stacked masonry wall failing during a tilt test

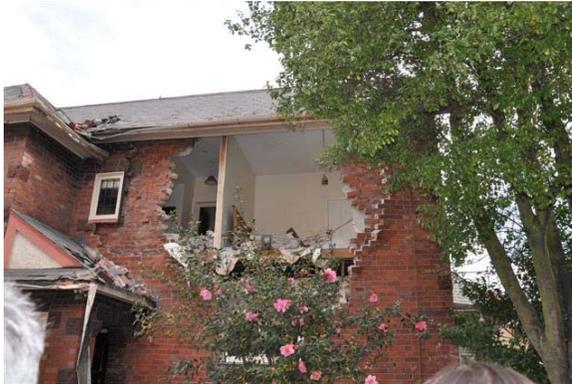
Cavity wall construction is generally believed to be much less common in New Zealand than is solid multi-leaf (or multi-wythe) construction. However, cavity wall construction can be extremely vulnerable to out-of-plane failure in earthquakes in situations where the cavity ties were poorly installed, or more commonly have corroded over time, as the wall is then comparatively slender and less stable than for solid construction. Figure 3.12(a) and (b) show examples of cavity wall buildings that suffered out-of-plane wall failures.

(a) Cavity wall failure in a residential building

Figure 3.12 Examples of out-of-plane failures in cavity walls

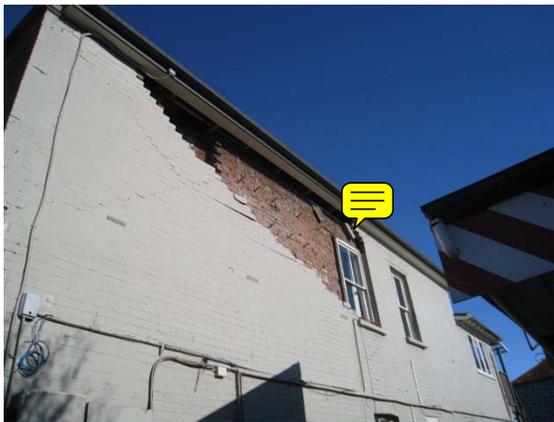
(c) Butterfly wall ties still intact

Figure 3.12(c) and (d) show that cavity ties were present but were insufficient to prevent the outer leaf from failing.

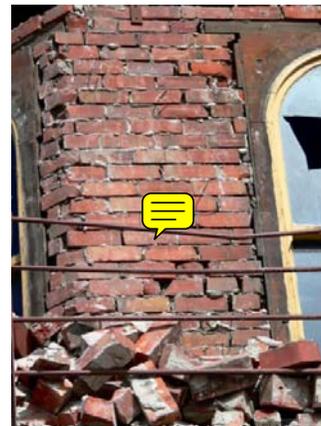
(d) Metal wall ties badly deformed.

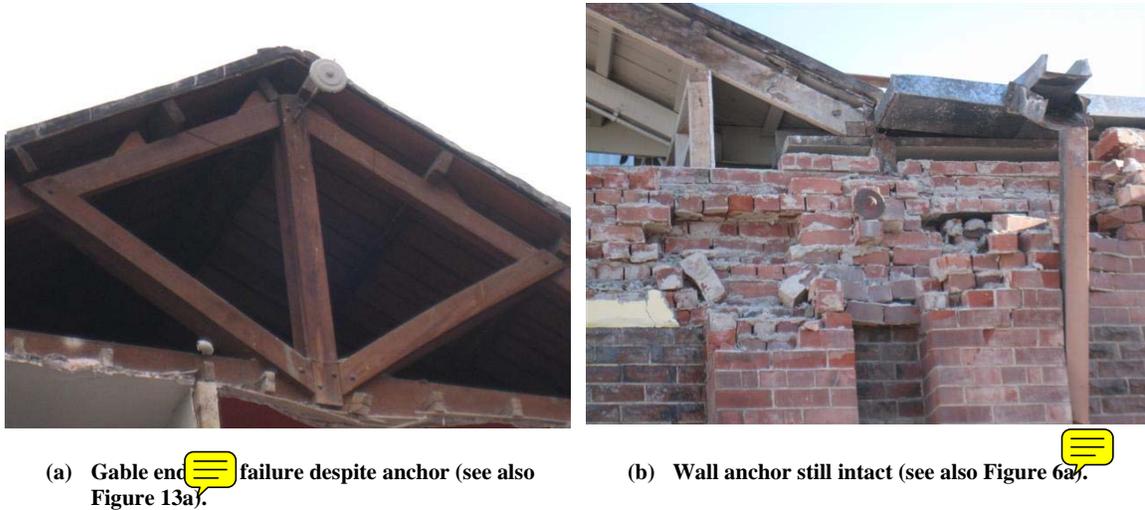
Figure 3.13 Wall-to-diaphragm anchor details

In some cases wall-diaphragm anchors remained visible in the diaphragm after the wall had failed, indicating that failure had occurred due to bed joint shear in the masonry (refer Figure 3.13(a)). Figure 3.13(b) shows a situation where a diaphragm anchor had been embedded within the wall. It can be seen that the anchor successfully prevented the restrained wall from failing, but was not able to prevent toppling of the parapet that was located above the anchor.

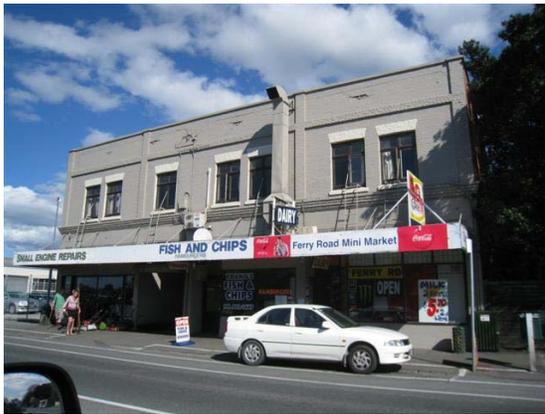
(a) Building overview

Another interesting feature of this earthquake is the observation of walls that only partly failed, allowing for identification of the specific failure mode at its onset. Several excellent examples are described below. The first of these is a 2-storey URM building on Ferry Road (see Figure 3.17) where the front, street facing, wall of the building had started to fail out-of-plane despite the presence of wall-roof diaphragm anchors. As is shown, the anchors were on the verge of pulling through the masonry wall. Internal inspection of the building revealed that the front wall had separated from the long side walls of the building and moved approximately 50 mm towards the road with respect to the ceiling/roof diaphragm (Figure 3.17(d)). It is believed that due to the nature of strength degradation of the brickwork at the onset of a punching shear failure, the anchorage has effectively failed and offers little residual resistance against further shaking. The only reason the wall did not completely collapse is probably due to the earthquake not imposing sufficient displacement on the wall after the anchorage failure.

Figure 3.17 Wall-roof anchorage failure and partial wall failure

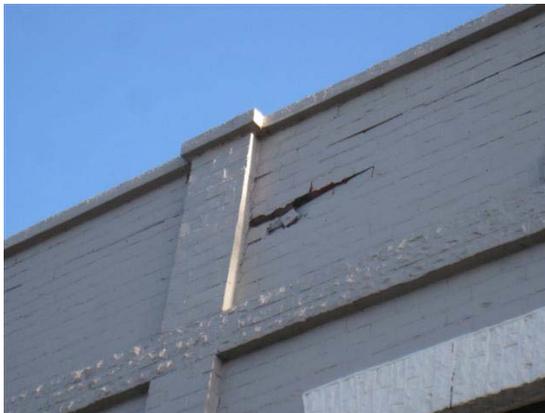
(c) Onset of anchorage failure

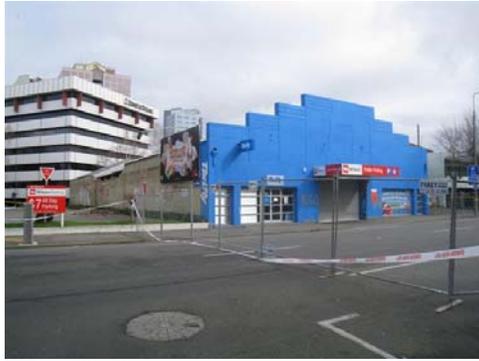
(a) Overview of building

There was one instance where it was clear that diaphragm deformation, relative to the in-plane walls, contributed to partial failure of an out-of-plane wall. Figure 3.20 shows several views of a building which suffered out-of-plane parapet failure along its long, side walls. In Figure 3.20(b) it can be seen that the roof joists have tilted towards the front of the building. This suggested that the front wall of the building was driven forward at its top. Careful inspection of the front wall (Figure 3.20(c)) revealed a substantial outwards curvature which was most pronounced at the top.

Figure 3.20 Example of diaphragm deformation causing out-of-plane wall failure

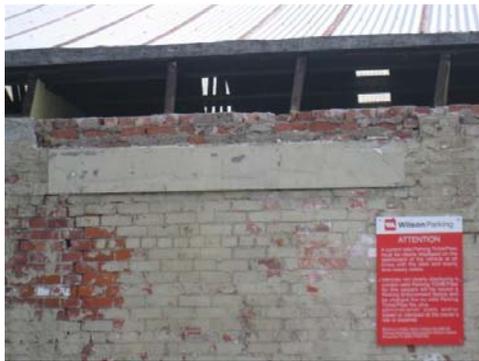
(b) Side-view of tilted joists

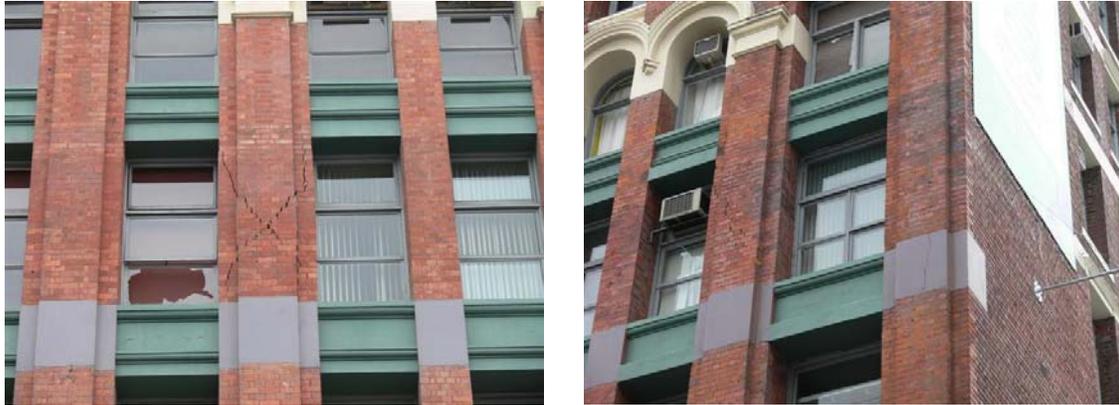
bearing unreinforced masonry piers around the exterior of the building and a steel frame internally (columns spaced roughly at 5 m) with timber floors throughout (New Zealand Historic Places Trust, 2010). The masonry piers, having dimensions of approximately 1200 x 900 mm, were badly cracked at levels 3 and 4 (Figure 3.24). This damage was most likely due to the transition from concrete to masonry at level 3 and the fact that the adjoining 2-storey building located along the southern wall side stopped providing lateral support at that level. It appears that the lift core had received some strengthening previously, as well as the roof, perhaps in the late 1980s as reported by the New Zealand Historic Places Trust (2010). Close up photographs of the masonry piers at levels 3 and 4 show the primary damage that concerned the assessment teams (Figure 3.24). Further inspection by the assessment team exposed the internal face of one pier on the western face of the building to reveal that the external cracking continued through the entire pier thickness.

(a) North wall piers, levels 3-4

(b) West wall piers, levels 4-5

Figure 3.24 Damage to masonry piers of Manchester Courts building at levels 3-5

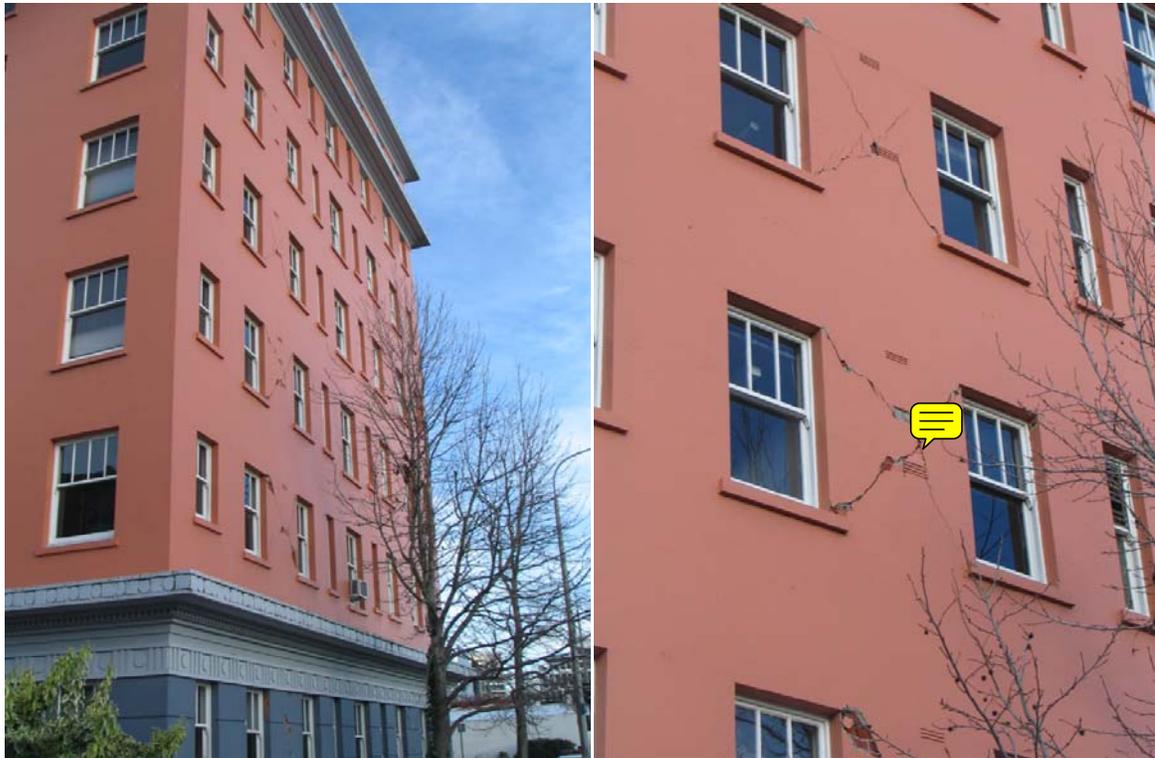
(a) Overview of building

St Elmo Court was also a 7-storey building that was ~~reported to be~~ a reinforced concrete frame building with external clay brick masonry piers. Owing to the absence of control joints between the masonry and concrete frame, it appeared that the masonry piers attracted sufficient seismic in-plane forces to cause shear failure (refer Figure 3.25). However, once the masonry cracked the seismic loads were transferred to the concrete frame. Judging by the extent of cracking in the brickwork, it appeared that the storey drifts developed during the 4 September 2010 earthquake were less than 1%, implying that the concrete frame was not pushed to its maximum capacity (strength or drift). ~~Following the 4 September 2010 earthquake the authors were not able to inspect the building from inside.~~

(b) Close-up of damage to brickwork

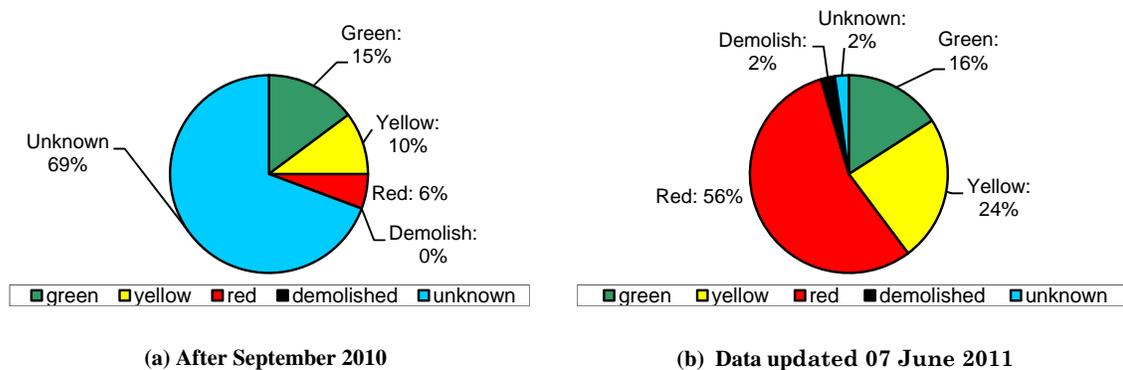
Figure 3.28: Distribution of safety evaluation placarding applied to stone masonry buildings

The seismic performance of stone masonry buildings was partially identified by considering the safety assessment data that was collected following the earthquakes that occurred in September 2010 and February 2011. Figure 3.28 shows the distribution of building safety assessments after the 4 September 2010 and 22 February 2011 earthquakes, respectively. From this figure it can be seen that there was a significant

escalation of damage due to the continuing earthquake activity in the Christchurch region. Figure 3.29 gives a further breakdown of this data for the two major earthquakes on the basis of building usage. As noted earlier, green placards were assigned to structures that were deemed to be safe to re-enter and required no further intervention; yellow placards were applied to buildings whose accessibility was restricted due to minor damage; and red placards were applied to buildings that were considered unsafe and likely to have a moderate to severe level of damage. At the time of the study reported here, several buildings had been demolished already because of the hazard associated with their damage state. As shown in Figure 3.28, only 16% of the stone masonry buildings surveyed were assigned a green placard after the 22 February 2011 earthquake whereas approximately 50% (15% green compared with 16% yellow and red) had green placards after the 4 September 2010 earthquake.

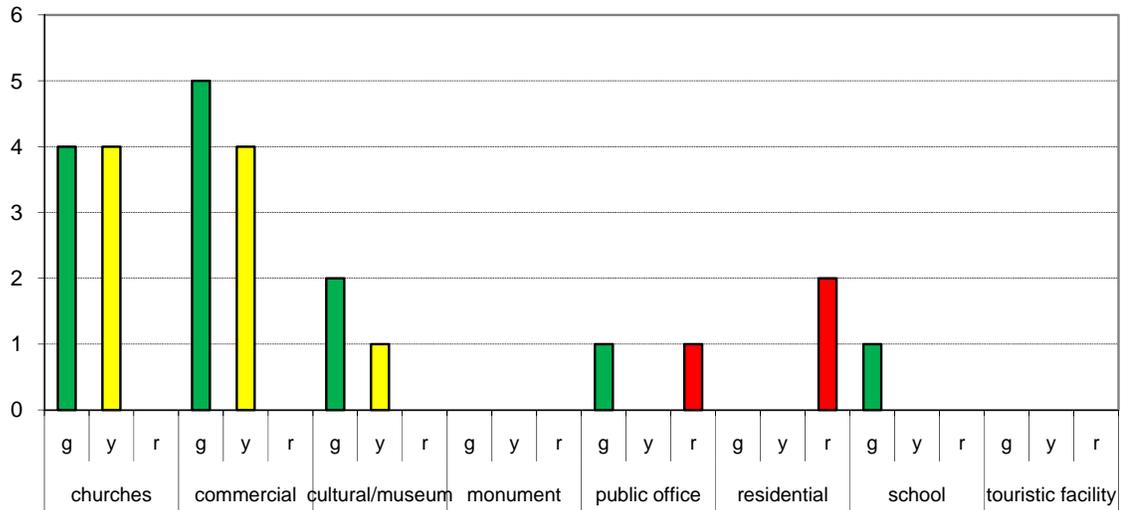
(a) after September 2010

Figure 3.29 Distribution of safety evaluation placarding applied to stone masonry buildings differentiated by building usage

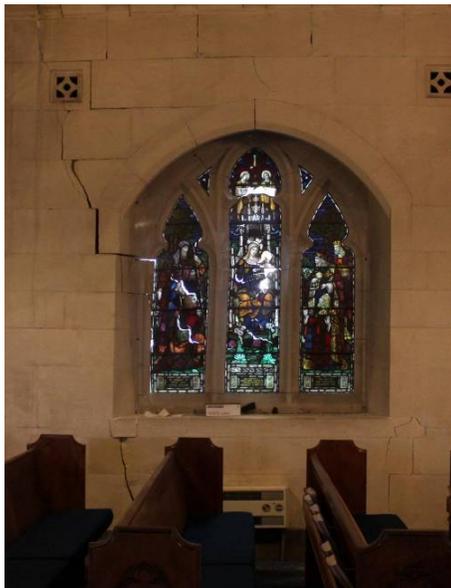
(a) Interior view

Damage that was attributable to plan irregularity was frequently observed, particularly for stone churches, due to interaction between adjacent structural elements at the intersections between walls. In most churches where the bell tower or low annexes are connected to the nave, damage developed at the intersection of the different structures (see Figure 3.36 and Figure 3.37).

Figure 3.36 St. Barnabas' Church, showing interaction between the nave and the bell tower

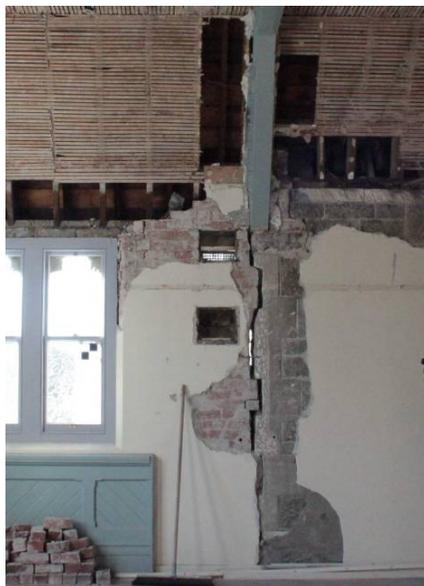
(a) Distant view

Another distinct example of damage due to plan irregularity in association with differential foundation settlement was observed at the former Old Boy's High building. Figure 3.38 shows the vertical crack that formed at the intersection between two buildings constructed in successive phases, attributable to the lack of connectivity between the structural walls and their separate foundations.

Figure 3.38 Interior views of Old Boy's High (part of the Arts Centre Complex, 2 Worcester St), showing interaction between adjacent buildings

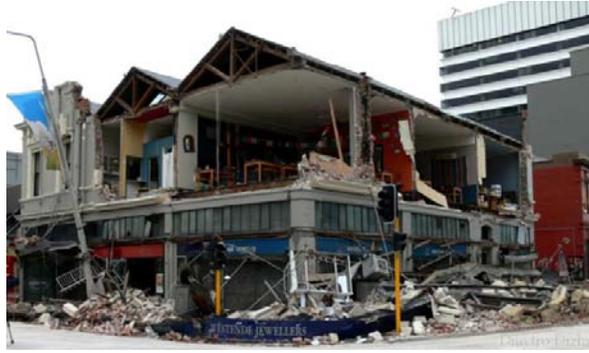
Figure 4.10 An extreme case in the 2010 Darfield earthquake where inadequate connections have resulted in wall collapse (Welstead House, 184-188 Manchester Street)

The most problematic deficiency in URM construction is inadequate connection of diaphragms to walls (FEMA, 2006), as failure of these connections can potentially lead to global collapse of the building. The addition of a network of small ties can substantially increase the strength of the building by fixing the walls to the floor and roof diaphragms (Robinson & Bowman, 2000). These ties need to resist two actions: shear from the diaphragms trying to slide across the walls; and tension from the diaphragm and wall trying to separate. If these ties are missing, the walls will be acting as a cantilever from the ground level under lateral loads, and floors and roofs are far more likely to be dislodged from their supports, which is the most common mode of failure for URM buildings in an earthquake. This failure mode is shown in Figure 4.10.

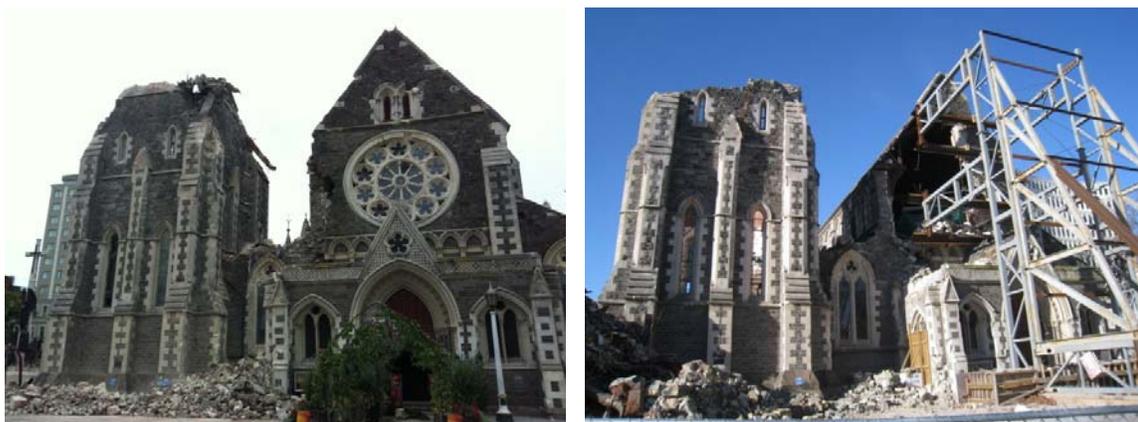
Figure 5.1 Damage to Christchurch Cathedral

Christchurch Cathedral occupies a position of prominence at the centre of the Christchurch Square which is in the centre of the CBD. For many people the damage to the Cathedral has been a defining image of the events in Christchurch since 4 September 2010. The Cathedral's masonry construction is complex, with dressed outer stone and a clay brick interior. Anchor plates that were installed in the gable end wall above the rose window (see Figure 5.1(a)) helped to secure the wall during the 22 February 2011 earthquake, presumably enabling those within the Cathedral at the time to safely exit through the front door. Unfortunately the rose window sustained damage on 13 June 2011. The building is recommended for attention largely for its historic significance, but also because it is currently anticipated that the Cathedral will be rebuilt. Structural improvements to the Cathedral prior to 4 September 2010 appear to have been effective, but clearly have not prevented substantial damage to the building. See Figure 3.30 and Figure 3.34 for further images of the Cathedral.

(a) Condition after 22 February 2011

(b) Condition after 13 June 2011

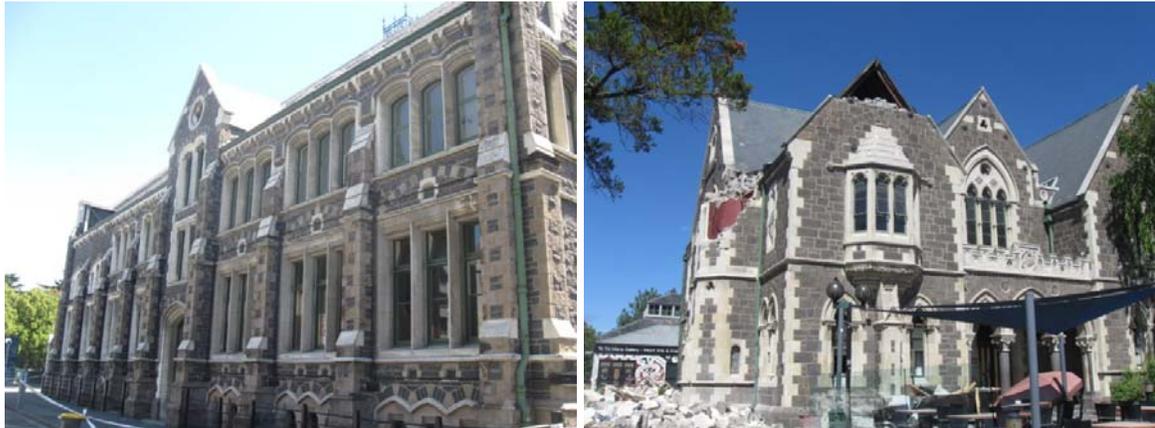
Figure 5.4 Mixed performance of the Christchurch Arts Centre (images taken post-February 2011)

effectively restrained the major part of gable end walls although some damage at the top of gables has occurred (see Figure 5.4(b)), and the use of surface bonded fibre reinforced polymers to the interior of the building. Documenting the successful performance (or otherwise) of these technologies will be useful when considering appropriate seismic improvement techniques for other iconic stone masonry buildings. See also Figure 3.32, Figure 3.38 and Figure 3.40.

(a) Good performance of stone masonry building with horizontal and vertical external post-tensioning

(b) Poor performance of stone masonry tower and top of gable

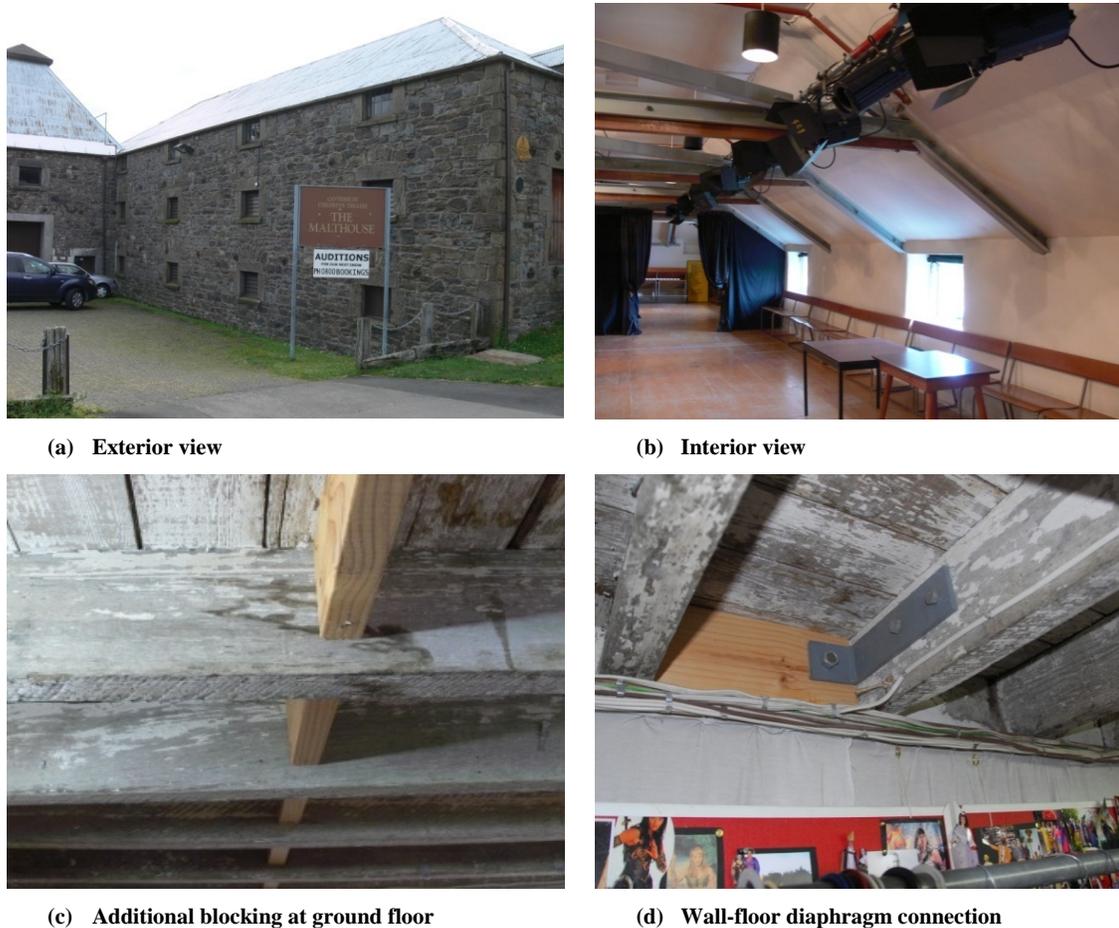
Figure 5.5 Former City Malthouse (images taken post-September 2010)

The Malthouse is a stone masonry building that was constructed in 1867-1872 (see Figure 5.5). The Malthouse is one of New Zealand's oldest buildings¹³ has three levels, with a half basement, timber floor and roof diaphragms and an irregular floor plan. The building was used as a Malthouse until 1955, when it was converted to the Canterbury Children's Theatre. Between 1972 and 1984 the Malthouse went through several architectural renovations that included seismic retrofit. The roof was raised in two stages: the first stage involved raising half of the roof in 1992 and the second stage involving raising the remainder of the roof in 2003. Seismic retrofit of the Malthouse in 2003 was found to be insufficient and consequently the building's lateral load resisting system was again updated in 2008. The seismic retrofit involved injecting grout into the rubble masonry walls, strengthening the roof by introducing new steel trusses (see Figure 5.5(b)), strengthening of the floor diaphragms by replacing the plywood and introducing additional timber blocking (see Figure 5.5(c)), and installing new wall-diaphragm anchors. It was established from discussions with the manager that the cost of retrofit was approximately \$NZ 750,000. The building appears to have performed well.

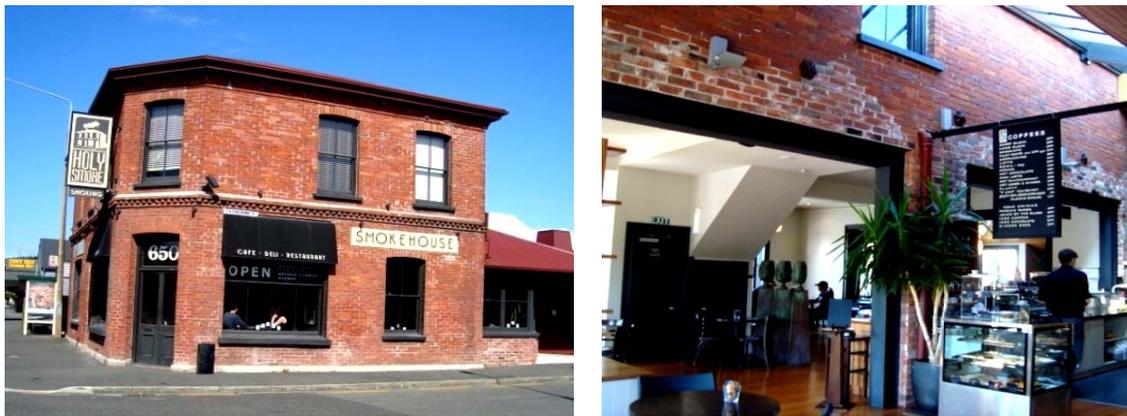
Figure 5.6 The Smokehouse, 650 Ferry Road (images taken post-September 2010)

The Smokehouse was seismically retrofitted in 2007 by introducing secondary moment resisting steel frames. This retrofit also included alterations to the internal layout, which involved partial removal of original external walls and replacement with moment resisting steel frames that created openings into the adjoining new section of the building (see Figure 5.6(b)), and also infilling one window at the second floor level. The retrofit design of the building won the New Zealand Architectural Award in 2008 for initiative in retention, restoration and extension of a significant building and its adaption to new uses¹⁴. The building appears to have performed well, with no significant signs of earthquake damage observed.

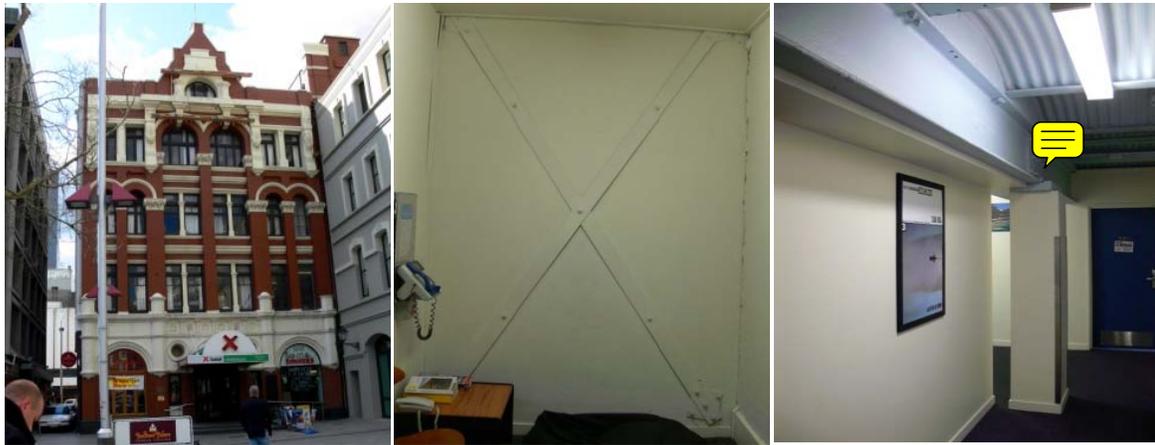
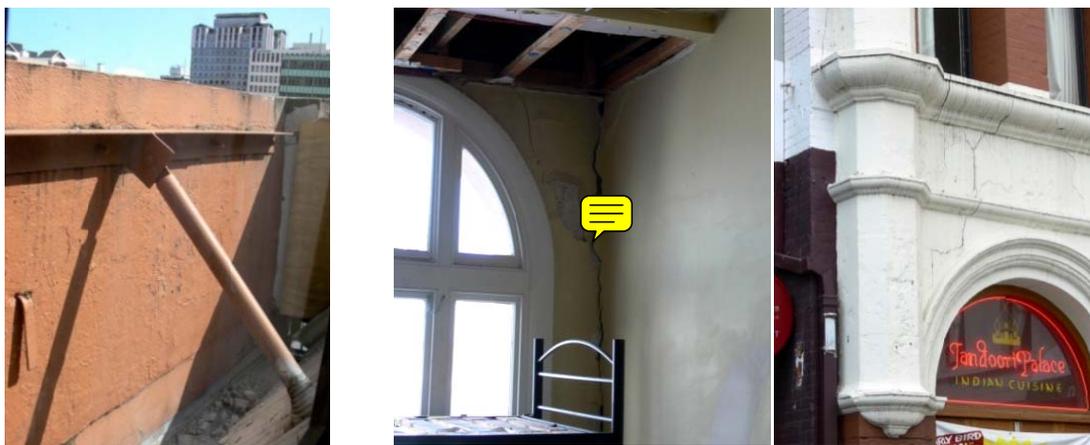
Figure 5.9 X Base Backpackers, 56 Cathedral Square (images taken post-September 2010)

(e) Façade separation

(f) Cracking through the spandrel on ground level

The X Base Backpackers building was seismically retrofitted in 2001 using steel moment resisting frames. The moment frames, as seen from the fourth floor of the building, are shown in Figure 5.9(c). As part of the seismic retrofit scheme, the parapets were tied back to the roof structure using hollow steel circular sections (see Figure 5.9(d)). In a recent inspection of the building, steel straps anchored to the side walls in an X pattern were also observed (shown in Figure 5.9(b)) and were possibly part of an earlier retrofit scheme.

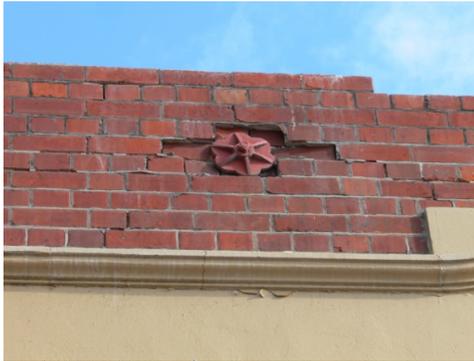
(a) wall-diaphragm anchor punching

During the 4 September 2010 earthquake the parapets collapsed out-of-plane and the wall-diaphragm anchors pulled out from the wall, with the anchors punching through the brickwork and creating localized wall damage (refer to Figure 5.10(a)). The building was cordoned off as falling hazards had been identified during post-earthquake evaluation but the internal retail area remained open.

Vast Furniture, 242 Moorhouse Ave	September: Partial punching shear of wall-diaphragm anchor, parapet collapse. See Figure 5.10.

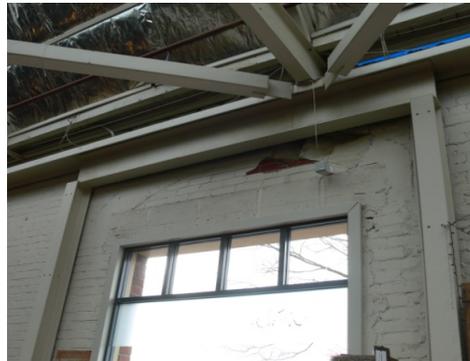
(c) interior of the building (location where anchor plate pull out occurred)

The trusses are further supported on steel portal frames, but the frames had more modern welded joints than the old fashioned riveted joints used in trusses, which suggests that the portal frames were added later to the building as a seismic retrofit solution (see Figure 5.10(b) and (c)).

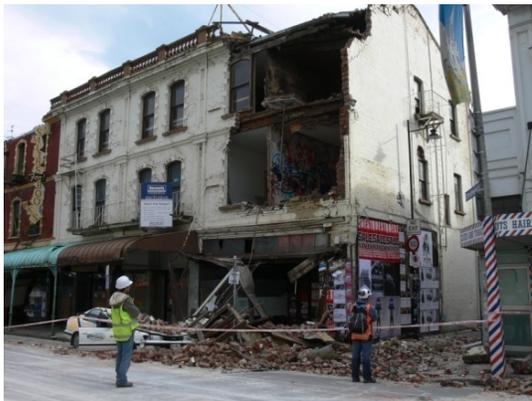
(a) 135-139 Manchester Street, out-of-plane facade collapse

Figure 5.14 Damage to clay brick URM building at 135-139 Manchester Street (images taken post-September 2010)
