Report to the Royal Commission of Inquiry

The Performance of Unreinforced Masonry Buildings in the 2010/2011 Canterbury Earthquake Swarm

Associate Professor Jason M. Ingham

August, 2011

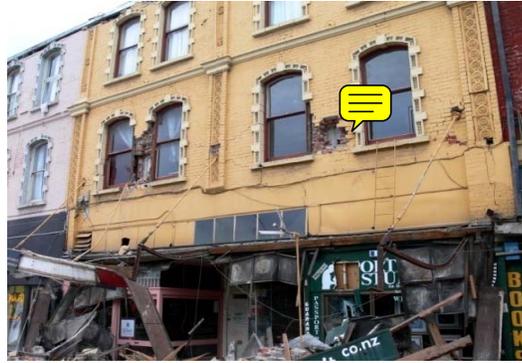
Figure 5.15 137 Manchester Street, pull out of the canopy supports

It appears that the through steel anchors at the gable did not provide sufficient restraint to the masonry, with the brickwork being pulled around the steel anchor plates. Furthermore, from images prior to the earthquake it is evident that there were significant cracks through the spandrel and the parapet over the top corner window of 139 Manchester Street. Falling parapets landed on the canopies, resulting in an overloading of the supporting tension braces that led to canopy collapse. The connections appeared to consist of a long, roughly 25 mm diameter rod, with a rectangular steel plate (approximately 5 mm thick) at the wall end that was approximately 50 mm wide x 450 mm long and fastened to the rod, and was anchored either on the interior surface or ~~within the centre~~ of the masonry pier or wall. The force on the rod exceeded the capacity of the masonry, causing a punching shear failure in the masonry wall (see Figure 5.15).

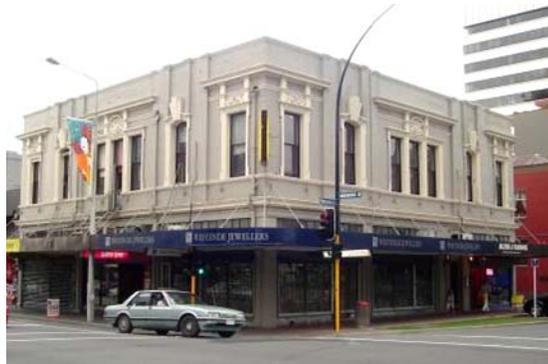
Figure 5.19 Welstead House, 184-188 Manchester Street, before the 4 September 2010 earthquake

standalone two storey brick URM building with a regular rectangular plan and no vertical irregularities. A photograph of the building prior to the 4 September 2010 earthquake is shown in Figure 5.19.

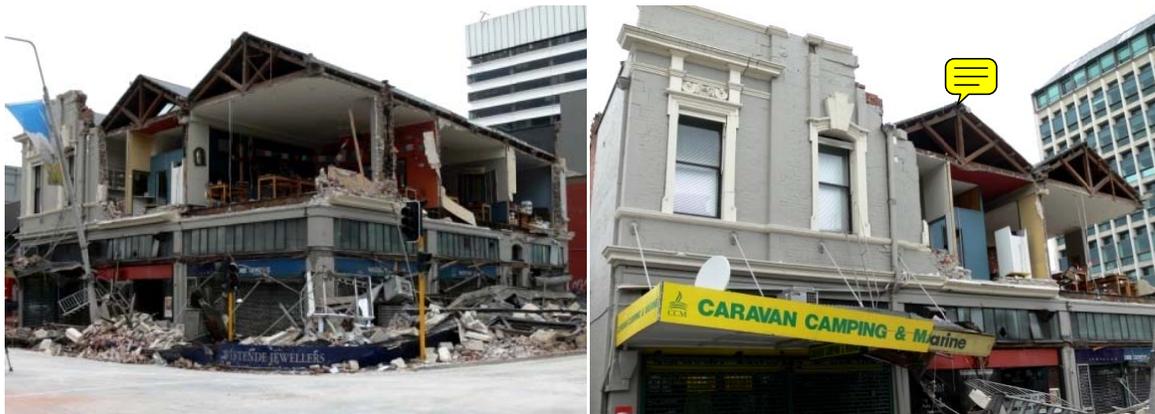
(a) Corner view

(b) Side view, showing steel anchors

The building experienced a complete out-of-plane collapse of the street front corner facade walls (see Figure 5.20(a)). Anchors in the gables did not provide sufficient restraint, as they remained in the timber roof structure following the earthquake as shown in Figure 5.20(b). Steel anchor plates which were observed along the Worcester Street roof were positioned between the masonry leaves. These anchors remained in the timber roof structure, indicating that insufficient out-of-plane restraint was provided. Due to excessive damage and safety considerations the building was demolished following the 4 September 2010 earthquake.

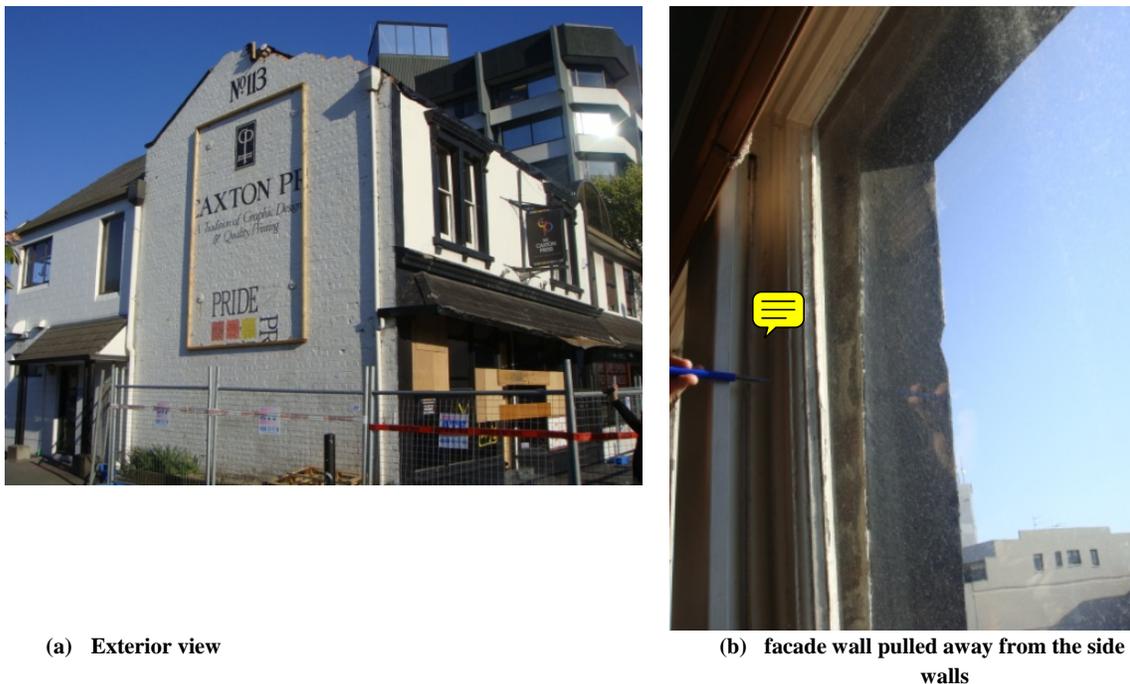
Figure 5.21 Caxton Press building at 113 Victoria Street (images taken post-September 2010)

The Caxton Press building was extensively damaged during the Darfield earthquake and the subsequent aftershocks. From external observation, the parapets on the facade wall had collapsed, the top of the gabled side walls had failed due to out-of-plane loading seen in Figure 5.21(a), the perforated facade wall had developed extensive shear cracks through the spandrel over the openings, and the facade wall had pulled away from the side walls due to insufficient anchorage, as shown in Figure 5.21(b). Furthermore, pounding was evident from cracking on the side walls adjacent to where the new concrete block building butted up to the URM building. On internal inspection, evidence of diaphragm movement was apparent as indicated by displacement of the floor boards and the 15 mm displacement of the bricks in the side walls.

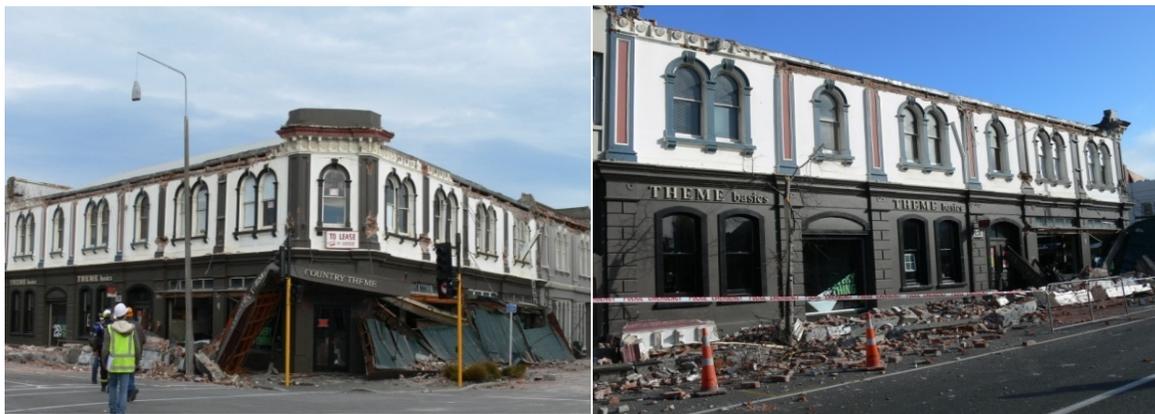
(a) Corner view showing parapet collapse

(b) concrete beam on the ground

Figure 5.22 Cecil House / Country Theme Building, 68-76 Manchester Street (images taken post-September 2010)

The most apparent earthquake damage was the toppled parapets around the street frontage as illustrated in Figure 5.22(b), with a lightly reinforced concrete beam on top of the parapet providing insufficient restraint. Falling parapets landed on the canopies below, overloading the supporting tension braces that caused a punching shear failure in the masonry wall and subsequent canopy collapse. The connections appeared to consist of a long, roughly 25 mm diameter rod, with a round steel plate (about 10 mm thick) at the wall end that was approximately 150 mm in diameter.
