Investigation into the Collapse of the Forsyth Barr Building Stairs on 22nd February 2011

Prepared for Department of Building and Housing (DBH)

By Beca Carter Hollings & Ferner Ltd (Beca)

26th September 2011

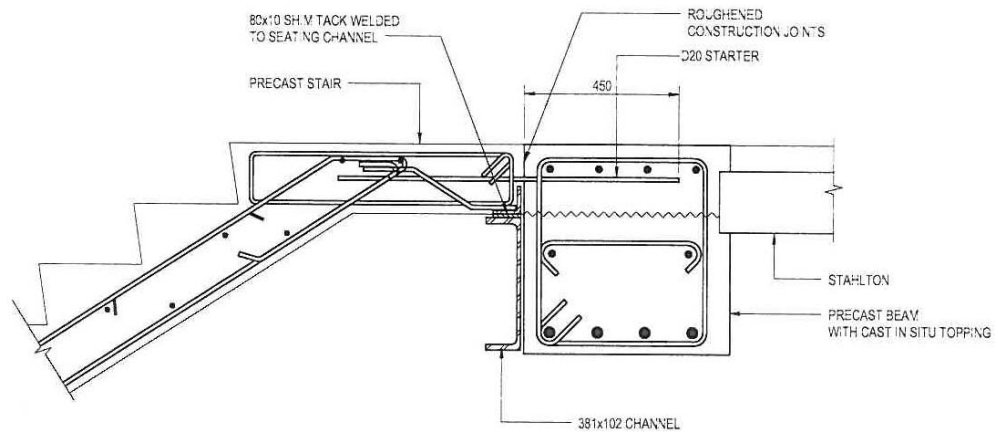
Figure 4.4 : Typical Stair Top Support Detail

The majority of the stair flights were precast concrete units (cast as a single unit, not as separate flights connected by a cast in-situ slab as shown on the drawings) cast into the supporting concrete beam at the top landing (refer to Figure 4.4 for the detail). At their lower end, they were seated on a steel channel with a horizontal gap specified to be 30 mm wide (refer to Figure 4.5 for the detail). The steel channels also support the ‘toilet’ slab.

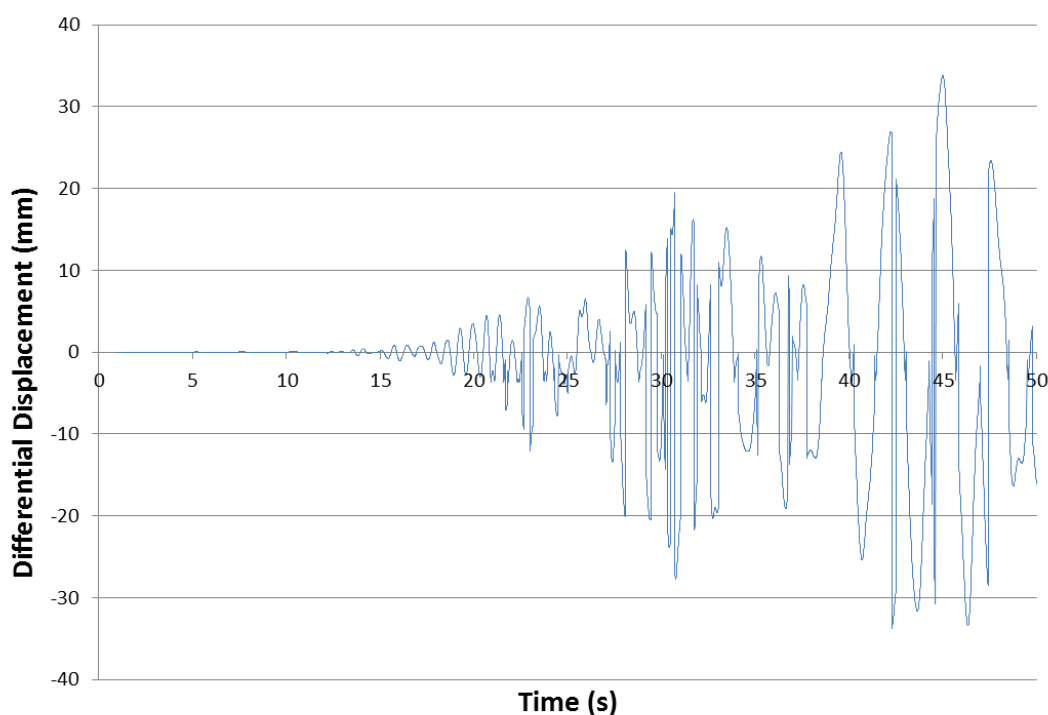
Figure 5.6 : Predicted Variation with Time of the Inter-storey Drift between Levels 13 and 14 during the 4th September 2010 Earthquake Obtained from Time-History Analyses Using the REHS Strong-Motion Record

A plot of the inter-storey drift (relative horizontal displacement between adjacent levels) with time for Levels 13 to 14, for the 4th September earthquake, is shown in Figure 5.6. The drift between these two levels was the largest in the building of the analyses that were carried out. The drift shown was calculated at the stair location for the direction parallel to the stair flights.

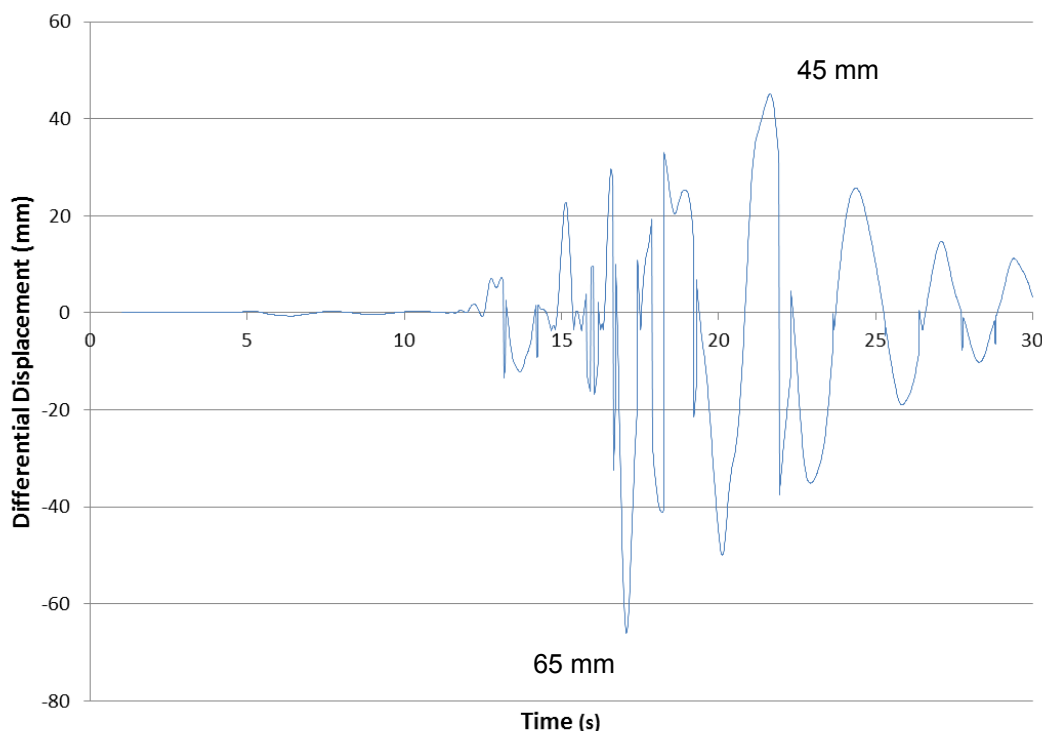
Figure 8.1 : Predicted Variation with Time of the Inter-Storey Drift between Levels 13 and 14 during the 22nd February 2011 Earthquake Obtained from Time-History Analyses Using the REHS Strong-Motion Record.

Our analyses predicted the changes in inter-storey drift (relative horizontal displacement between adjacent levels) with time for Levels 13 to 14 for the 22nd February earthquake that are shown in Figure 8.1. The drifts between these two levels were the largest in the building for the analyses that were carried out. It can be seen that the maximum drift predicted for this earthquake was of the order of twice that for the 4th September 2010 earthquake (refer to Figure 5.5), although the number of cycles during the September event was greater.

The level of drift predicted by these analyses (65 mm) is greater than we determined was required to be considered for design (34 mm) in accordance with NZS 4203 by a factor of nearly two. When compared with the clearances and seatings provided it also exceeded the seismic gap by a factor of two, but was less than the seating length that had been detailed (72 mm, assuming this had not been eroded by construction tolerances). The level of drift in this earthquake also exceeded the drift requirements of the current code, NZS1170.5, which have been estimated at 40 mm.
