# CHRISTCHURCH CITY COUNCIL

BUILDING - 605 COLOMBO STREET

SEISMIC RISK BUILDINGS - SURVEY

**Notices under the Building Act 2004 not to use or occupy your building and to repair your building  
605 Colombo Street**

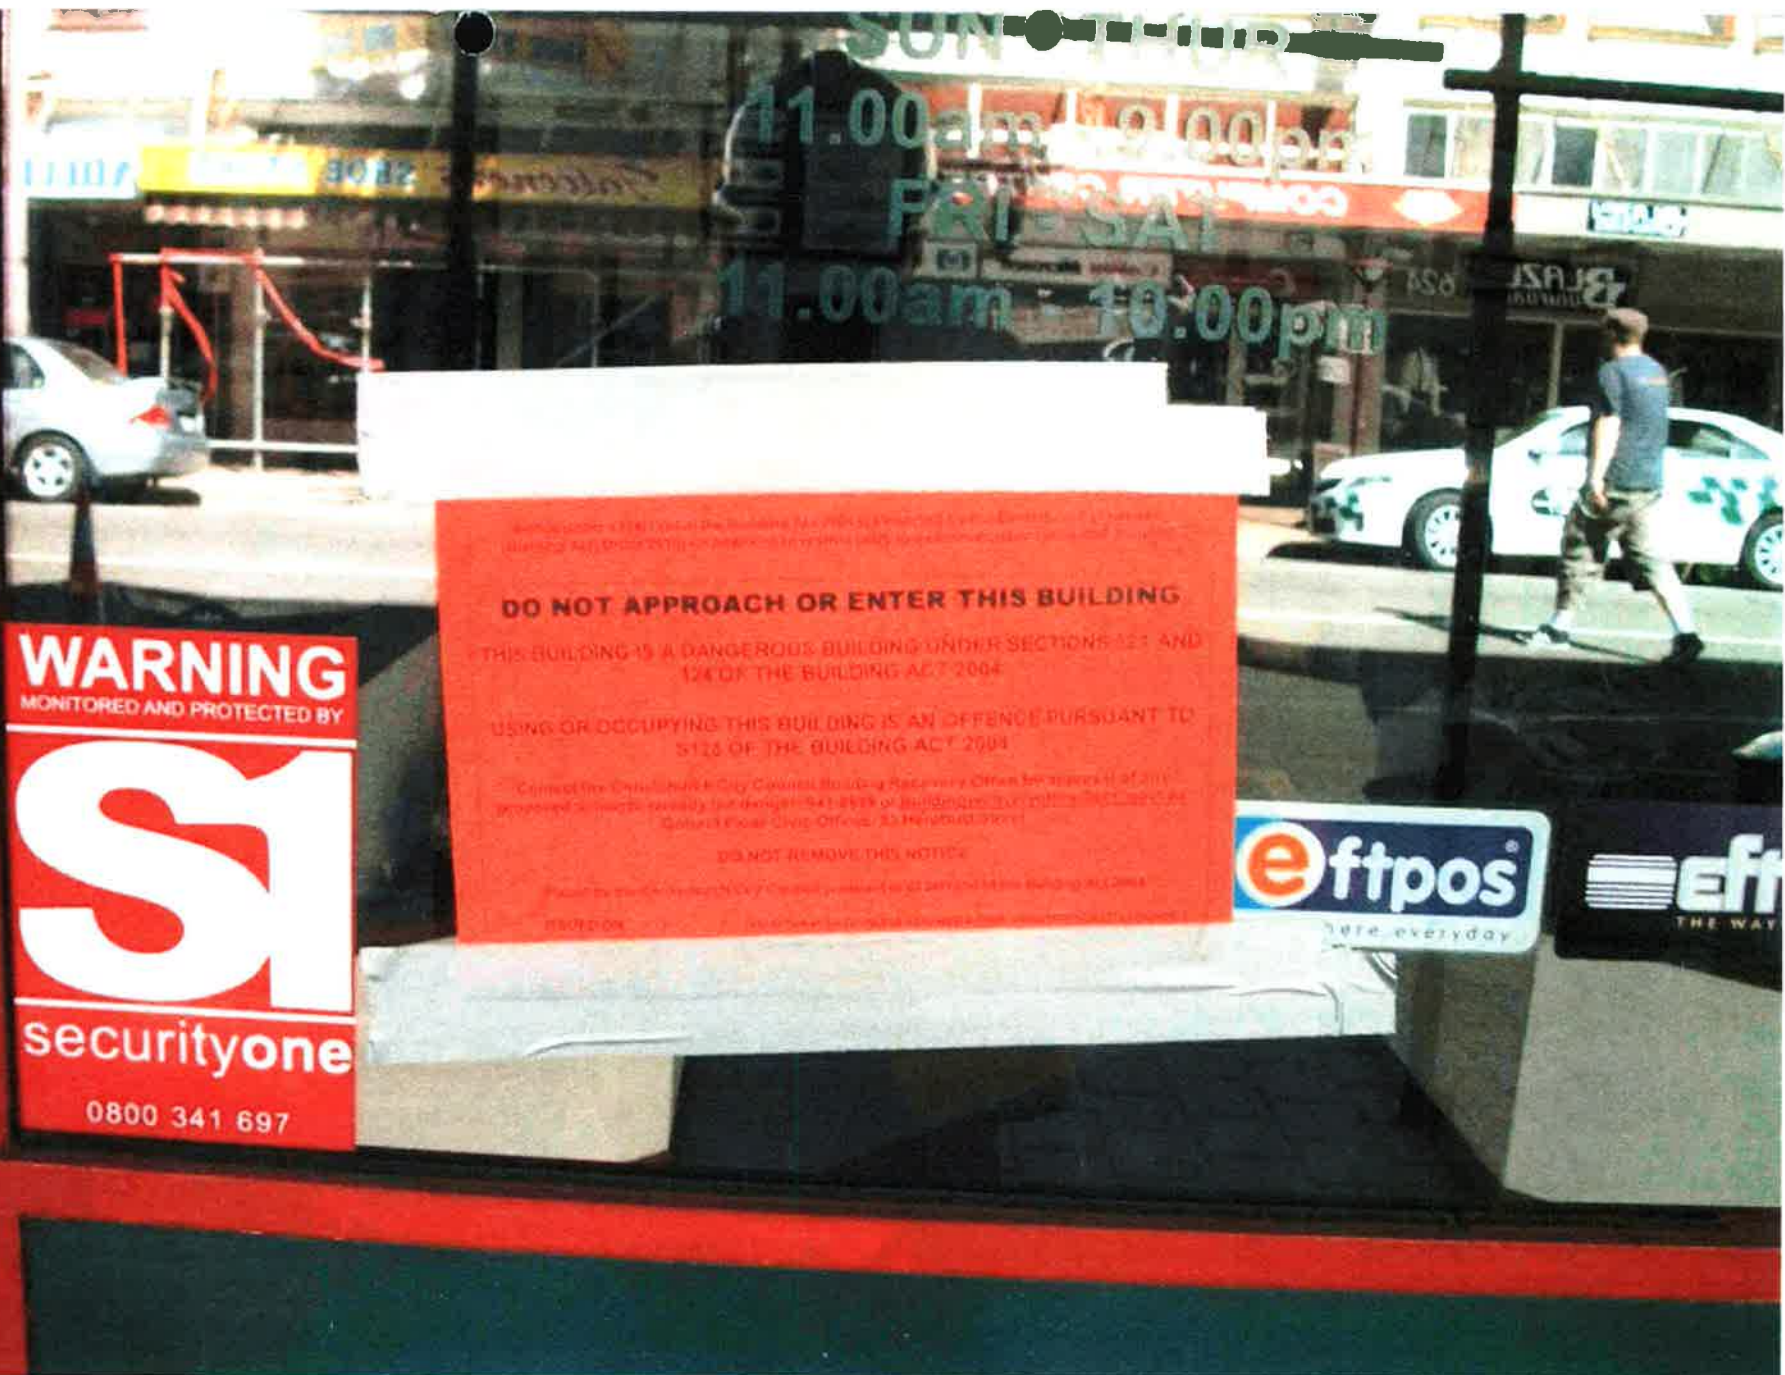
**DO NOT APPROACH OR ENTER THIS BUILDING**  
THIS BUILDING IS A DANGEROUS BUILDING UNDER SECTIONS 121 AND 124 OF THE BUILDING ACT 2004  
USING OR OCCUPYING THIS BUILDING IS AN OFFENCE PURSUANT TO 5116 OF THE BUILDING ACT 2004  
Contact the Christchurch City Council Building Recovery Officer for approval of any proposed works or to report any unsafe building. Tel: 03 378 7222  
Council Floor Civil Officer: 33 HERIQUAD STREET  
DO NOT REMOVE THIS NOTICE  
Faced by the Christchurch City Council Building Recovery Officer for approval of any proposed works or to report any unsafe building. Tel: 03 378 7222  
15/07/2004
