Christchurch Eq RAPID Assessment Form - LEVEL 2

The 123 Mort

91A Cashel St.

91 Cashel Street – Earthquake Damage Assessment

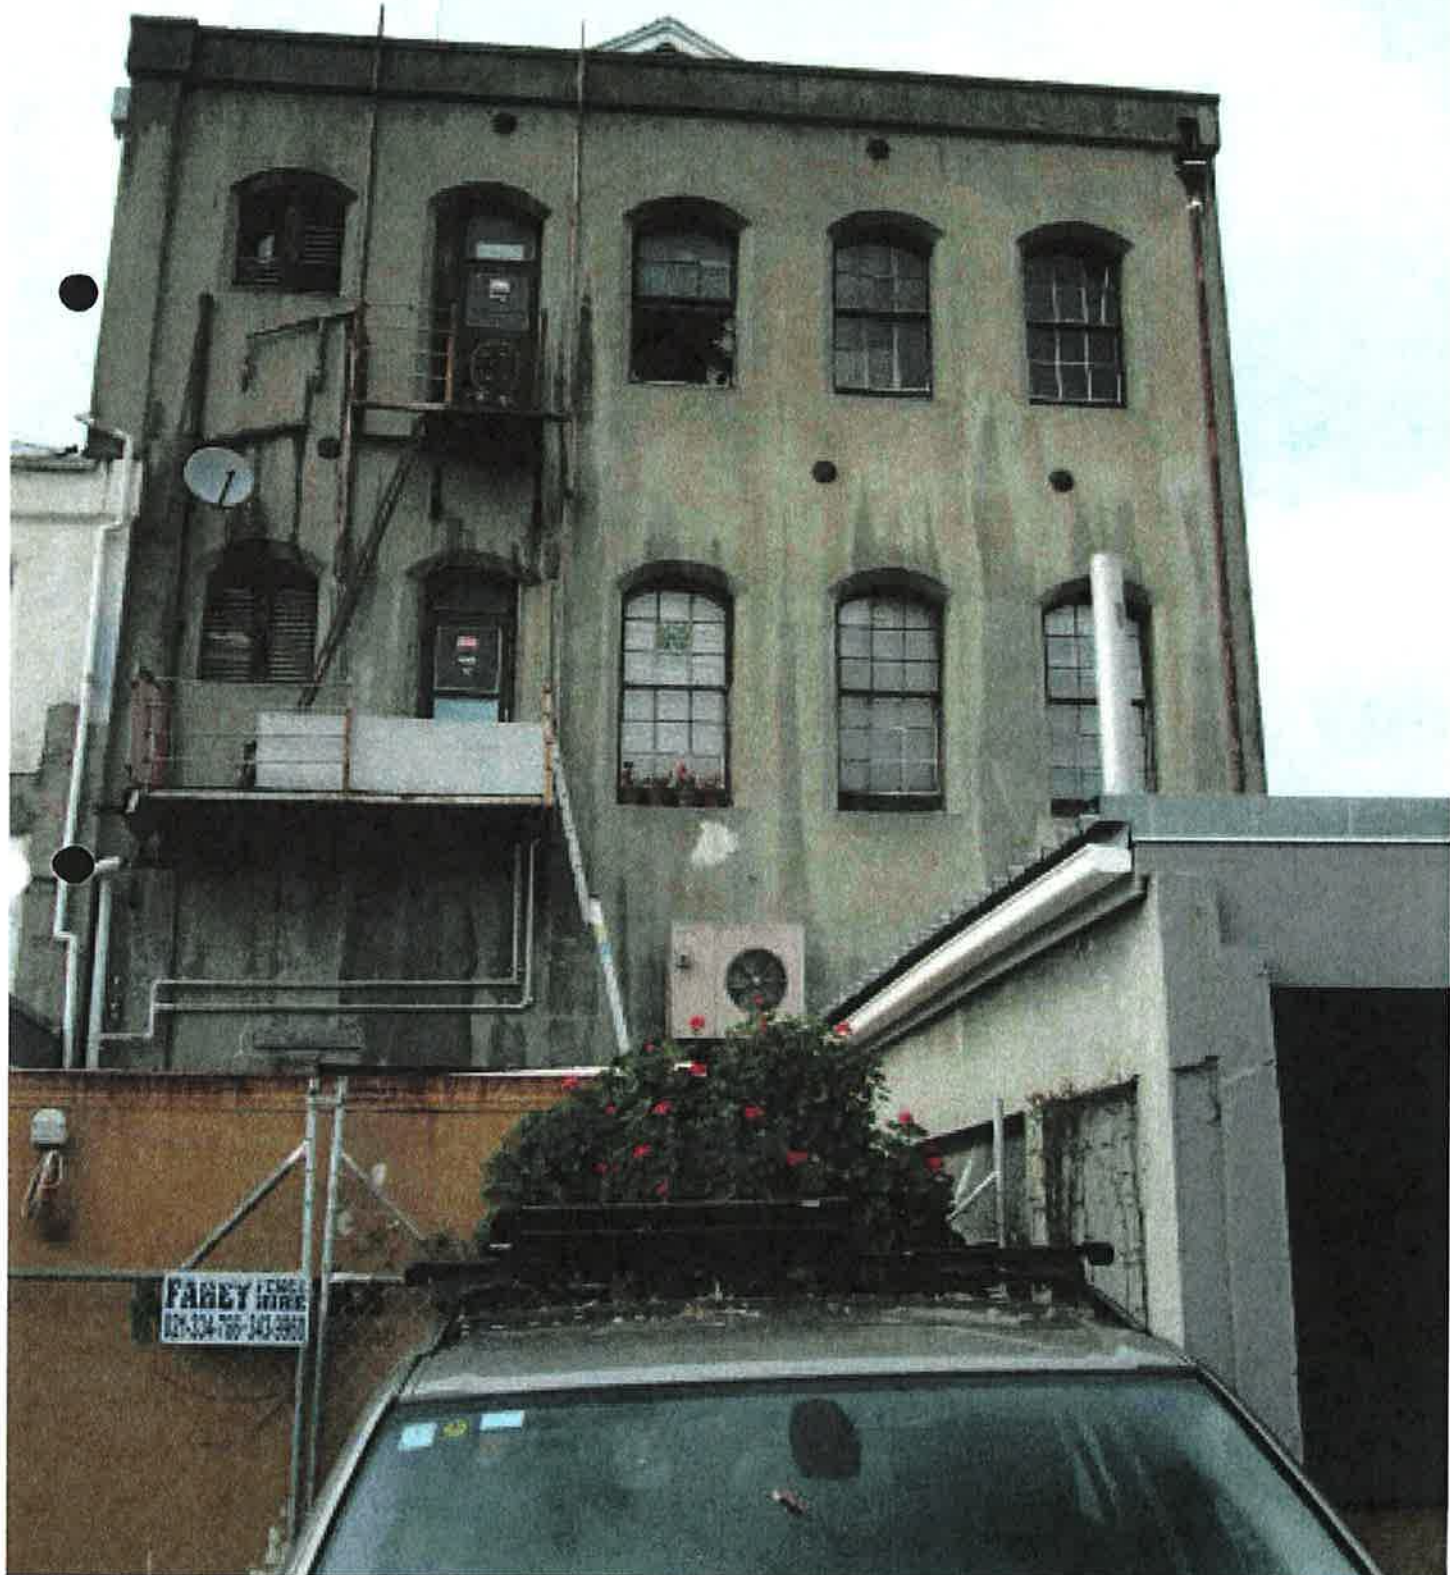
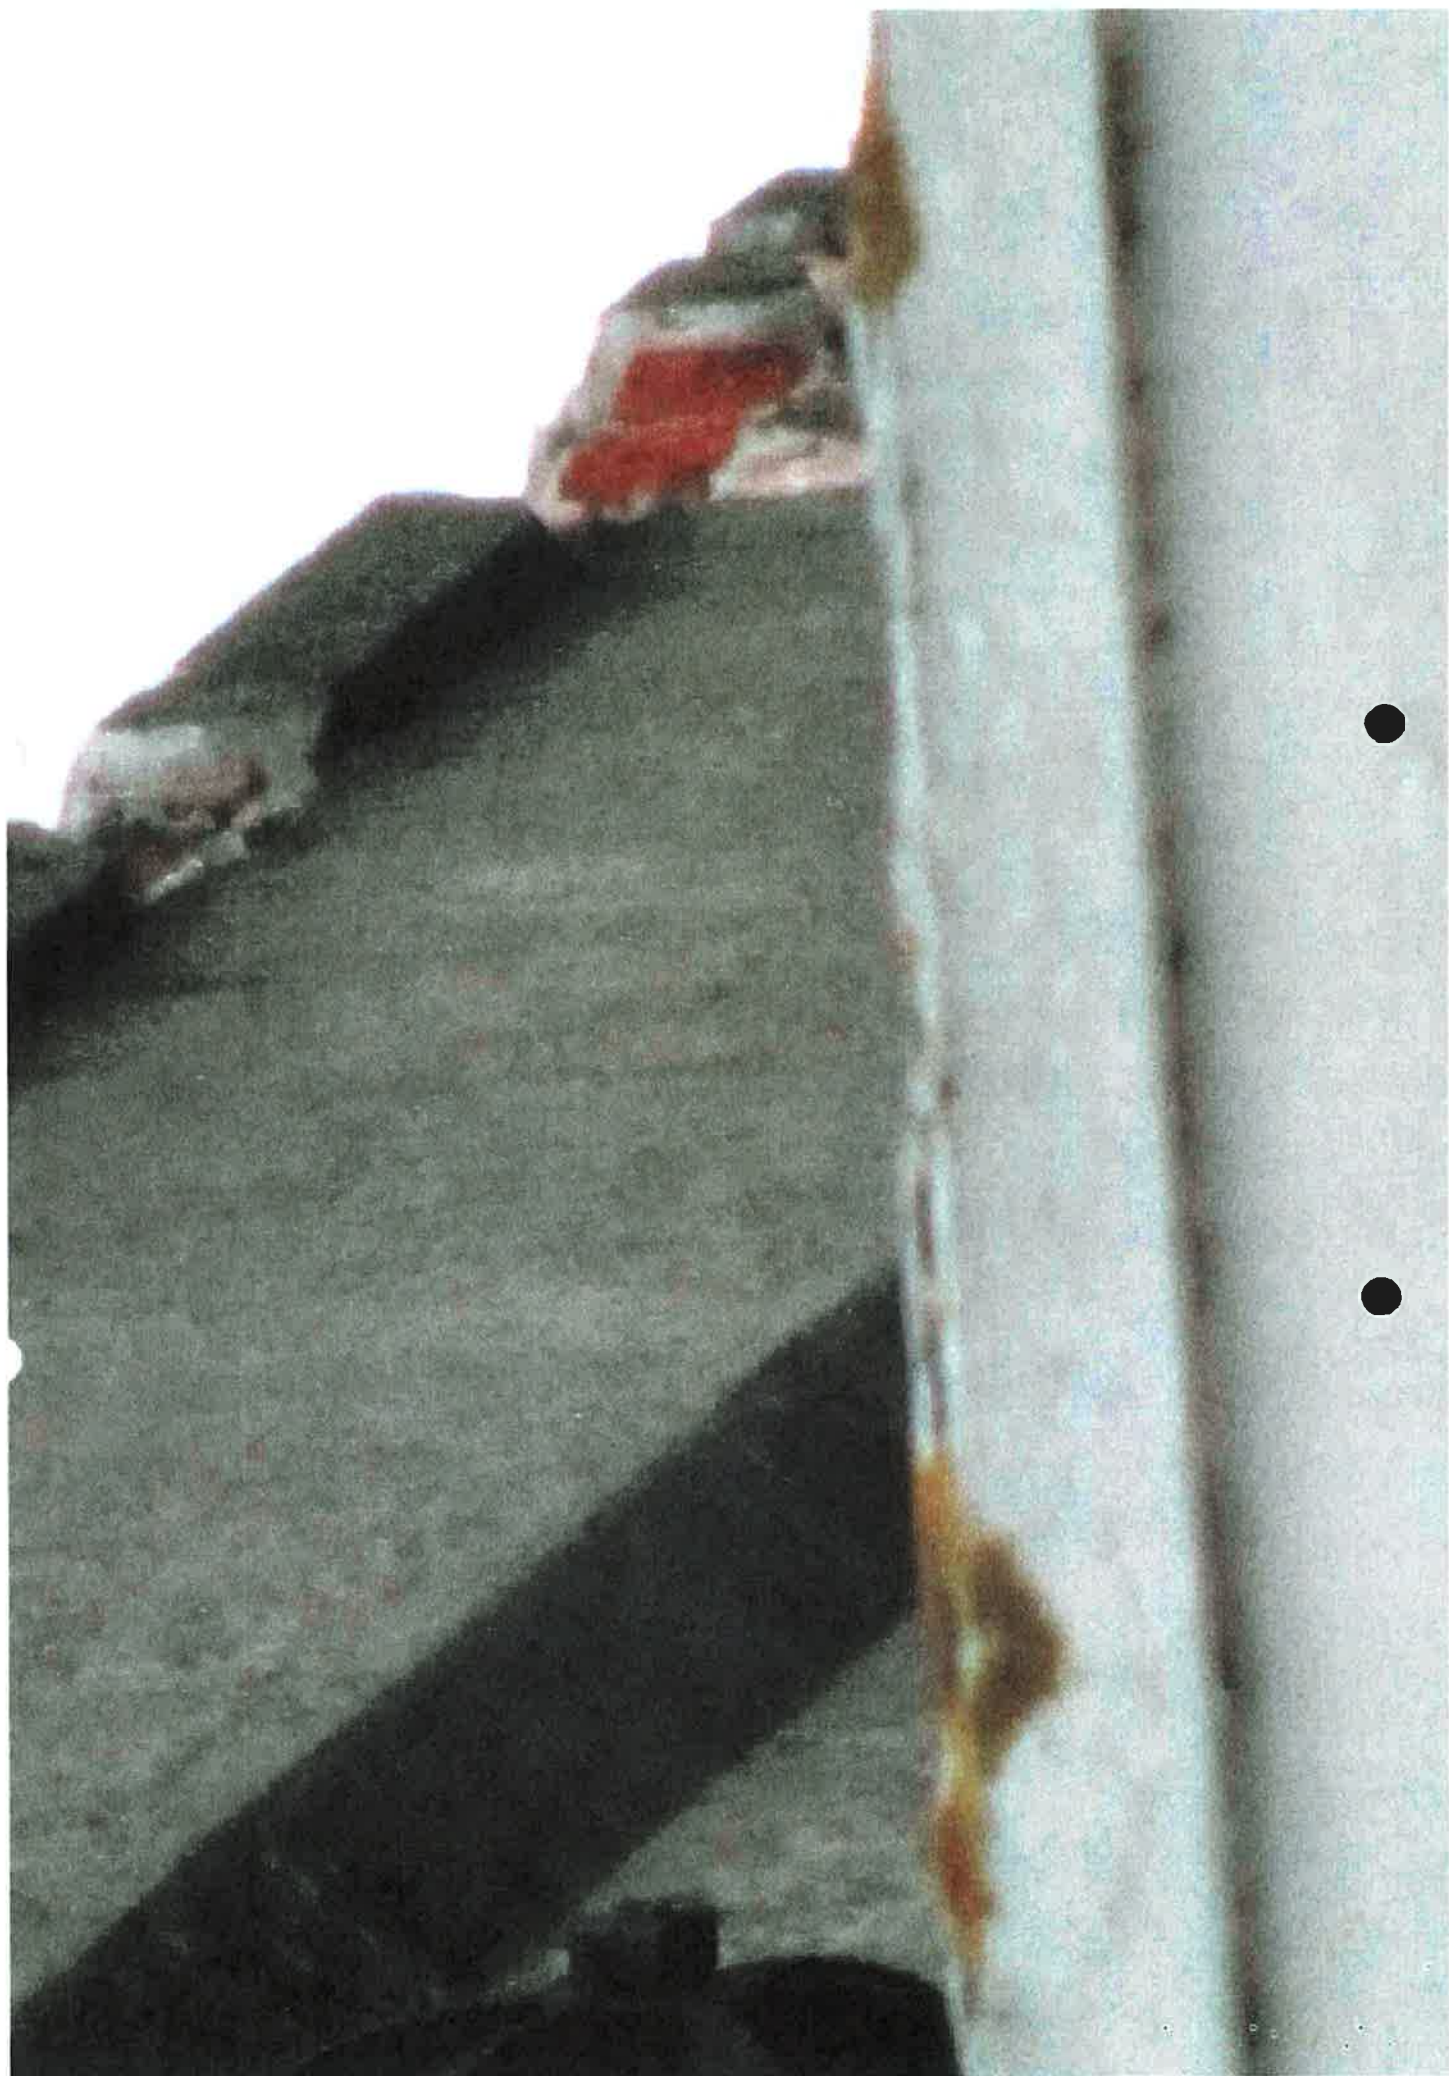
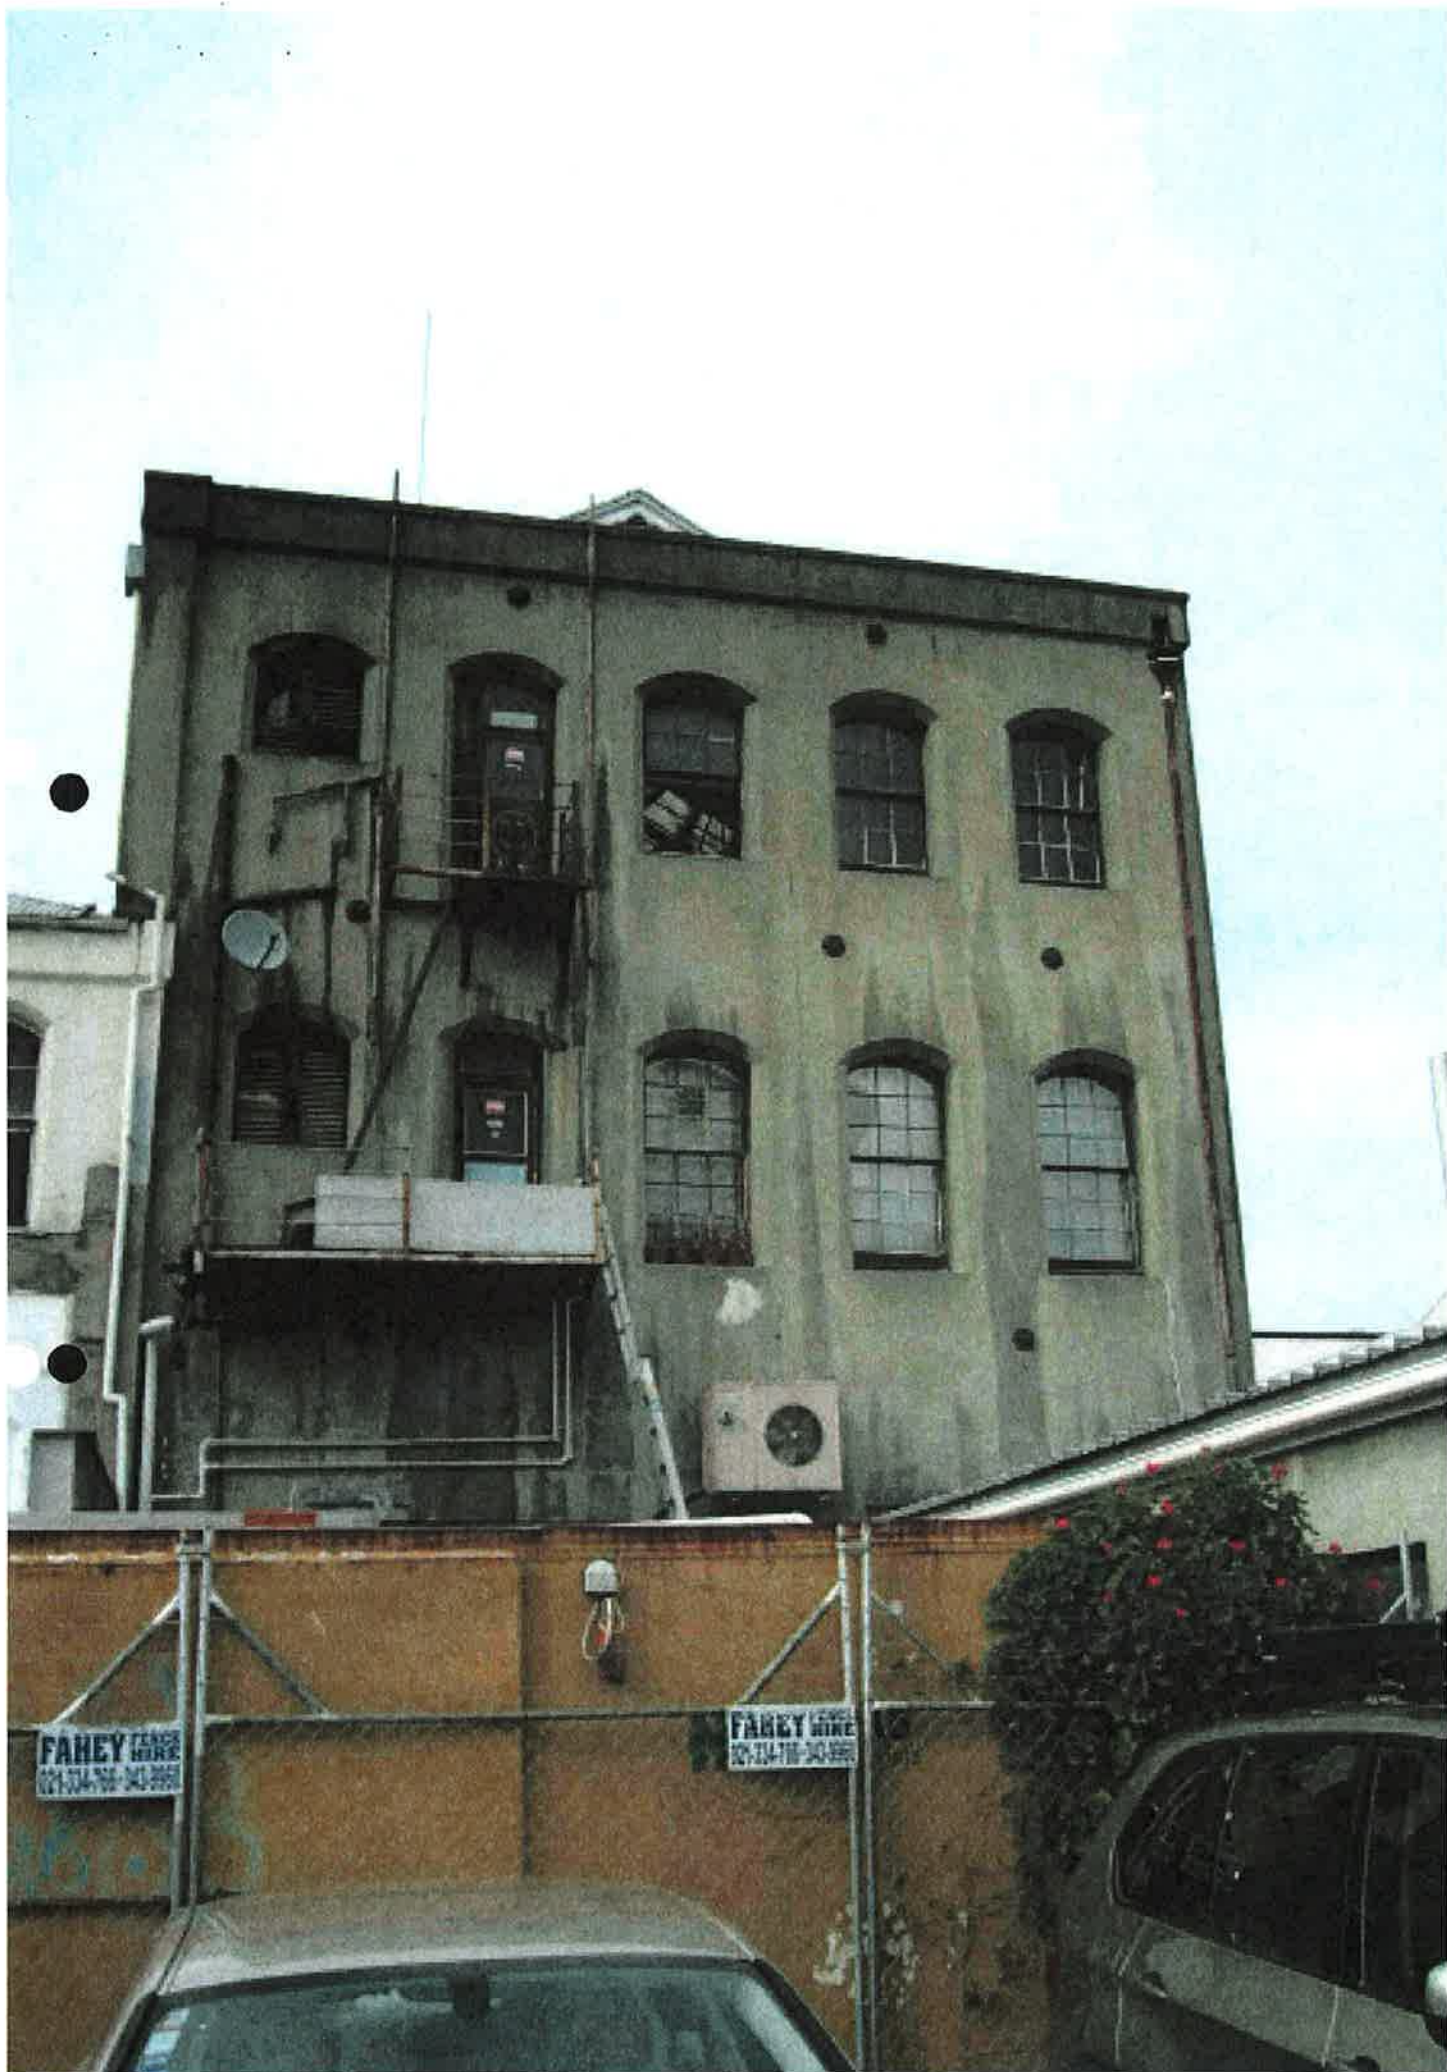
check by engineer - hairline crack in structural wall

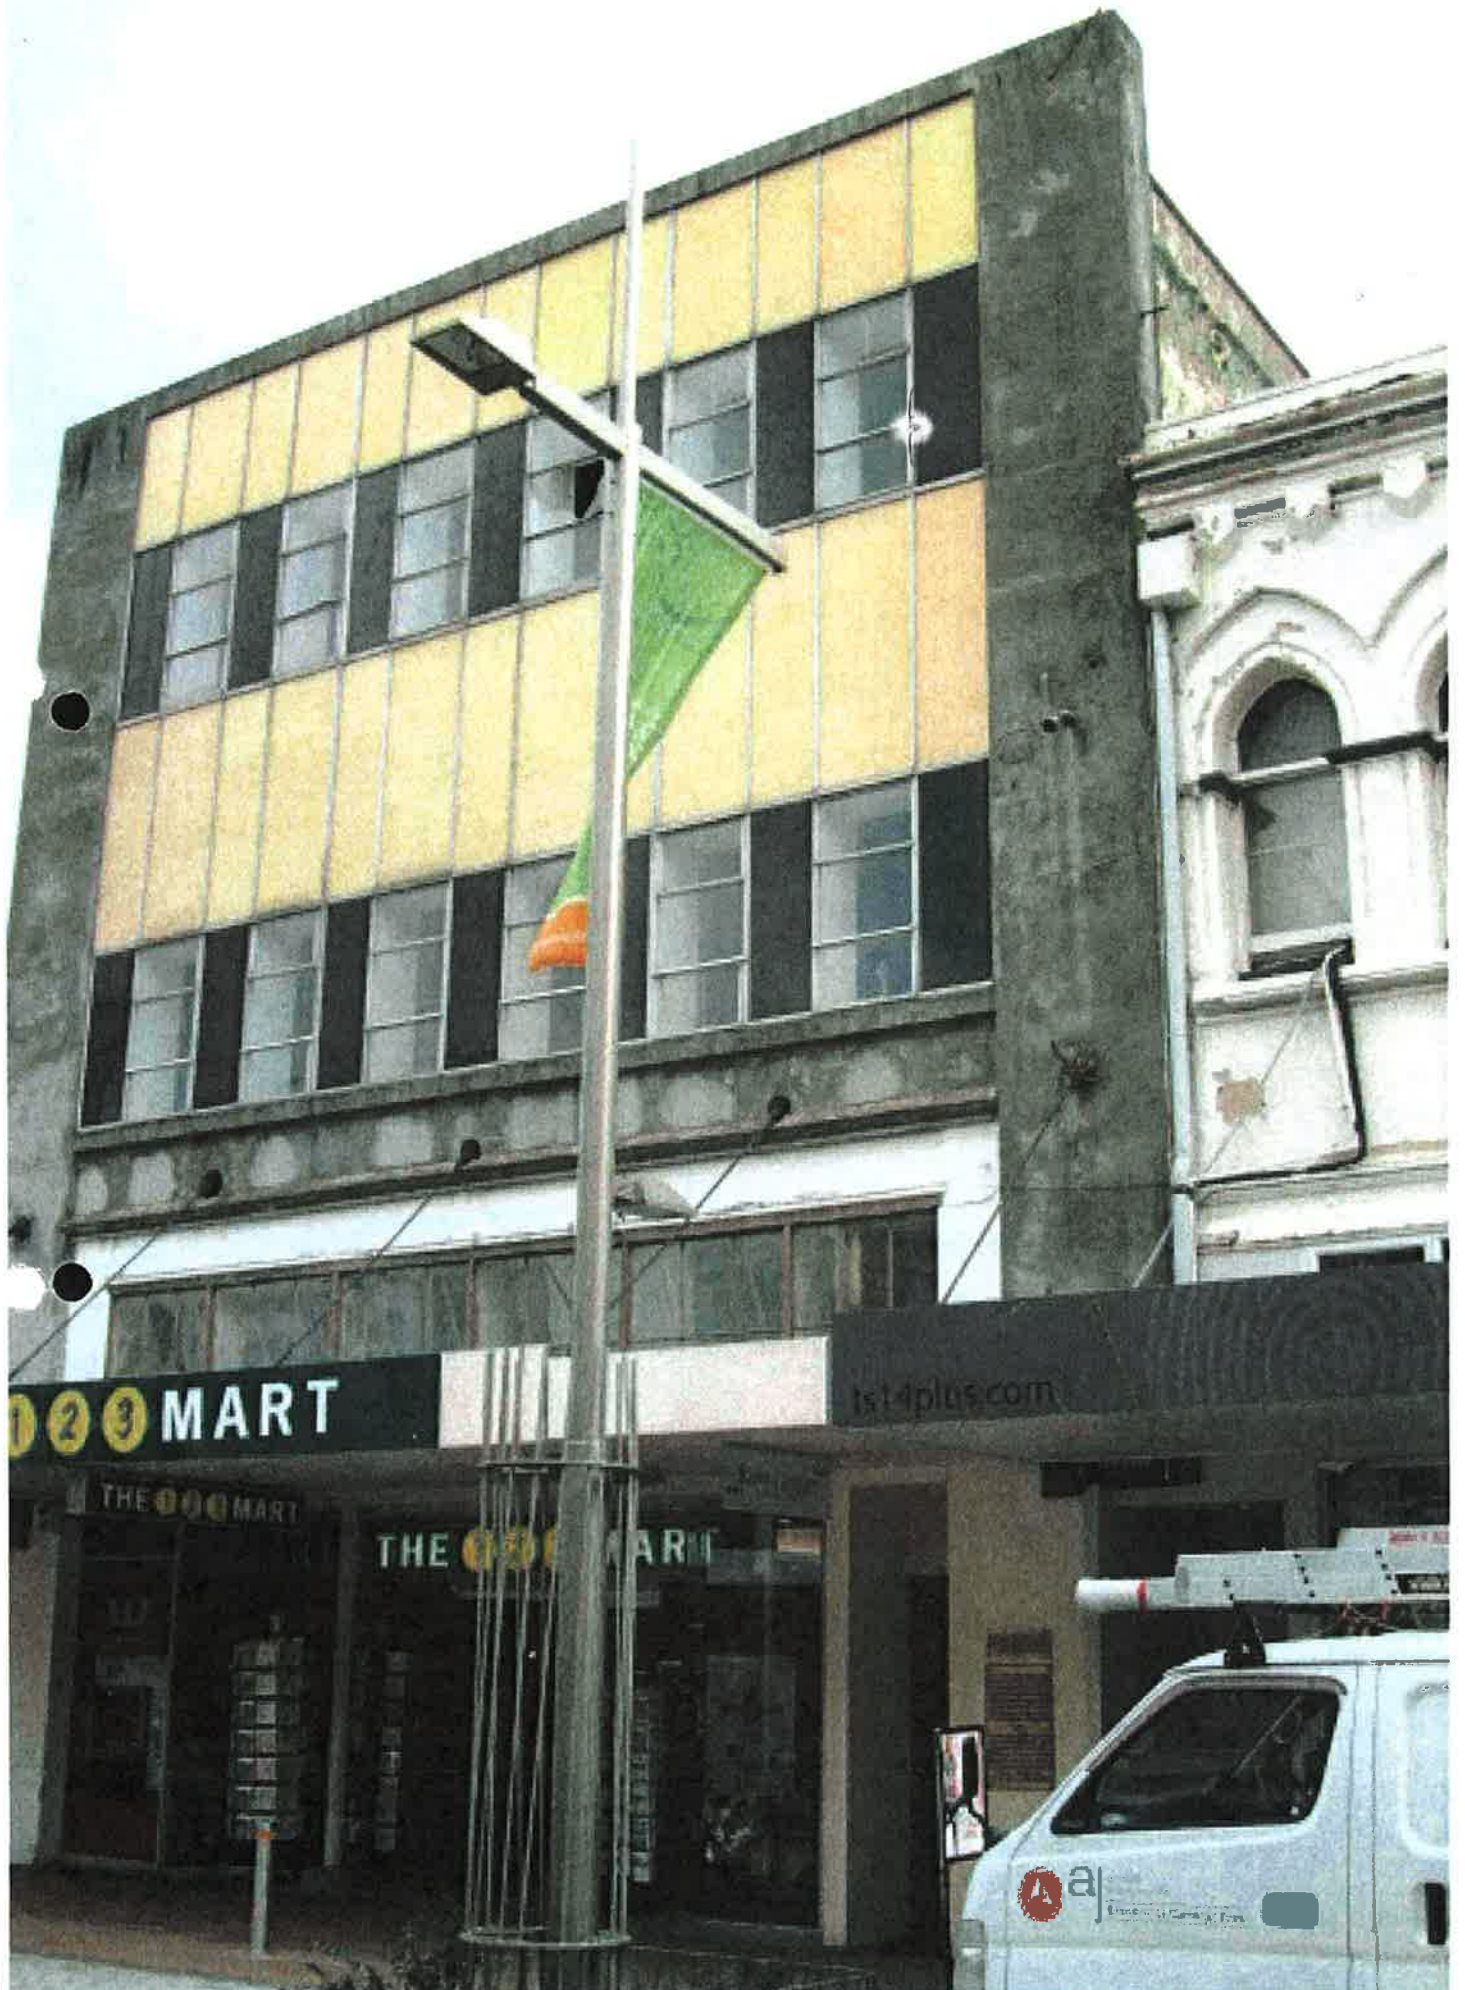
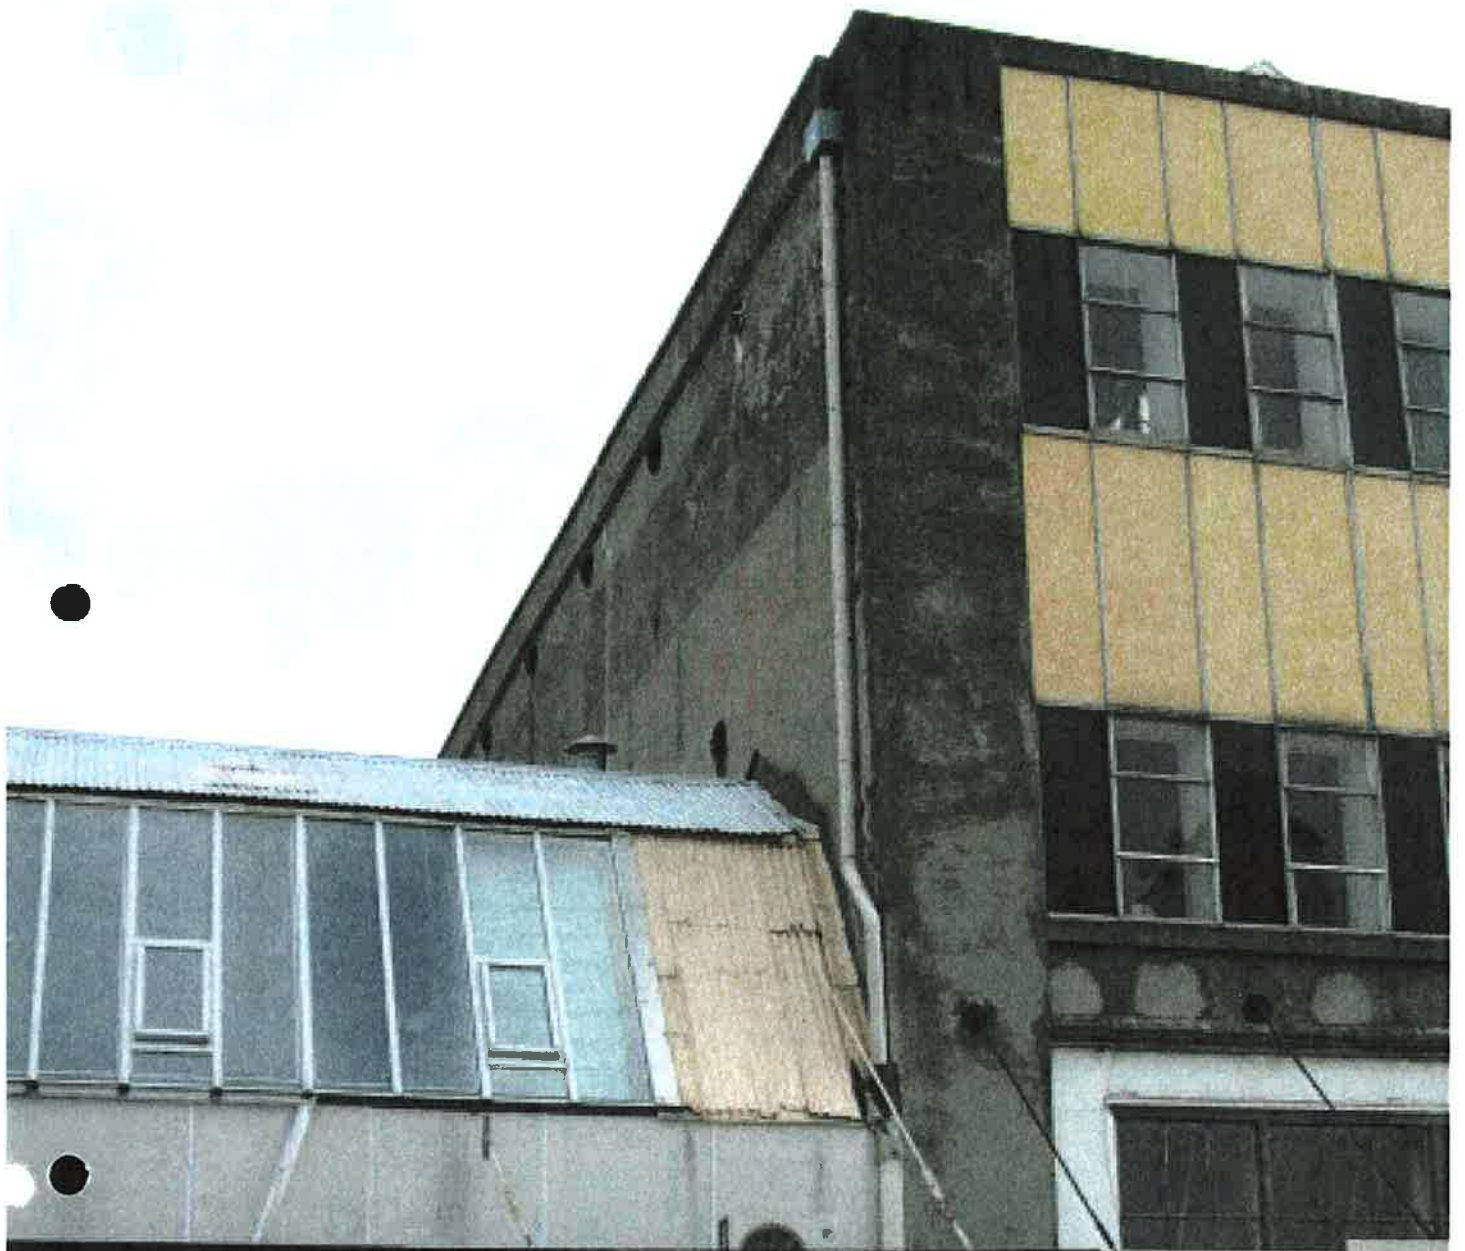
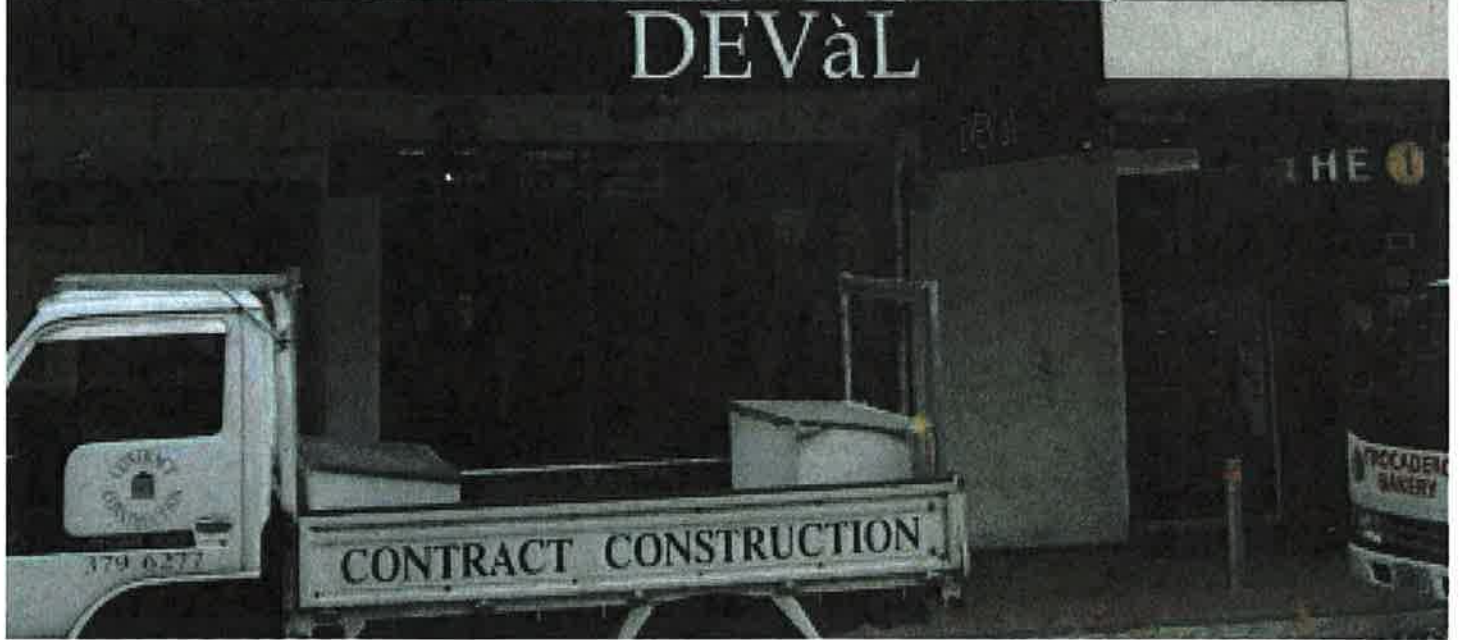
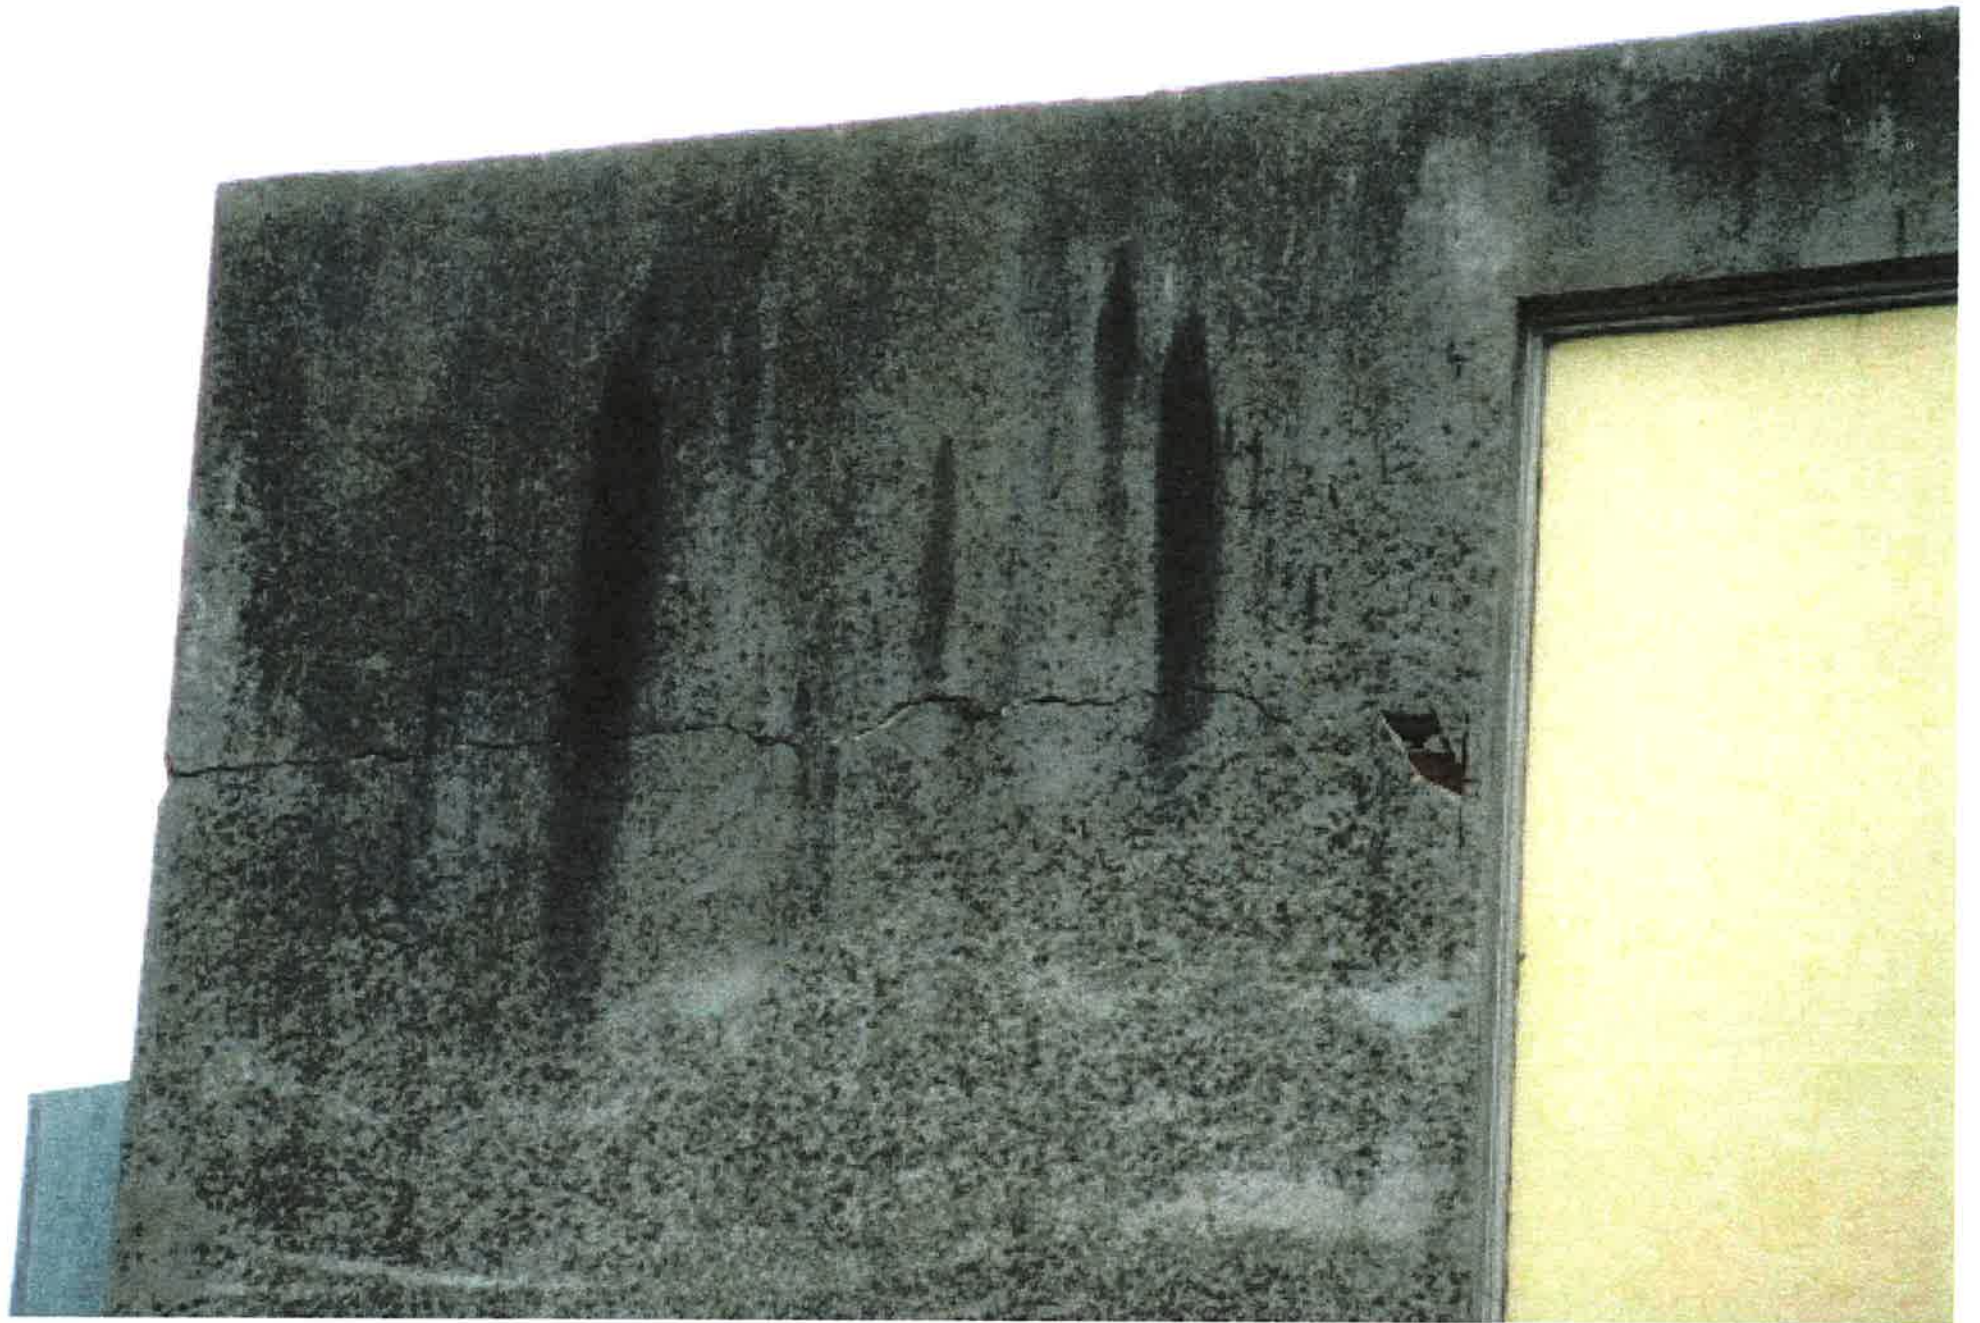
exposed face brick (see photo) cracks (see photo)

- Vertical cracks observed in external walls east and west.
- Cracks observed at joints between side walls and horizontal members on Cashel Street frontage.
- Concern is that if mechanism of seismic restraint is not well understood, there may be repercussions during subsequent aftershocks. ~~An engineer~~ that are not apparent at this stage.

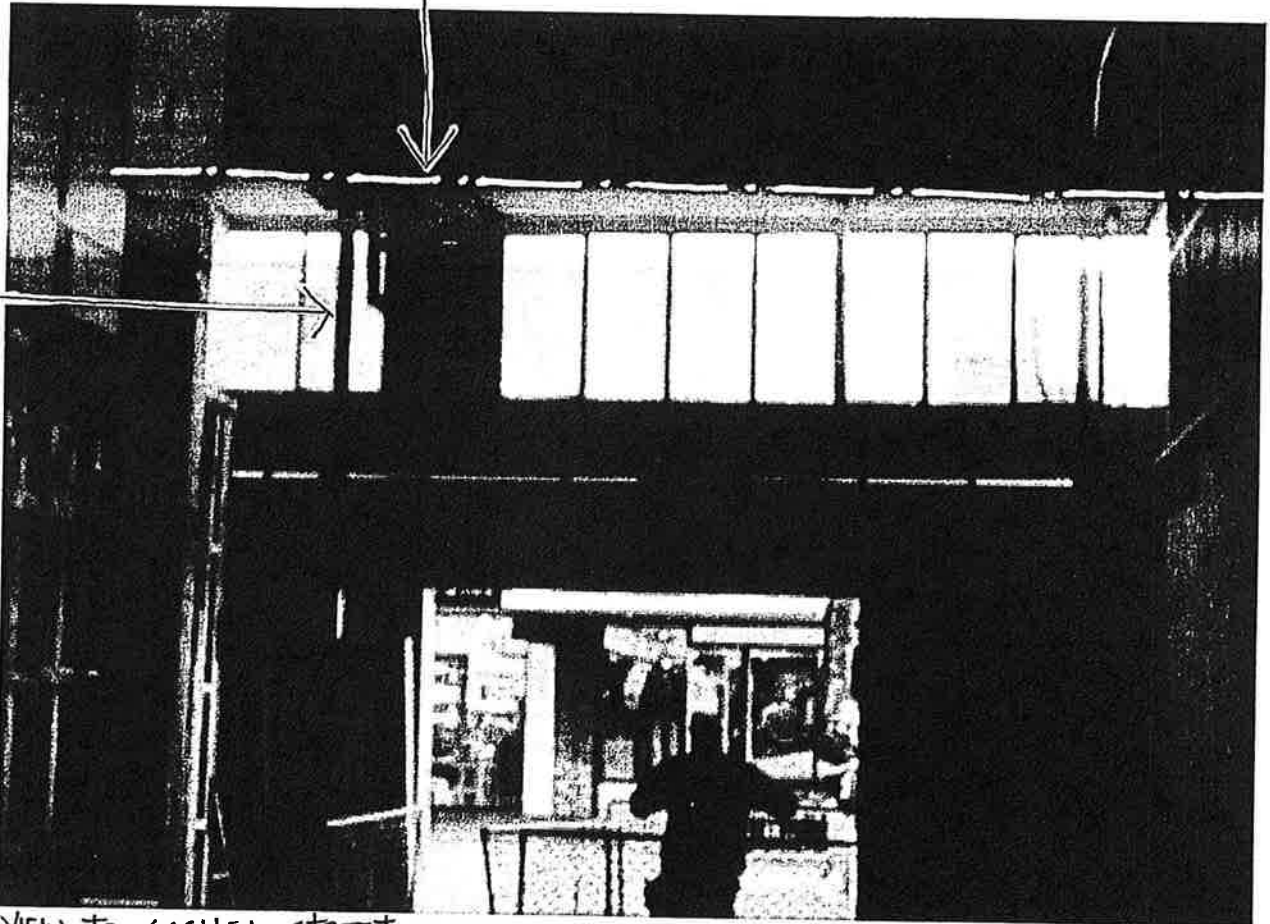
VIEW TO CASHEL STREET.

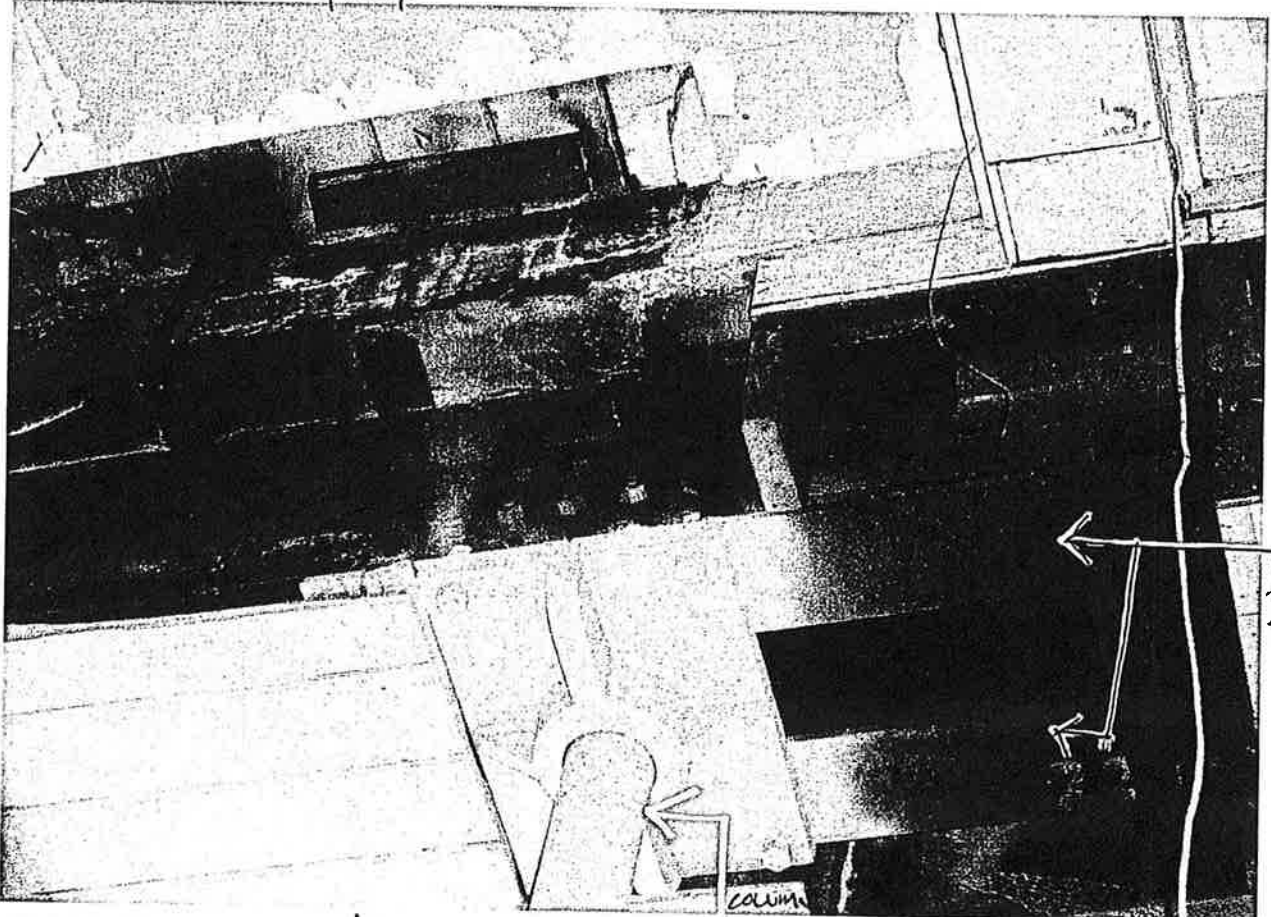
EXIST PAIR BEAMS

CLOSE UP - COLUMN / BEAM CONNECTION (EXISTING)

13 CASHEL ST - SITE PHOTOS - EXISTING SOUTH ELEVATION STRUCTURE.
