Canterbury Earthquakes Royal Commission**Komihana a te Karauna hei Tirotiro i ngā Whare i Horo i ngā Rūwhenua o Waitaha**

391/391A Worcester Street, Christchurch

9 September 2011

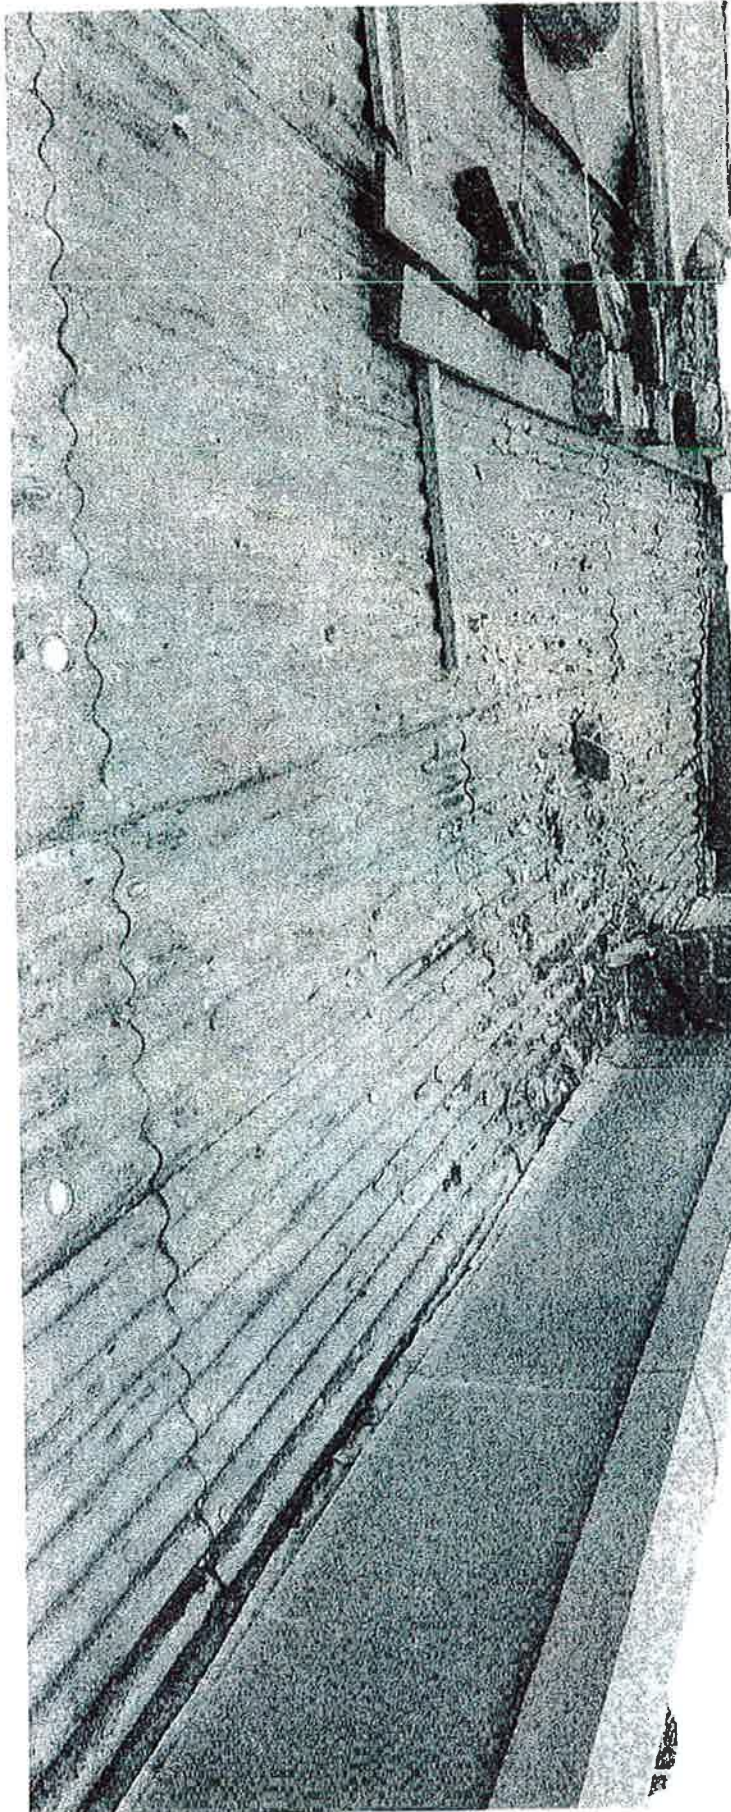
upper chimney that
fell in the first earthquake

This parapet cap was
existing when we arrived
on site

This eastern parapet was lowered, and
covered with a flashing

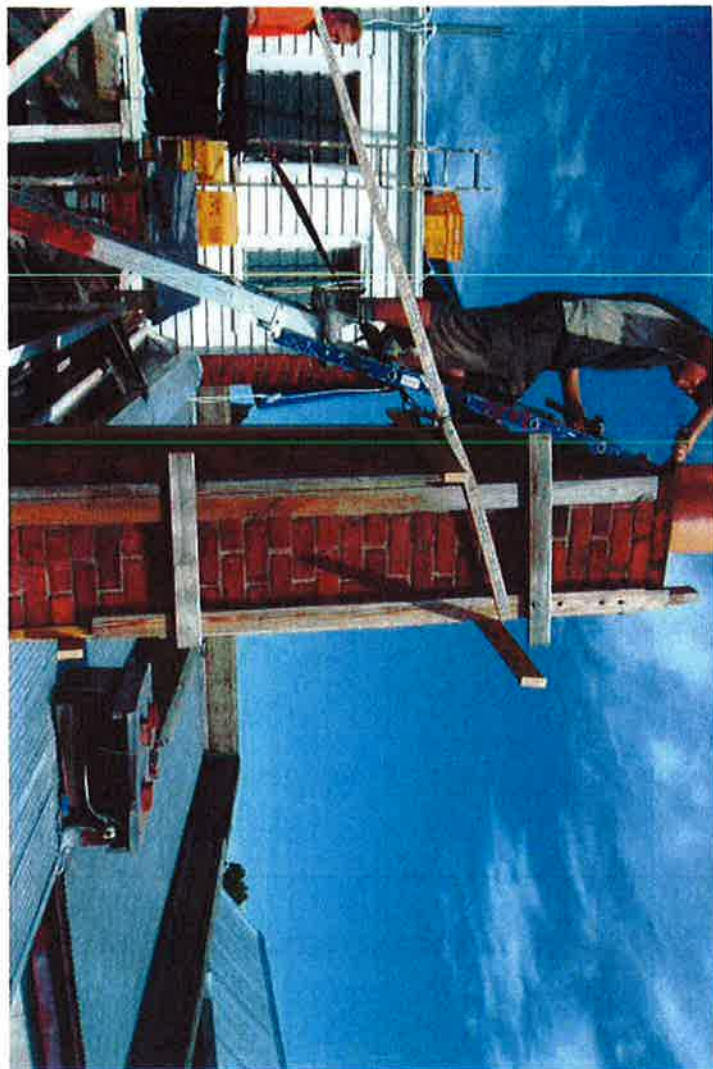
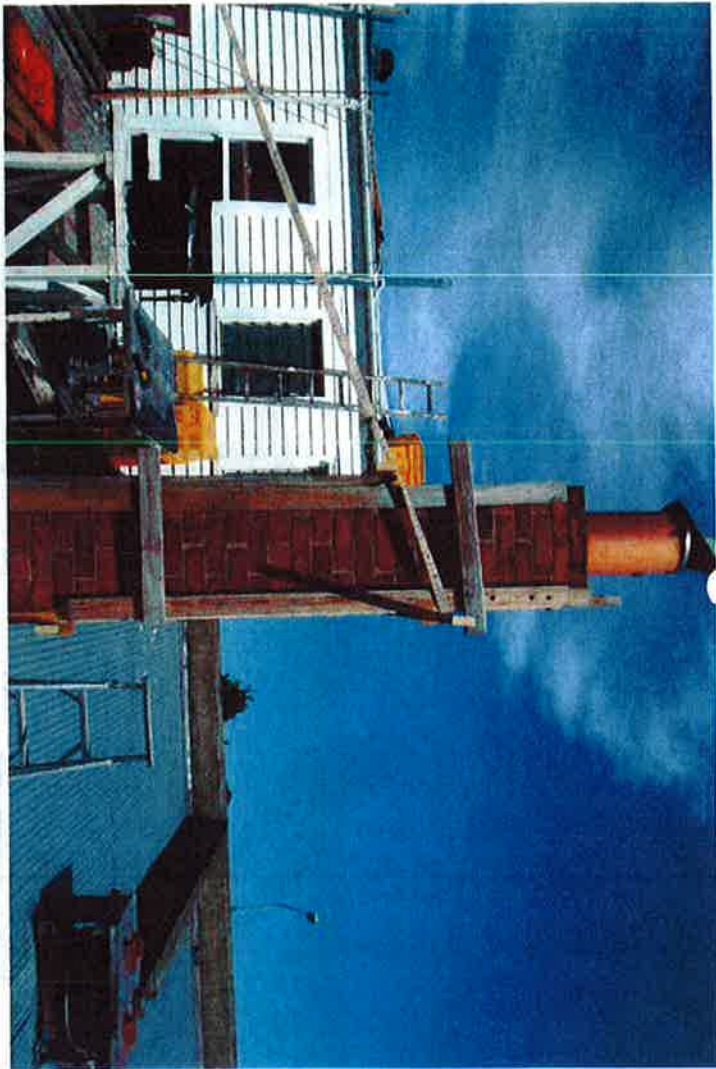
30 September 2010
Bracing of 2nd (lower level) chimney
in preparation for removal

- Later in September we were called to investigate a further leak. At that stage our Construction Manager noticed the second chimney was now unstable, and advised the Lokes that it should be removed. They agreed, and the work was undertaken.
