20 December 2011

Canterbury Earthquakes Royal Commission
PO Box 14053
Christchurch Mail Centre
Christchurch 8544

91A Cashel Street, Christchurch

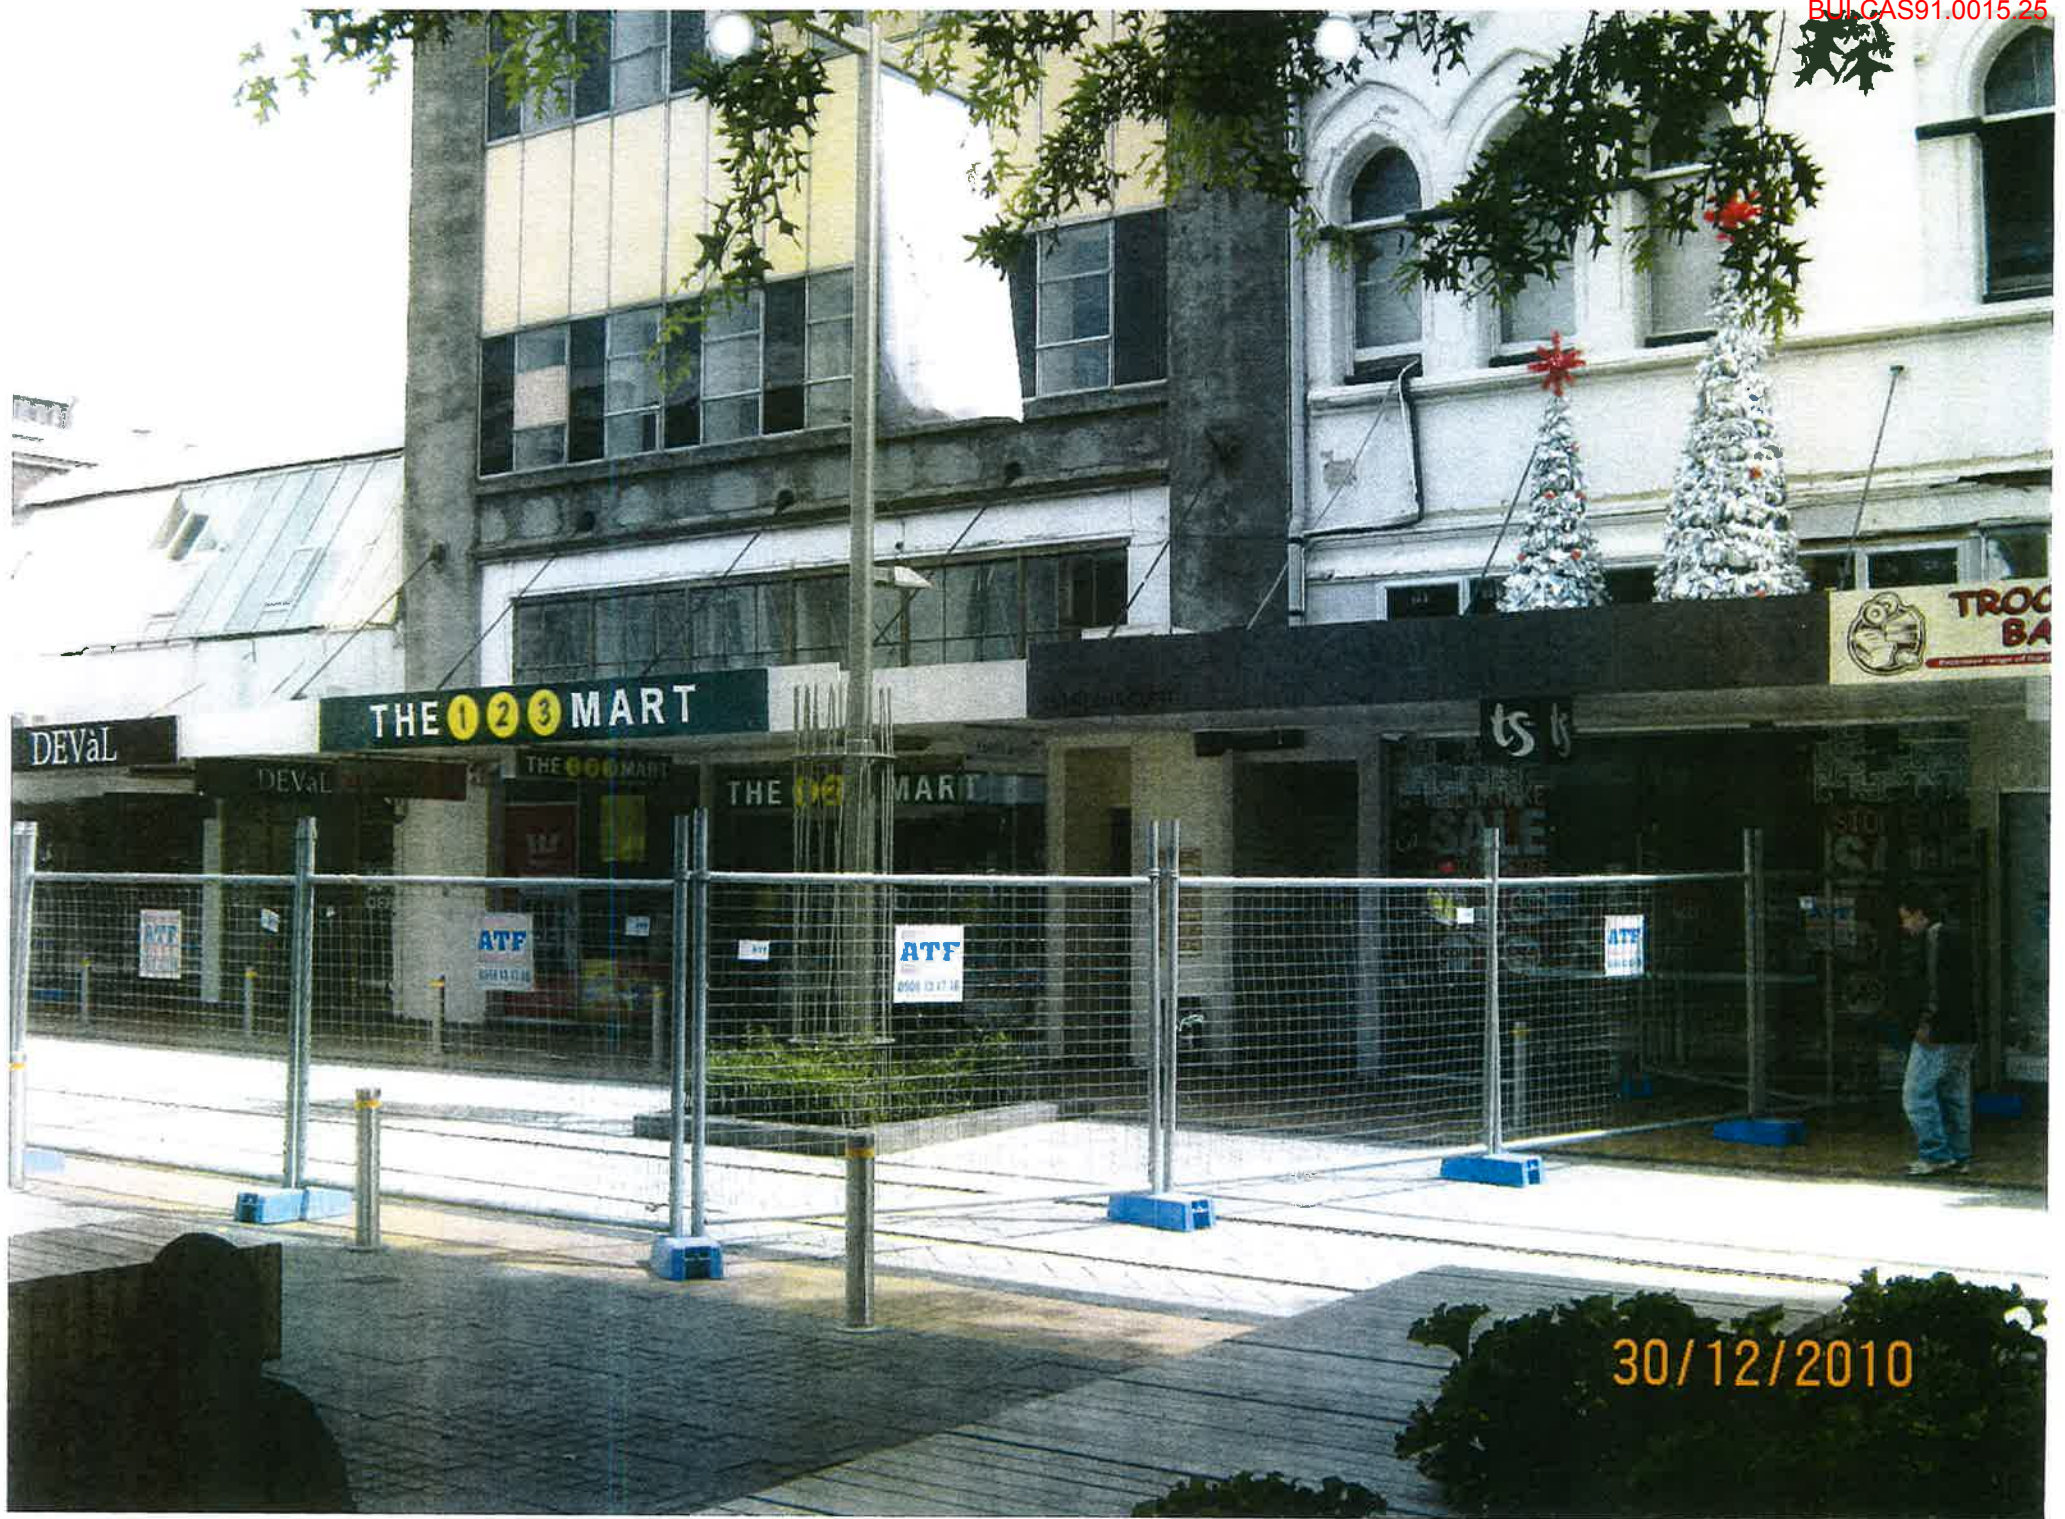
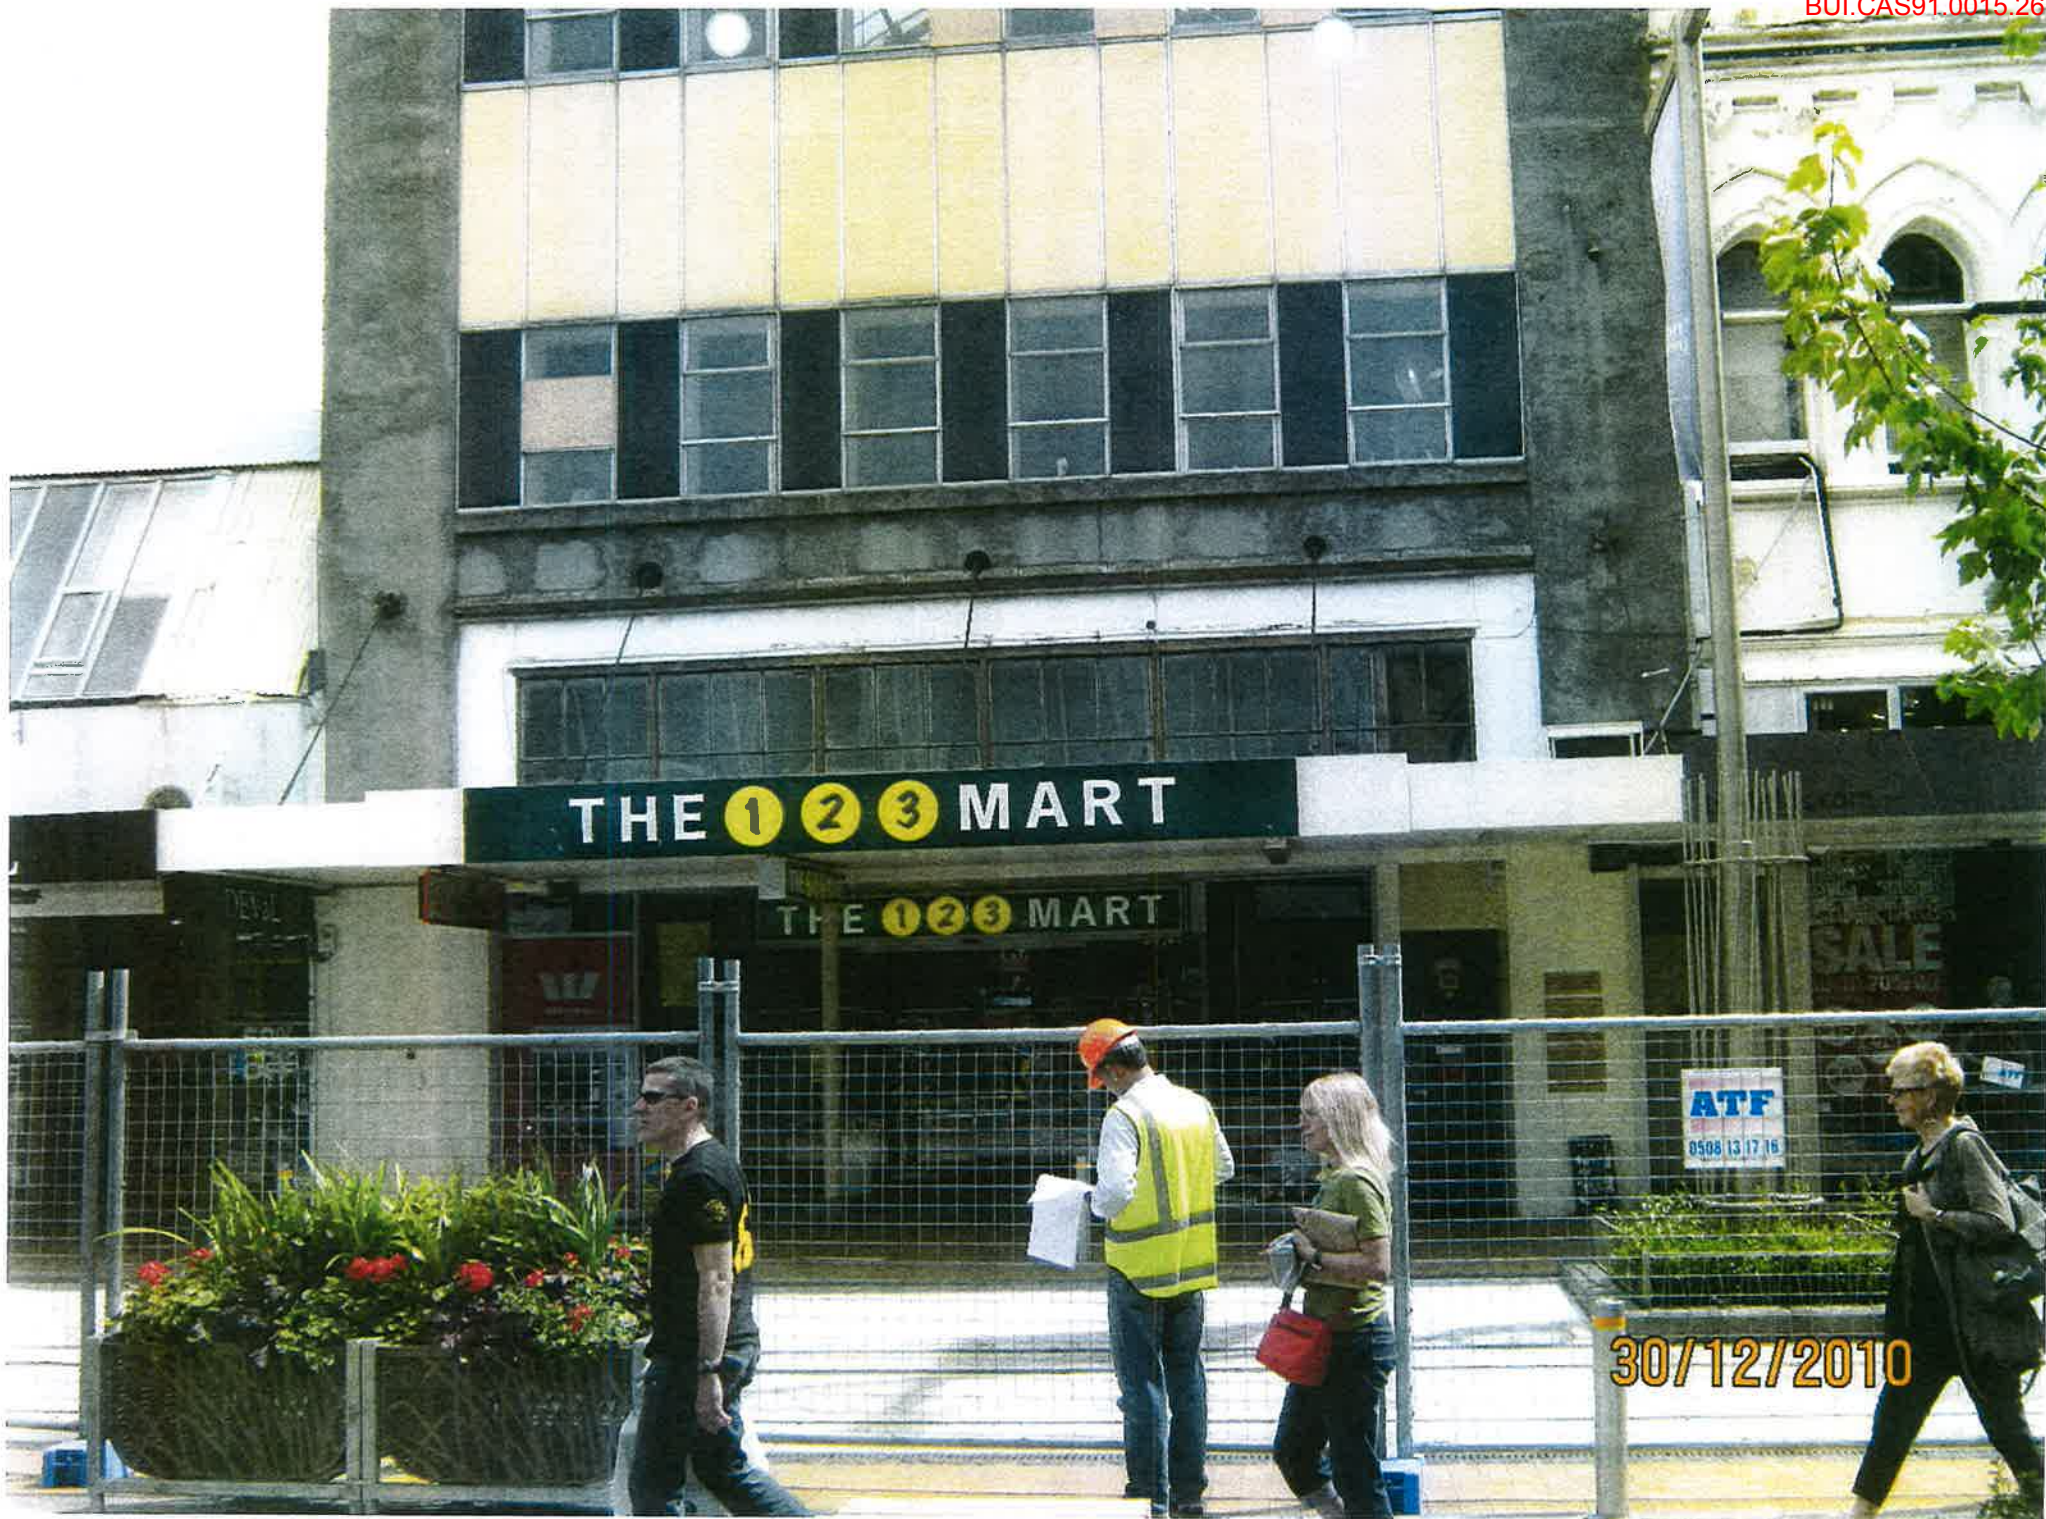
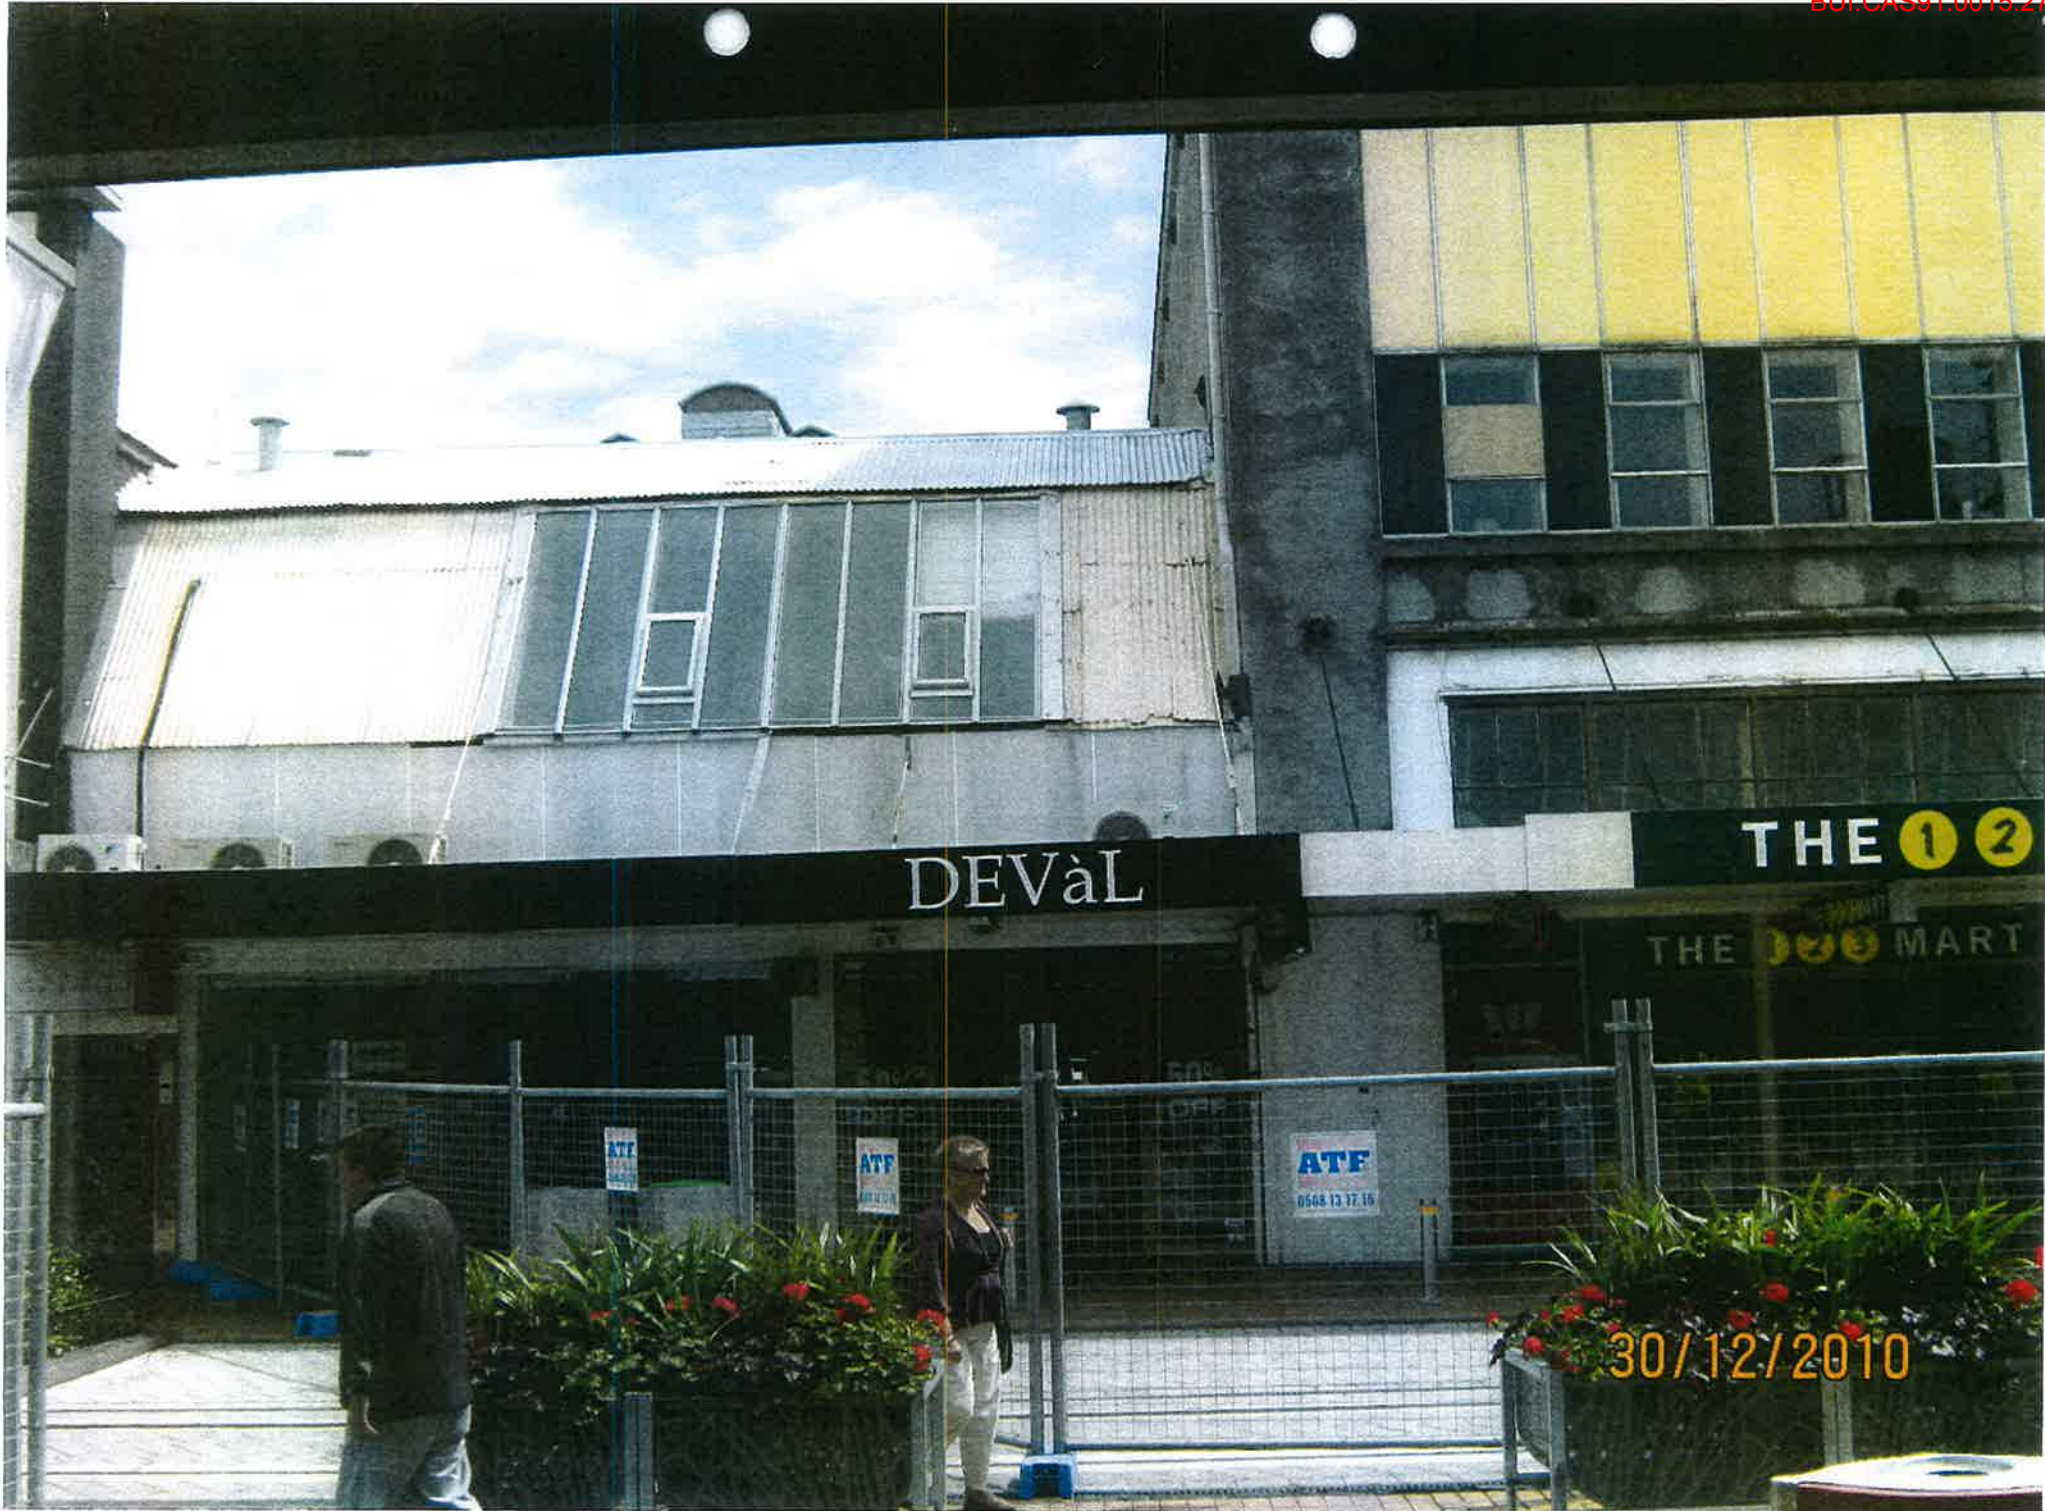
Issued by the Christchurch City Council pursuant to s124(1)(b) of the Building Act 2004
VALID FOR 10 DAYS UNLESS RENEWED BY THE CHRISTCHURCH CITY COUNCIL
