5 Earthquake Effects on Site and Building

6888 Ch-ch EQ CBD Building Performance Investigation

Hotel Grand Chancellor - Final 26 Sept 2011

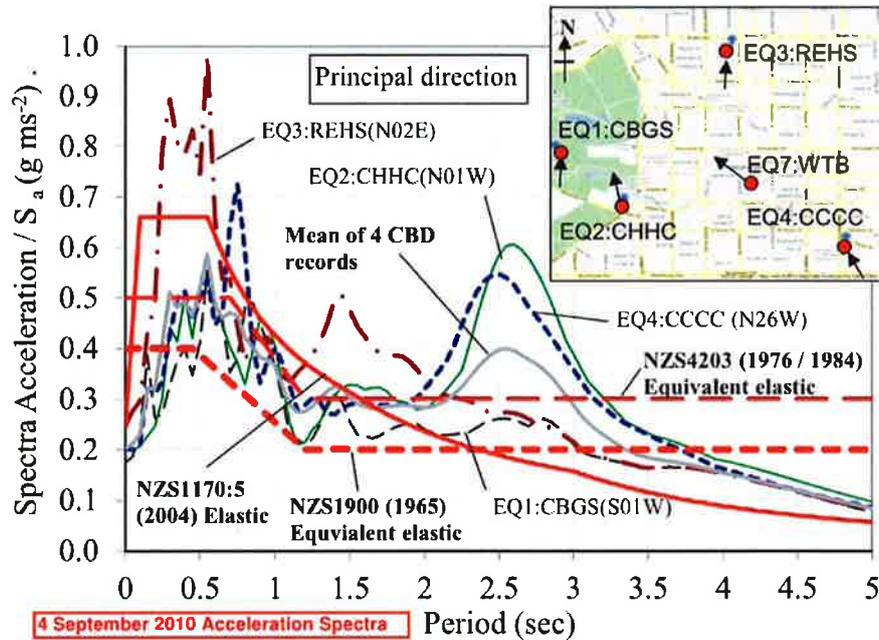
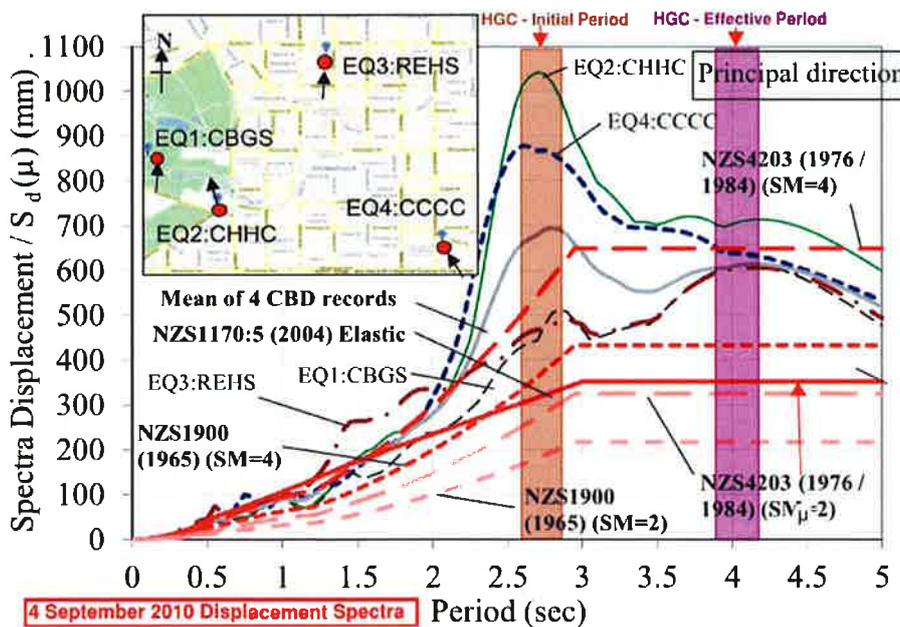
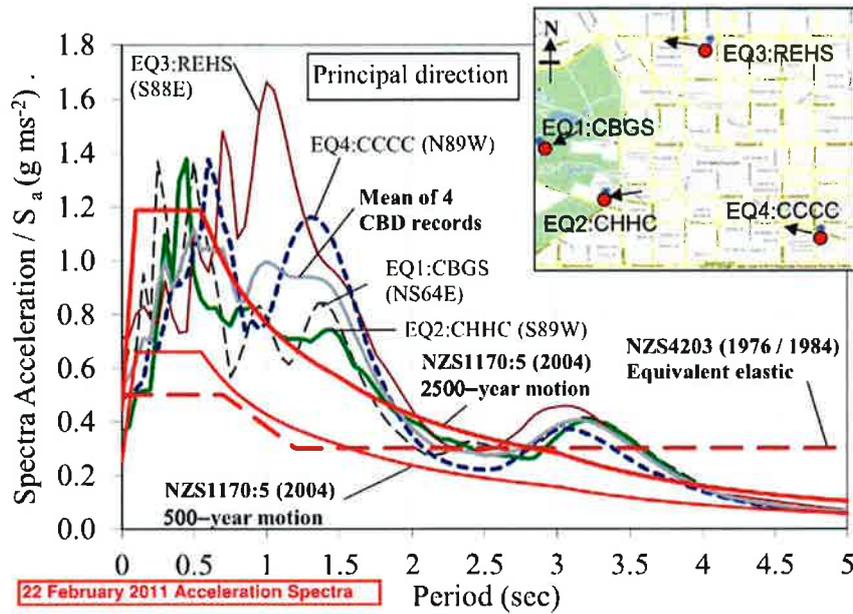
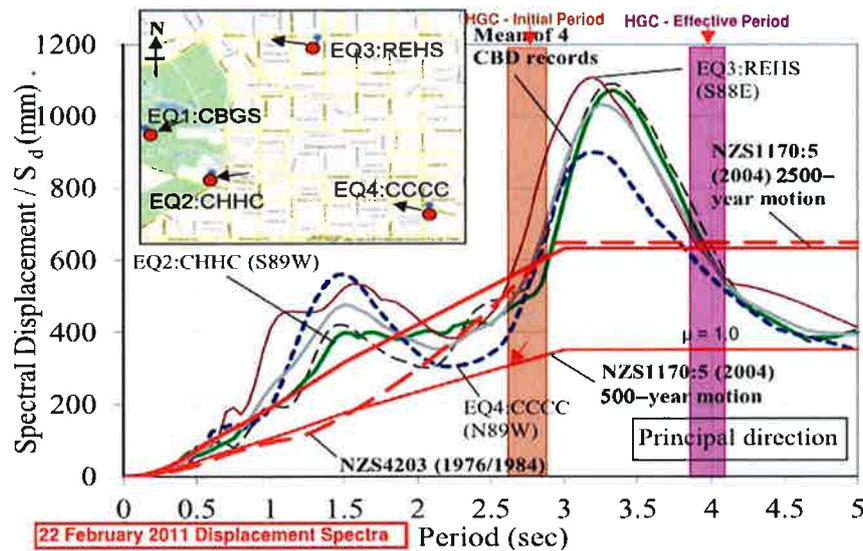
Figures 6(a), (b), (c) and (d) show acceleration and displacement spectra as recorded at 4 locations around the central business district for the 4 September event and the 22 February events. Only the principal direction of motion at each location is shown (the ground motion is normally recorded in two orthogonal directions, and one vertical). For analysis of the Hotel Grand Chancellor average values have been used to determine the response of the structure.

In the September event the north-south ground motions were stronger than the east-west motions at the Hotel Grand Chancellor site. In the 22 February event the motions were stronger in the east-west direction. Actions in this direction, in particular, accentuated vertical loads on the critical wall D5-6.

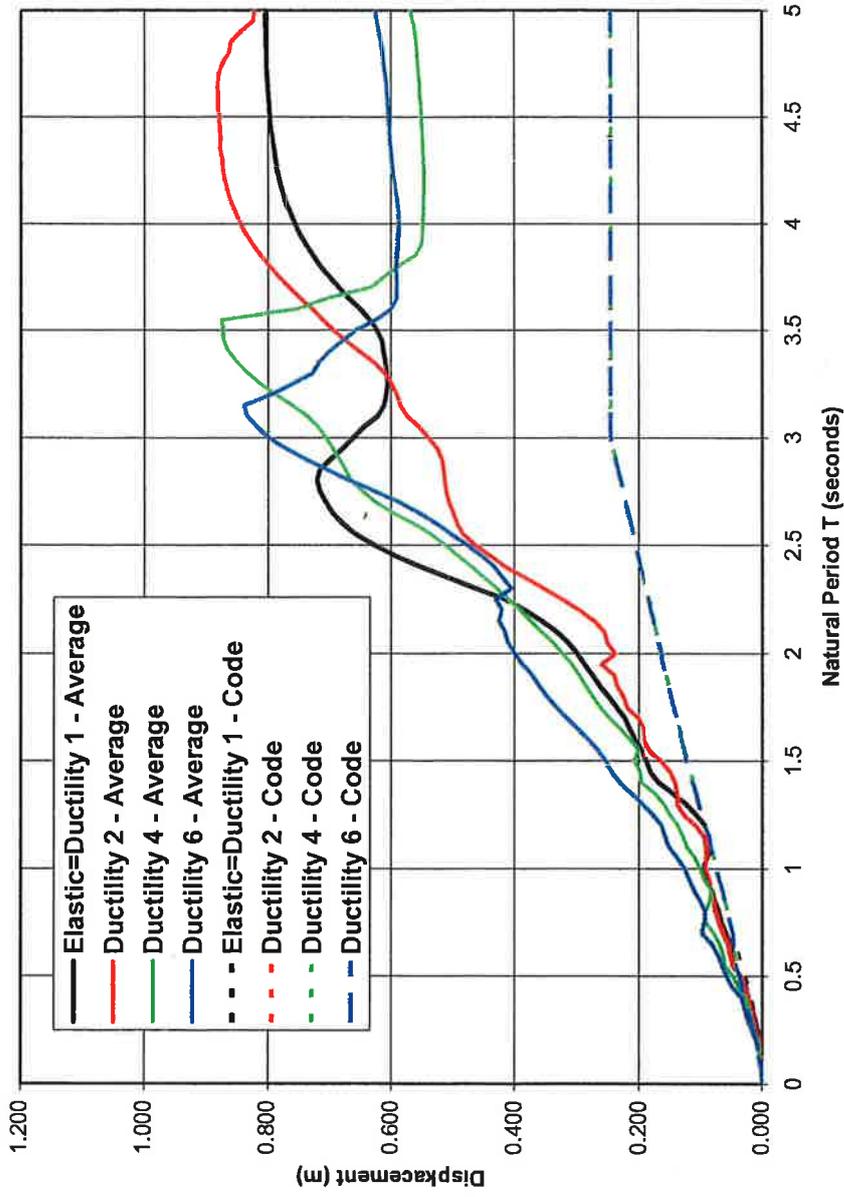
**Figure 46. Average Displacement Response Spectra vs NZS1170.5
Christchurch 4 September 2010
CHHC_N01W, CBGS_S01W, CCCC_N26W, REHS_N02E**

- For the September earthquake see page 40, Figure 46 in the Carr report, the spectral displacement for a ductile structure in the period range of interest is of the order of 700mm in the North South direction, while for the February earthquake, see pages 42 and 108 of the Carr report, the spectral displacements in the East West direction are of the order of 500mm for the bilinear hysteretic model and 450mm for the Takeda hysteretic models.

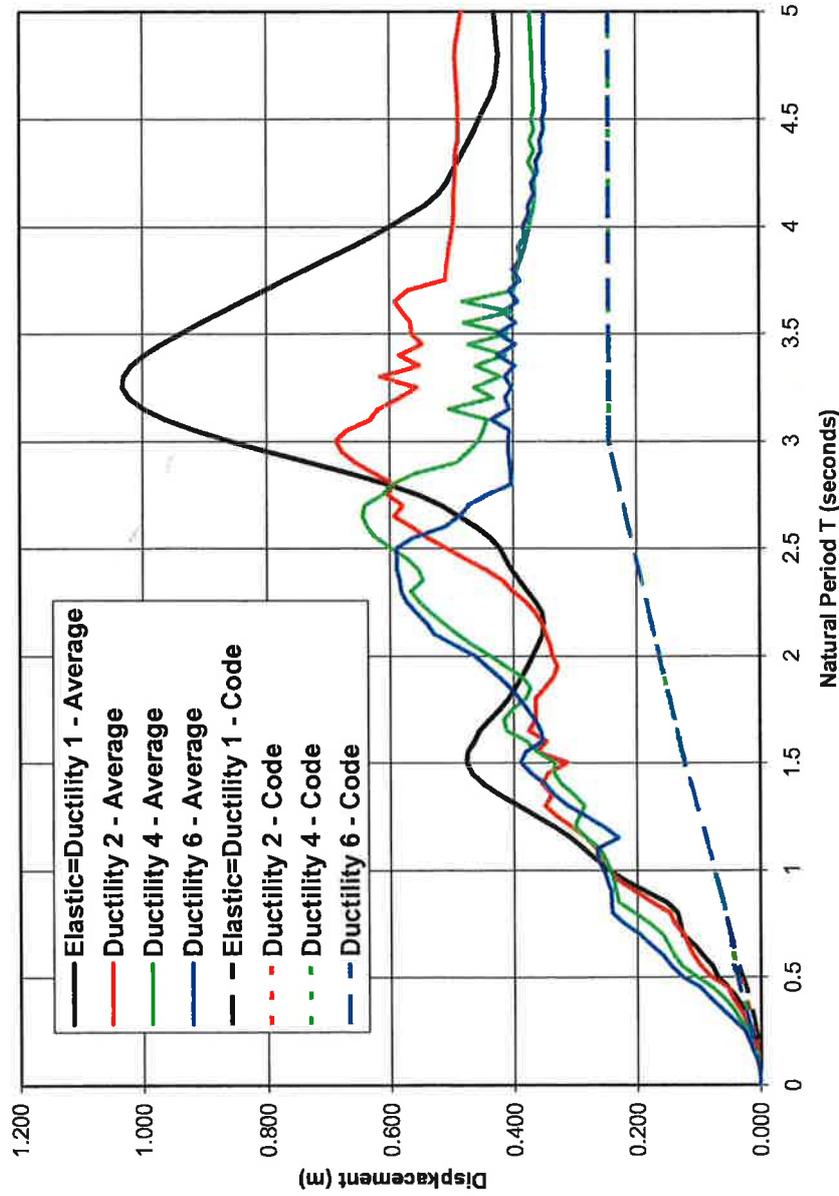
**Figure 49. Average Displacement Response Spectra vs NZS1170.5
Christchurch 22 February 2011
CHHC_S89W, CBGS_N89W, CCCC_N64E, REHS_N88W**

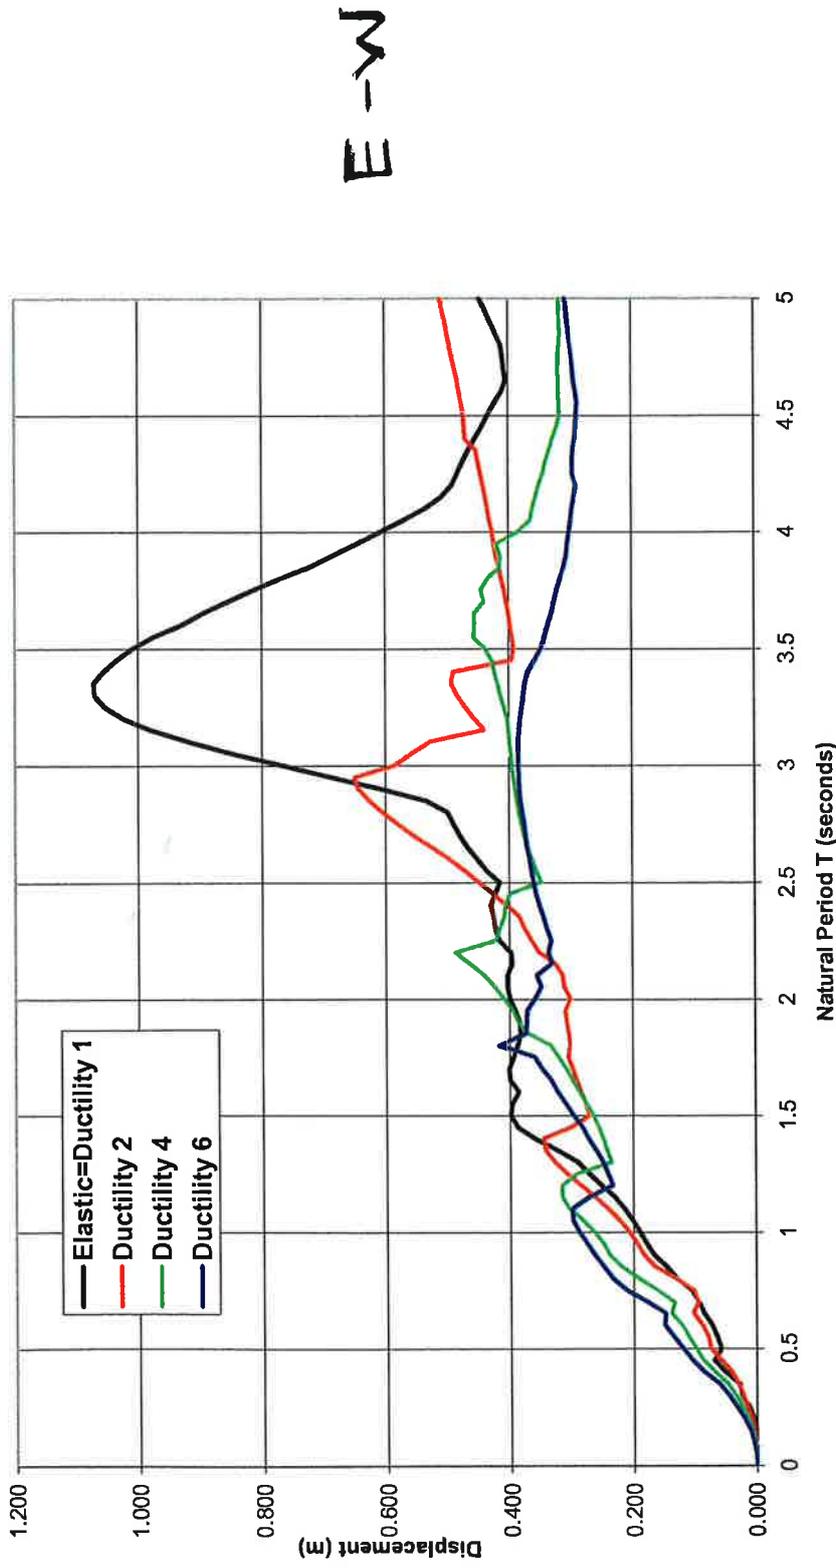
**Figure E-1. Displacement Response Spectra
Christchurch Hospital 22 February 2011- South 89° West Component
Modified Takeda Hysteresis**

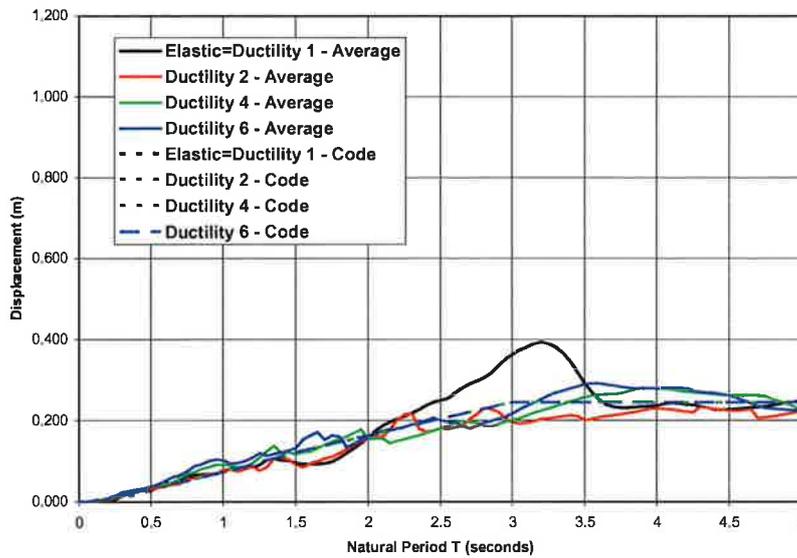
**Figure 45. Average Displacement Response Spectra vs NZS1170.5
Christchurch 4 September 2010
CHHC_S89W, CBGS_N89W, CCCC_N64E, REHS_N88W**

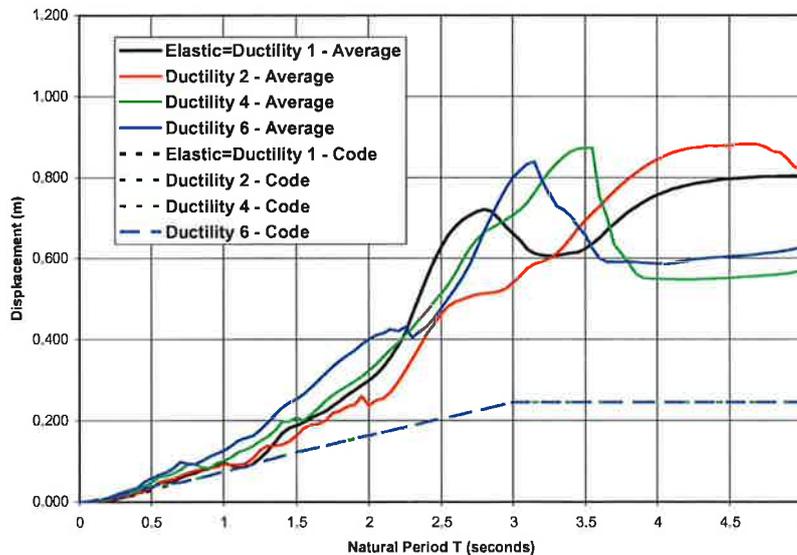
**Figure 46. Average Displacement Response Spectra vs NZS1170.5
Christchurch 4 September 2010
CHHC_N01W, CBGS_S01W, CCCC_N26W, REHS_N02E**
