CTV BUILDING

CTV BUILDING SITE EXAMINATION
AND MATERIALS TESTS
FOR DEPARTMENT OF BUILDING AND HOUSING
16TH JANUARY 2012

REPORT PREPARED BY:
DR CLARK HYLAND
PhD, BE(Civil), BCom, CWE-NZIW, CPEng
Hyland Fatigue + Earthquake Engineering
PO Box 97282, Manukau, AUCKLAND 2241
Phone: (09) 262 0203
Mobile: 021 348 352
Email: clark@fatigueandfracture.com
www.fatigueandfracture.com

Report Issue Date: 16 January 2012

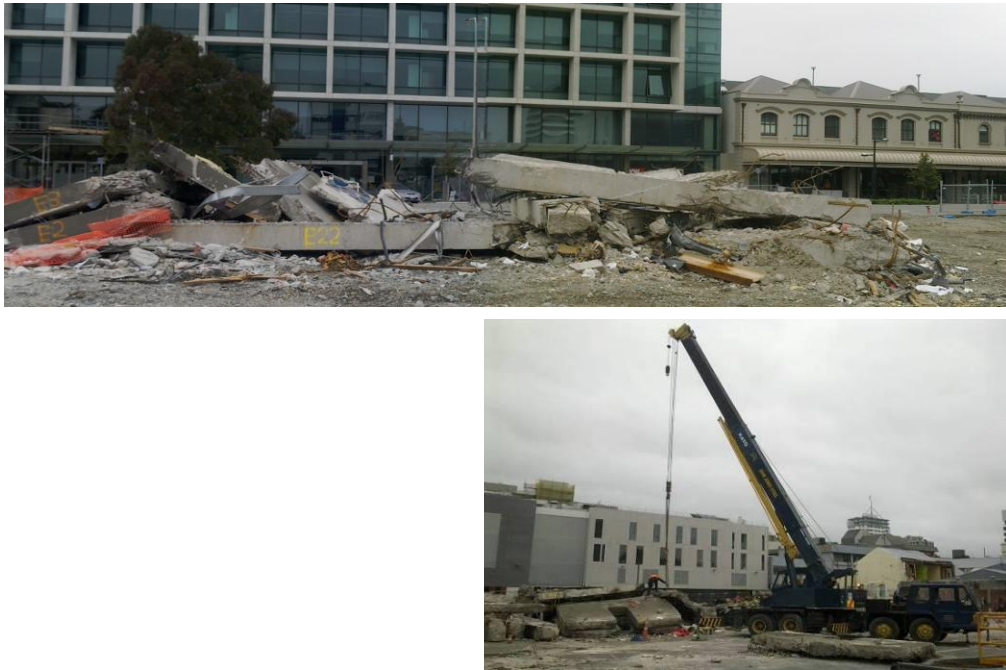
The examination of structural remnants was undertaken by the author and a DBH Engineer, on Saturday 12 March, 2011 (Figure 3). It was then visited again with an engineer from Structuresmith Ltd on 5 April, 2011.

Figure 3 – Structural debris pile on CTV site (top to bottom) (a) At start of Site Examination; (b) Crane used to move debris remnants for examination

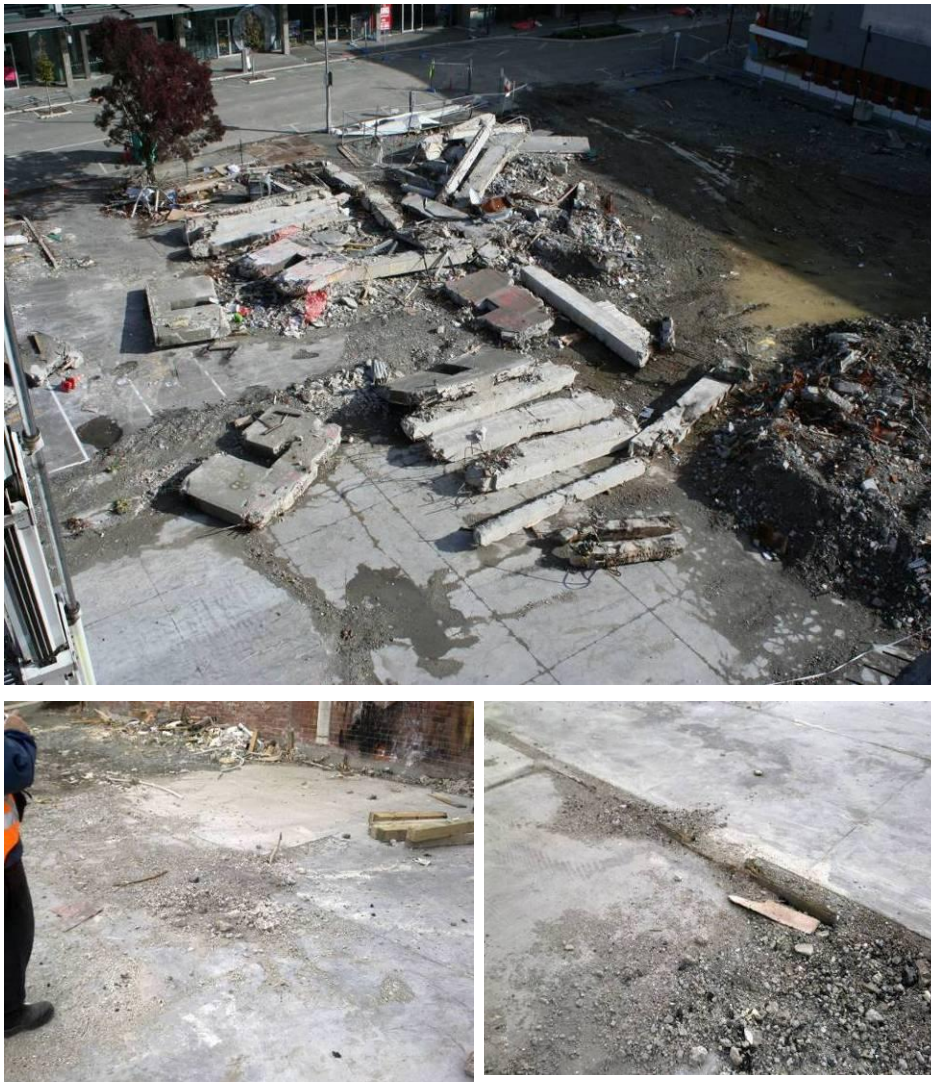
The slab appeared to be in reasonable condition and there weren't any obvious heave or localised damage at column or shear wall locations. A "levels and positional survey" was undertaken to check for signs of settlement and lift core rotation and is reported in Section 3.

Figure 4 - Ground floor Level 1 slab on grade (clockwise from top) (a) View from snorkel of debris and western portion of Level 1 slab on grade; (b) Slab in northwest corner with column reinforcing protruding; (c) Ramp formed in concrete overlay in front of Line 4 lift core walls.

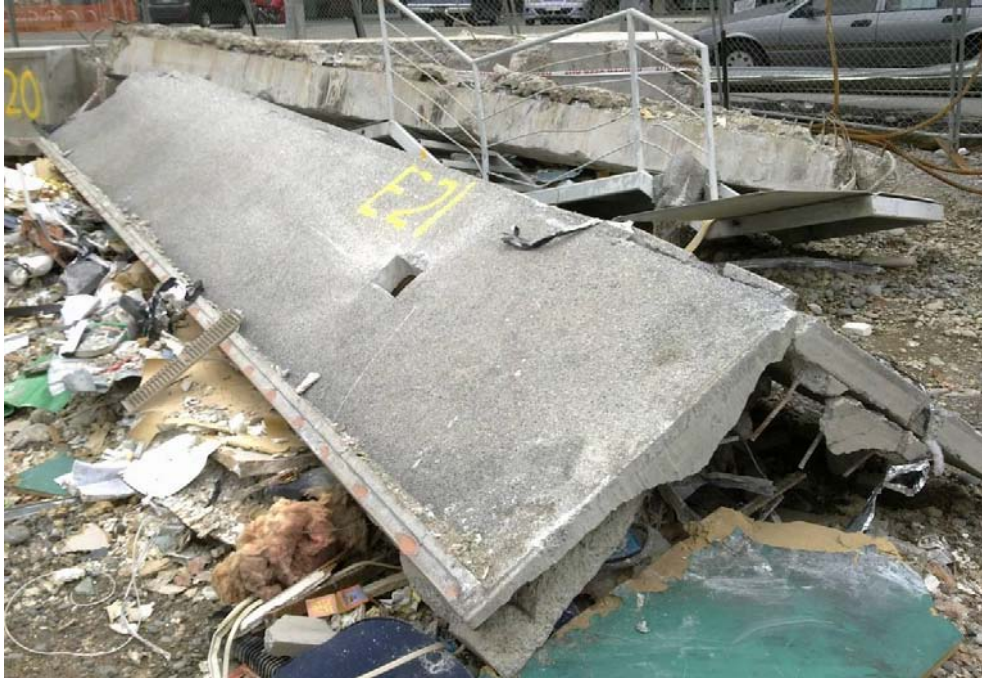
Figure 5 - Pre-cast spandrel panel Item E21 (DENG Dwg S25 (Figure 65))

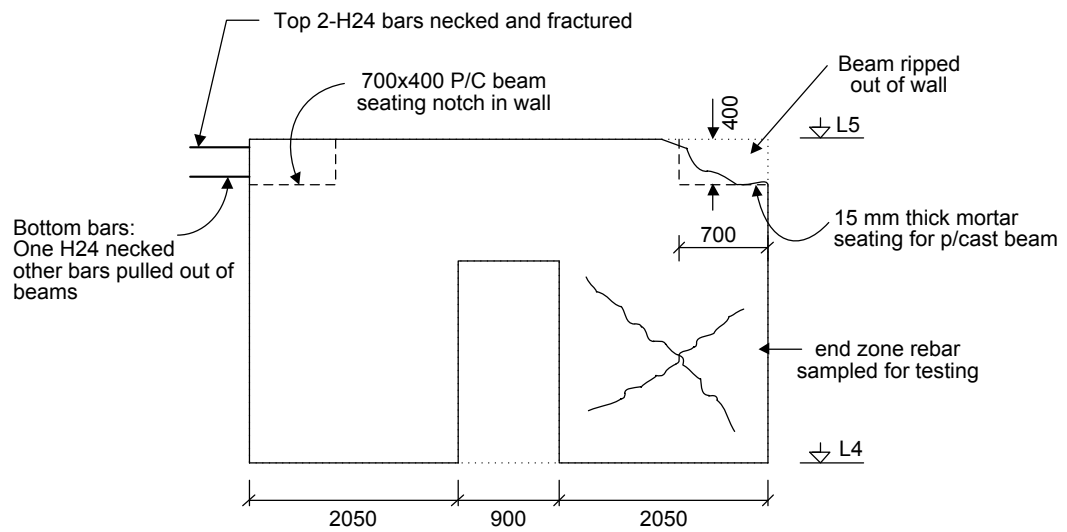
Figure 21 - South Wall Item E4 schematic of damage observed.

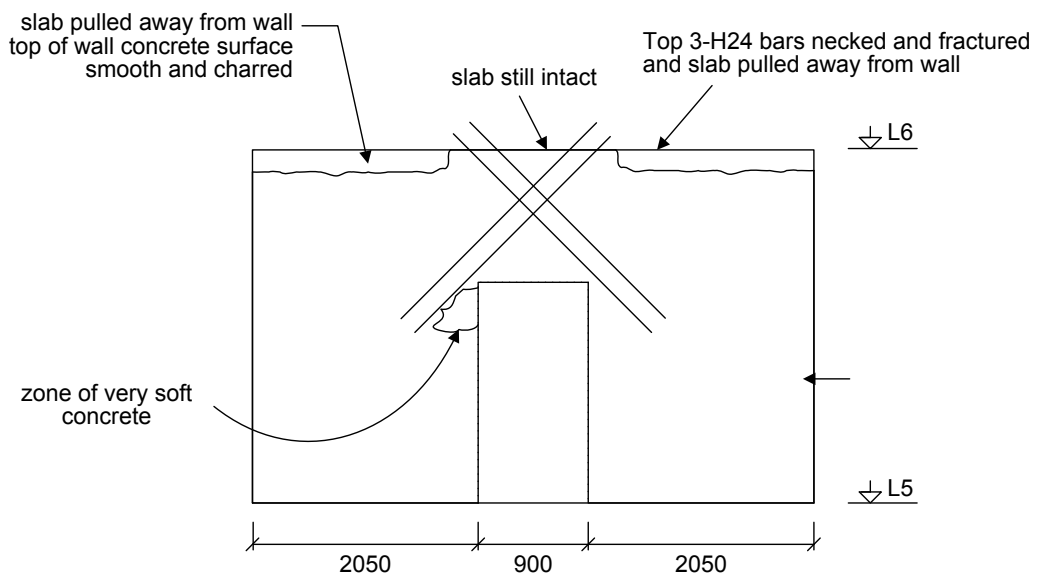
Figure 23 - South Wall Item E5 schematic of damage observed.

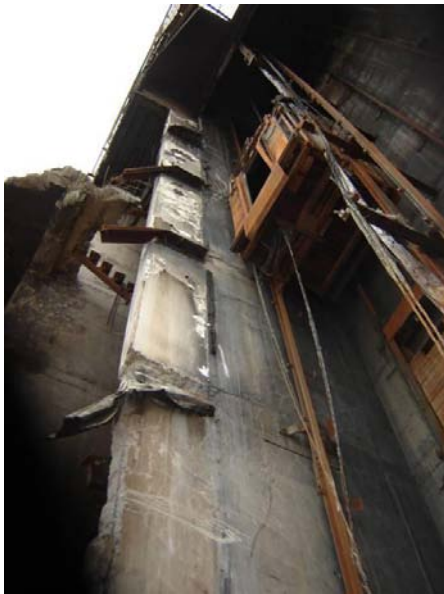
Drag Bars had been fixed into the slab and into the shear walls at Levels 4, 5 and 6 with epoxy grouted threaded anchors after the original construction had been completed (Figure 33).

The profiled metal deck floor slab at Level 4, 5 and 6 had additional Drag Bars connecting it to the north-south wing walls, ("the Drag Bars") on either side of the lift well, sometime after the original construction was completed. Threaded rods had been fixed into the slab with what appeared to be epoxy grout and bolted to the underside of the Drag Bars, as seen in Figure 36 to Figure 40.

Figure 33 - Drag Bar connections at Levels 6, 5 and 4 on lift well west wing wall on Grid D. No Drag Bar at Level 3 or 2 (Figure 32)

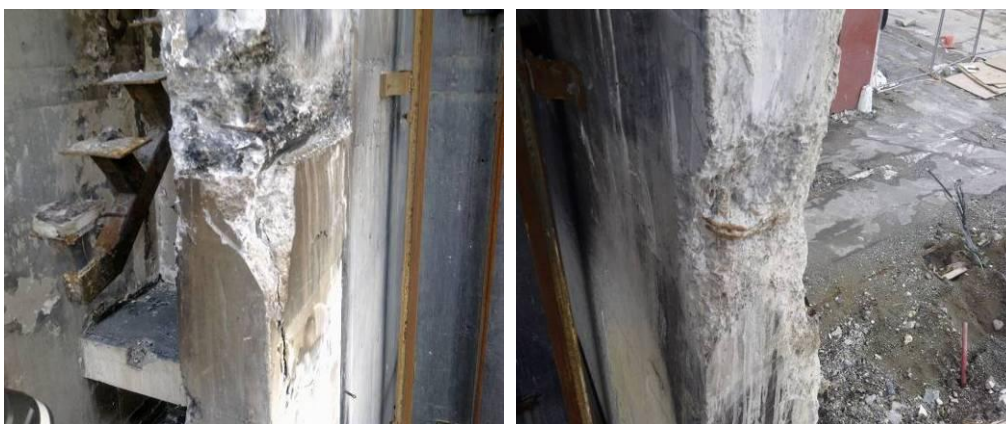
A 20 mm hole was found in the west wing wall D where a reinforcing bar had pulled out (Figure 34).

No reinforcing steel was found to have connected the east wing wall D/E to the slab (Figure 35).

Figure 34 - Level 2 Lift Well Wing Walls Grid D and D/E (left to right) (a) 20 mm hole in end where a reinforcing bar has pulled out of wall. 200 mm thick construction joints in wall at slab level; (b) No reinforcing steel attachment into the east wing wall at Level 2

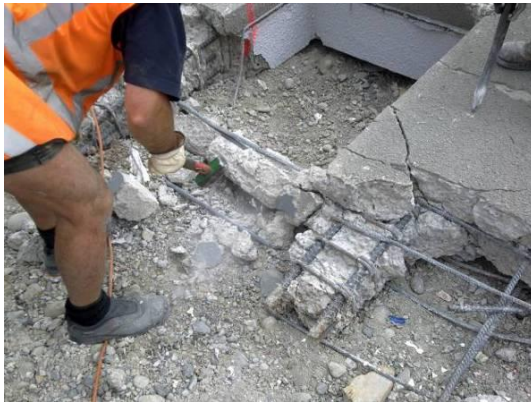
Figure 42 - Line 1 South Wall Item E1 H16 bars from masonry door infill.

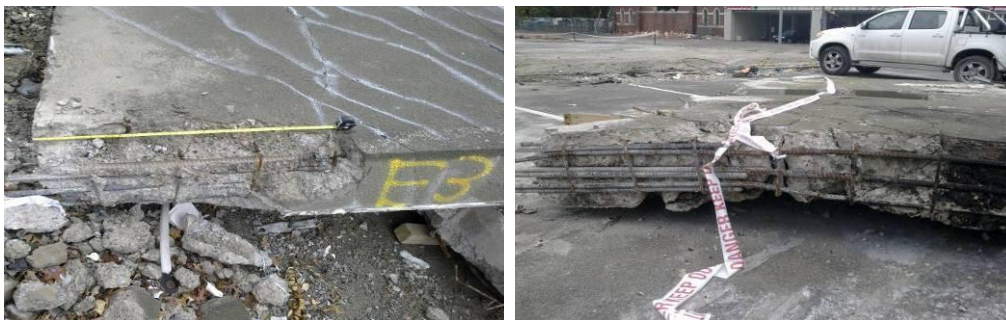
Figure 44 - Locations of H24 reinforcing bar samples (left to right) (a) East end of Line 1 South Wall item E3, one cut from lower 1050 mm of wall; (b) Two lapping bars from lower E3 wall item taken from east end of wall item E4

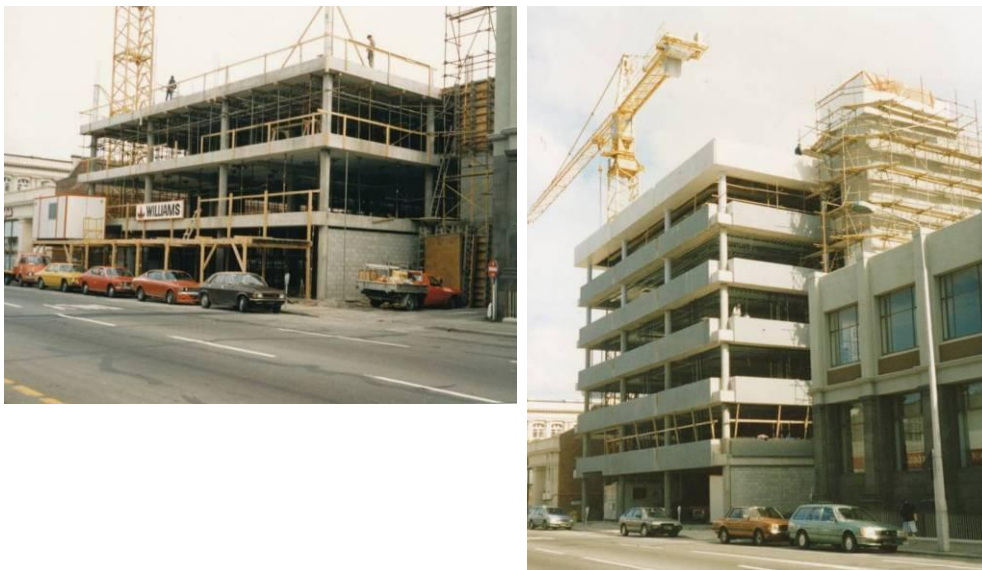
The specified concrete 28-day strength for these two Level 1 columns was 35 MPa at 28 days according to the Specification. However the mean strength was 24.9 MPa (26.9 MPa when adjusted for test orientation) based on the Rebound Hammer tests, so appeared to have not complied with the requirements for 35 MPa concrete. Photos, taken by a member of the public during construction, show that these columns were not cast at the same time as the other Level 1 columns (Figure 45).

Figure 45 - CTV Building under construction (left to right) (a) May 1987 with floors cast up to Level 4; (b) October 1987 with roof on and pre-cast spandrel panels attached; Columns C21 to C23 had not been built at that time in the northeast corner closest to camera.

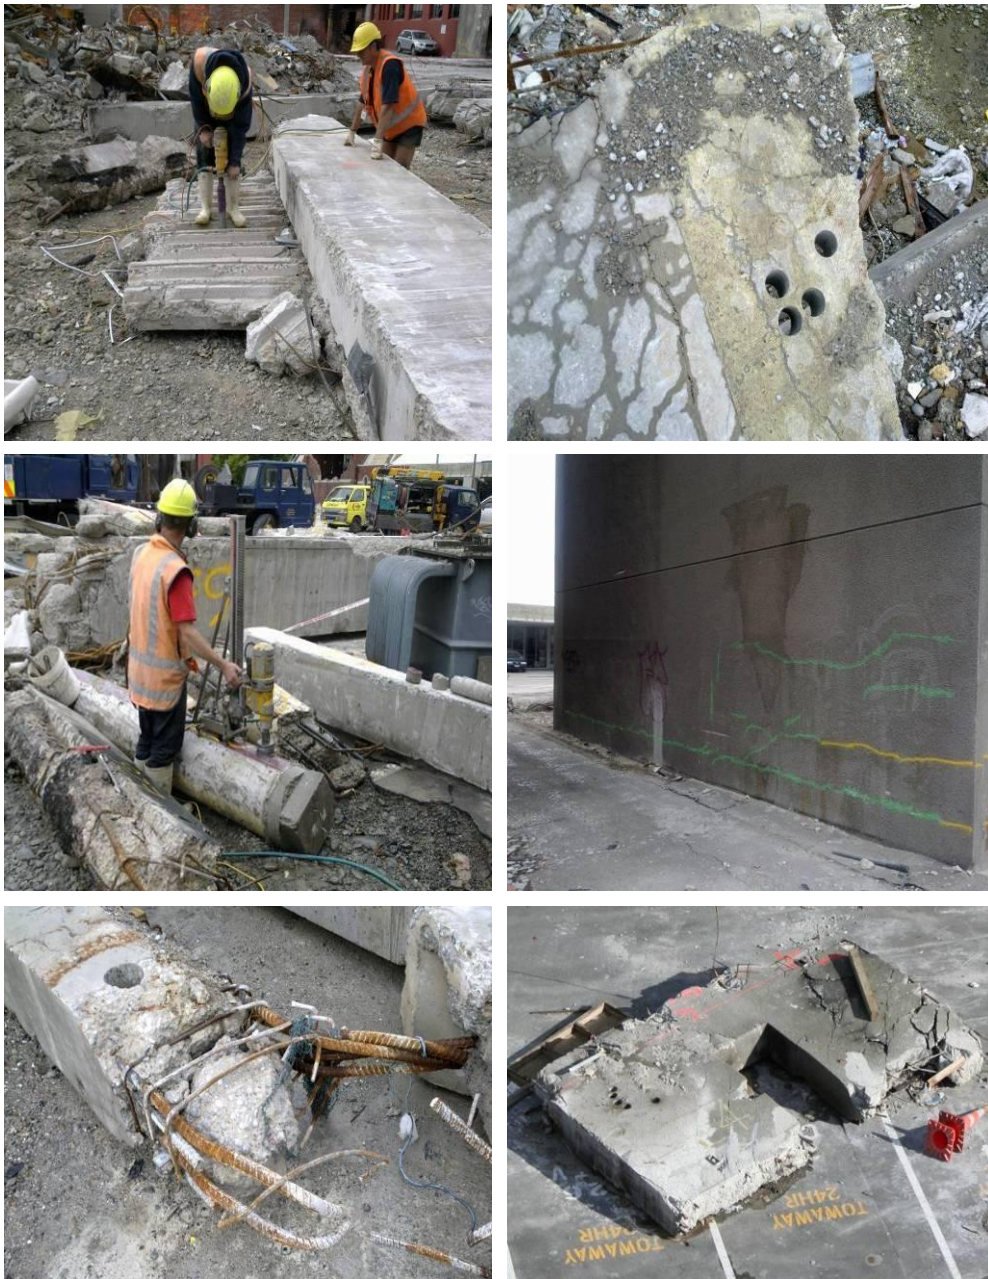
Concrete cores were extracted at the CTV site from suspended slabs in two locations (Item E14 and E23); the Line 5 wall at Level 1 of the North Core; the Line 1 South Wall between Level 4 and 5 (Item E4); the 400 mm diameter column between Level 6 and 7 (Item E25) (Figure 46); and the Level 1 400 mm square column from Line 4 – D/E (C18) stub (Figure 47).

Figure 46 – Locations of concrete cores taken for testing (clock-wise from top left) (a) Slab attached to Line 1 or 4 perimeter shell beam (Item E23) (b) Slab attached to Line 4 perimeter shell beam (Item E14); (c) Line 5 shear wall through stair well at Level 1; (d) Line 1 South wall Level 4 to 5 (Item E4); (e) Pre-cast log beam from Line 2 or 3; (f) Level 6 400 mm diameter column (Item E25)

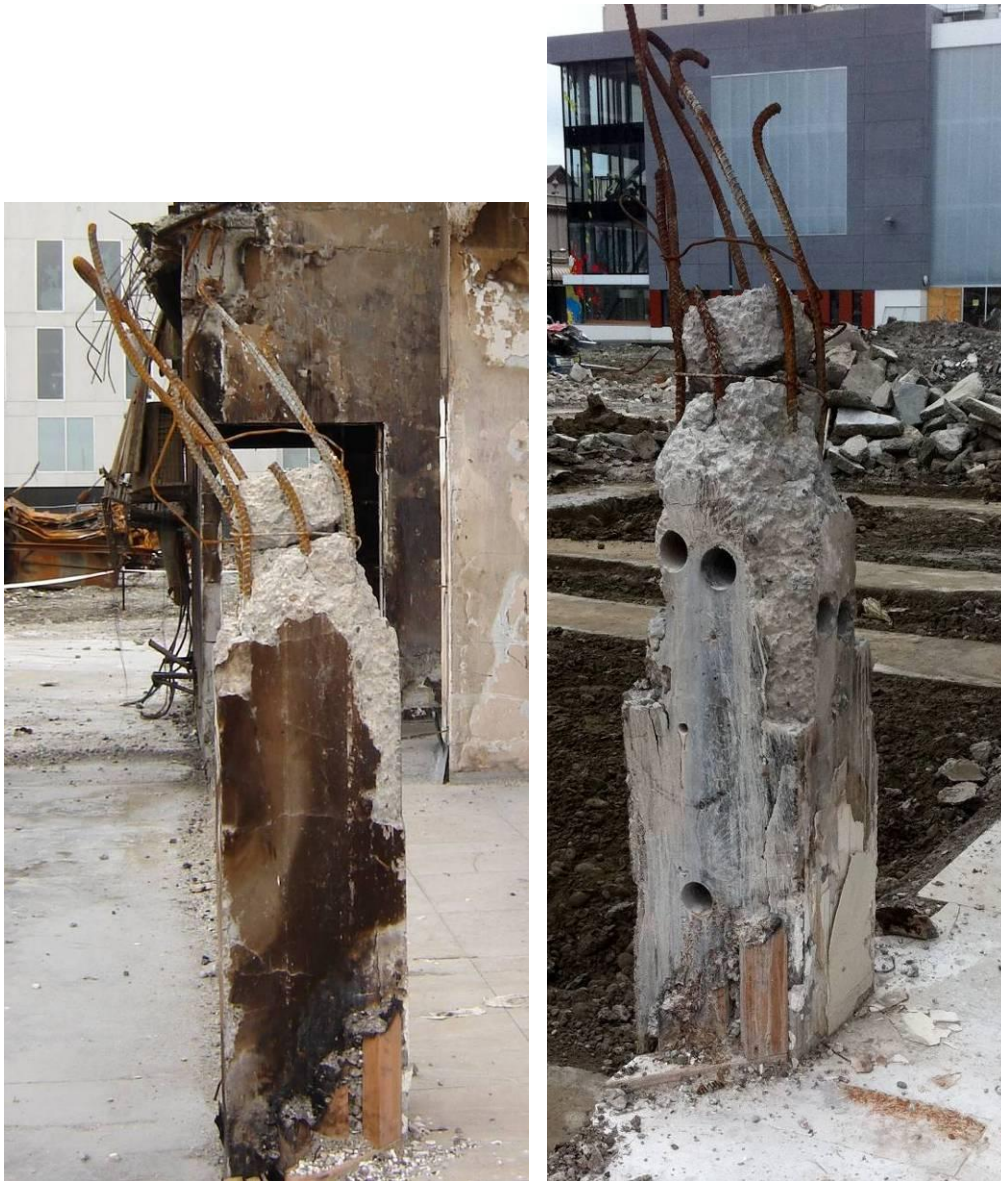
All the concrete columns had been removed to floor slab level except for a 400 mm square column stub C18 stub adjacent to the east end of the lift core walls (Figure 47).

Figure 47 – Locations of concrete cores taken on site for testing on column C18 on Line 4, adjacent to wall D/E

In conclusion, at the time of the tests, subject to there being no detrimental effects on the concrete test samples from heat from the post-collapse fire, the Level 1 400 mm square column concrete would not have complied with the requirements of concrete with the specified 28-day strength of 35 MPa nor 15 MPa. However it is recognised that this remnant had been affected by heat and collapse damage.

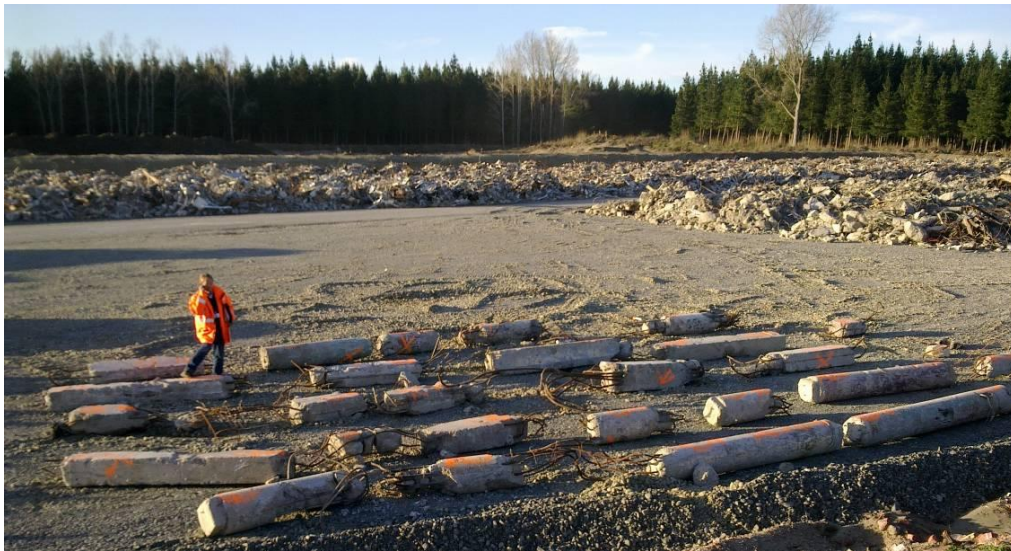
Thirteen 400 mm diameter circular and twelve 400 x 300 mm rectangular concrete column remnants were extracted from the CTV debris located in the specially designated area at the Burwood Eco landfill (Figure 48).

Figure 48 - CTV Columns remnants extracted from the Burwood Landfill CTV debris (at right) for Schmidt Hammer testing and coring. Full height and partial height remnants can be seen.

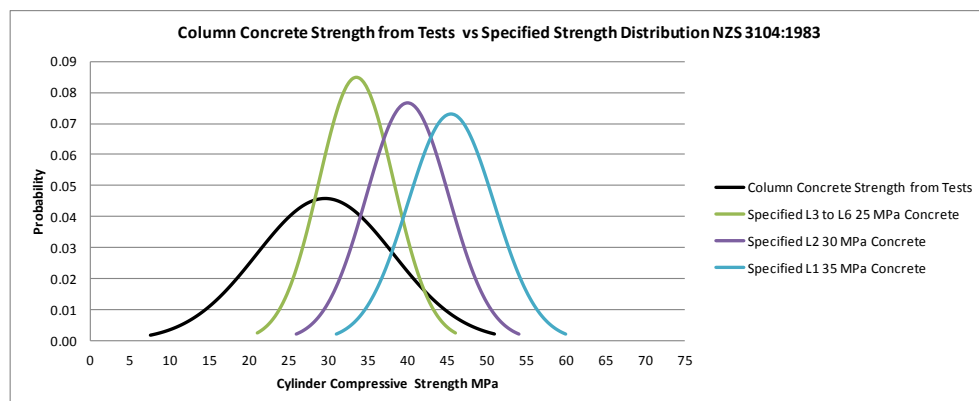
The strength distribution assumed for ready –mixed New Zealand concrete 28-day strengths at the time of the CTV Building construction was NZS 3104:1983 Table 5 (SNZ 1983). This is plotted in Figure 51 with the actual test strength distribution.

Figure 51 Column strengths from tests adjusted 8% for test orientation vs 28-day concrete strength distribution according to NZS3104:1983

This indicates that at the time of the testing the column remnants from Levels 1 to 6 had mean concrete strength consistent with that of concrete with specified 28-day strength of 20 MPa (Figure 51 and Figure 52). This is less than the minimum specified concrete 28-day strength of 35 MPa for columns at Level 1; 30 MPa for columns at Level 2; and 25 MPa for columns from Level 3 to Level 6.

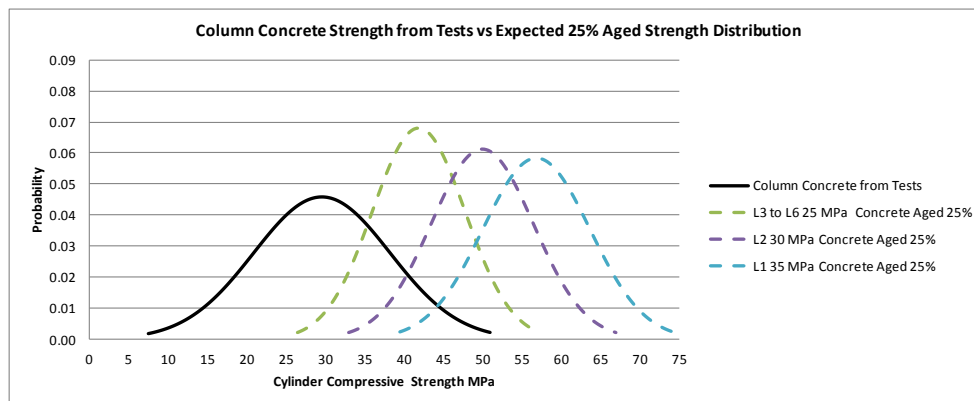
The statistical properties of the same concrete strength-aged were derived by application of a factor of 1.25 to the mean and standard deviation of the 28-day strength properties (Table 3). The 28-day strength properties strength-aged by 25% are plotted in Figure 52 with the actual test strength distribution.

Figure 52 Column test strengths adjusted 8% for test orientation vs 28-day concrete strength distribution according to NZS 3014:1983 strength-aged by 25%

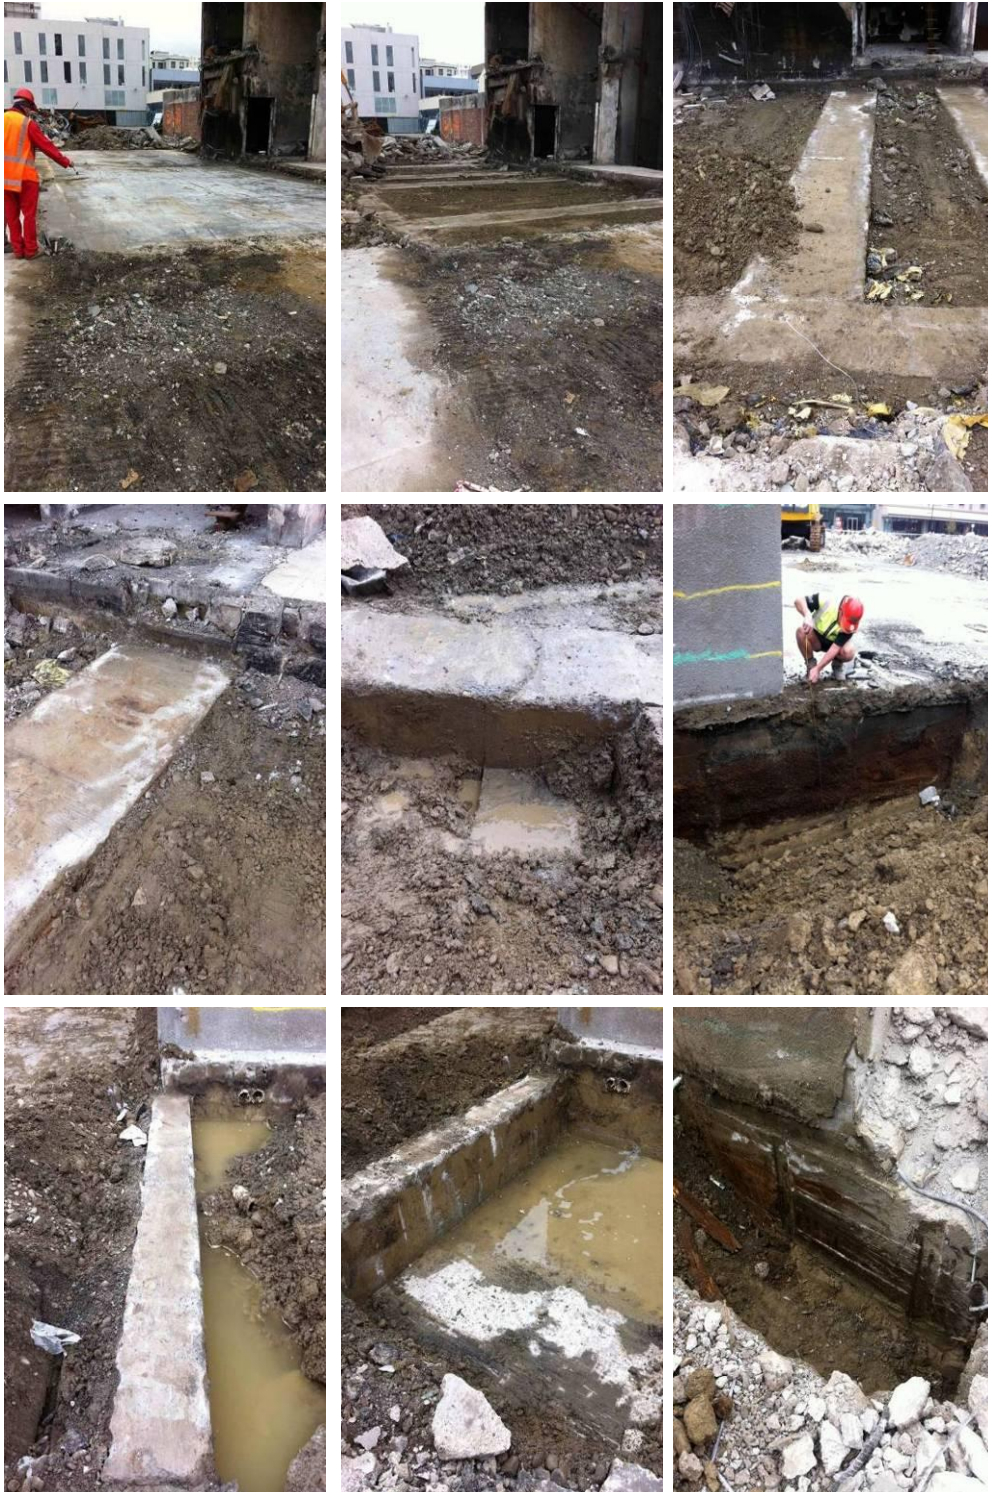
The following are notes for the photos during the inspection by a CERA engineer in Figure 60. The location at which the photos were taken is shown in Figure 59.

Figure 60 - Foundation Inspection (From left to right in rows from top) (a) P947; (b) P948; (c) P968; (d) P971; (e) P960; (f) P903; (g) P964; (h) P919; (i) P993

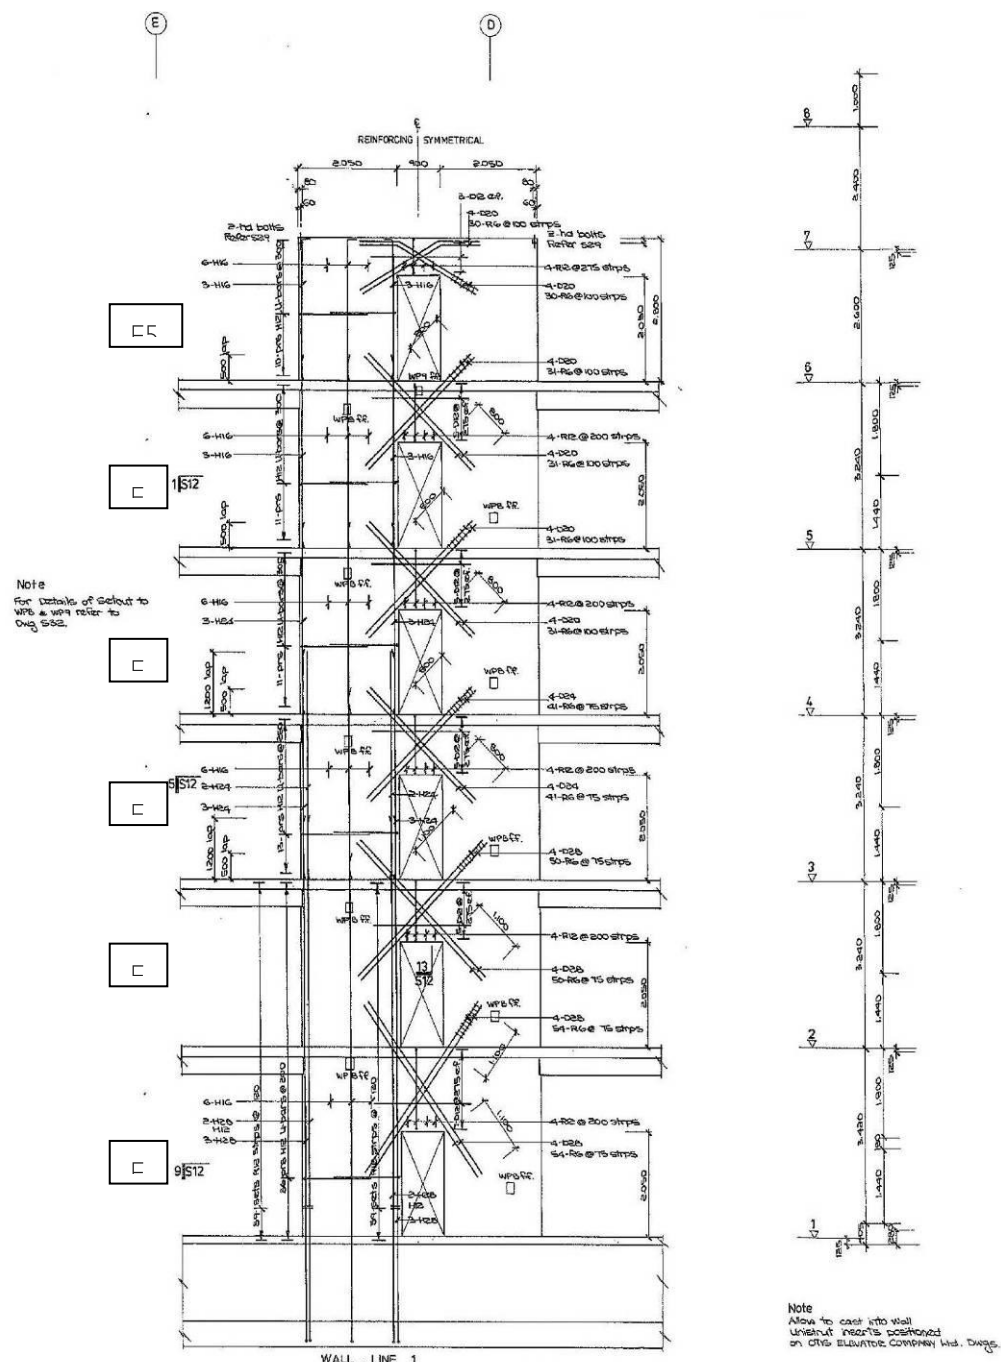
The Line I South Wall that extended from Level 1 on the ground to the roof had been broken up into single story components during de-construction (Figure 74).

The Line 1 South wall ran full height from Level 1 to the Roof. During deconstruction the wall was broken into six floor to floor portions and labelled E1 to E5A. The number refers to the level at the bottom of the wall portion, except for E5A which was located on Level 6 (Figure 74).

Figure 74 - Line 1 South Wall with Items E1 to E5A identified (Extract from DENG Dwg S10)
