**INDEPENDENT ASSESSMENT ON EARTHQUAKE PERFORMANCE
OF**

WESTPAC TOWER – 166 CASHEL STREET

**Royal Commission of Inquiry into building failure caused by the Canterbury
Earthquakes**

**Report prepared by Peter C Smith and Vaughan England
Spencer Holmes Limited**

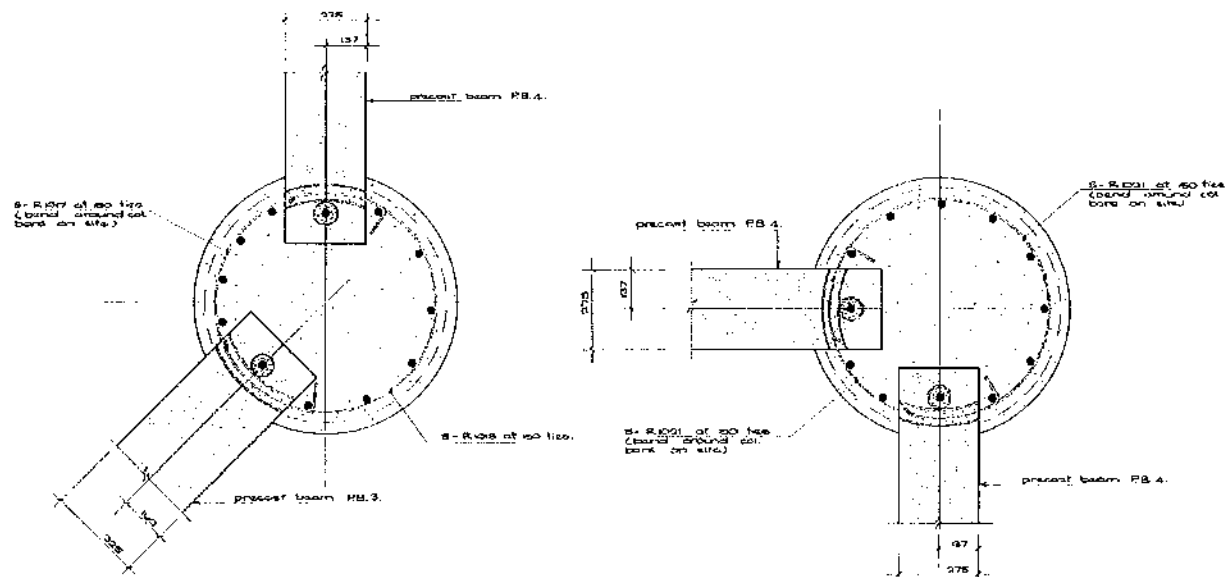
Pre-cast truss to column details from drawing 936 / S48

The external feature truss elements extend into the 900mm dia columns on the exterior of the building. Refer details below. As the seating for the pre-cast trusses extends through the spiral, the pre-cast truss units are detailed with curved ducts to allow the column spiral to pass through the end of the pre-cast truss sections. This reinforcement was placed once the truss units were in their final position. A longitudinal column bar is placed through a duct in the pre-cast truss and the spacing of column bars is increased at the precast truss locations.

The presence of construction joints within the columns at the pre-cast truss column junction created by seating the ends of the pre-cast trusses on the 900mm circular columns during construction of the building contributed to the extent of damage at the pre-cast truss- 900mm dia column connections. Continuing the spiral column reinforcement through the depth of the truss by use of spirals proved reasonably effective in protecting the column at the joint, but the weakness induced through the projection of the pre-cast truss into the column reduced the resilience of the joint. Testing of the concrete to the circular in-situ columns established concrete strength in the order of 20-25MPa. The concrete strength to the precast truss is yet to be tested but it is expected that the concrete strength of the trusses was approximately double that of the columns. The significant difference in strength combined with the projection of the truss into the column is assessed to have significantly contributed to the damage that occurred to the pre-cast truss-columns at the joint.

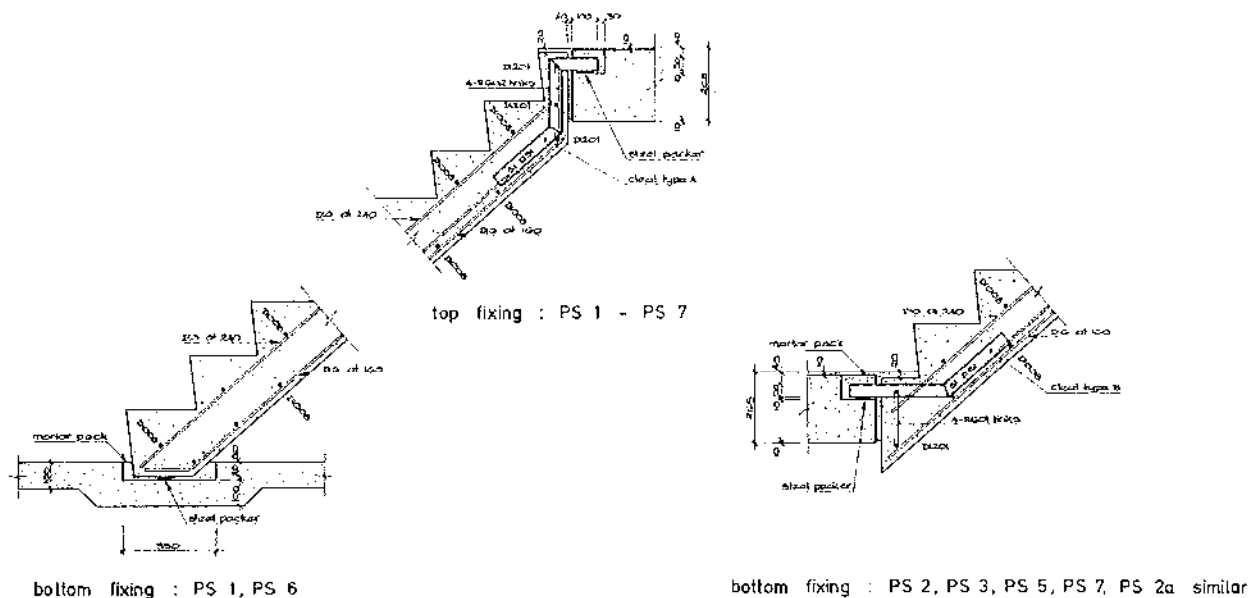
Details from drawing 936 / S70

The main stairs are located within the shear core. They are constructed of single flight pre-cast reinforced concrete. The stairs incorporate 51 x 4mm steel CHS legs embedded in the pre-cast unit and these legs are seated and mortared into pockets formed at the in-situ concrete slab edge. The details provide little provision for inter-storey deformations.

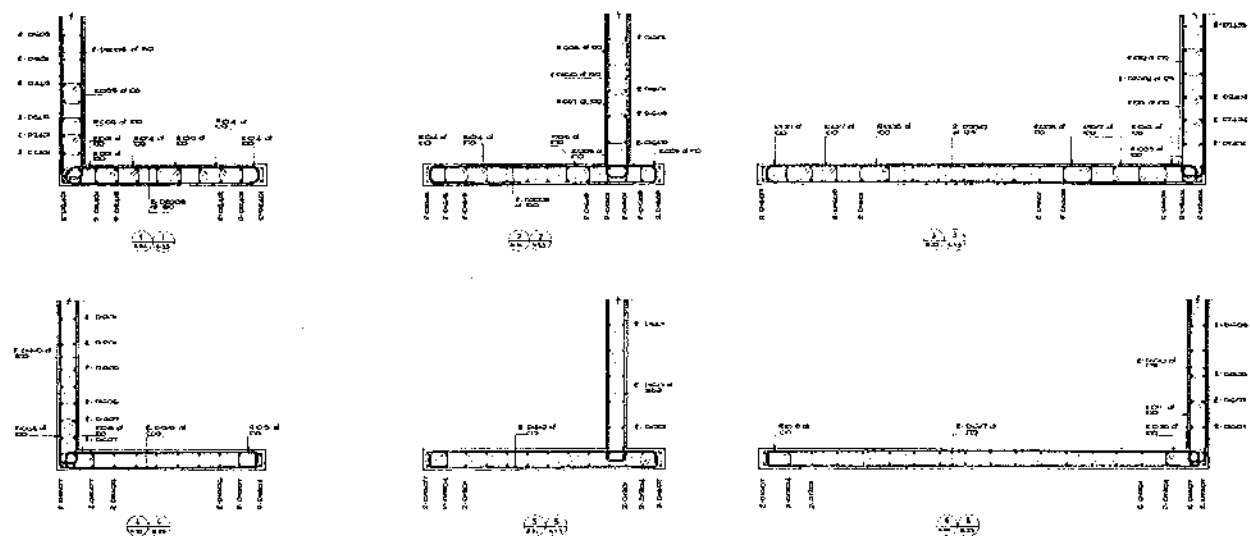
Detail drawing 936 / S35

Buckling of the main tensile reinforcement occurred in the areas of greatest inelastic deformation. (Refer Photos in Appendix 3). The importance of maintaining stirrup spacing at distances that prevent buckling of longitudinal reinforcement is obvious. The spacing of stirrups in the area of main reinforcement buckling was measured as 120mm. The longitudinal reinforcement size that buckled was 16mm deformed bar (D16), giving a relative spacing of 7.5 diameters. The spacing of lateral restraint reinforcement detailed on the plans was 100mm, or 6.25 diameters, which is close to the current code requirements of 6 diameters. Refer photo in Appendix 3. The difference of 20mm emphasises the importance of engineering inspection of those aspects of construction that are critical to achieving the inelastic performance necessary to achieve the design level of ductility. As the performance of the building under seismic loading is determined by the widest spacing of stirrups in the areas of inelastic demand, consideration should be given to all areas of expected inelastic deformation being inspected and approved to level CM4 construction monitoring.

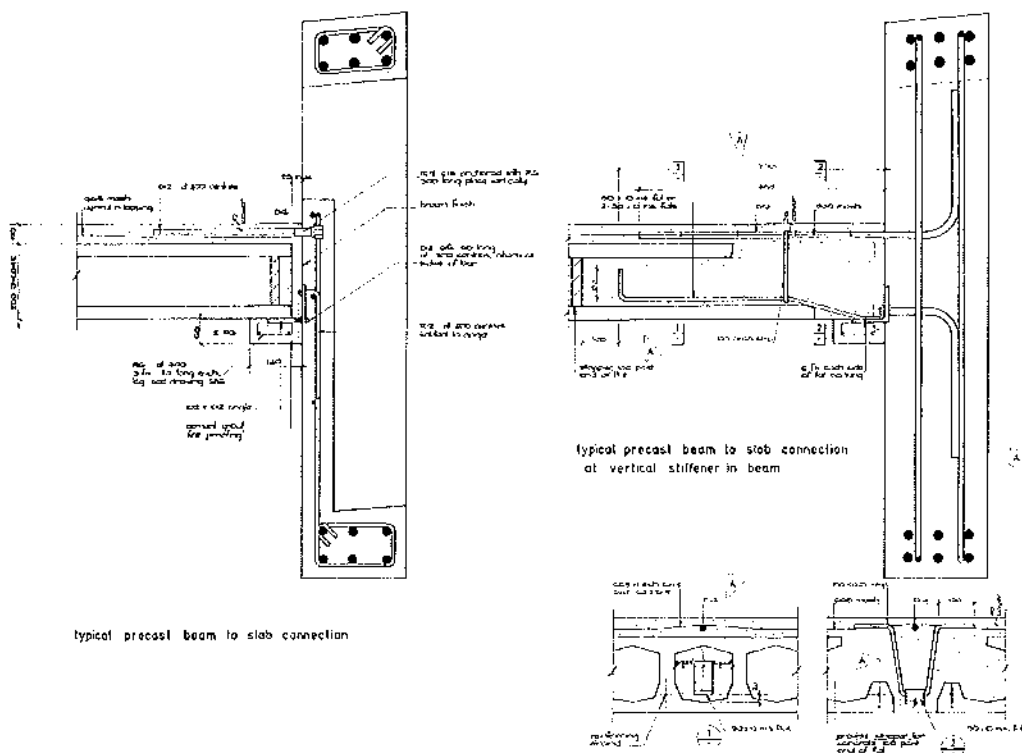
Dycore seating on trusses from drawing 936/S68

Outward movement of the 900mm diameter columns due to inelastic deformations at the pre-cast truss-column interface has also caused outward movements between the truss and the floor over a distance of several metres either side of the columns. This movement has likely caused a failure of the 50mm deep inserts embedded in the 100mm thick up-stand of the pre-cast trusses, or failure of the starters threaded into the inserts under the forces induced through inelastic deformations at the truss-column connection. Furthermore, the use of shallow inserts or inserts embedded in thin singly reinforced concrete elements in such situations is not recommended.

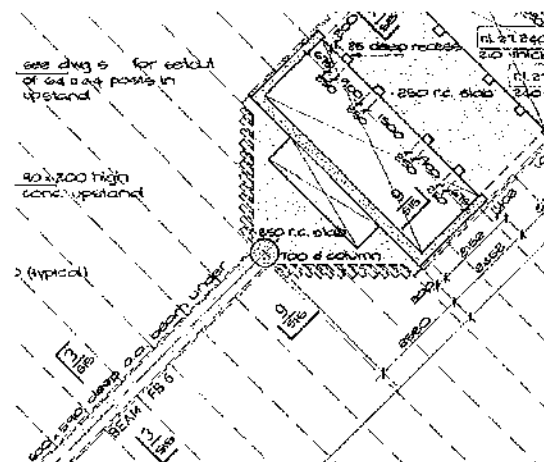
Area of in-situ concrete slab adjacent to shear core on drawing 936/S15

A 590mm deep by 600mm wide reinforced concrete beam spans from the external columns at the northwest and southeast ends of the hexagonal floor plate, and terminates at the 700mm diameter internal columns at the northwest and southeast of the shear core. An in-situ wedge of 250mm thick floor provides the support of the Dycore over the span from the internal column to the shear core. Refer drawing 936/S15. The in-situ slab adjacent to the northwest and southeast ends of the shear core is penetrated by a 3200mm by 700mm services duct so that the Dycore is in effect supported by a strip of 250mm thick in-situ slab between the outer corners of the shear core and the internal 700m diameter column.

The presence of the duct opening and the displacements imposed on the in-situ slab due to displacements of the shear core have resulted in damage to the in-situ slab, the integrity of which is important to the support of the adjoining Dycore floor units. Areas of gravity support need to be detailed to accept displacement-induced deformations under severe seismic events.

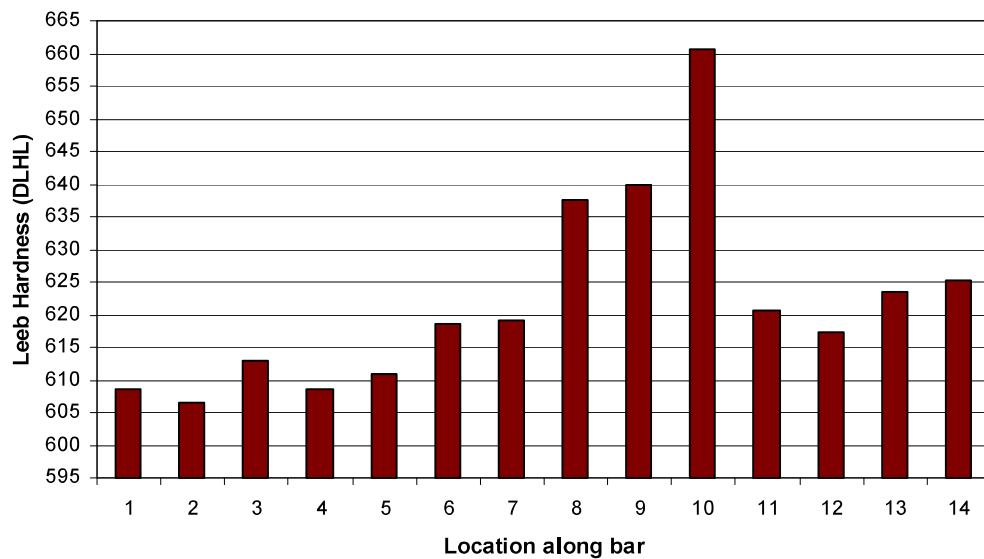
Figure 11 Leeb Hardness result for Vertical Bar 2 in zone of damage

The Leeb hardness results for the Vertical Bar 2 shows a peak elevated hardness value of 660 DLHL approximately mid way along the length of tested steel. This zone of elevated hardness coincides with the location where the reinforcing bar crosses a significant crack in the wall element. The zone of elevated hardness occurs over a length of approximately 35-40 mm, equivalent to 2 times the diameter of the reinforcing bar. Based on the derived correlations obtained from the undamaged reinforcing bars, this level of Leeb Hardness indicates that the steel has previously been strained to approximately 10% strain. This level of induced strain indicates that the steel has lost approximately 75% of the available strain capacity, and can only undergo an additional 5% strain before fracturing. Based on the short zone observed to have an elevated hardness, this would equate to approximately 2 mm of elongation over a 40 mm length prior to fracture.

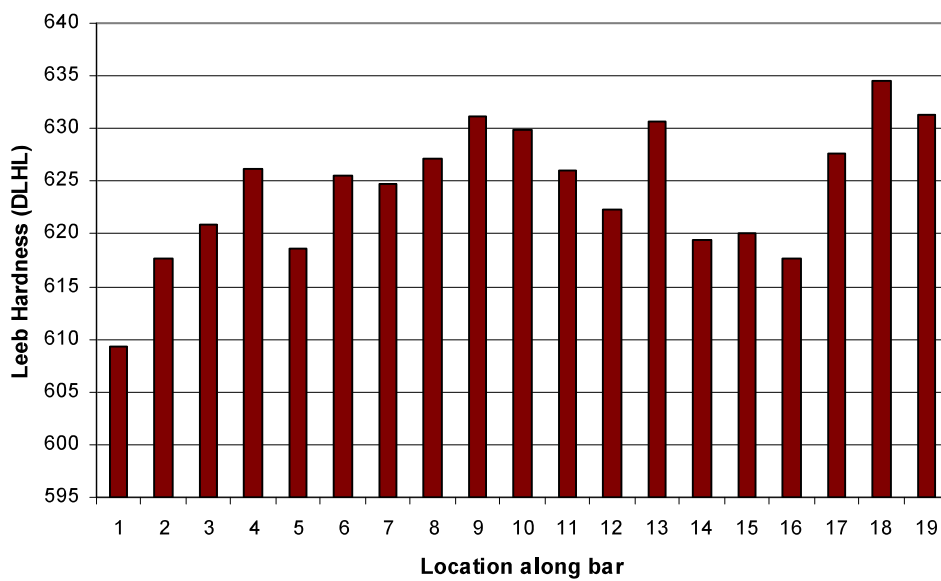
Figure 12 Leeb Hardness result for Horizontal Bar 2 in zone of damage

The Leeb hardness for the Horizontal Bar 2 shows signs of moderately increased strain hardening over lengths of approximately 75-100 mm. Based on the correlations between Leeb Hardness and strain obtained previously, it is suggested that this steel sample has been previously strained to 2%.

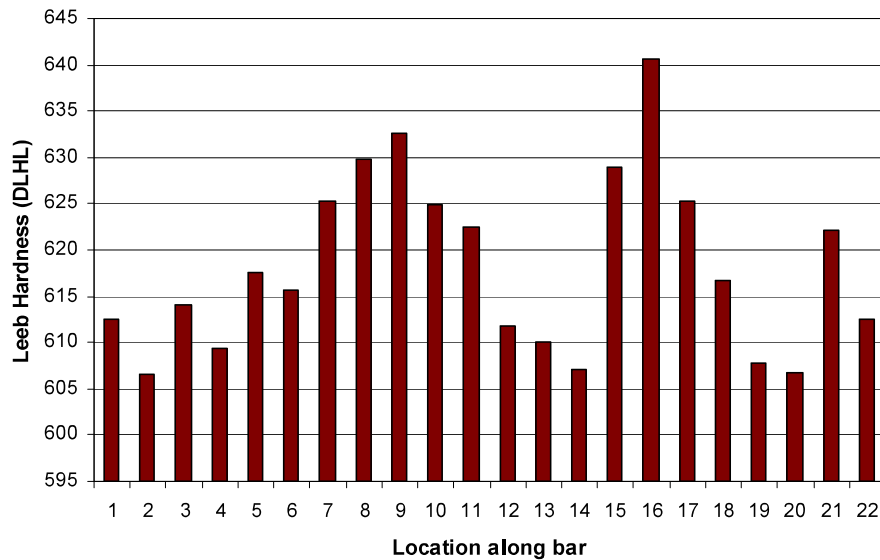
Figure 13 Leeb Hardness result for Vertical Bar 3 in zone of damage

Vertical reinforcing Bar 3 shows two zones of increased hardness, corresponding to two cracks observed to cross the steel in the wall element. The first zone of elevated hardness is relatively wide, indicating that any yielding of the steel occurred across a relatively long length on the bar. The second zone of elevated hardness has a maximum recorded Leeb value of 640 DLHL and appears to occur over a relatively short distance. This level of hardness indicates that the steel was previously

strained to approximately 5%. The results for Horizontal Bar 3 are similar to the previous horizontal bar with Leeb hardness values suggesting the steel was subjected to inelastic strains of approximately 2% over a relatively long length of the steel.

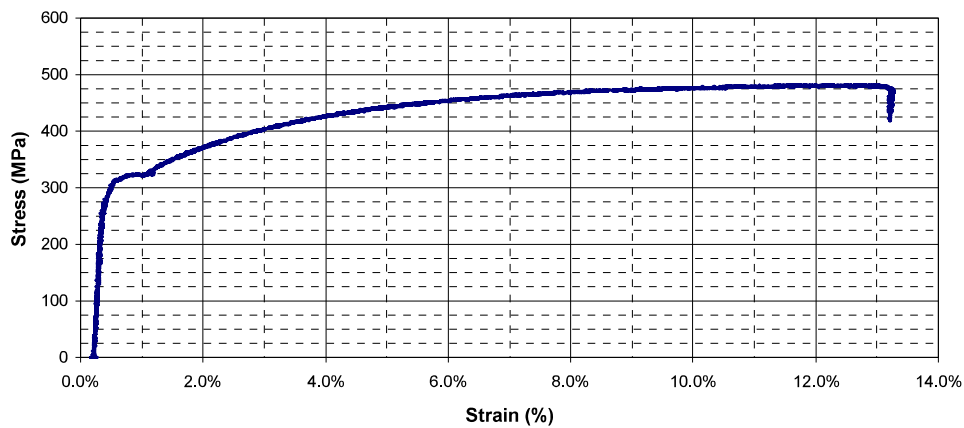
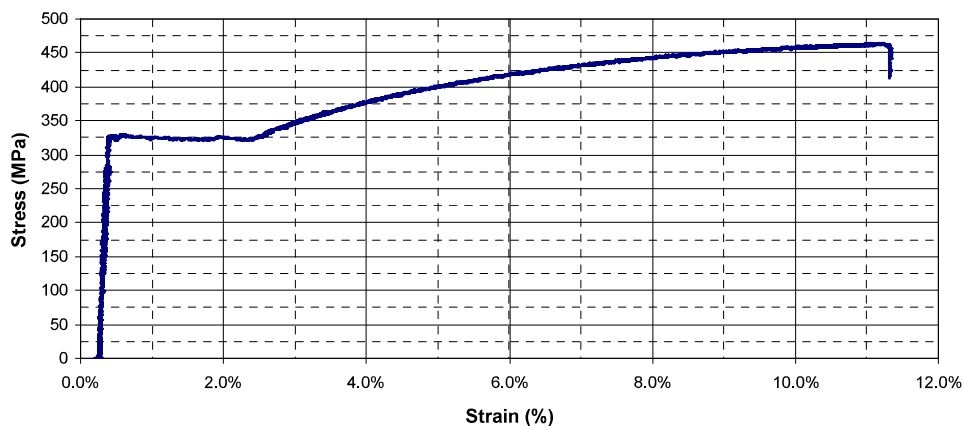
The vertical steel sections were found to have considerable lower uniform elongation capacity when compared to the horizontal steel section, with actual elongation capacities between 11% and 13%. This result indicates that the steel has lost strain capacity due to being exposed to previous cycles of inelastic loading. The yield strength of the vertical steel sections was found to be 319 MPa and 330 MPa respectively.

Figure 15 Stress-strain response for vertical steel section located in damaged zone

Figure 16 Stress-strain response for vertical steel section located in damaged zone

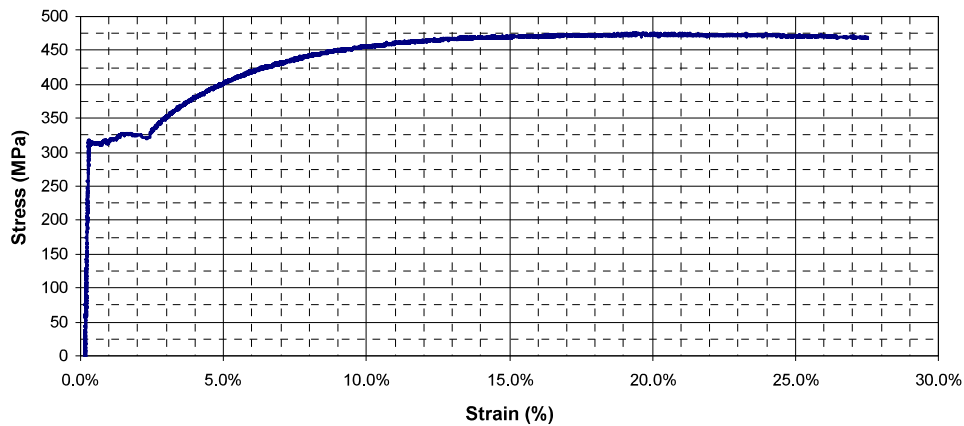
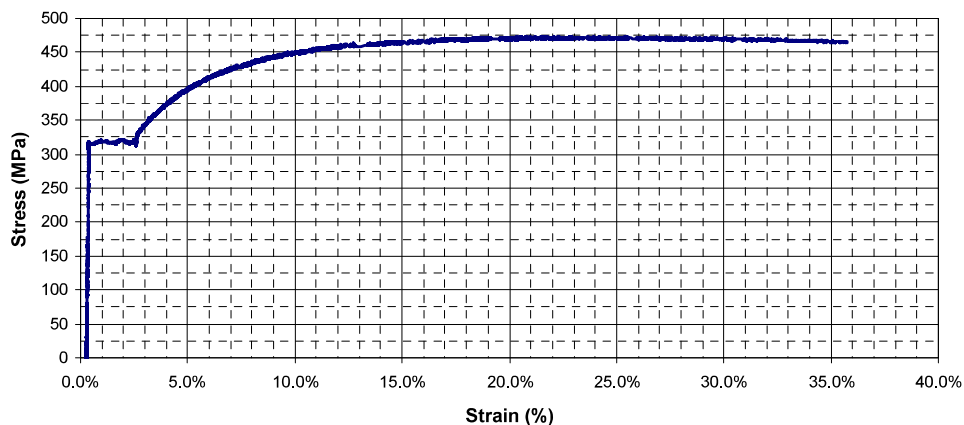
A further 4 reinforcing bar samples were removed from the building and subjected to destructive tensile testing. The results from the testing are shown below. The results indicate that the horizontal steel remained undamaged during the earthquake, with recorded uniform strain capacities in excess of 33%. The yield strength of the tested horizontal steel samples was found to be 314 MPa and 315 MPa respectively.

Figure 17 Stress-strain response for horizontal steel section located in damaged zone

Figure 18 Stress-strain response for horizontal steel section located in damaged zone

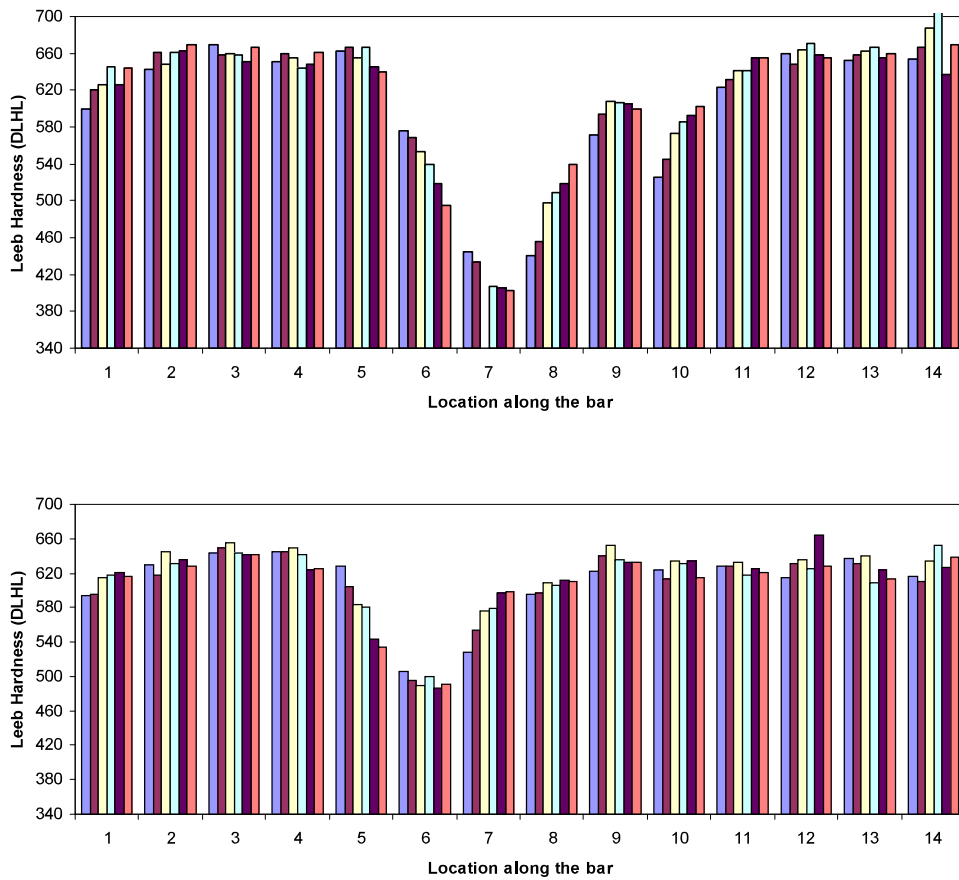
Figure 19 Leeb Hardness result for steel samples provided from IRD Building

Both steel samples showed significant reduction in Leeb hardness readings at the location marked on the bars as corresponding with the crack in the concrete member. Reduction in Leeb hardness typically only occurs in steel bars immediately prior to the onset of necking, where micro alloy steel has been found to strain soften.

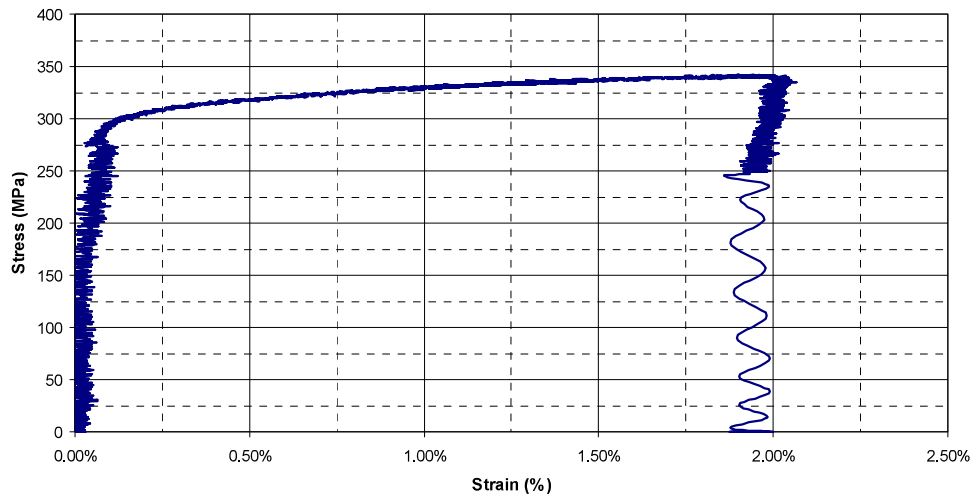
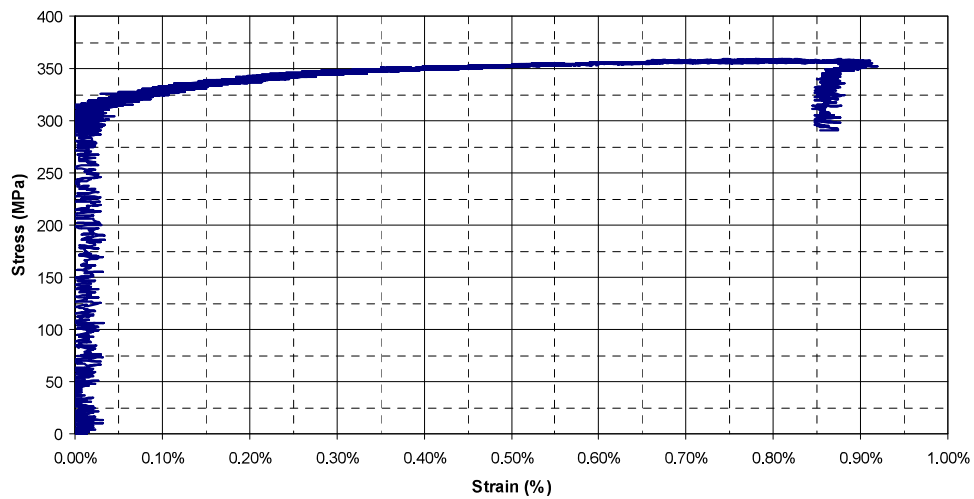
Figure 20 Stress-Strain responses for steel samples provided from IRD Building

The steel samples were then subjected to uniaxial tensile testing, with the obtained stress-strain responses shown in Figure 20. From the obtained stress-strain responses it would appear that the parent material was Grade 300E reinforcing steel. Grade 300E reinforcing steel has a lower characteristic yield strength of 300 MPa and is required in the New Zealand manufacturing Standard (AS/NZS 4671) to have a minimum uniform elongation capacity in excess of 15%. The results obtained for the two samples show they have an elongation capacity of 2% and 0.9% indicating that they have undergone significant inelastic deformation and are close to fracturing. This correlates with the observed Leeb Hardness results, showing significant strain softening at the cracked region.
