Analysis of the CTV Floor Diaphragm Adequacy

**By Associate Professor G Charles Clifton
Department of Civil and Environmental Engineering**

November 2011

Report to Hyland Consultants Ltd for the Department of Building and Housing investigation into the collapse of the CTV Building during the 22 February 2011 earthquake after-shock.

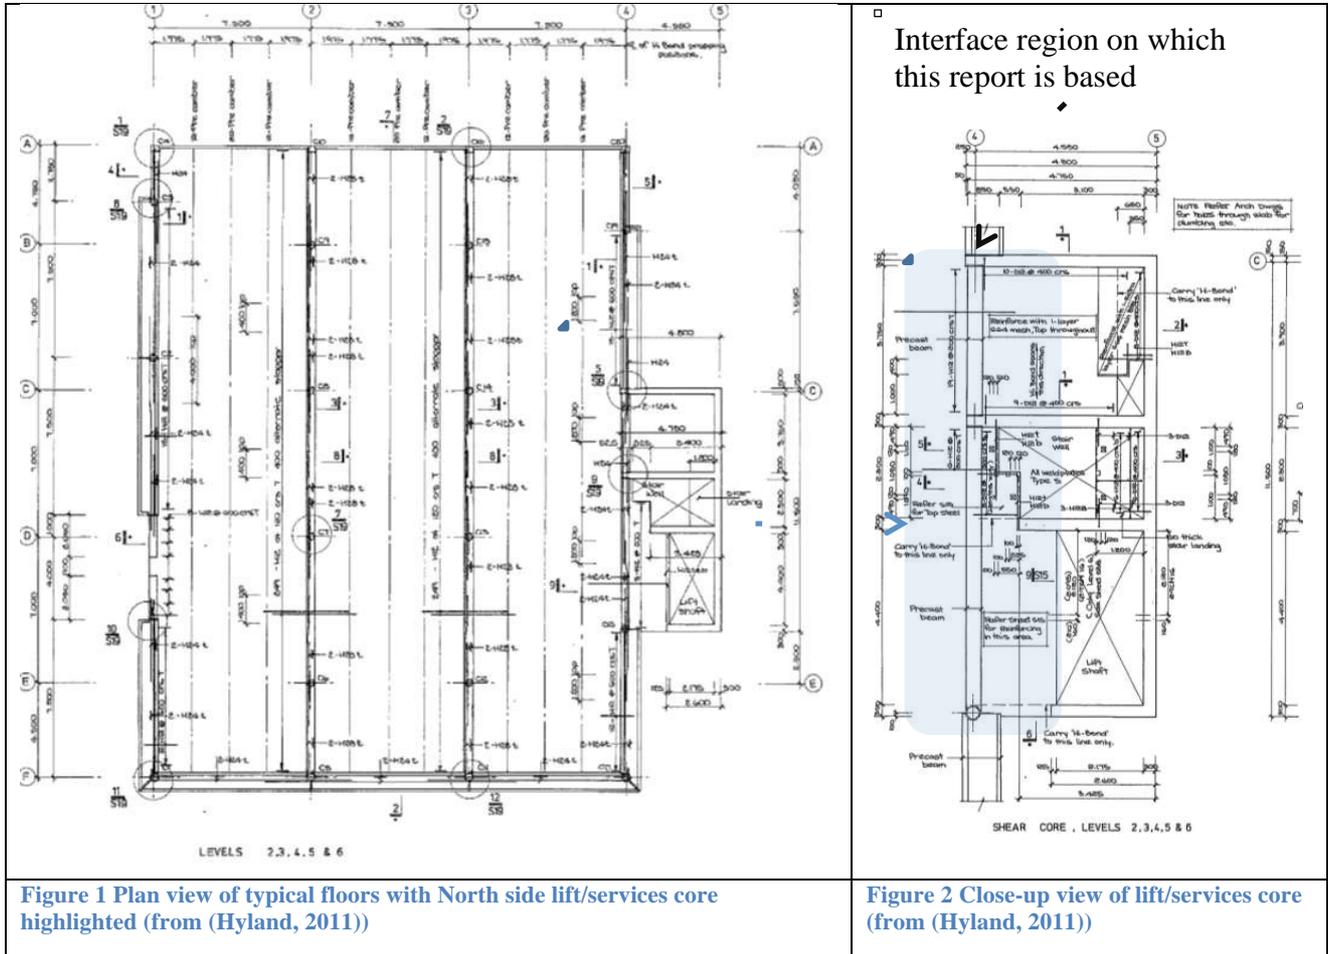
Figure 1 shows a general plan view of levels 2 to 6, with the north side lift/services core highlighted. Figure 2 shows a close-up of this core and the interface with the floors. This report focuses on the capacity of the floor to lift/services core interface, which is along the left hand side of the plan view in Figure 2, as indicated in that figure.

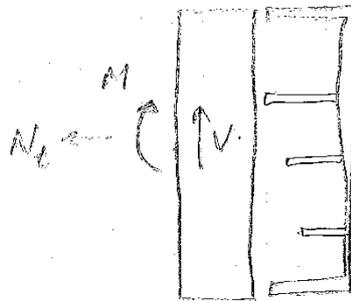
A.4 Summary of Resistance of Slab
Remnant, Levels 4-6.

$$\left. \begin{array}{l} M = 42,973 \text{ kNm} \\ N = 9,165 \text{ kN} \\ V = 5,256 \text{ kN} \end{array} \right\} \begin{array}{l} \text{Level 6 slab} \\ \text{remnant} \end{array}$$

↳ conservative.

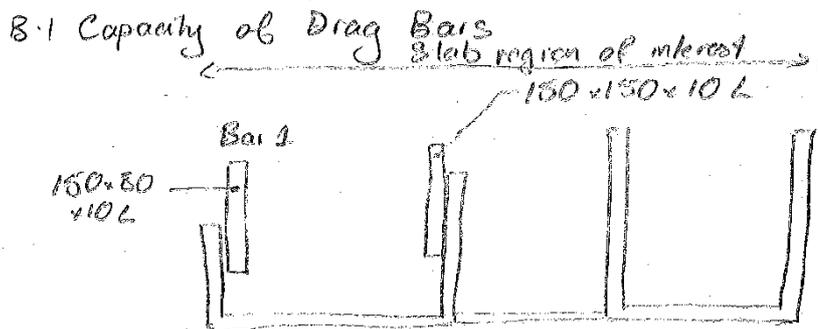
B: Levels 6, 5, 4: Approximate Capacity - Connection to Lift/Services Core.

north side lift/services core standing after the collapse. The second failure plane is shown on page B1 of Appendix B and involves failure of the interface between the slab and the north side lift/services core walls. Along this failure plane, the decking is considered to develop its full tensile contribution for the length of interface between the two north core walls that intersect the building slab along gridline 4. This may be overly optimistic in terms of the decking contribution. However, this interface does not provide contribution further east than that region, due to lack of interconnection of this region of the slab with the north side lift/services core wall on gridline D and the eastern most wall between gridlines D and E. For that region, the interconnection on levels 4 to 6 is via the 150x150x10 EA's bolted to the walls and the floor slab. No other connection to those walls is considered dependable across that interface..

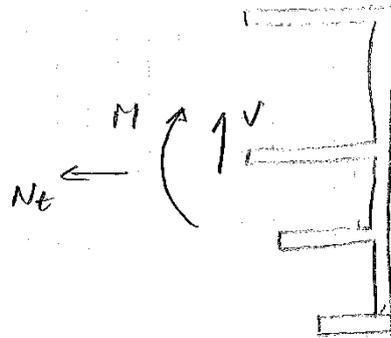
B5 Summary of Capacities Across
Slab at Level 6.5.4 Attachment to
Lift / Services Core.

$$M = 12,523 \text{ kNm}$$

$$N_t = 4,042 \text{ kN}$$

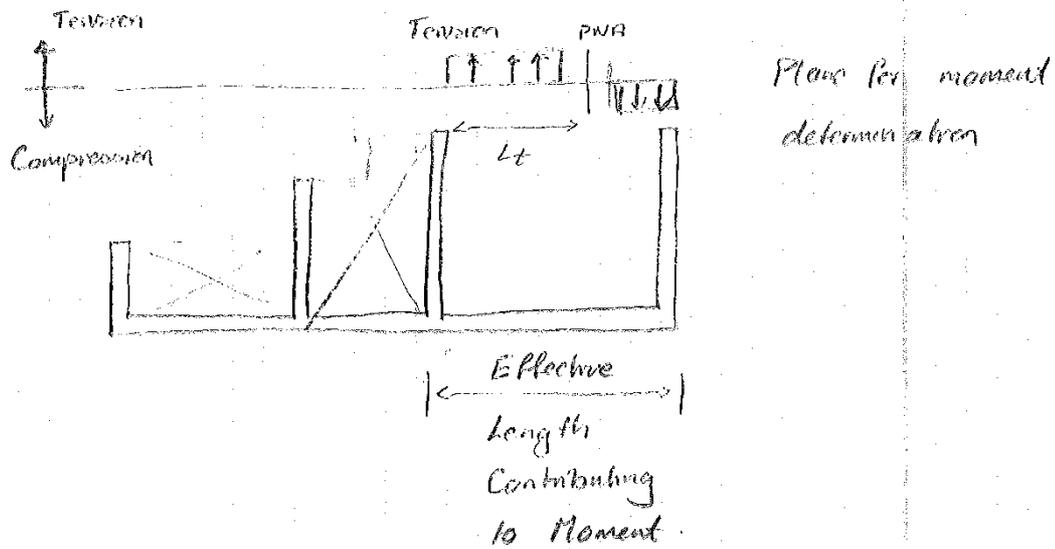
C: Levels 3, 2 : Approximate Capacity - Connection to Lift / Services Core.

For levels 2 to 3 in the north-south direction, the effective width of slab contributing to tension capacity is very much smaller, as shown on page C1 of Appendix C. The tension capacity is assessed from failure across this interface. The construction drawings and failure photos show the mesh fractured across this failure plane and the decking appeared to have also fractured; thus the tension contribution of both were included in the failure plane capacity. There is no effective interconnection between the floor slab and the north side lift/services core wall on gridline D or between the floor slab and the wall between gridlines D and E, as the interconnecting angles are not present at those levels.

For levels 2 to 3 in the east-west direction, the effective width of slab contributing to tension capacity due to bending moment or able to carry diaphragm shear is very much smaller, as shown on page C1 of Appendix C. The construction drawings and failure photos show the mesh fractured across this failure plane and the decking appeared to have also fractured; thus the tension contribution of both were included in the failure plane moment capacity. There is no effective interconnection in tension between the floor slab and the north side lift/services core wall on gridline D or between the floor slab and the wall between gridlines D and E as the interconnecting angles are not present at those levels. This makes direction of moment that puts the east side of the interface into tension critical, which is why the assessed capacity calculated in Appendix C is based on moment acting in this direction; see the figure on page C4.

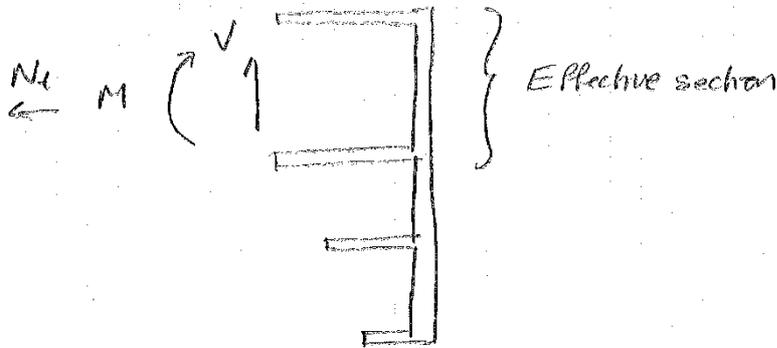
C.4 Summary of Capacities Across
Slab at Levels 3, 2 Attachment to
Lift / Services Core.

$$M = 4967 \text{ kNm}$$

$$N_t = 2912 \text{ kN}$$
