**ROYAL COMMISSION OF INQUIRY INTO  
BUILDING FAILURE CAUSED BY CANTERBURY  
EARTHQUAKES  
KOMIHANA A TE KARAUNA HEI TIROTIRO I  
NGA WHARE I HORO I NGA RUWHENUA O  
WAITAHA**

**STATEMENT OF EVIDENCE OF PENELOPE ANN SPENCER  
IN RELATION TO THE CTV BUILDING**

**DATE OF HEARING: COMMENCING 25 JUNE 2012**

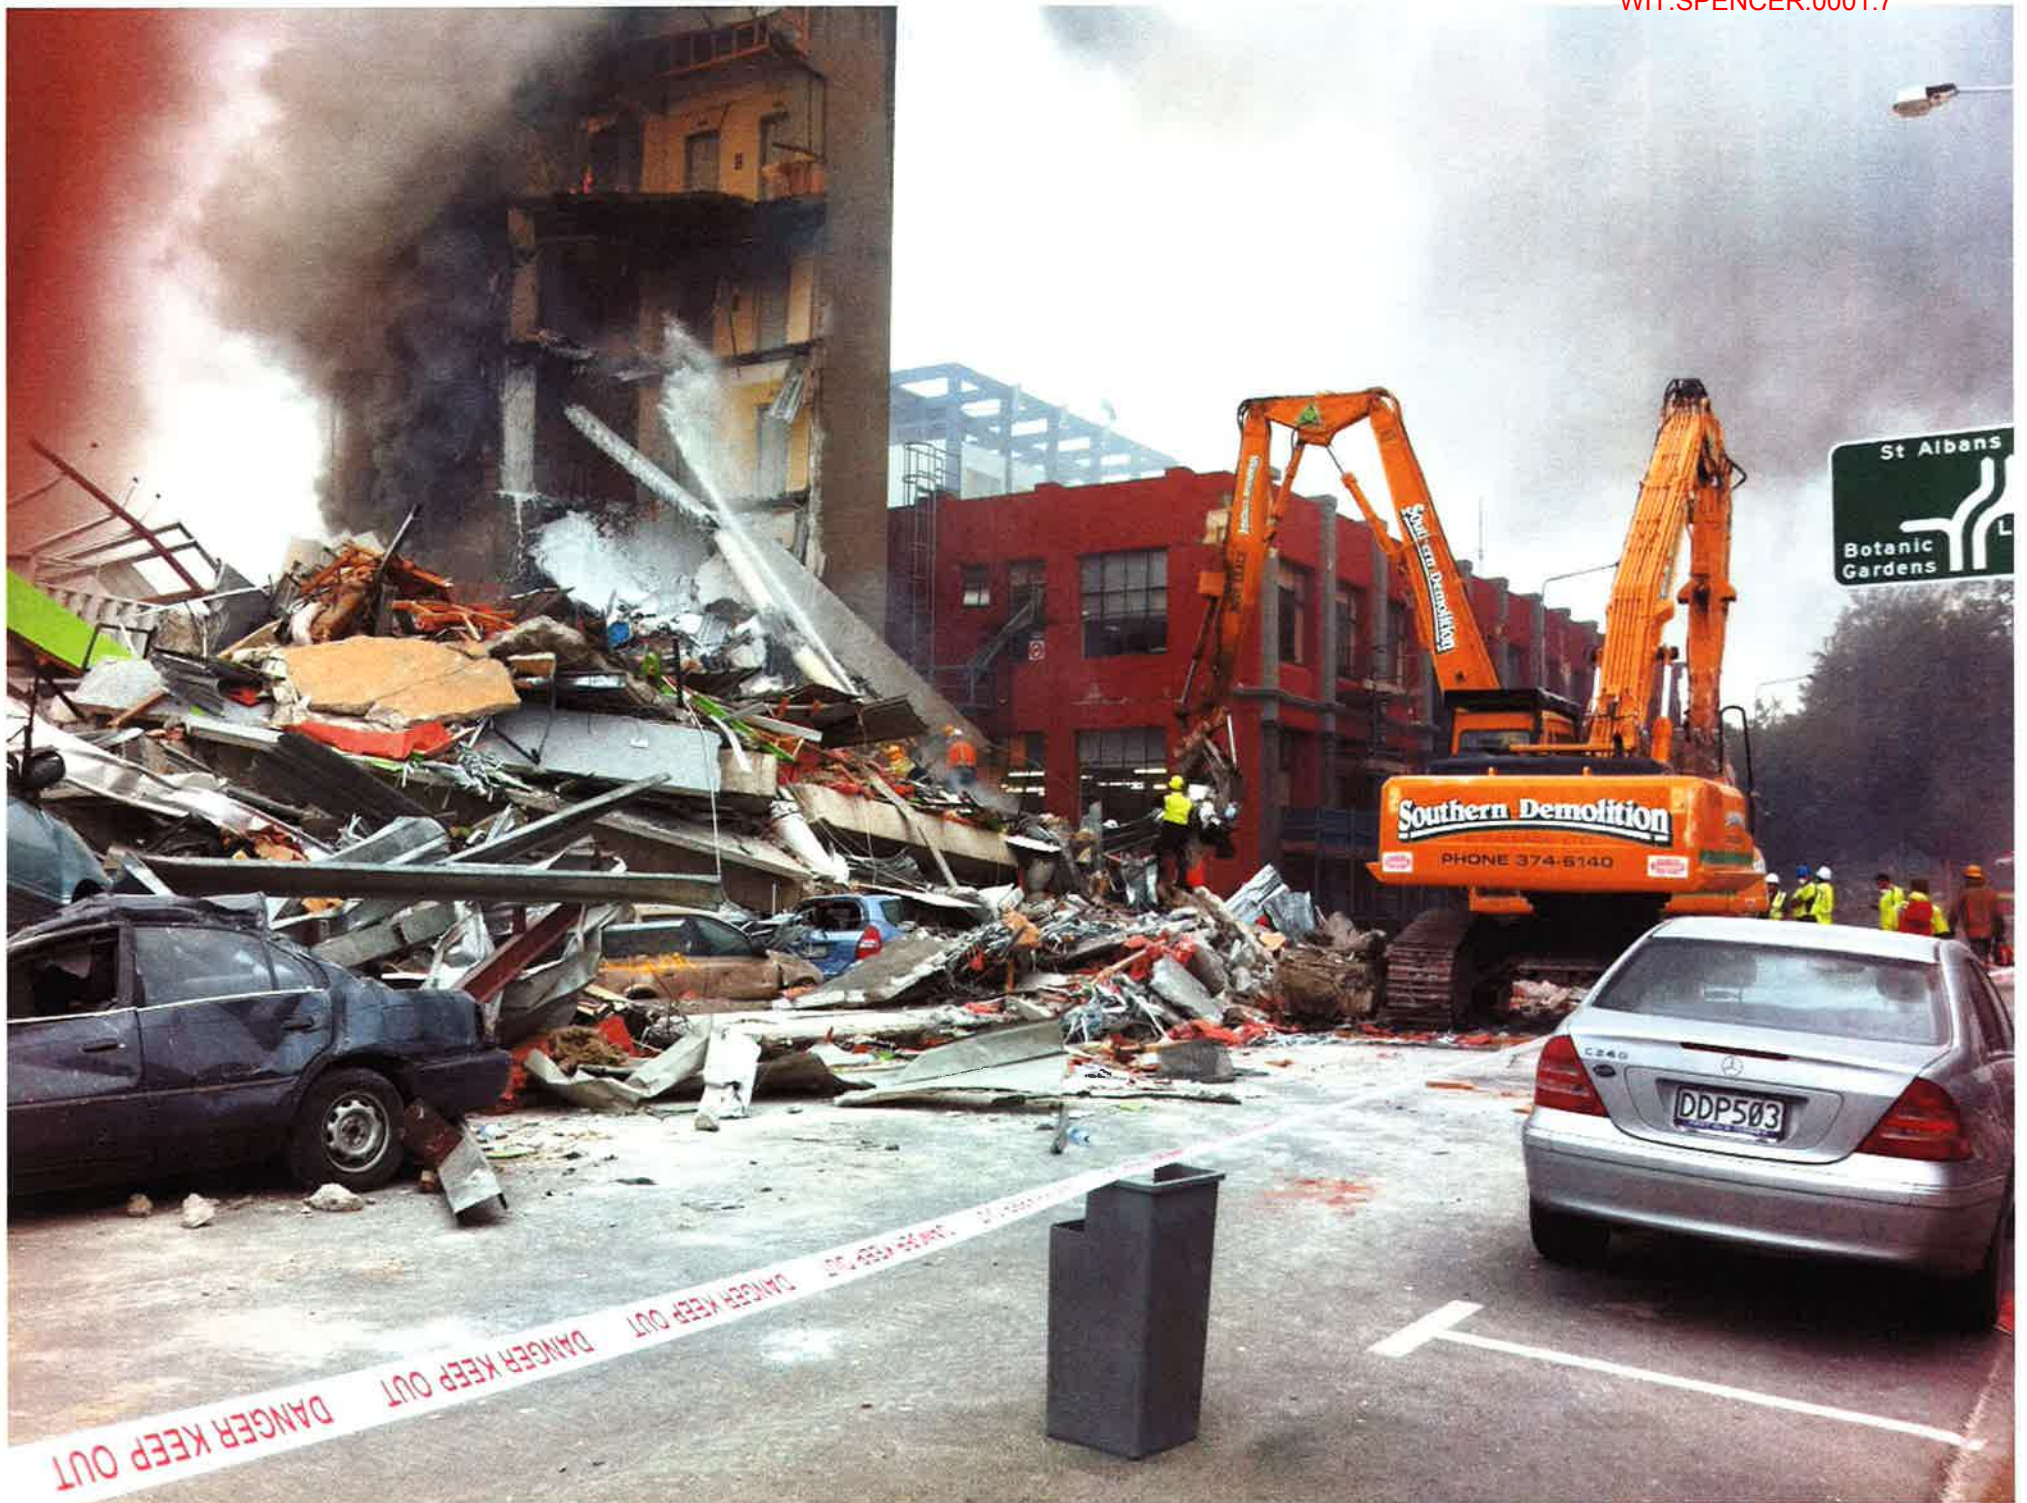
# CTV BUILDING LEVEL 1 (GROUND FLOOR)

6. After the September 2010 earthquake the Building also had several noticeable cracks. On Level 1 there were cracks in the plasterboard on the south wall of the master control room. One crack went diagonally up the wall and was about 50 centimetres long. After Boxing Day this crack went almost the whole length of the wall, about 2 to 2.5 metres in length. This crack also had other cracks leading off it after the Boxing Day earthquake. I have marked the location of this crack with the number "1" on the Plan.

7. There was a significant crack around the internal pillar between the cafeteria and the staff computers on Level 2. Here the carpet along the edge of the internal wall had separated from the pillar by about 1 centimetre. This had previously been attached before the September 2010 earthquake. I have marked the location of this pillar with the number "2" on the Plan.

8. There were cracks on internal walls on Level 2. Cracks on walls along the corridor by the editing room went straight up the wall and were 10 to 20 centimetres long. I am sure these cracks also grew bigger after the Boxing Day 2010 earthquake. I have marked the location of these cracks with the number "3" on the Plan. I am sure there were also cracks around windows and door frames but I do not recall where they were. I think windows may have been broken along the east wall of Level 2 too.
9. I never saw any cracking on the outside of the Building.
10. I do not think anyone at CTV felt safe in the Building. Sometimes we would joke around and jump into the cafeteria on Level 2 which would make the floor shake. The floor also shook every time someone walked down the corridor on Level 2. This did not happen prior to the September 2011 earthquake.

1. Cracking on the wall in the master control room
2. Cracking on internal pillar
3. Cracking on internal corridor walls
4. Location at the time of the earthquake
5. Location of Tom's car in the CTV carpark
