**ROYAL COMMISSION OF INQUIRY INTO  
BUILDING FAILURE CAUSED BY CANTERBURY  
EARTHQUAKES  
KOMIHANA A TE KARAUNA HEI TIROTIRO I  
NGA WHARE I HORO I NGA RUWHENUA O  
WAITAHA**

**BRIEF OF EVIDENCE OF GRAHAM EDWARD FROST  
IN RELATION TO THE CTV BUILDING**

**DATE OF HEARING: COMMENCING 25 JUNE 2012**

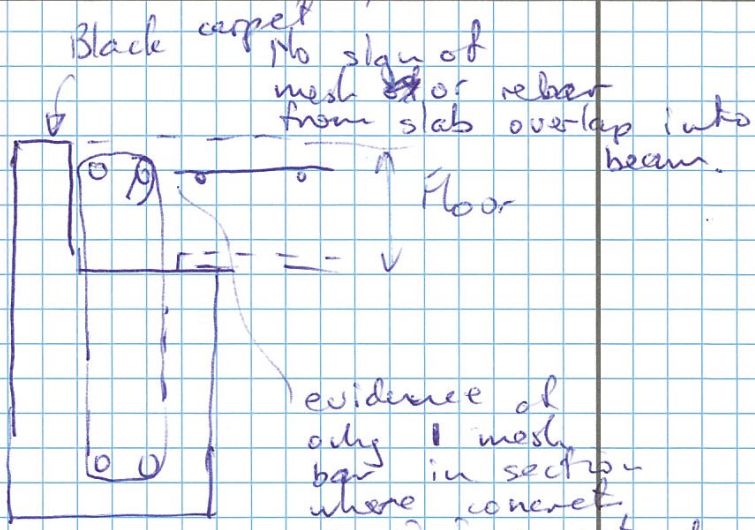
*E18*

*sq end to precast L-shape*

Found first beam-beam-column joint where components still 'linked' near NW cor of bldg.

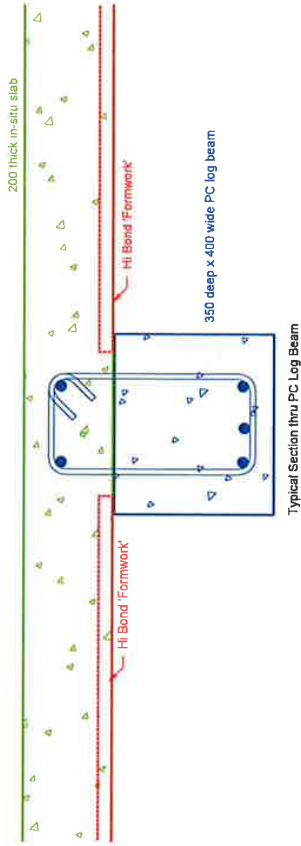
Typical Section thru PC Log Beam

Reduced Bearing Area Available for PC Log Beam on Column (3,510mm<sup>2</sup>)  
(if PC beam length or column position out by just 10mm  
and corners have spalled off PC log beam.

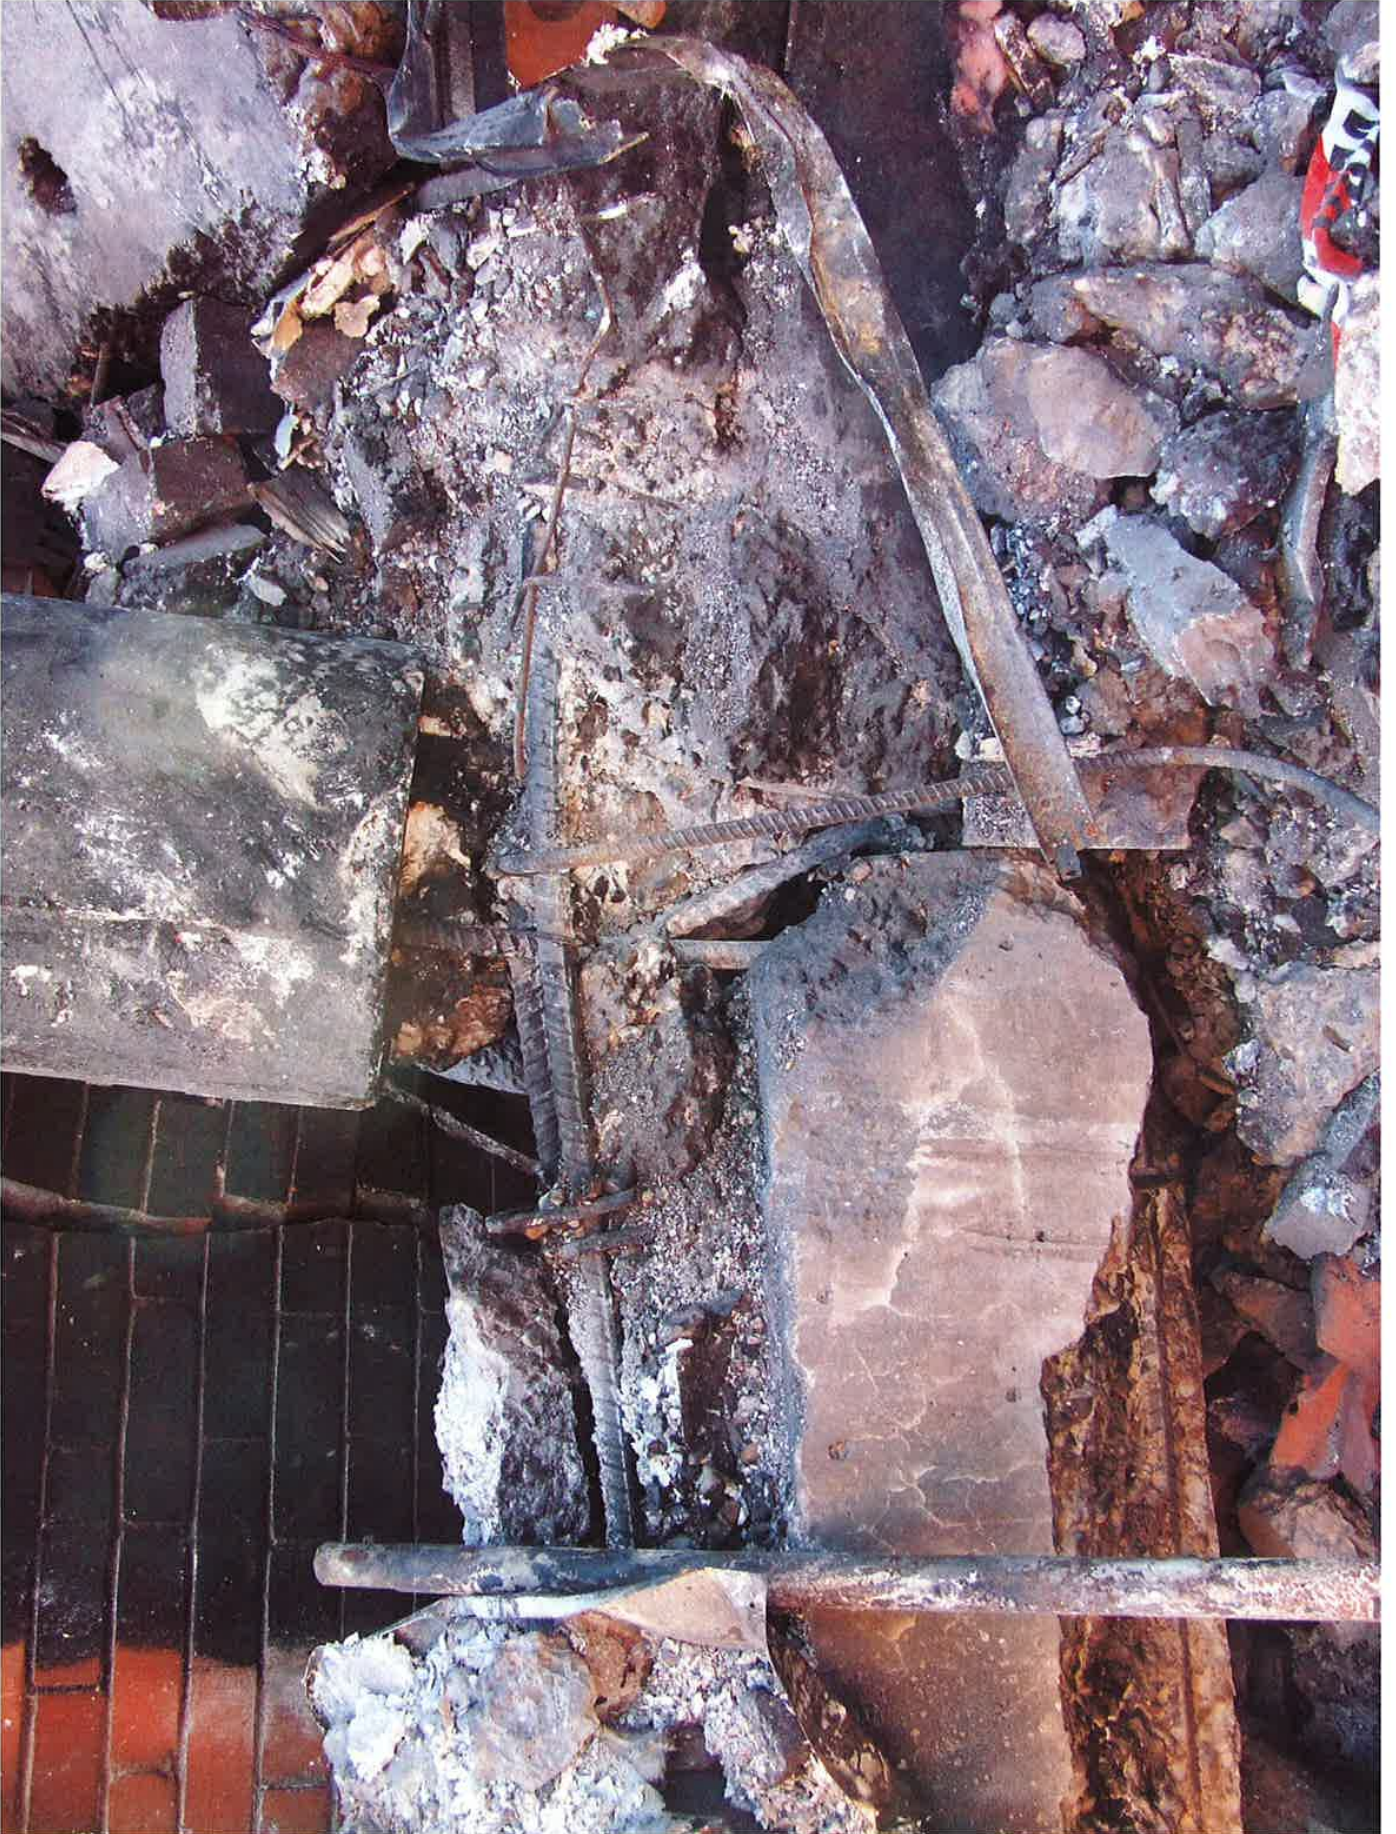
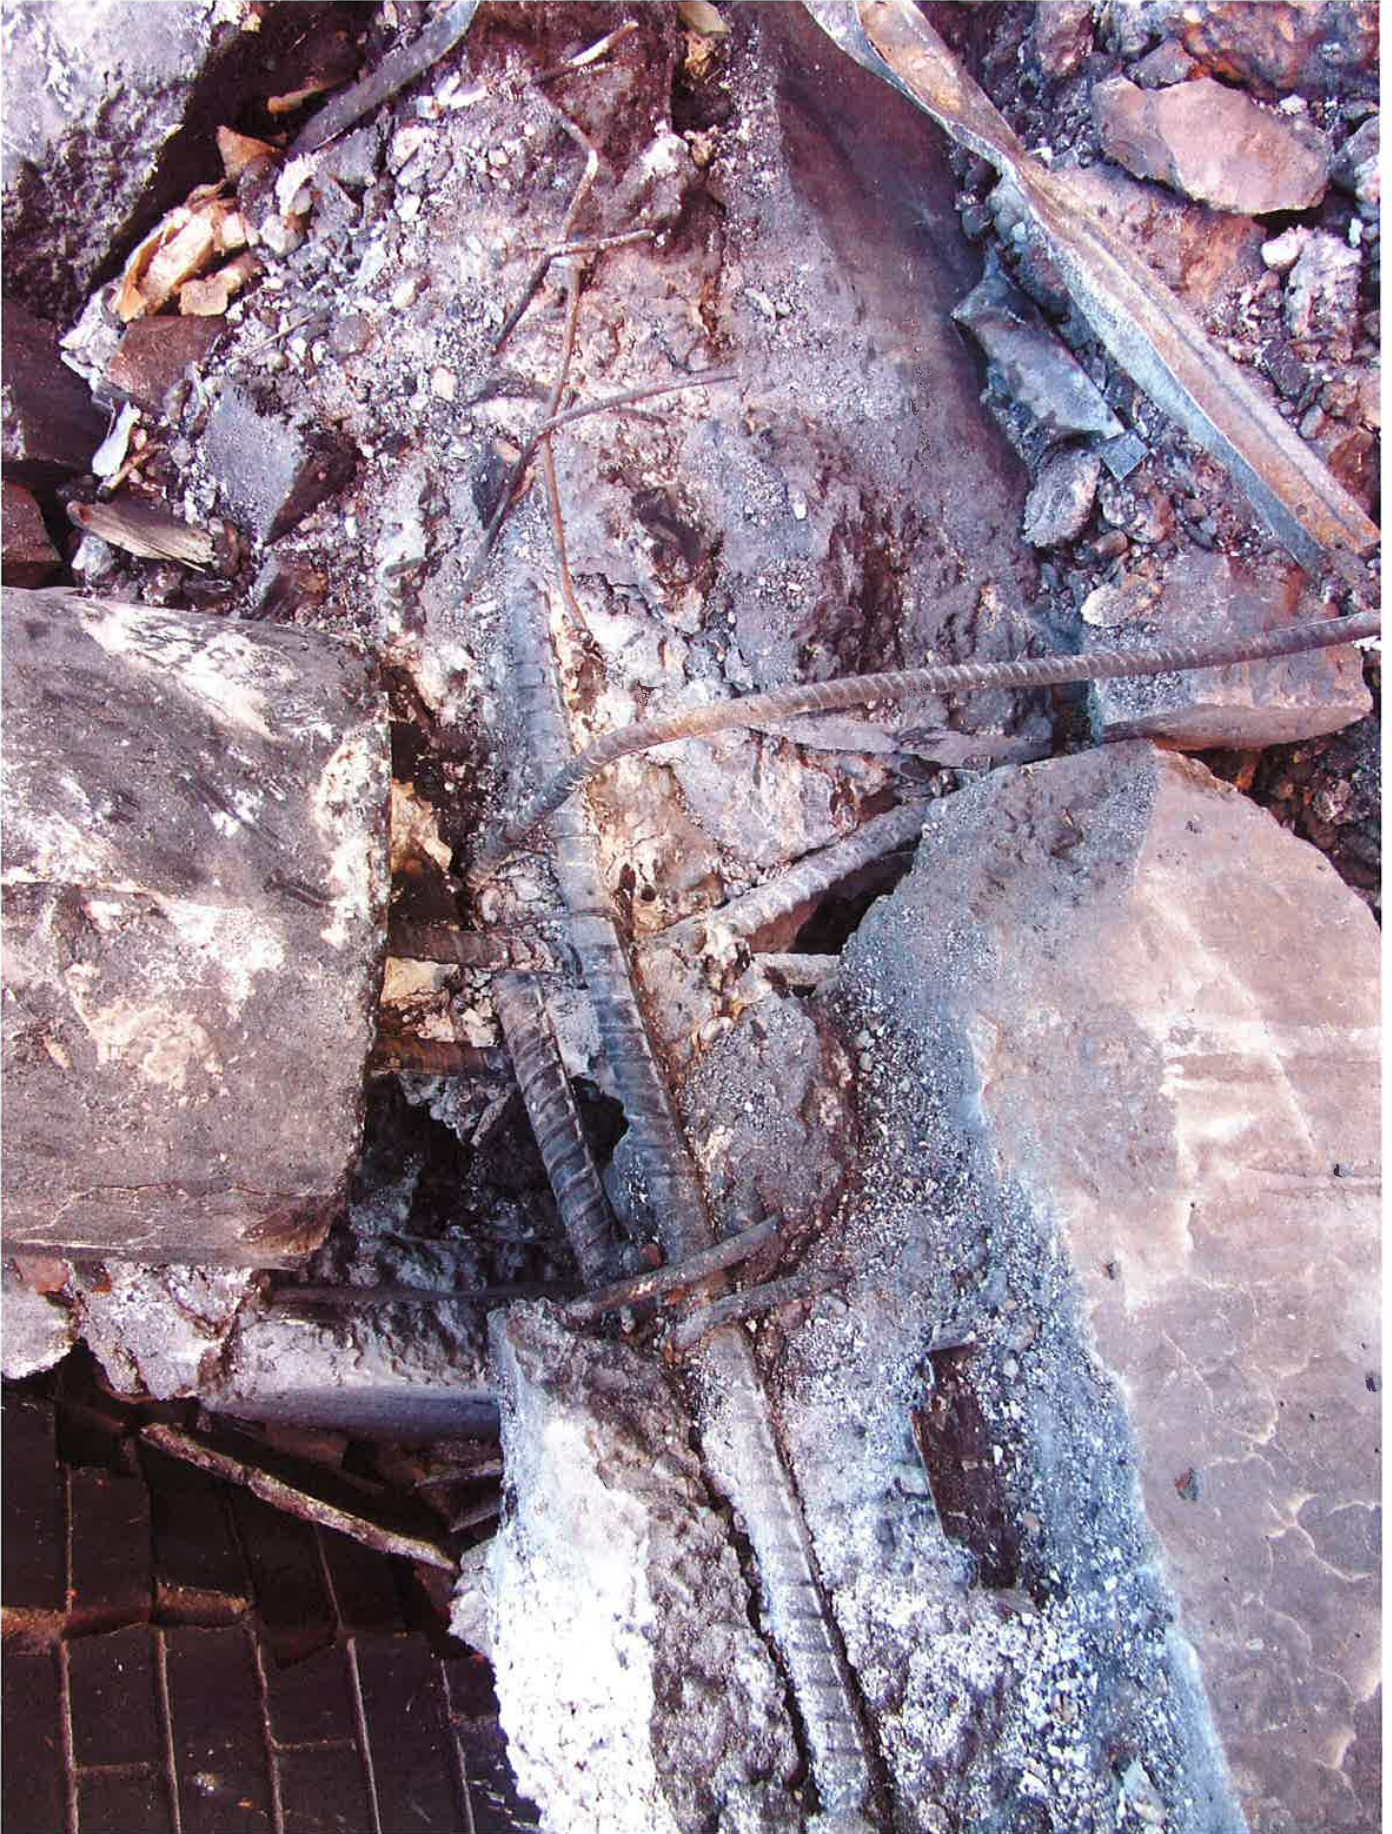
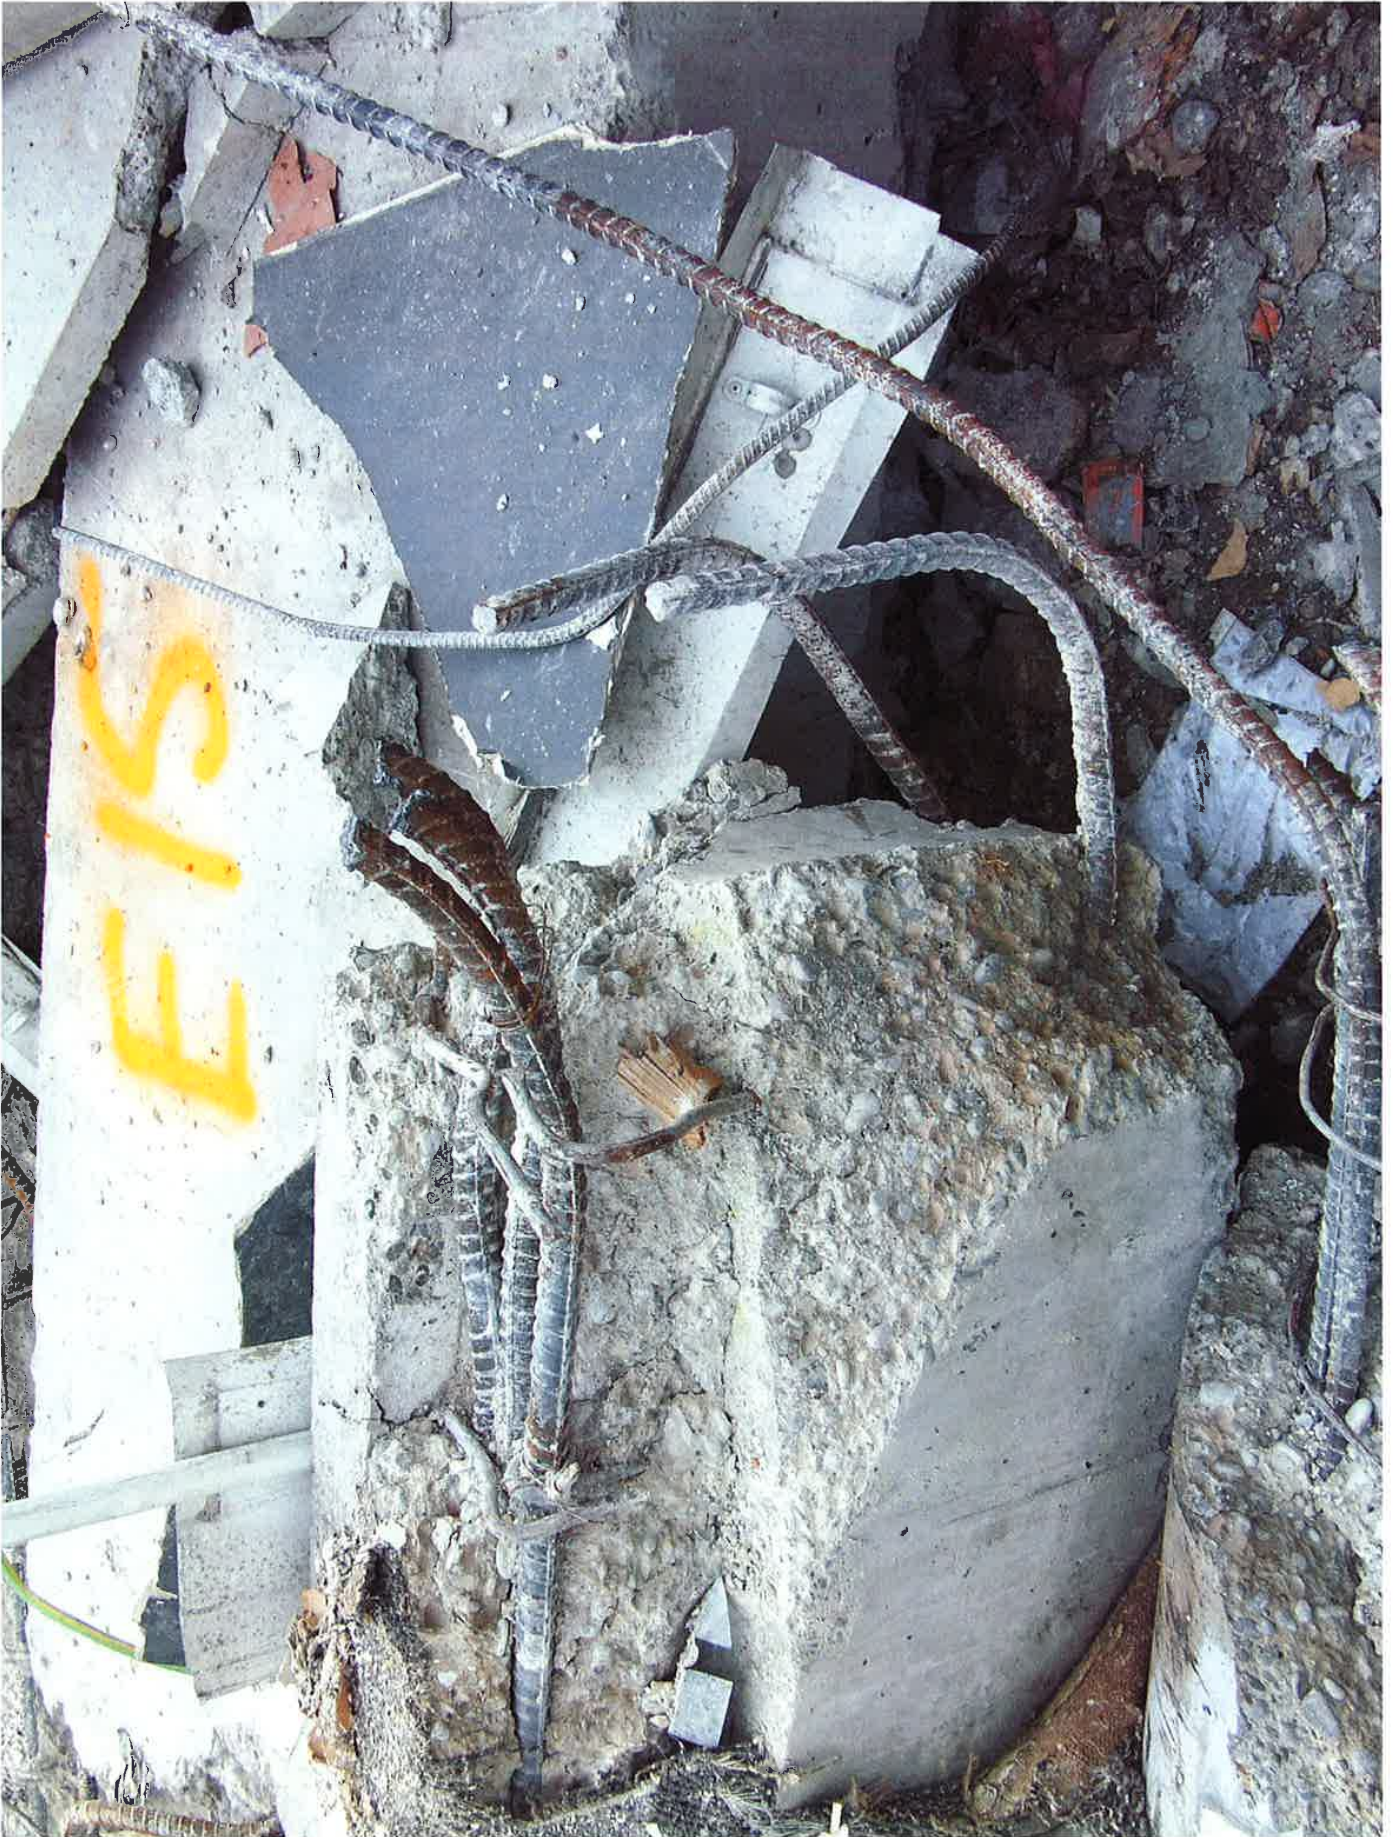
SK GF 20120501

PLAN SECTION 3-3 - INTERIOR BEAM-COLUMN JOINT  
(ALLOWING 10mm CONSTRUCTION TOLERANCE + CORNER SPALLING)
