Under **THE COMMISSIONS OF INQUIRY ACT 1908**  
In the matter of the **CANTERBURY EARTHQUAKES ROYAL COMMISSION  
OF INQUIRY INTO THE COLLAPSE OF THE CTV  
BUILDING**

**STATEMENT OF EVIDENCE OF DOUGLAS JON HAAVIK**

**BRIEF OF EVIDENCE OF DOUGLAS JON HAAVIK**

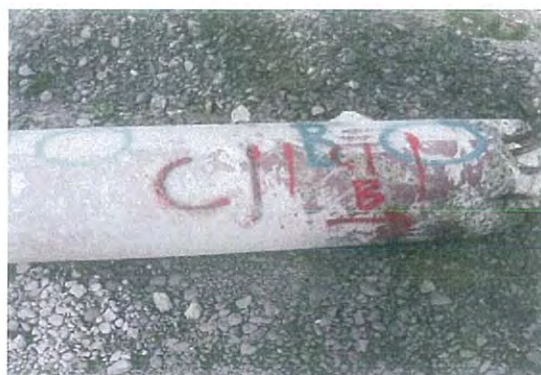
C1-B

| Notes: | Sample broken due to pre-existing crack in concrete | Sample broken due to pre-existing crack in concrete |

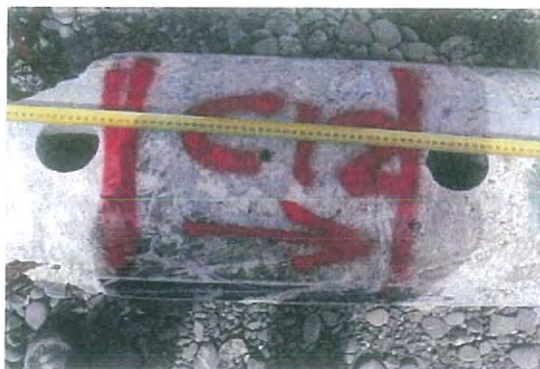
C12

| Notes: | Sample broken due to pre-existing crack in concrete |

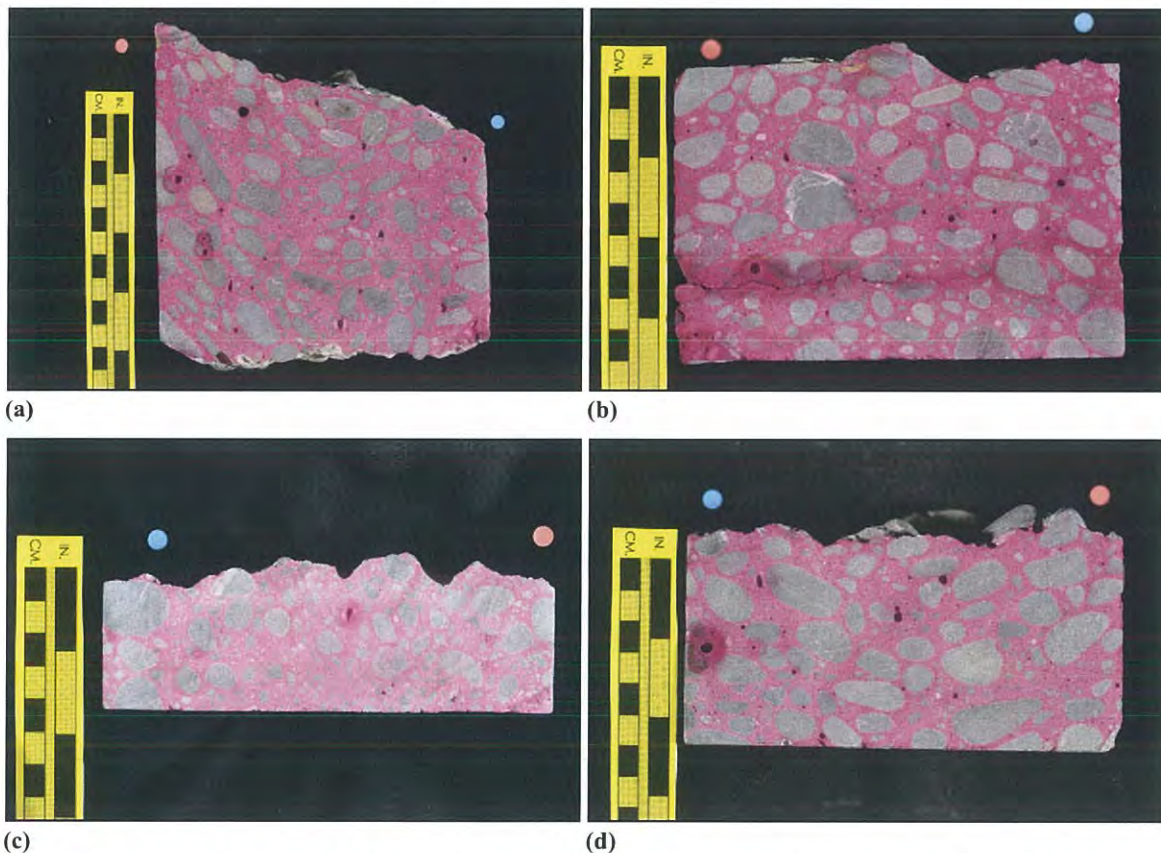
**3.9 Secondary Deposits** No significant secondary deposits were observed in the cores aside from the ettringite observed in voids and occasional microcracks described above. None of the cores show evidence of significant carbonation, as indicated by both phenolphthalein staining (**Figure 9**) and thin section analysis.

Figure 9. Photographs of phenolphthalein stained surfaces from (a) Core C1-T 1/2, (b) Core C4 B, (c) Core C12 B 1/2, and (d) Core R-7.

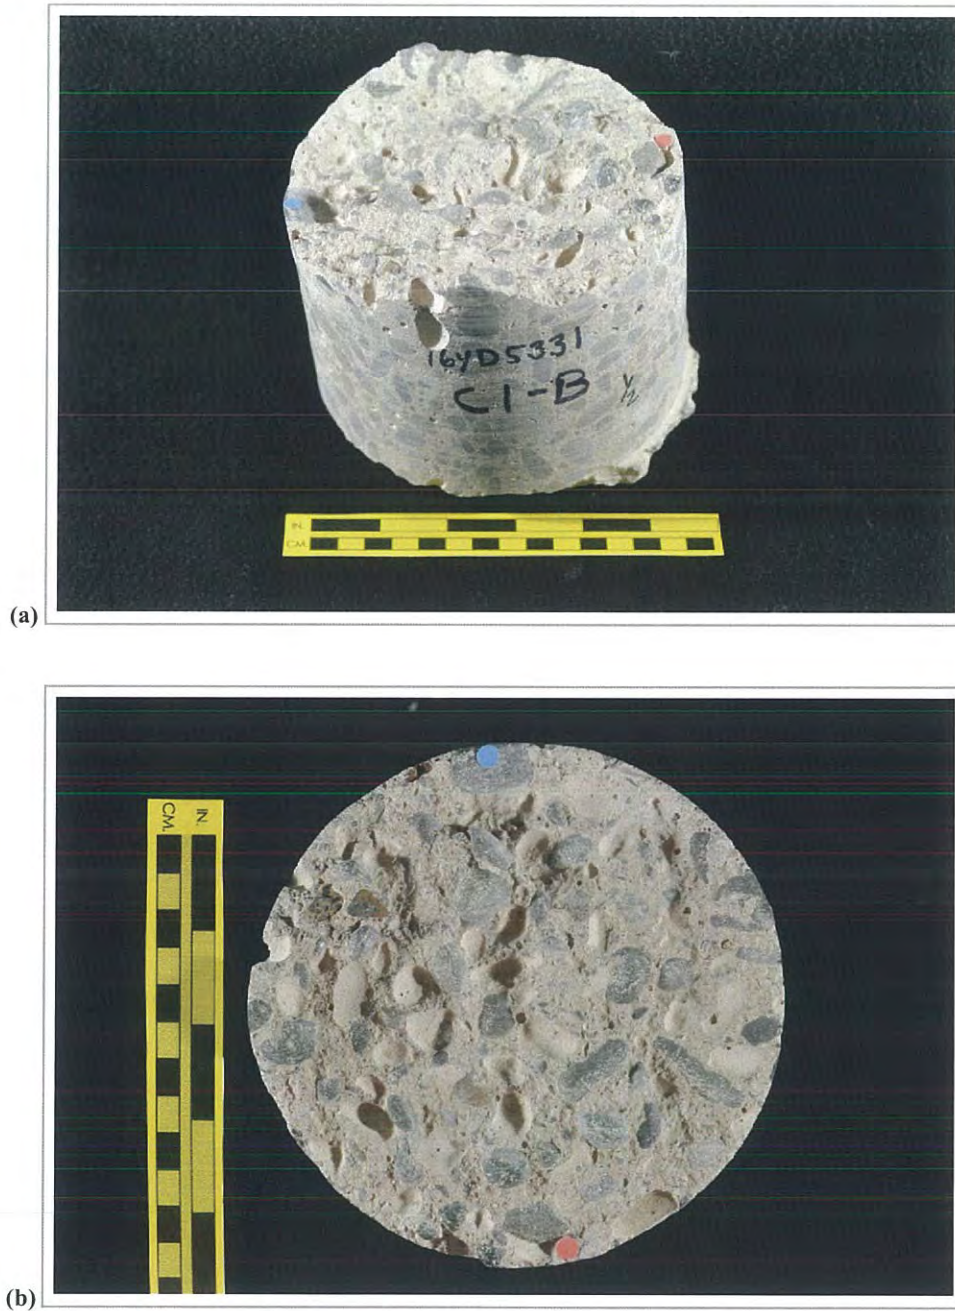
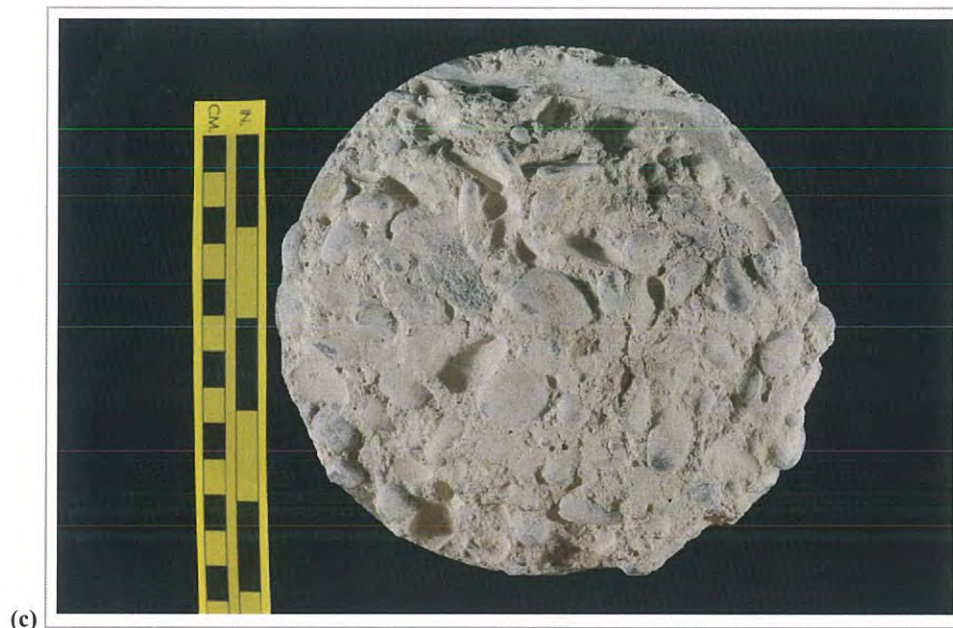
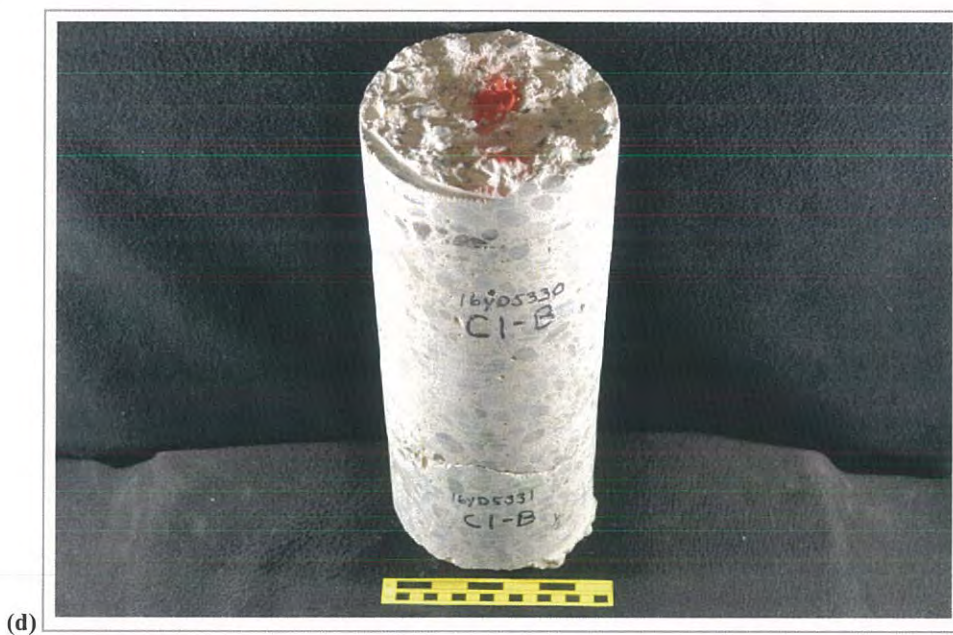
Figure A1 (cont'd). (c) Photograph showing the bottom surface of the core. (d) Photograph showing both sections of the core designated as C1-B. The section that was the subject of the petrographic examination represented the lower portion of the core.

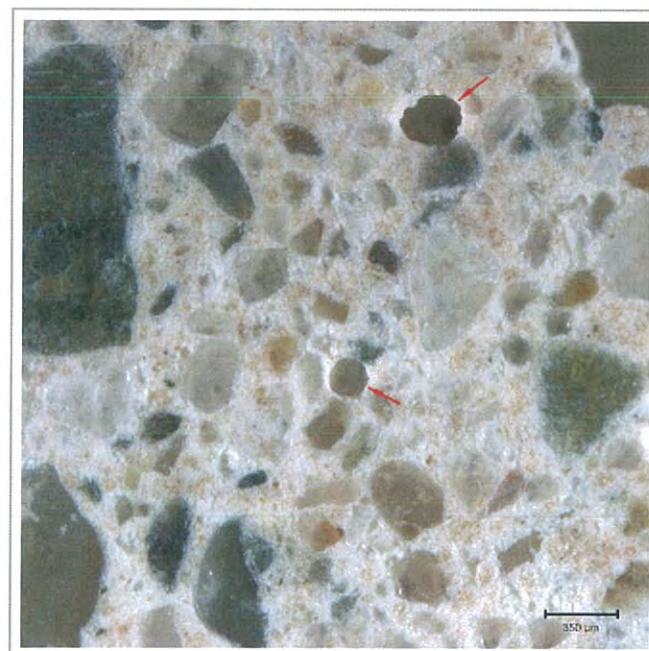
Figure A4. Oblique reflected light photomicrograph of polished surface showing voids (red arrows highlight examples).

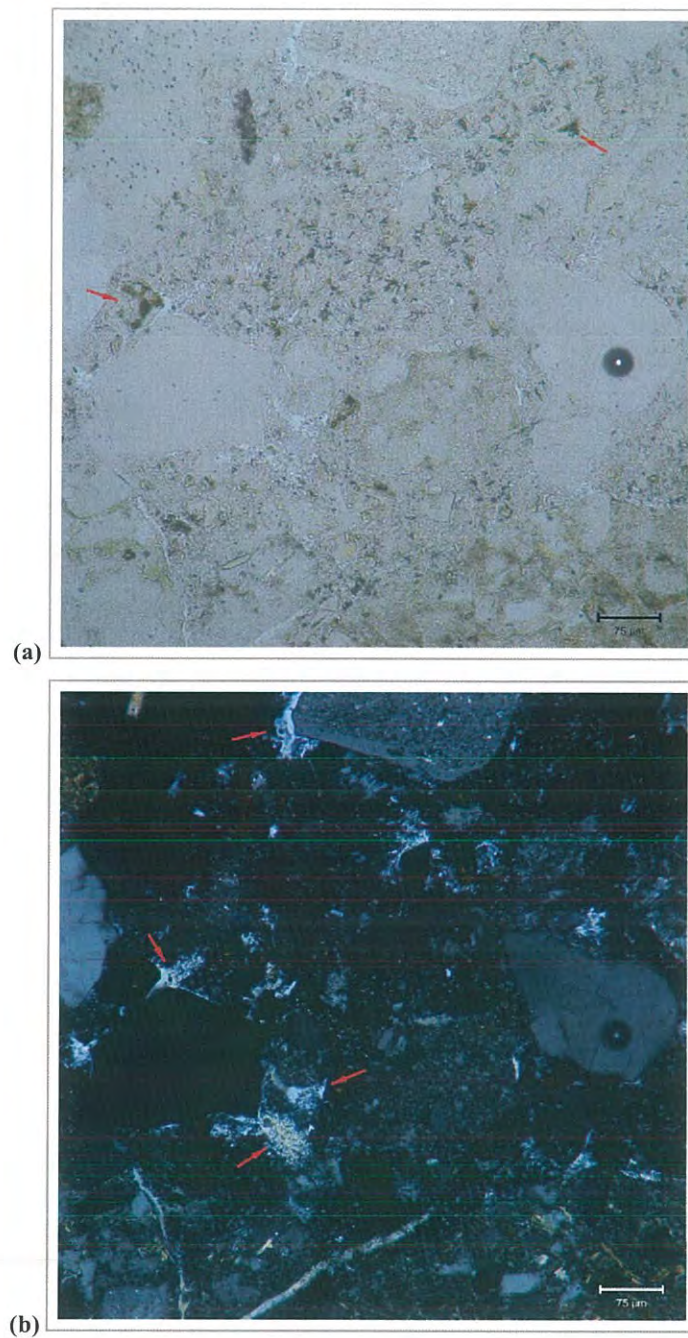
Figure A8. Transmitted light photomicrographs of thin section from the concrete core showing detail of paste in (a) plane-polarized and (b) cross-polarized light. The red arrows in (a) indicate RRCG; in (b) they indicate CH.

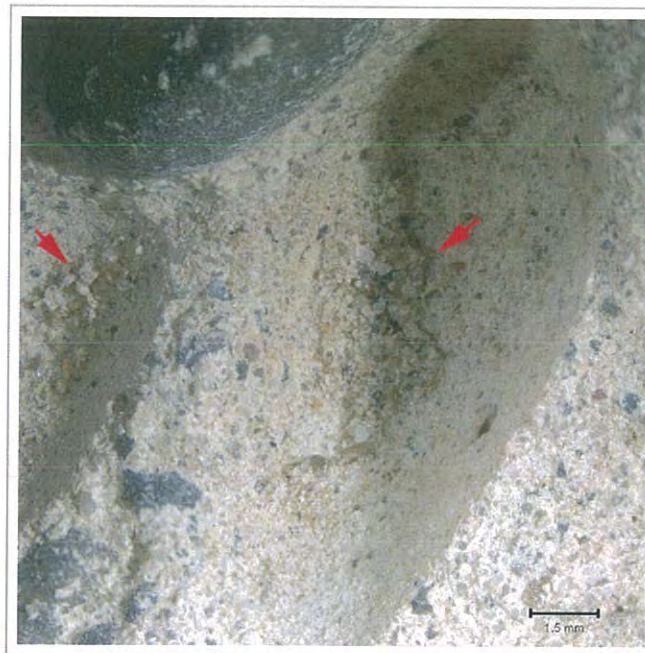
Figure A9. Reflected light photomicrograph of a fresh fracture surface showing two aggregate sockets that contained sand grains (red arrows).

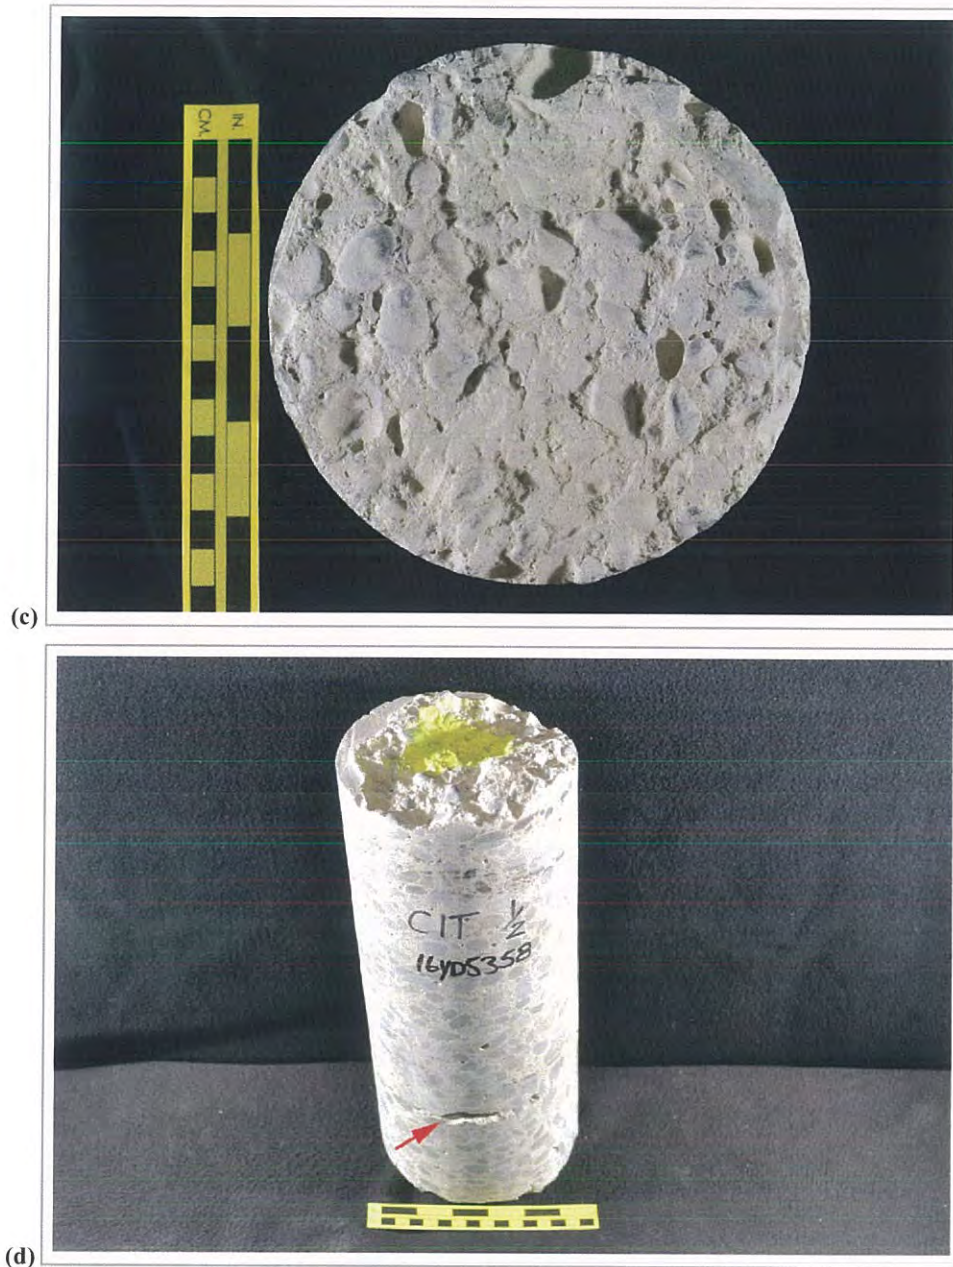
Figure B1 (cont'd). (c) Photograph showing the bottom surface of the core. (d) Photograph showing both sections of the core designated as C1-T ½. The section that was the subject of the petrographic examination represented the lower portion of the core. The red arrow highlights the crack that separated the top and lower portions of the core.

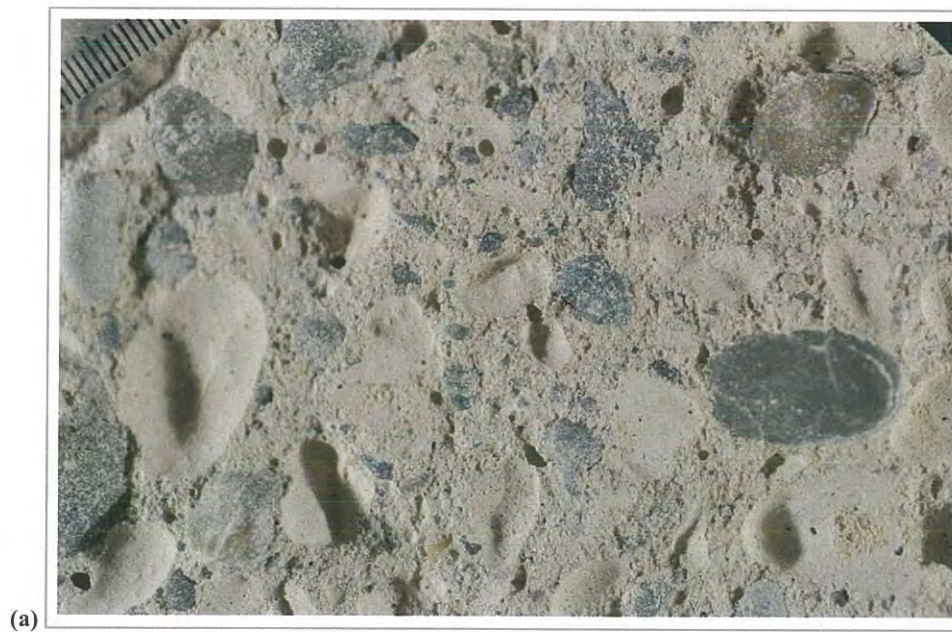
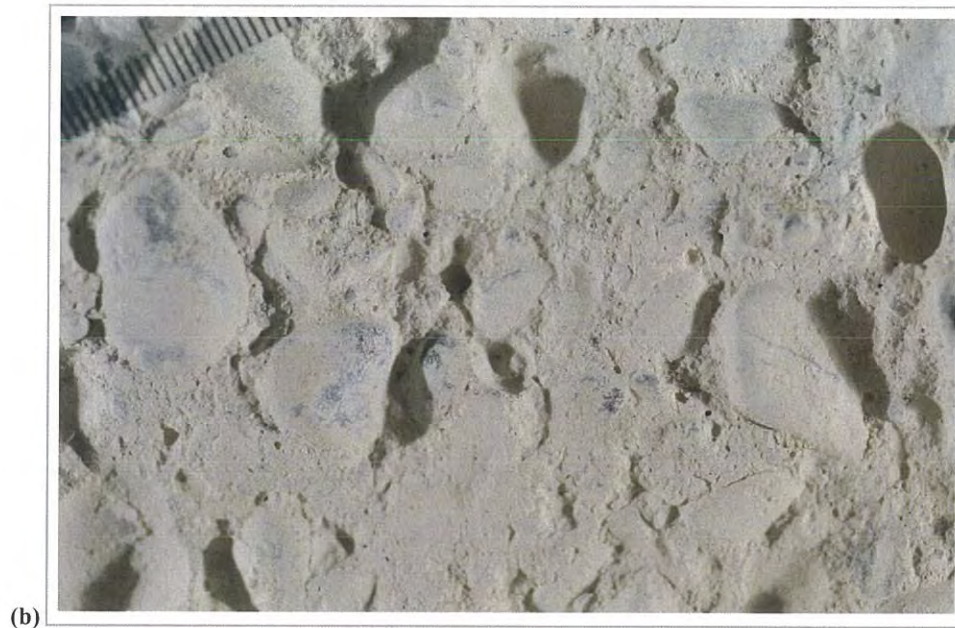
| GENERAL CONDITION | The concrete is hard and compact and rings lightly when sounded with a hammer. The as-received fracture surfaces at the top and bottom of the core cut around aggregate particles ( <b>Figure B3</b> ). The bottom surface was covered with more mud or fine detrital material than the top surface. |

Figure B3. Photograph showing detail of the top surface of the core; scale in millimeters.

Figure B3 (cont'd). Photograph showing detail of the bottom surface of the core; scale in millimeters.

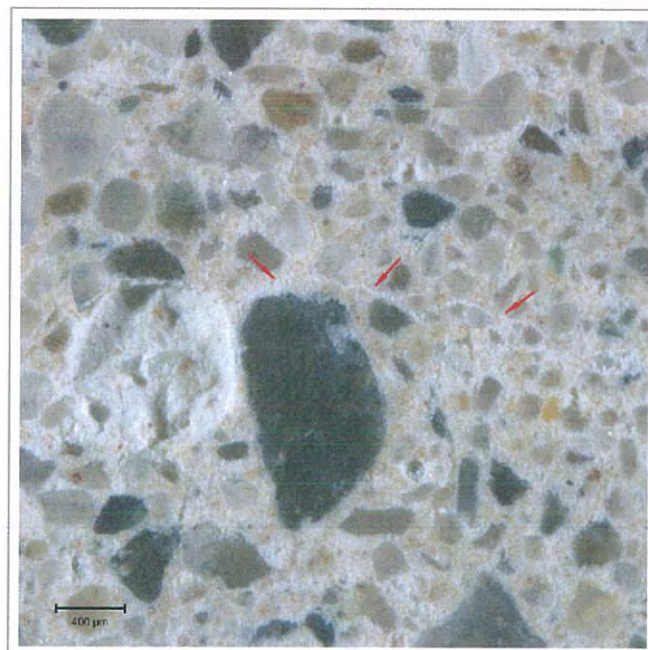
| MICROSCOPIC | No significant microcracking observed. A few rare microcracks ranging up to 25 µm (1 mil) wide and 2.5 mm (100 mil) long were observed striking sub-horizontally through the paste ( <b>Figure B4</b> ). The microcracks contain white secondary deposits. |

Figure B4. Reflected light photomicrograph of polished surface showing microcrack (red arrows).

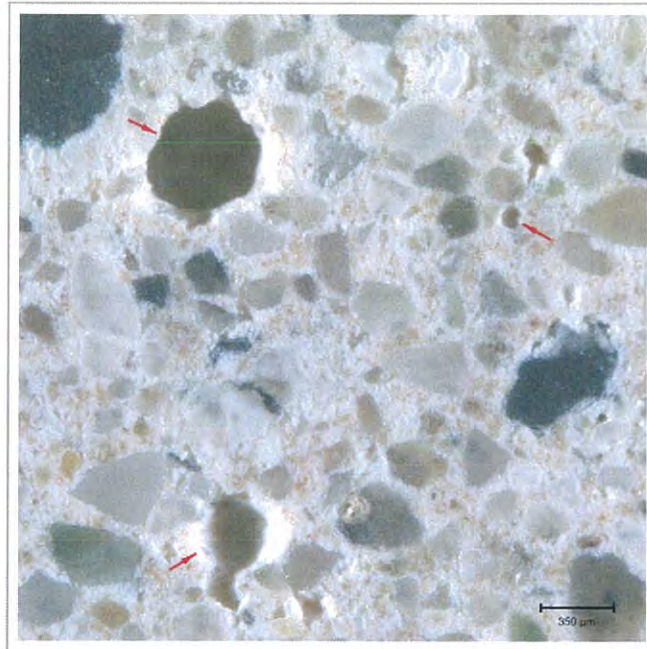
| VOID SYSTEM | Concrete is not air-entrained and contains less than 2.0% air by ASTM C457 ( <b>Figure B5</b> ). The consolidation of the concrete is good with no large entrapped voids or bleed voids observed. |

Figure B5. Oblique reflected light photomicrograph of polished surface showing voids (red arrows highlight examples).

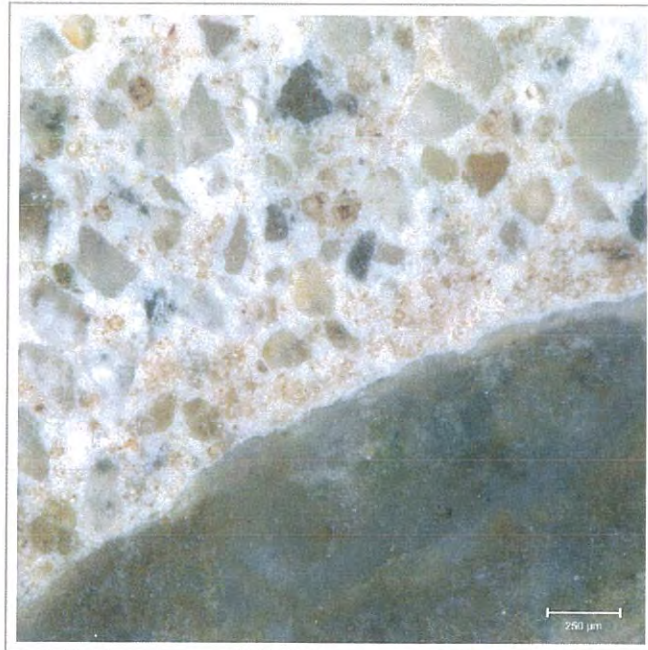
| OTHER FEATURES | No deleterious coatings or incrustations observed but many particles show brown paste along the paste-aggregate boundary ( <b>Figure B7</b> ). No low w/c mortar coatings observed. No reaction rims, significant internal microcracking, deposits of gel or other evidence of ASR observed. |

Figure B7. Reflected light photomicrograph of polished surface showing the fine aggregate.

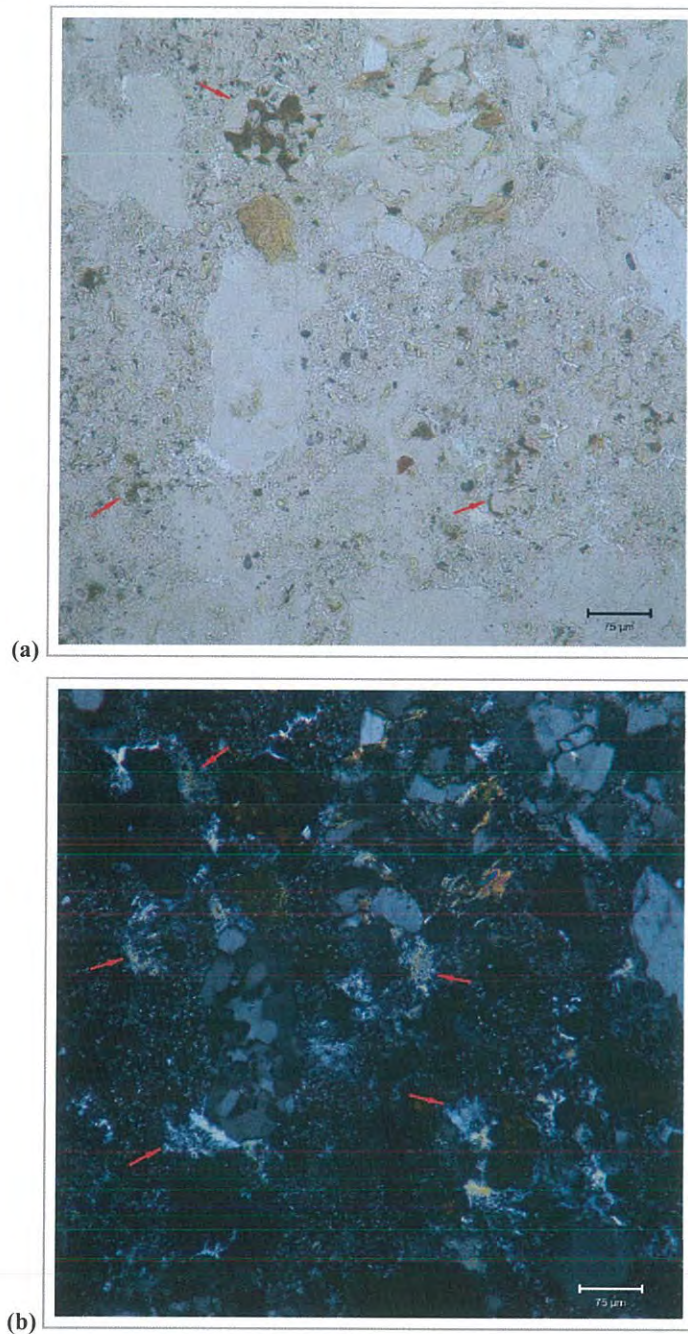
| THIN SECTION* | The paste contains hydrated portland cement; no fly ash, slag cement or other SCM were observed ( <b>Figure B10</b> ). The hydration is advanced with less than 3% RRCG that consist mostly of belite and interstitial aluminate and ferrite. CH makes up 15-25% of the paste, is coarse-grained and unevenly distributed. |

Figure B10. Transmitted light photomicrographs of thin section from the concrete core showing detail of paste in (a) plane-polarized and (b) cross-polarized light. The red arrows in (a) indicate RRCG; in (b) they indicate CH.

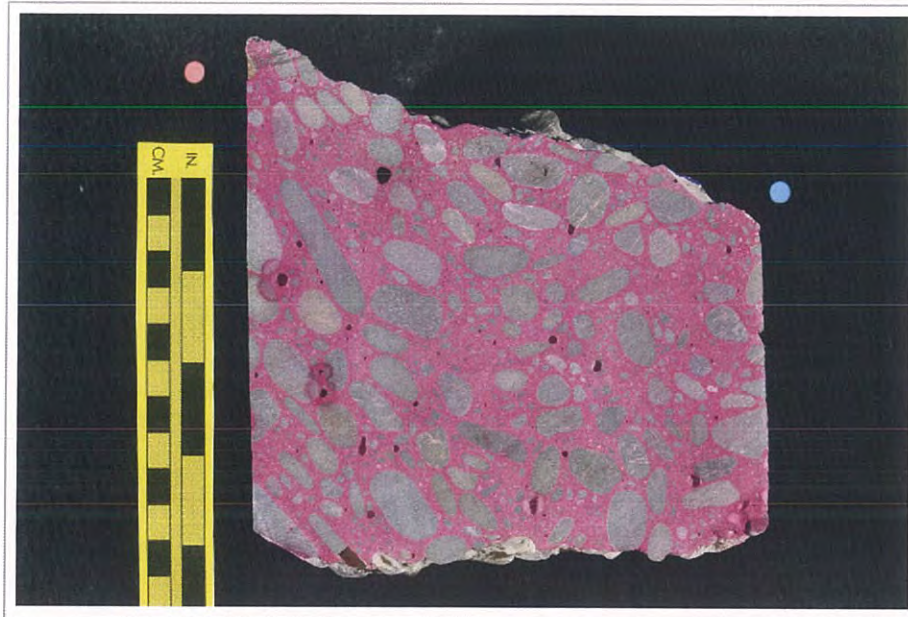
| PHENOLPHTHALEIN | Entire surface stains purple ( <b>Figure B11</b> ). |

Figure B11. Photograph showing phenolphthalein stained surface.

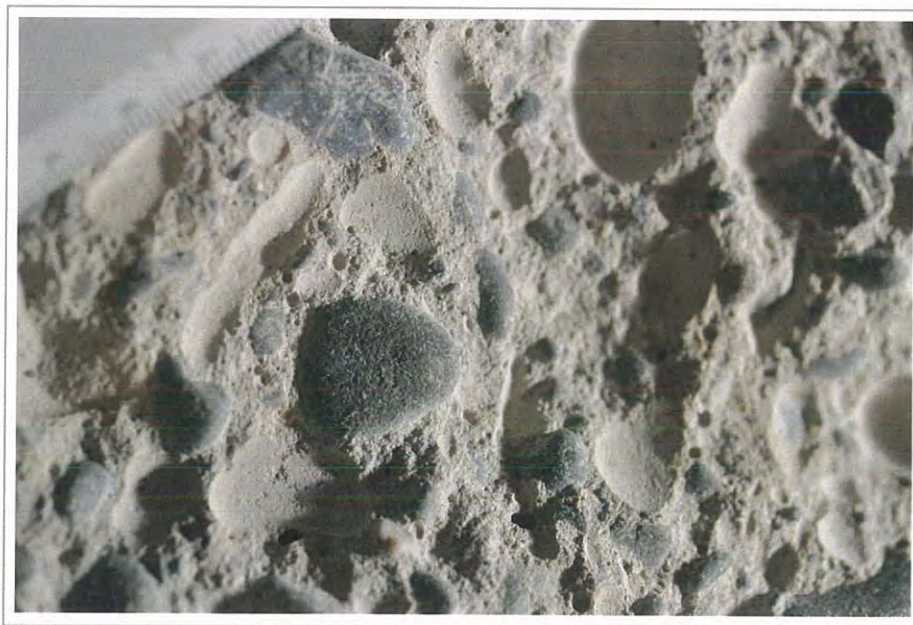
| 1. RECEIVED CONDITION | |
|---|---|
| GENERAL CONDITION | The concrete is hard and compact and rings lightly when sounded with a hammer. The as-received fracture surface at the bottom of the core cuts around aggregate particles ( <b>Figure C3</b> ). A crack cuts sub-horizontally around the core (see below) about 75 mm (3 in.) below the top surface of the core. The core was trimmed just below this crack and the section above was used for petrography. |

Figure C3. Photograph showing detail of the bottom as-received fracture surface; scale in millimeters.

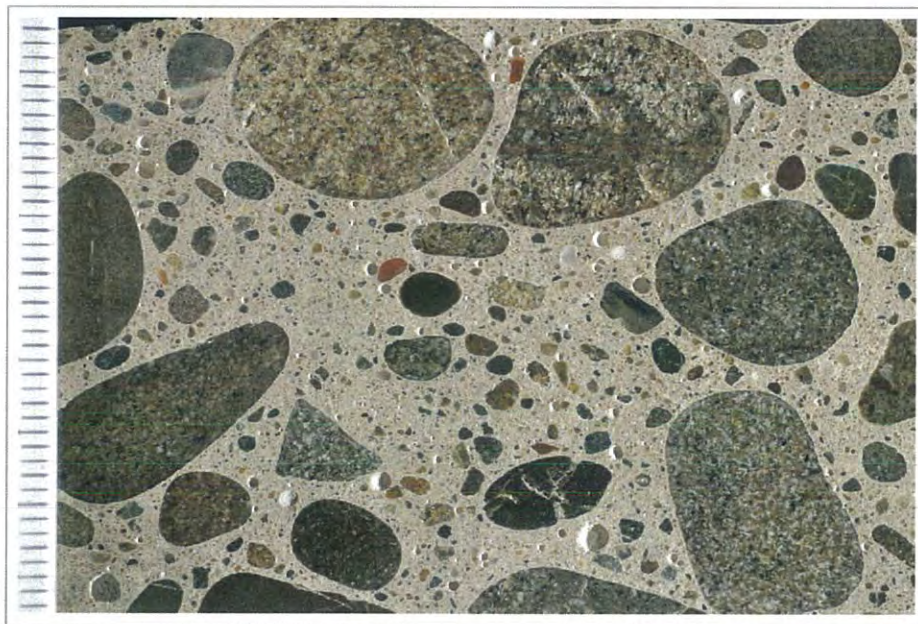
| 5. COARSE AGGREGATE | |
|---|---|
| PHYSICAL PROPERTIES | Natural river gravel with 19 mm (¾ in.) nominal top size ( <b>Figure C6</b> ). The rocks are hard and competent. The particles are mostly oblong in shape with well-rounded to round edges but sub-equant, rounded particles also make up a significant portion of the aggregate. No alignment of elongated particles observed. The grading and distribution is fairly even. |

Figure C6. Photograph of the polished surface showing coarse aggregate; scale in millimeters.

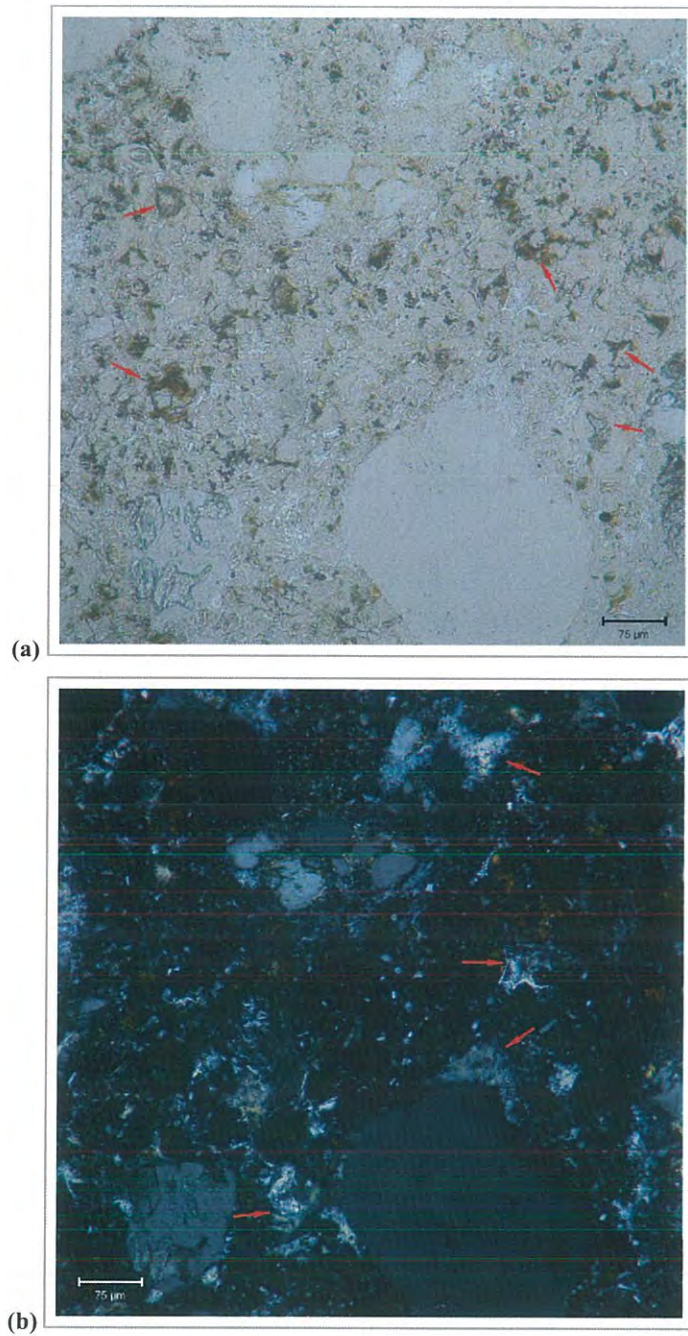
| THIN SECTION* | The paste contains hydrated portland cement; no fly ash, slag cement or other SCM were observed ( <b>Figure C10</b> ). The hydration is normal with 3-6% RRCG that consist mostly of belite and interstitial aluminate and ferrite. CH makes up 12-18% of the paste, is medium to coarse-grained and unevenly distributed. |

Figure C10. Transmitted light photomicrographs of thin section from the concrete core showing detail of paste in (a) plane-polarized and (b) cross-polarized light. The red arrows in (a) indicate RRCG; in (b) they indicate CH.

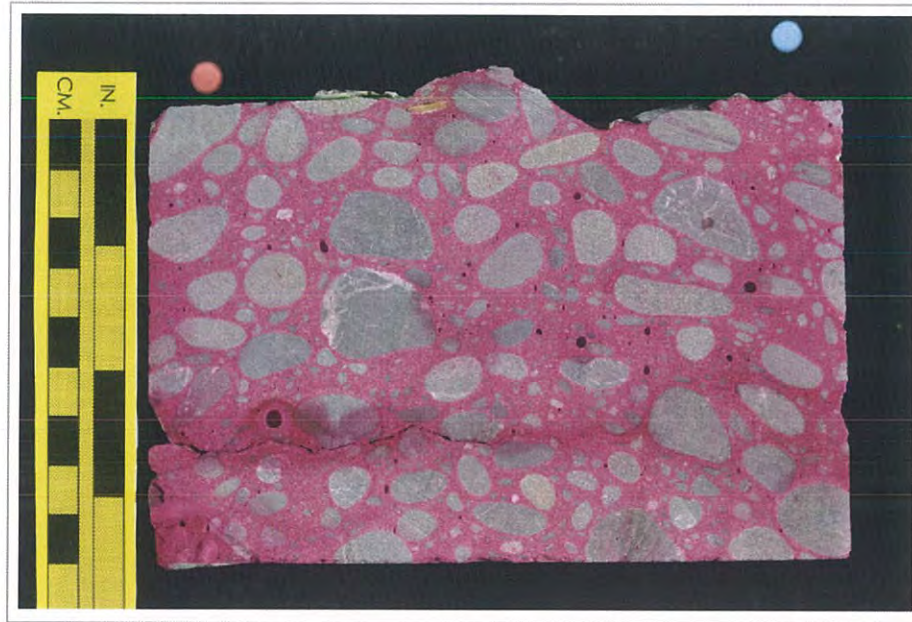
| PHENOLPHTHALEIN | Entire surface stains purple ( <b>Figure C11</b> ). |

Figure C11. Photograph showing phenolphthalein stained surface.

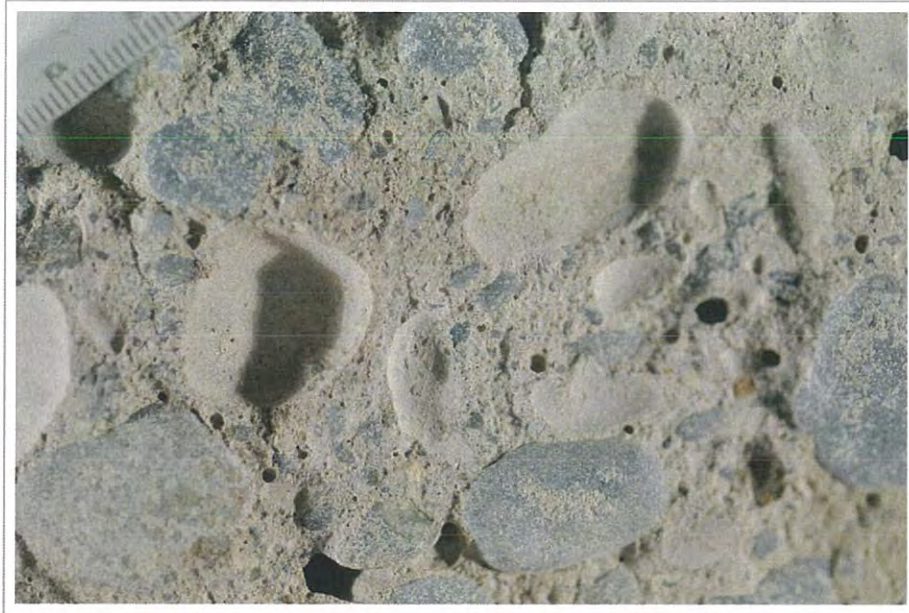
| 1. RECEIVED CONDITION | |
|---|---|
| GENERAL CONDITION | The concrete is hard and compact and rings lightly when sounded with a hammer. The as-received fracture surface at the bottom of the core cuts around aggregate particles ( <b>Figure D3</b> ). |

Figure D3. Photograph showing detail of the top fracture surface of the core; scale in millimeters.

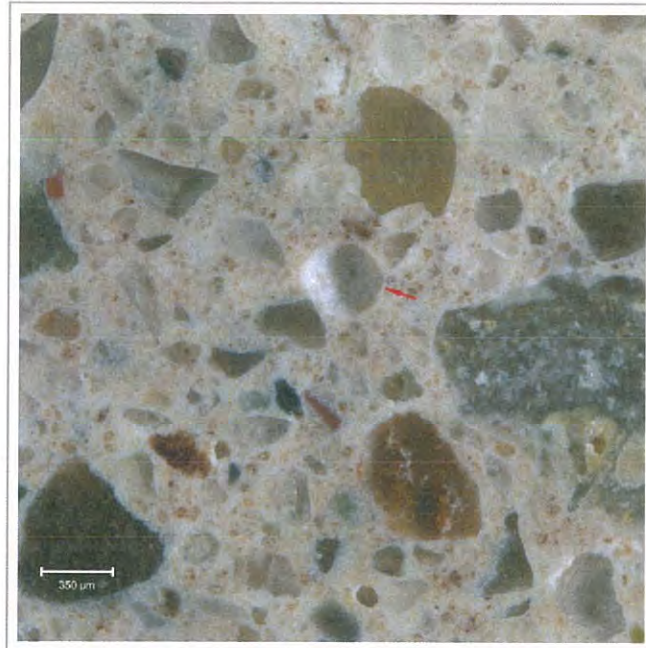
| 4. VOIDS | |
|---|---|
| VOID SYSTEM | Concrete is not air-entrained and contains less than 3% air by visual estimation (not determined following ASTM C457; <b>Figure D5</b> ). The consolidation of the concrete is good with no large entrapped voids or bleed voids observed. |

Figure D5. Oblique reflected light photomicrograph of polished surface showing view of voids (red arrow and dark circles).

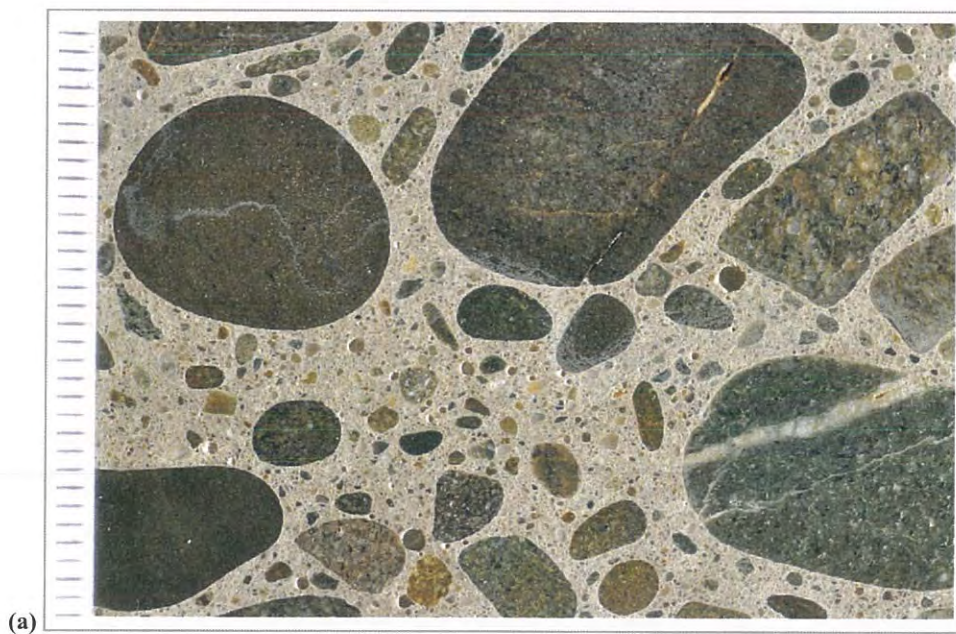
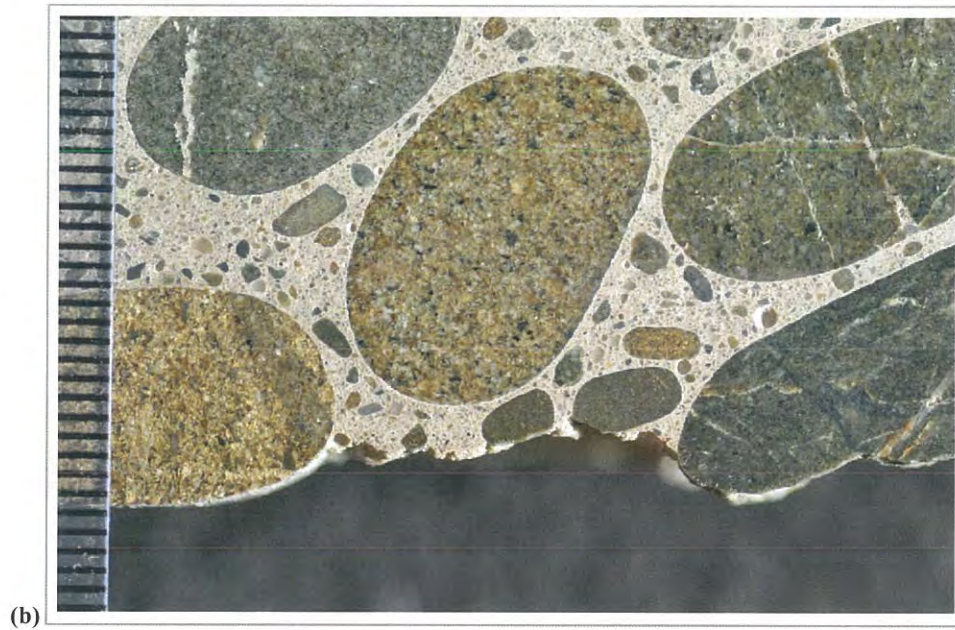
| 5. COARSE AGGREGATE | |
|---|---|
| PHYSICAL PROPERTIES | Natural river gravel with 19 mm (3/4 in.) nominal top size ( <b>Figure D6</b> ). The rocks are hard and competent. The particles are mostly oblong in shape with well-rounded to round edges but sub-equant, rounded particles are also make up a significant portion of the aggregate. No alignment of elongated particles observed. The grading and distribution is fairly even. |

Figure D6 (cont'd). Photograph of the polished surface showing coarse aggregate; scale in millimeters.

Figure D6 (cont'd). Photograph of the polished surface showing coarse aggregate near bottom fracture surface; scale in millimeters.

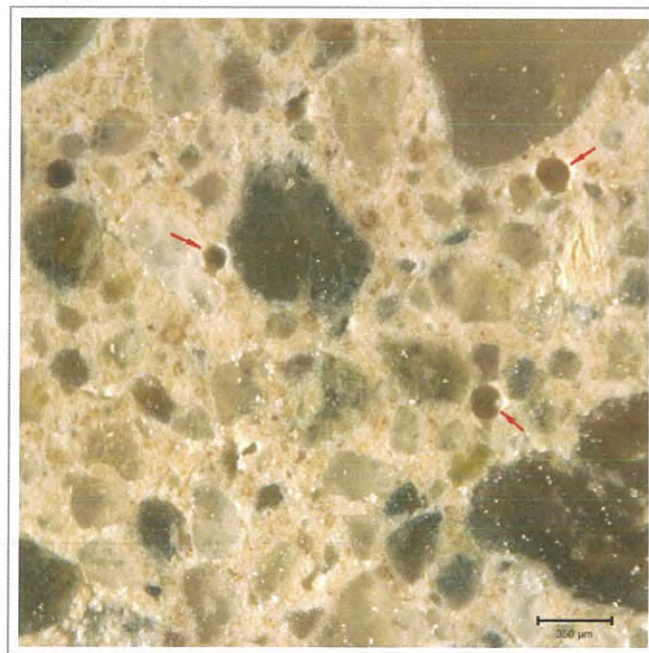
Figure E3. Oblique reflected light photomicrograph of polished surface showing voids (red arrows).

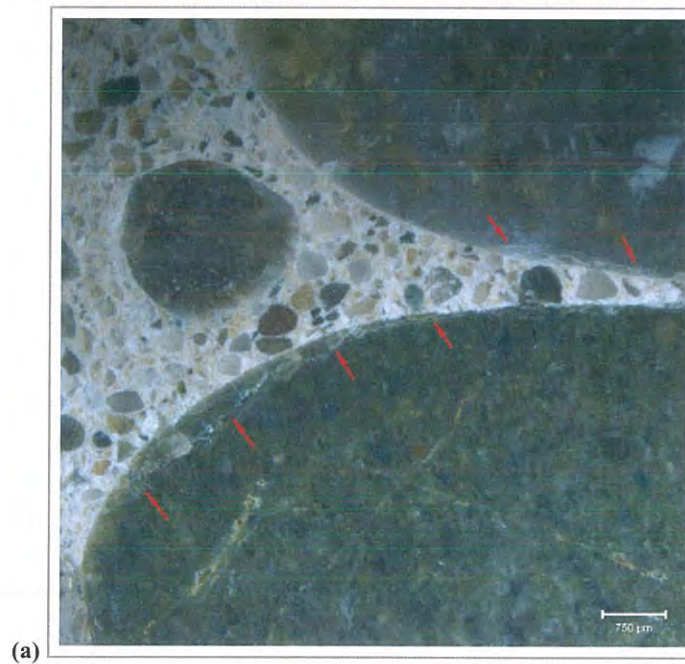
Figure E5. Reflected light photomicrograph of polished surface showing peripheral microcracks (red arrows) in aggregate particles. Note the microcracks do not cut into the paste.

Figure E5 (cont'd). (b) Reflected light photomicrograph of polished surface showing detail of peripheral microcracking (red arrows) in aggregate particle. Note the microcracks do not cut into the paste.

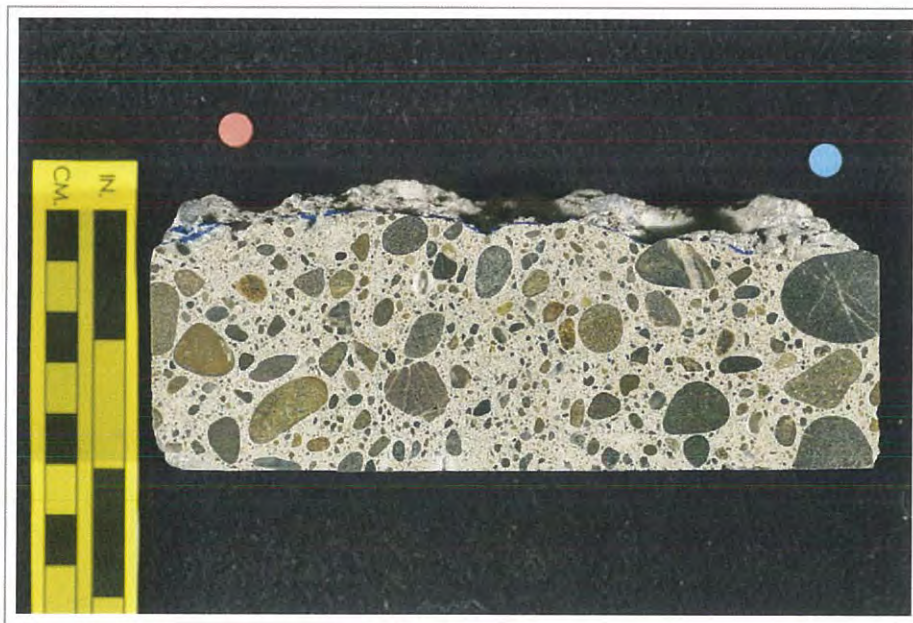
| 1. RECEIVED CONDITION | |
|---|---|
| SURFACES | The top and bottom surfaces are fracture surfaces such that the core represents a partial thickness of the column. The fractures pass consistently around aggregate particles; the fracture surface at the top of the core is relatively clean whereas the lower surface was covered with a thin film of detritus or drilling mud ( <b>Figure F2</b> ). The piece used for petrography has a fracture surface at the top and a saw-cut at the bottom and is about 50 mm (2 in.) thick. Both sides of the slab cut from this section were polished ( <b>Figure F3</b> ). |

Figure F3. Photograph of one of the polished surfaces used for petrographic work.

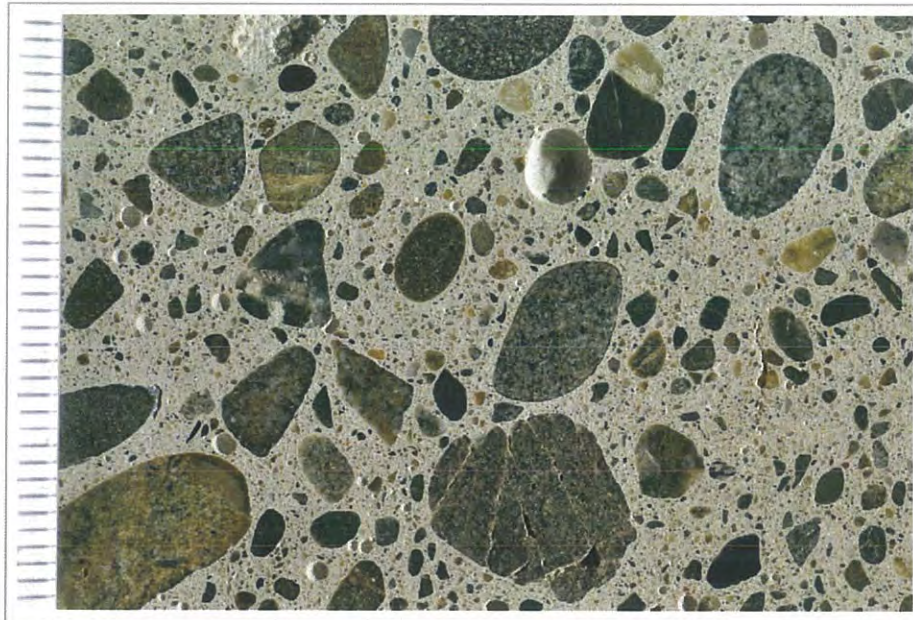
| PHYSICAL PROPERTIES | Natural river gravel with 19 mm (¾ in.) nominal top size ( <b>Figure F7</b> ). The rocks are hard and competent. The particles are mostly oblong in shape with well-rounded to round edges but sub-equant, rounded particles are also make up a significant portion of the aggregate. The grading and distribution are somewhat uneven. No significant alignment of elongated particles was observed. |

Figure F7. Photograph of the polished surface showing coarse aggregate; scale in millimeters.

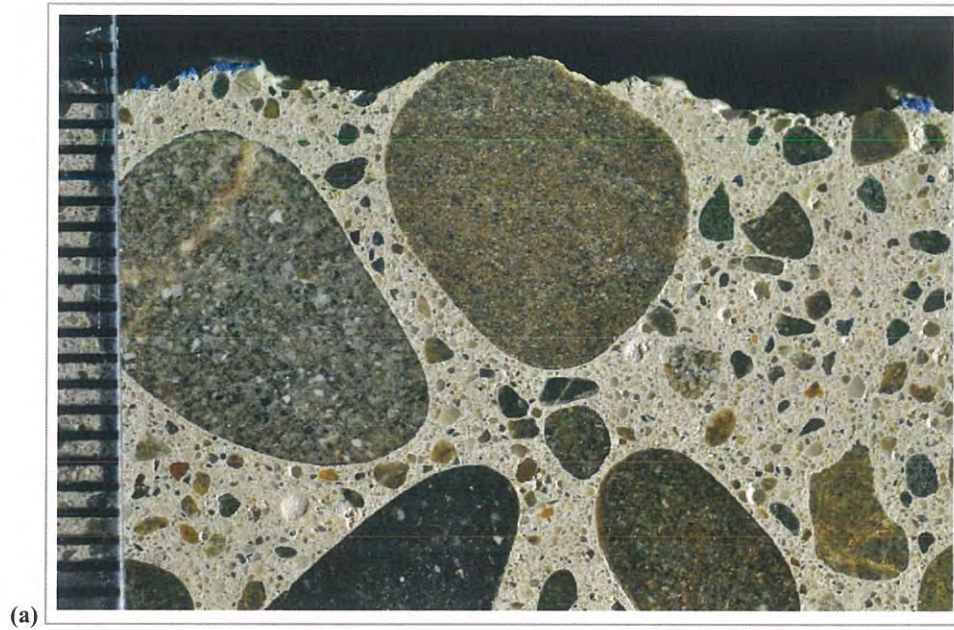
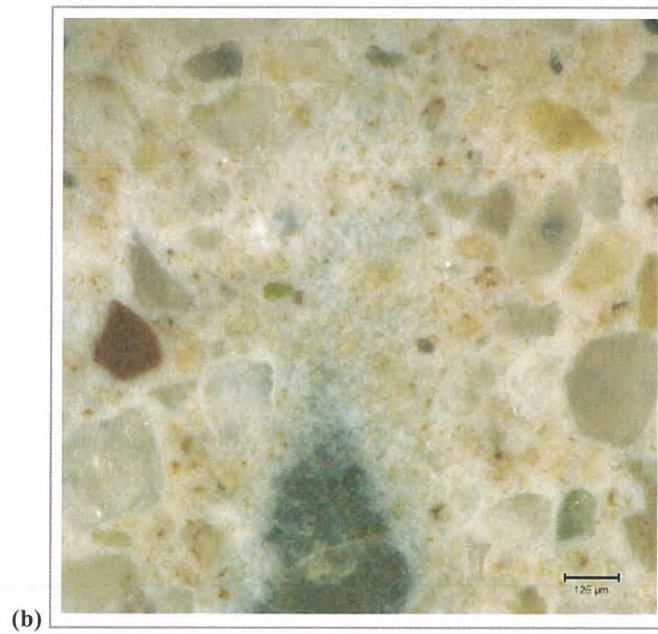
| POLISHED SURFACE | Paste is light gray (Munsell 10YR/7/2) when observed macroscopically but is mottled from white to light brown when viewed at high magnification under reflected light ( <b>Figure F9</b> ). The paste has a granular to smooth texture and a sub-vitreous luster. The paste is moderately hard (Mohs ~ 3). |

Figure F9. (a) Photograph of polished surface showing overview of paste at the top of the core. The scale is in millimeters. (b) Reflected light photomicrograph of polished surface showing detail of paste texture and luster.

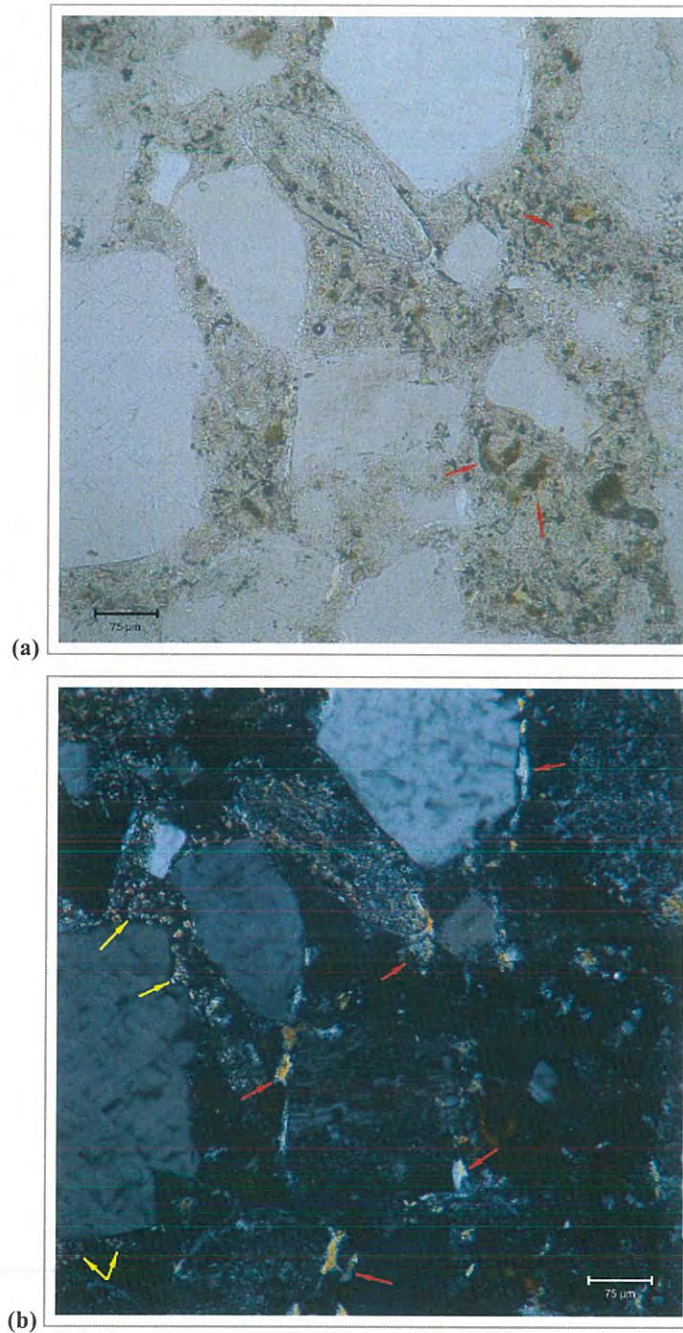
| THIN SECTION* | The paste contains hydrated portland cement; no fly ash, slag cement or other SCM were observed ( <b>Figure F10</b> ). The hydration is advanced with less than 3% RRCG that consist mostly of belite and interstitial aluminate and ferrite. CH makes up 15-25% of the paste, is coarse-grained and unevenly distributed. Fine crystallites of calcium carbonate also observed intermittently. |

Figure F10. Transmitted light photomicrographs of thin section from the concrete core showing detail of paste in (a) plane-polarized and (b) cross-polarized light. The red arrows in (a) indicate RRCG; in (b) they indicate CH. The yellow arrows in (b) indicate crystallites of calcium carbonate.

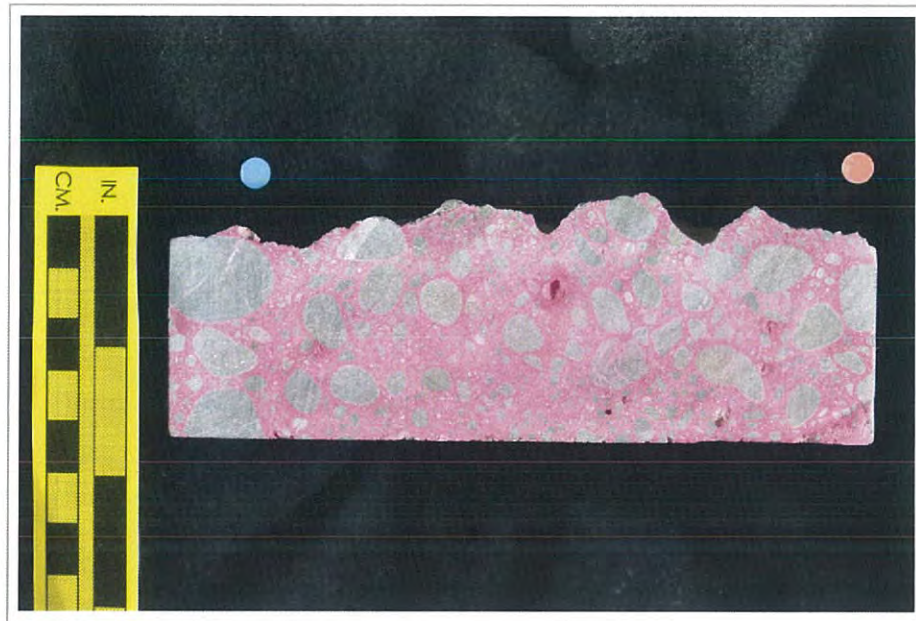
| PHENOLPHTHALEIN | Entire surface stains purple ( <b>Figure F11</b> ). |

Figure F11. Photograph showing the phenolphthalein stained surface.
