Under **THE COMMISSIONS OF INQUIRY ACT 1908**  
In the matter of the **CANTERBURY EARTHQUAKES ROYAL COMMISSION  
OF INQUIRY INTO THE COLLAPSE OF THE CTV  
BUILDING**

**STATEMENT OF EVIDENCE OF DOUGLAS JON HAAVIK**

**BRIEF OF EVIDENCE OF DOUGLAS JON HAAVIK**

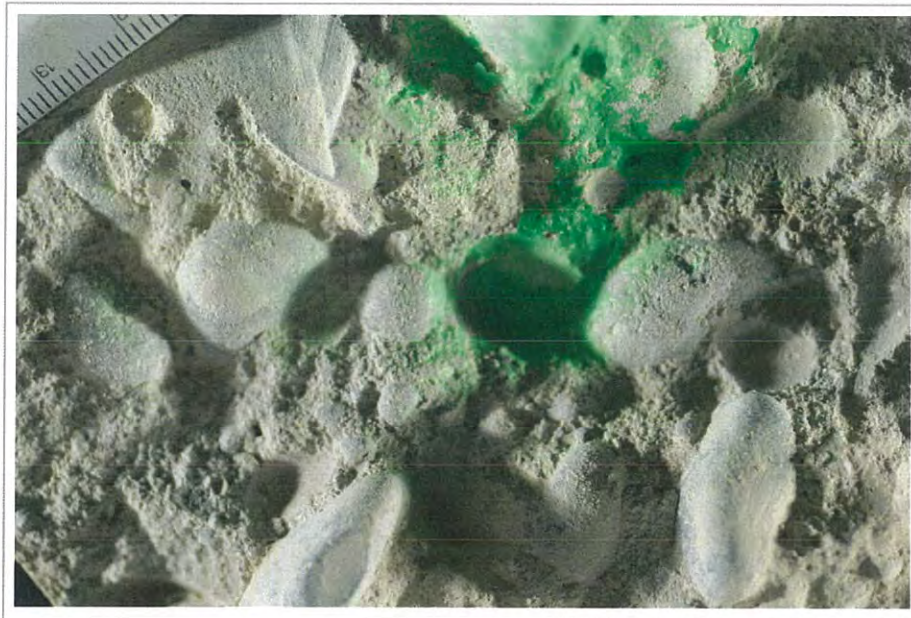
| SURFACES | The top and bottom surfaces are fracture surfaces such that the core represents a partial thickness of the column. The fractures pass consistently around aggregate particles ( <b>Figure G3</b> ). The piece used for petrography had the saw cut at the bottom and the fracture at the top. |

Figure G3. Photograph showing detail of the as-received top surface of the core.

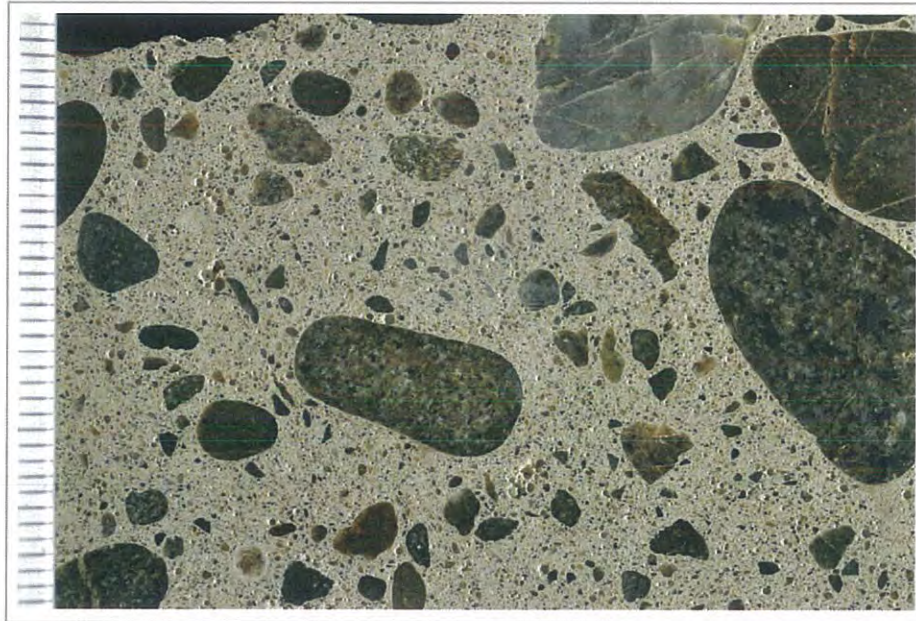
| PHYSICAL PROPERTIES | Natural river gravel with 19 mm (¾ in.) nominal top size ( <b>Figure G6</b> ). The rocks are hard and competent. The particles are mostly oblong in shape with well-rounded to round edges but sub-equant, rounded particles are also make up a significant portion of the aggregate. The aggregate is somewhat gap graded with few intermediate-sized particles such that the concrete has a high sand content with most sand particles less than 1.18 mm (#16 sieve). The distribution is relatively even. No significant alignment of elongated particles was observed. |

Figure G6. Photograph of the polished surface showing coarse aggregate; scale in millimeters.

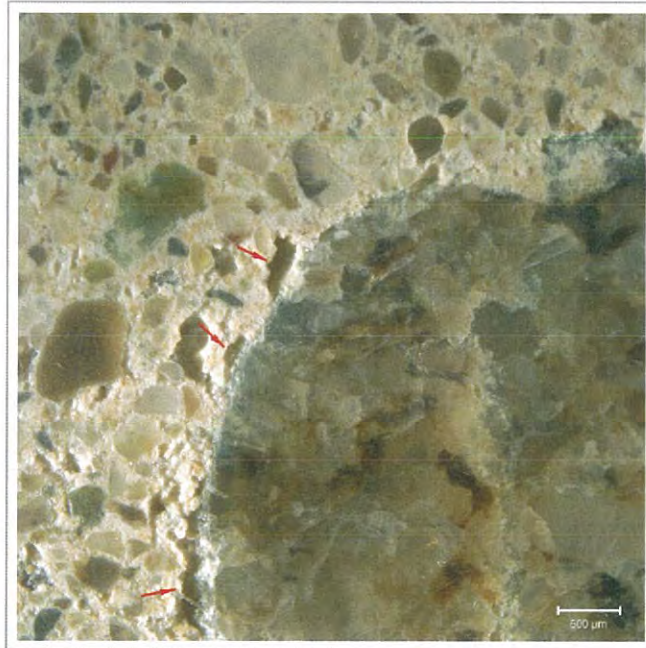
| OTHER FEATURES | No deleterious coatings or incrustations observed. No low w/c mortar coatings observed. No reaction rims, significant internal microcracking, deposits of gel or other evidence of ASR observed. Minor loss of paste observed around some aggregate particles; deposits of ettringite observed around aggregate ( <b>Figure G7</b> ). |

Figure G7. Reflected light photomicrograph of polished surface showing detail of paste-aggregate boundary and loss of paste around the aggregate (red arrows).

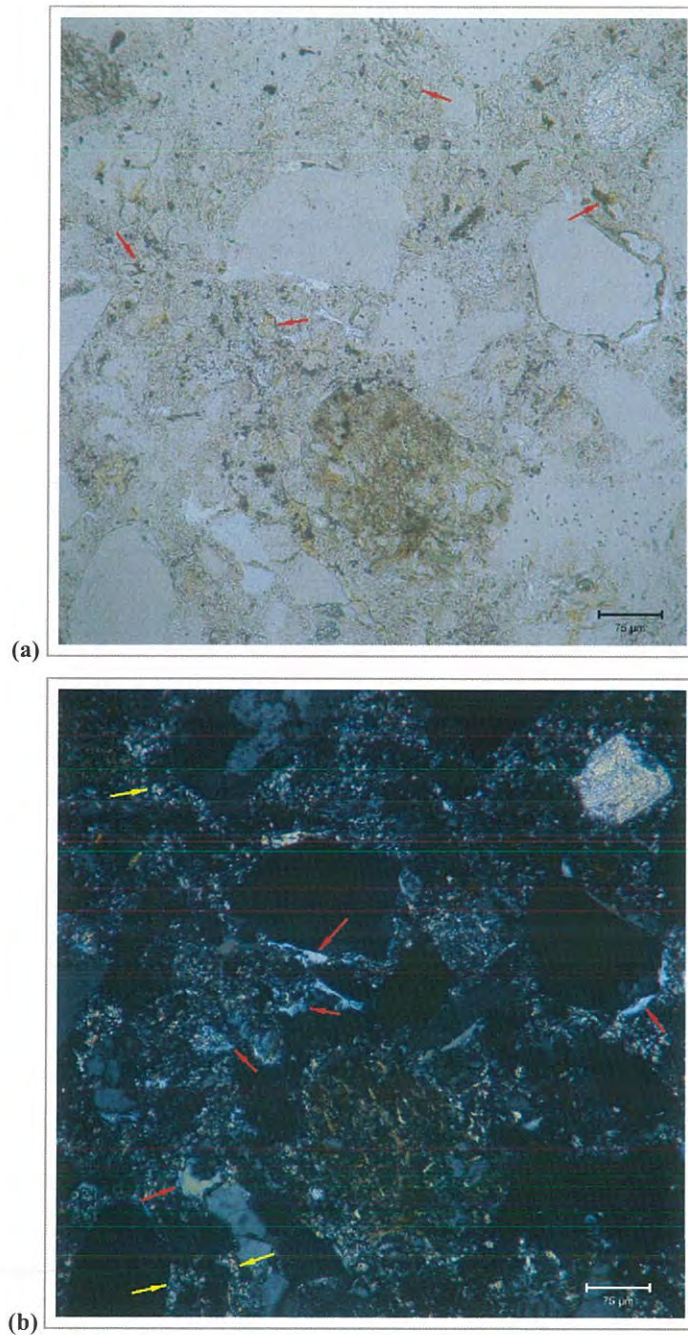
| THIN SECTION* | The paste contains hydrated portland cement; no fly ash, slag cement or other SCM were observed ( <b>Figure G10</b> ). The hydration is advanced with less than 3% RRCG that consist mostly of belite and interstitial aluminate and ferrite. CH makes up 15-25% of the paste, is coarse-grained and unevenly distributed. Fine crystallites of calcium carbonate also observed intermittently. |

Figure G10. Transmitted light photomicrographs of thin section from the concrete core showing detail of paste in (a) plane-polarized and (b) cross-polarized light. The red arrows in (a) indicate RRCG; in (b) they indicate CH. The yellow arrows in (b) highlight crystallites of calcium carbonate.

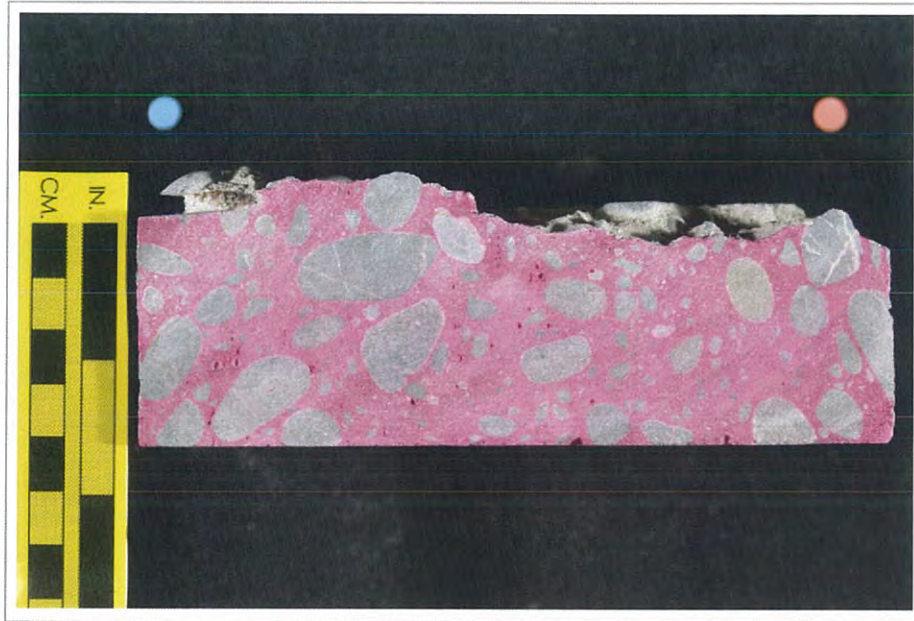
| PHENOLPHTHALEIN | Entire surface stains purple ( <b>Figure G11</b> ). |

Figure G11. Photograph showing phenolphthalein stained surface.

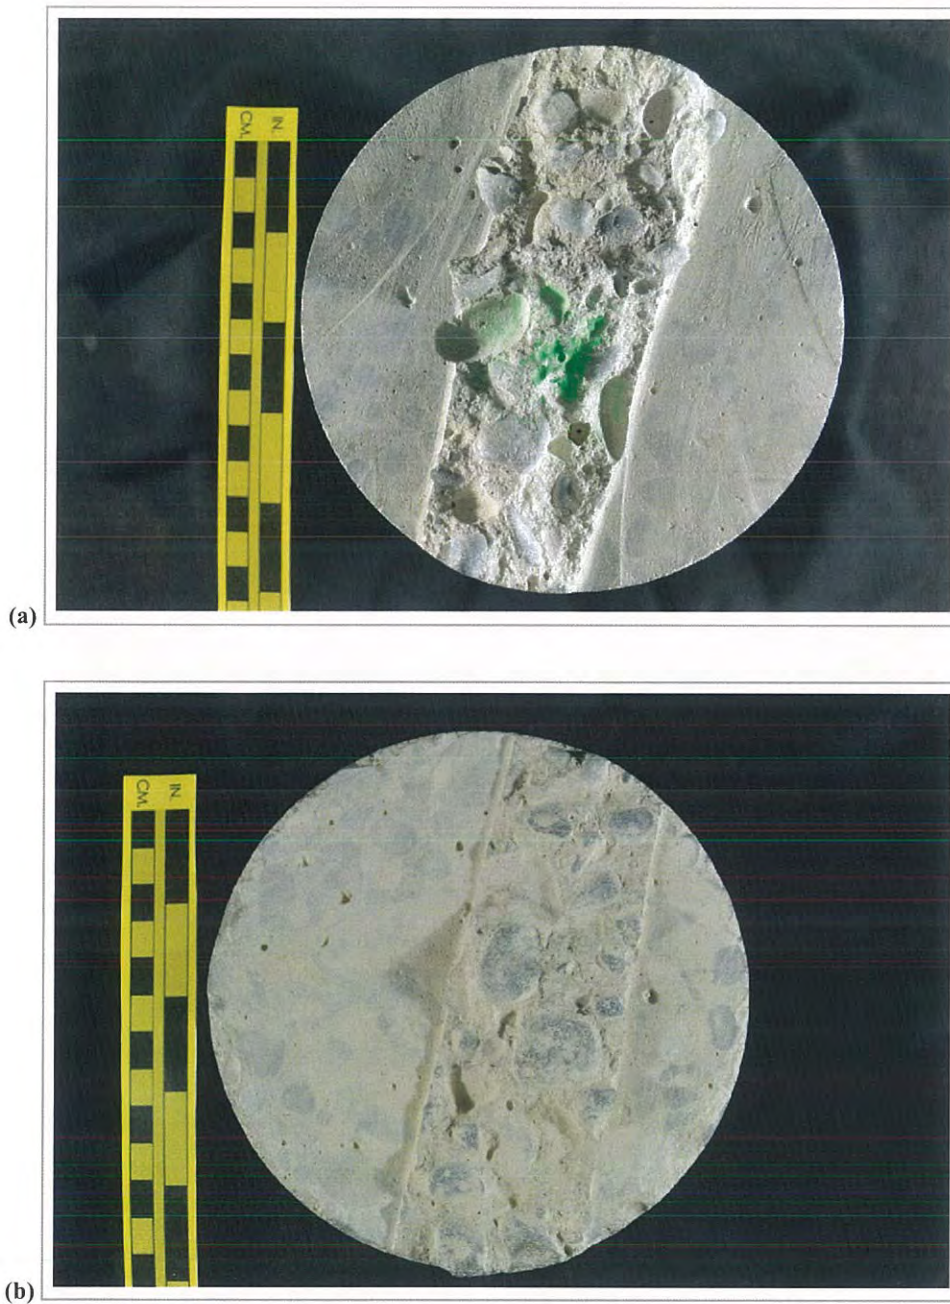
| SURFACES | The top and bottom surfaces have a saw cut over most of them with a fracture in the center of the surfaces, such that the core represents a partial thickness of the column ( <b>Figure H2</b> ). The bottom of the top piece and top of the bottom piece are fracture surfaces that pass consistently around aggregate particles and the fractured sections of the top and bottom surfaces also pass around aggregates ( <b>Figure H3</b> ). The piece used for petrography from the upper section of the core had the saw cut at the top and a fracture at the bottom and the piece from the bottom of the core had fractures at the top and bottom ( <b>Figure H4</b> ). |

Figure H2. Photographs showing the as-received (a) top and (b) bottom surfaces of the core.

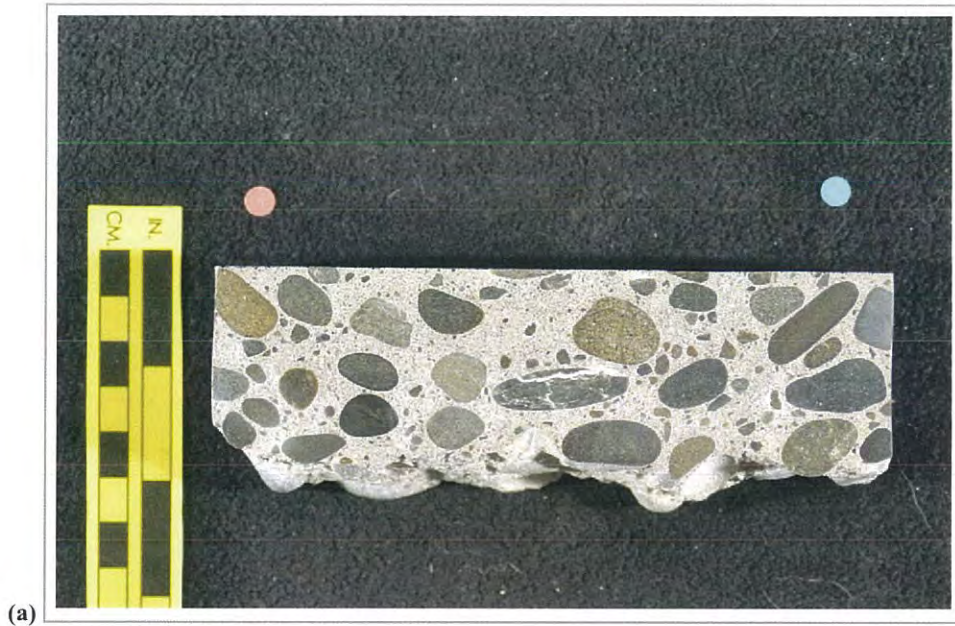
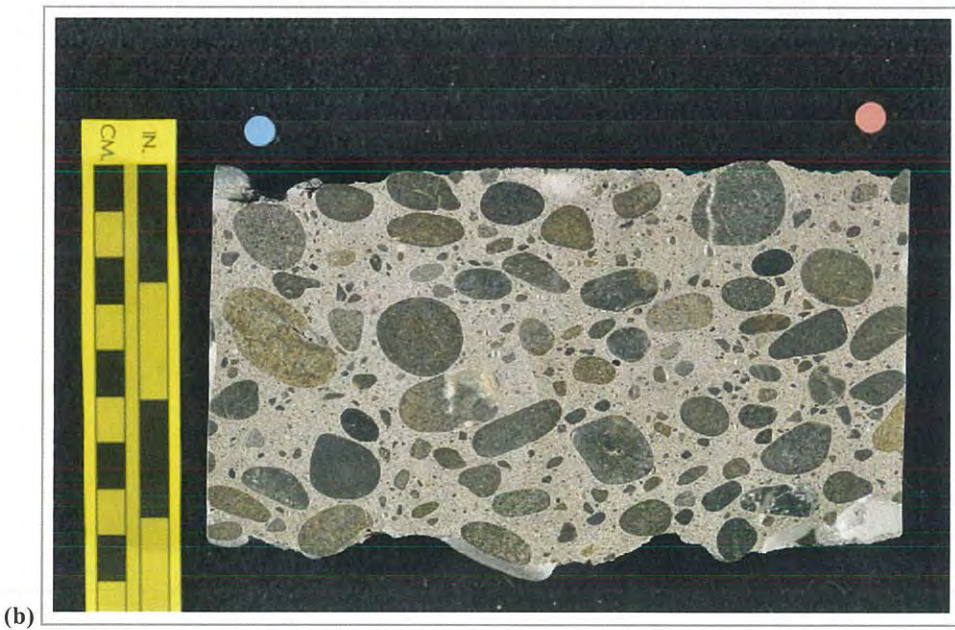
Figure H4. Photographs showing the polished surfaces from the (a) top section and (b) bottom section of the core.

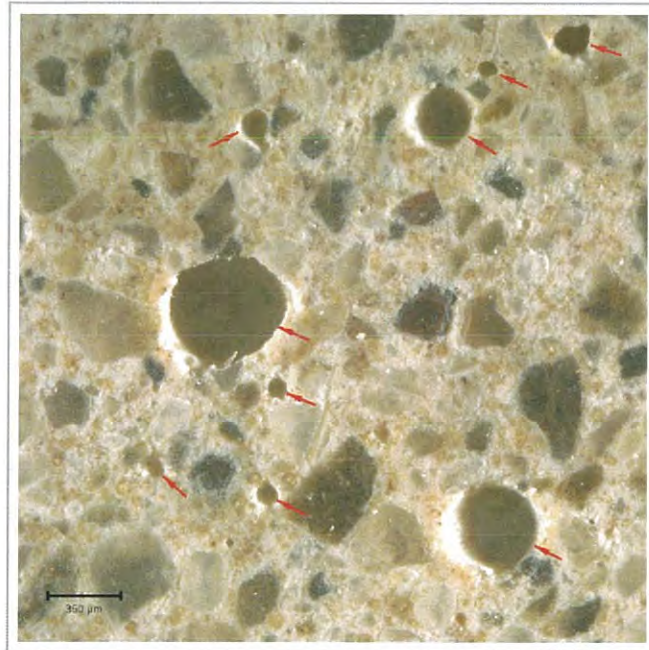
| VOID SYSTEM | Concrete is not air-entrained and contains 2.0% air by ASTM C457 ( <b>Figure H5</b> ). The point count analysis was done on the section from the bottom of the core. The concrete is well-consolidated in that no large entrapped voids or bleed voids observed. |

Figure H5. Oblique reflected light photomicrograph of polished surface showing view of voids (red arrows).

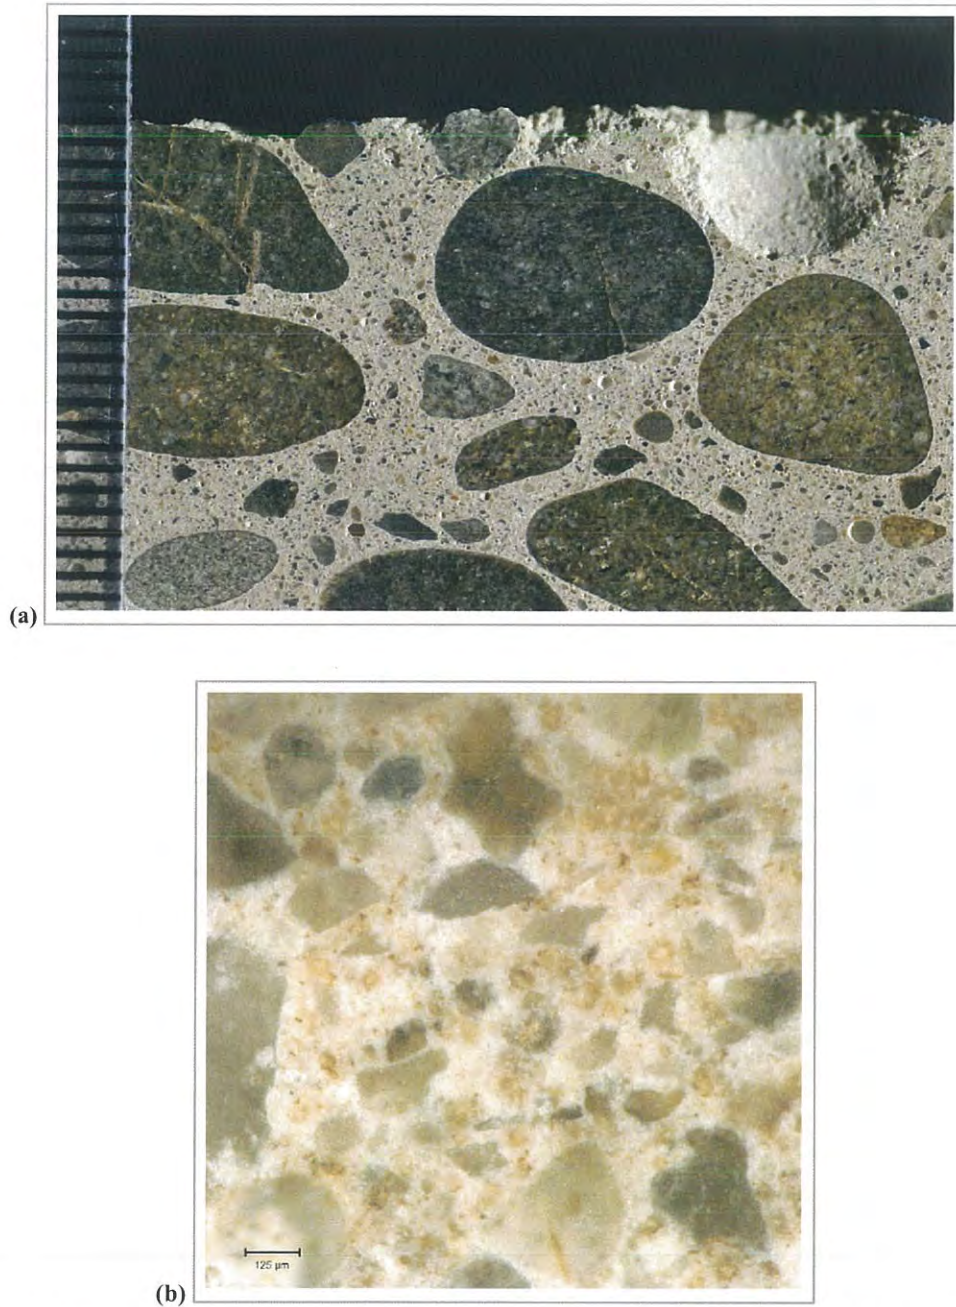
**Figure H8. (a) Photograph showing overview of paste at the top of the bottom section of the core. The scale is in millimeters. (b) Reflected light photomicrograph of polished surface showing detail of paste texture and luster taken in the middle of the bottom section of the core.**

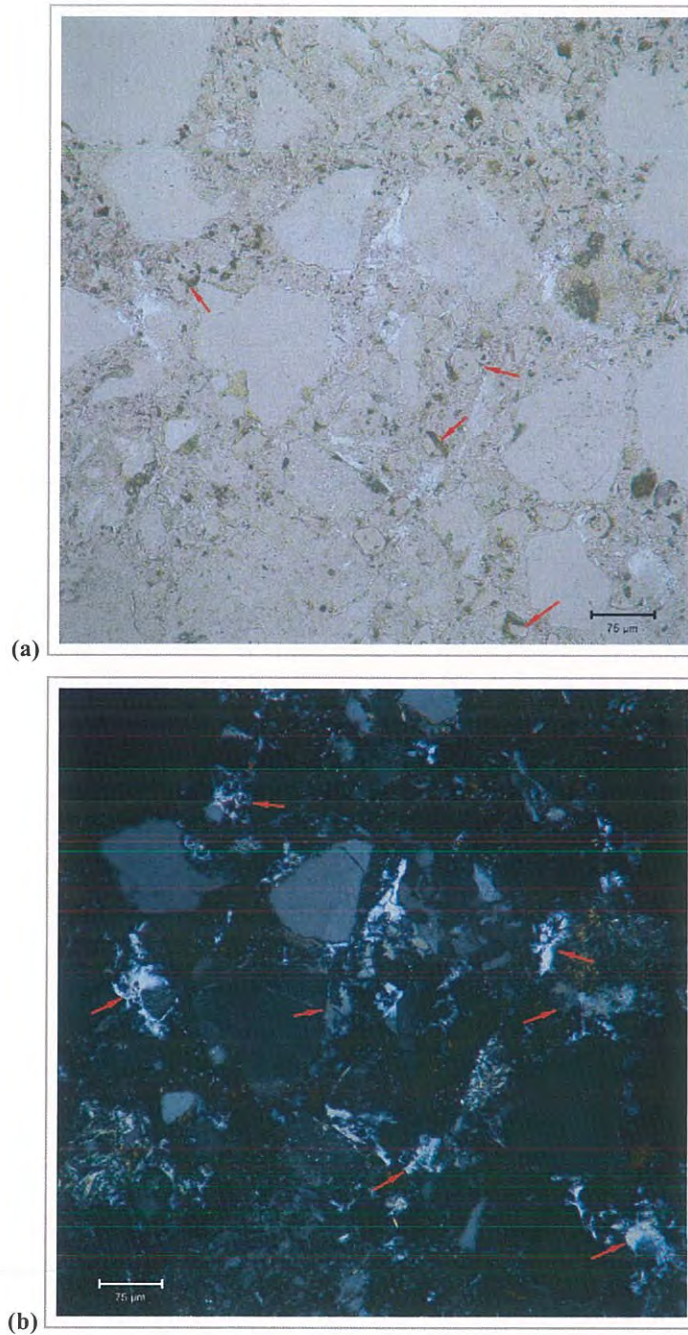
| THIN SECTION* | The paste contains hydrated portland cement; no fly ash, slag cement or other SCM were observed ( <b>Figure H9</b> ). The hydration is normal to advanced with 3-5% RRCG that consist mostly of belite and interstitial aluminate and ferrite. CH makes up 15-25% of the paste, is medium to coarse-grained and unevenly distributed. |

**Figure H9. Transmitted light photomicrographs of thin section from the concrete core showing detail of paste in (a) plane-polarized and (b) cross-polarized light. The red arrows in (a) indicate RRCG; in (b) they indicate CH.**

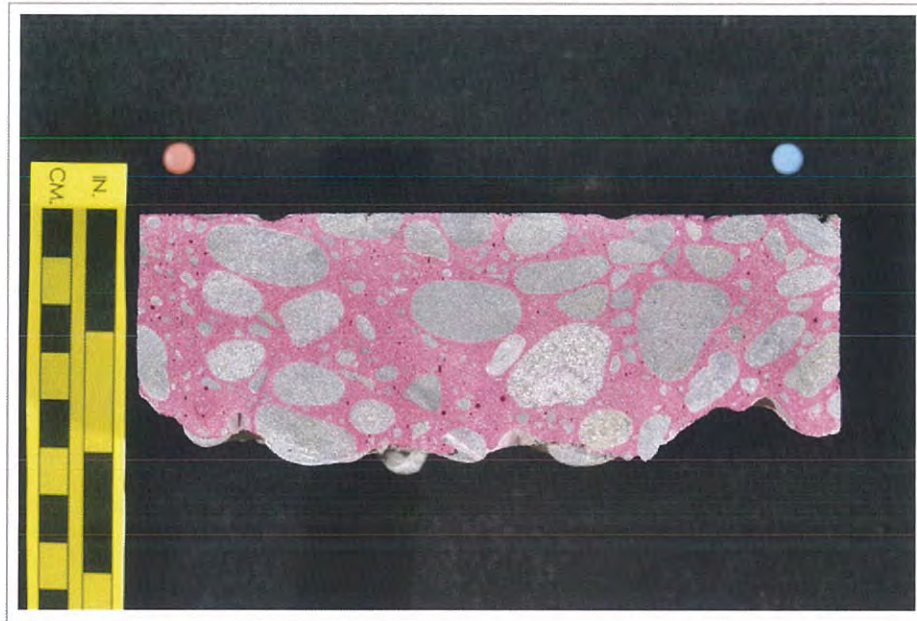
| PHENOLPHTHALEIN | Entire surface stains purple ( <b>Figure H10</b> ). |

Figure H10. Photograph showing phenolphthalein stained surface from the top section of the core.
