**Brief of evidence of Henry John Hare relating to the  
CTV Building (249 Madras Street)**

**Date: 1<sup>st</sup> June 2012**

- 6 This brief of evidence sets out my involvement, whilst employed by HCG, in the preparation of report for a prospective purchaser of an office development located at 249 Madras Street, subsequently known as the CTV Building (**the CTV Building**).

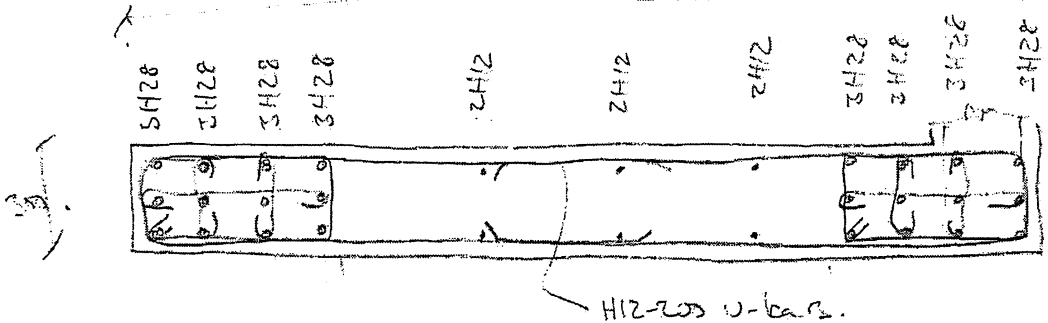
Wall capacity ✓

Appear to have steel of 26m

⇒ Wall supports not much more than self wgt at minimum. + Nominal floor area.

∴ - self wgt @ base = 399 kW
