CTV Building Collapse Technical Investigation

Canterbury Earthquakes Royal Commission

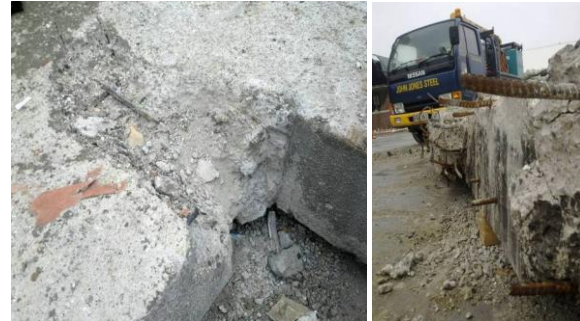
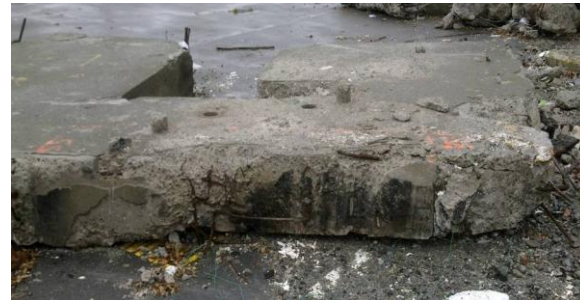
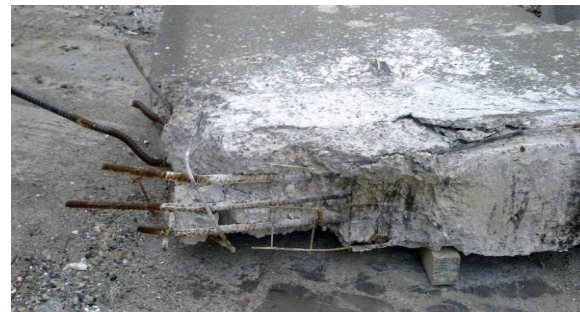
- South Wall Level 5 to 6
 - Soft concrete at door head
 - Non-compliant
 - Smooth construction joints
 - Non-compliant

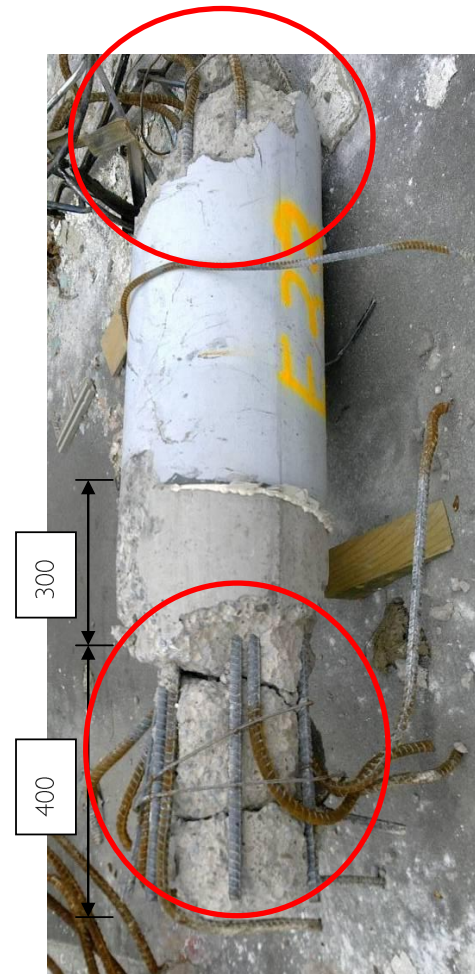
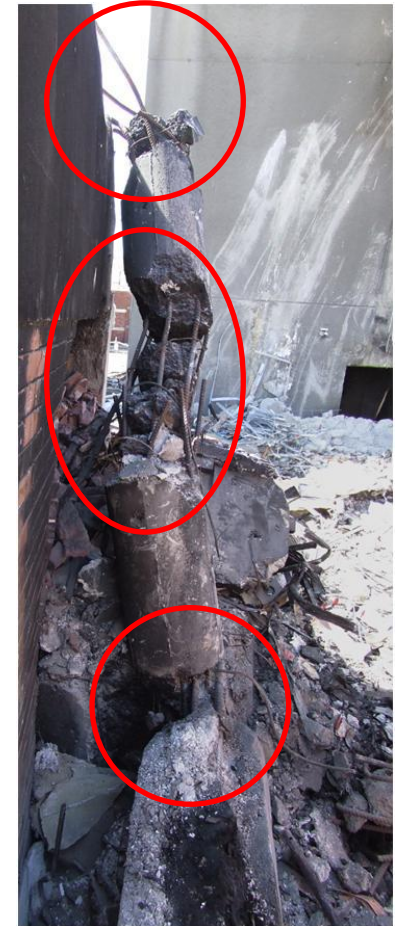
- Column Hinging
 - Base
 - Vertical reinforcing steel termination zone
 - Spandrel Panel contact?
 - Mid-height
 - Head

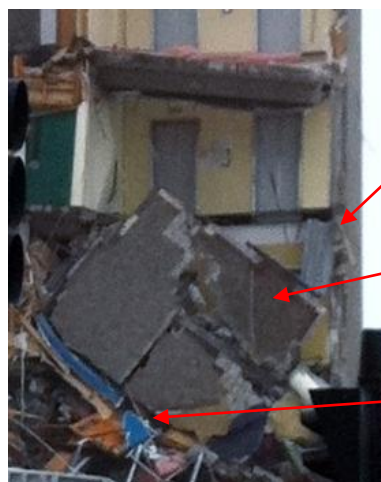
L5 Drag Bar

L5 slab from in front of lifts between Walls D/E and D

L5 slab failure surface 1200 mm out from Line 4 at end of H12 saddle bars

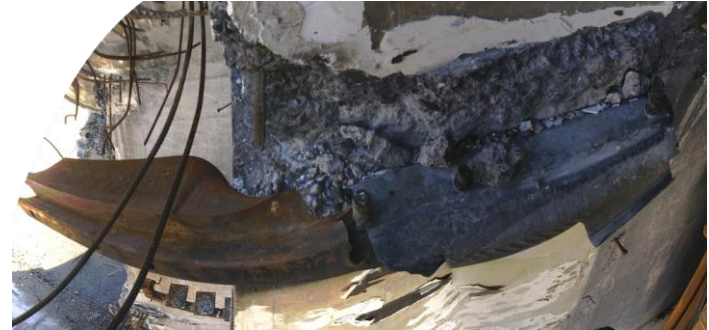
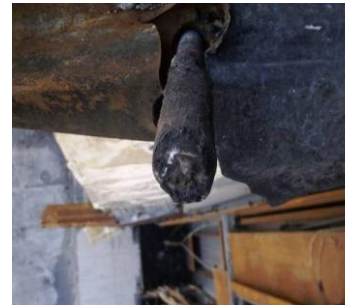
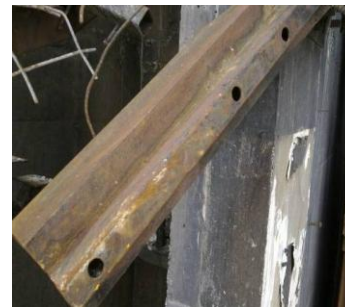
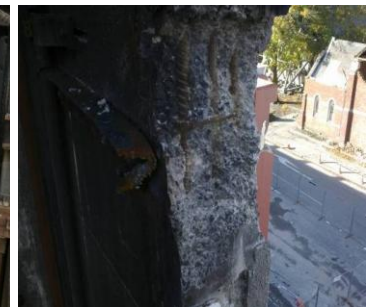
Level 4 Drag Bars

- Drag Bars slab anchors at Levels 4, 5 and 6 upright behind wall tips
 - Slab appeared to have rotated off after collapse further south in building
- Some Drag Bars had been cut off during recovery operations

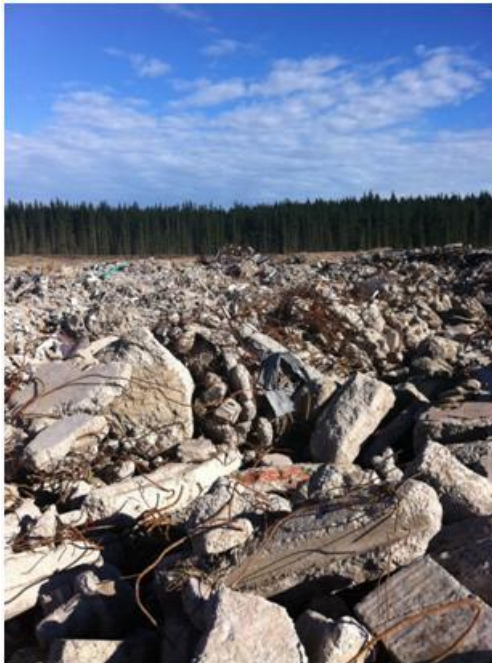
The CTV Building debris field at the Burwood Eco Landfill from which columns were extracted

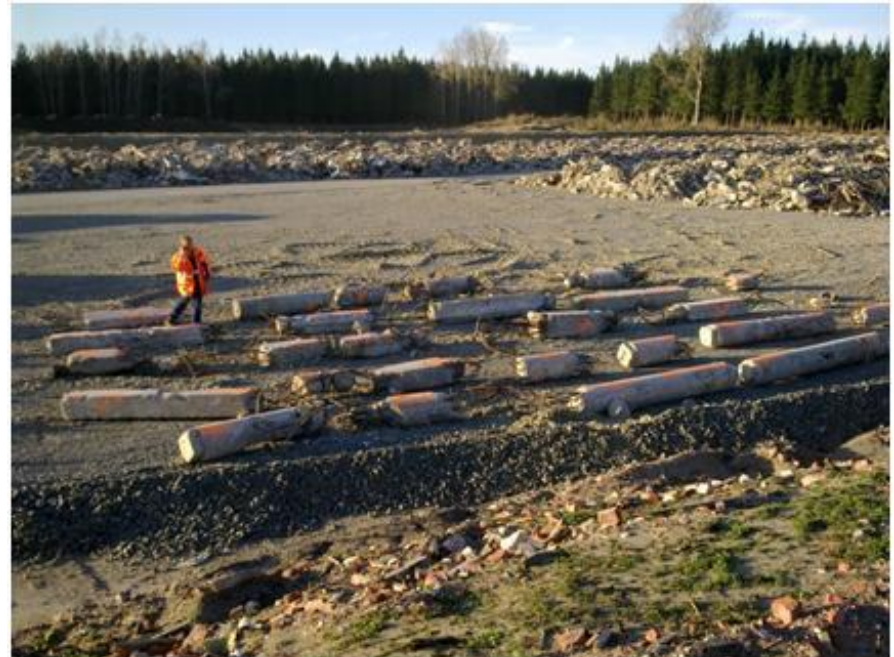
CTV Building columns extracted for examination and testing

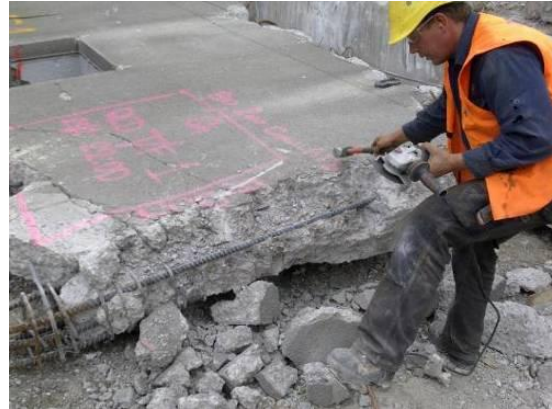
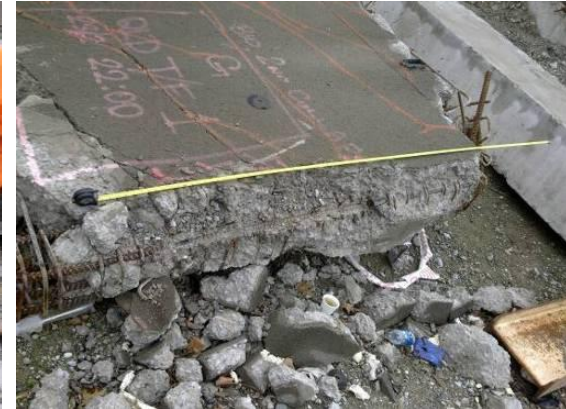
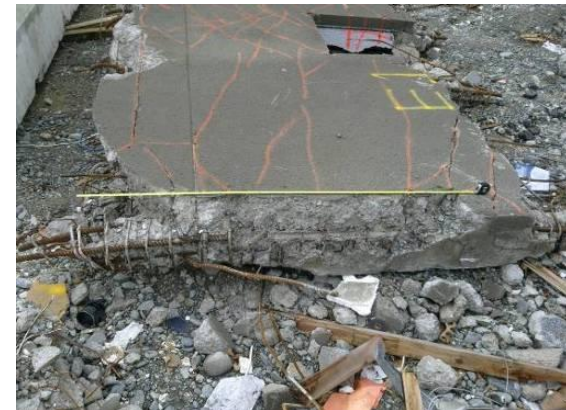
Reinforcing Steel

- South Wall
 - Compliant
 - Some yielding at base only

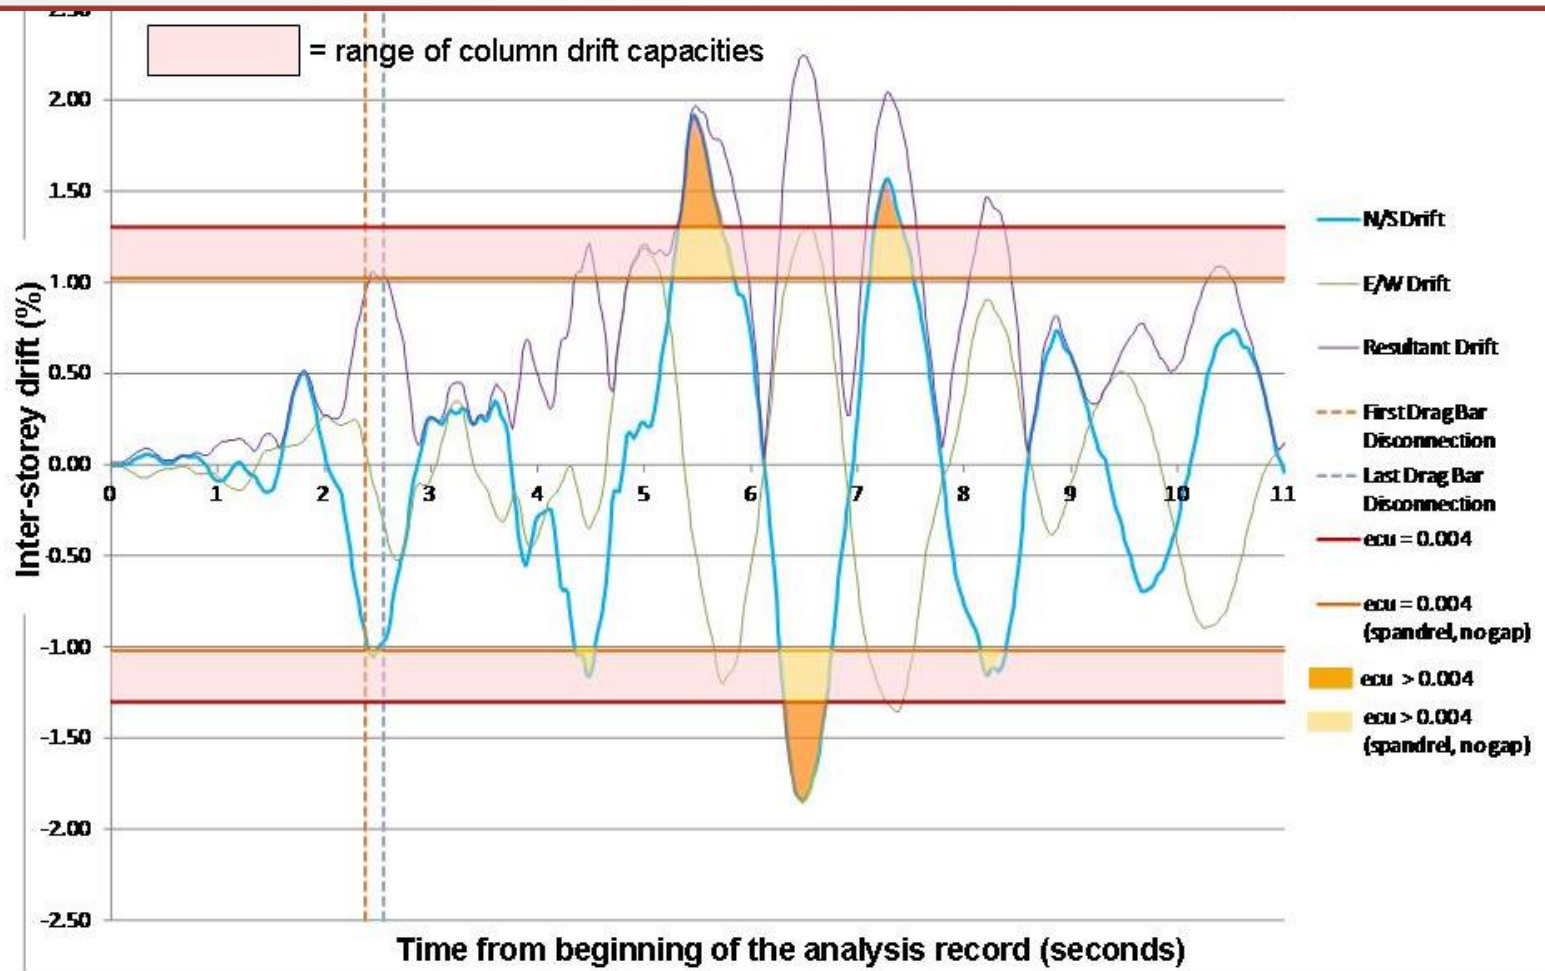
Column F2 Level 3 – 22 Feb 2011 – CBGS Record

Column drift demand and capacity

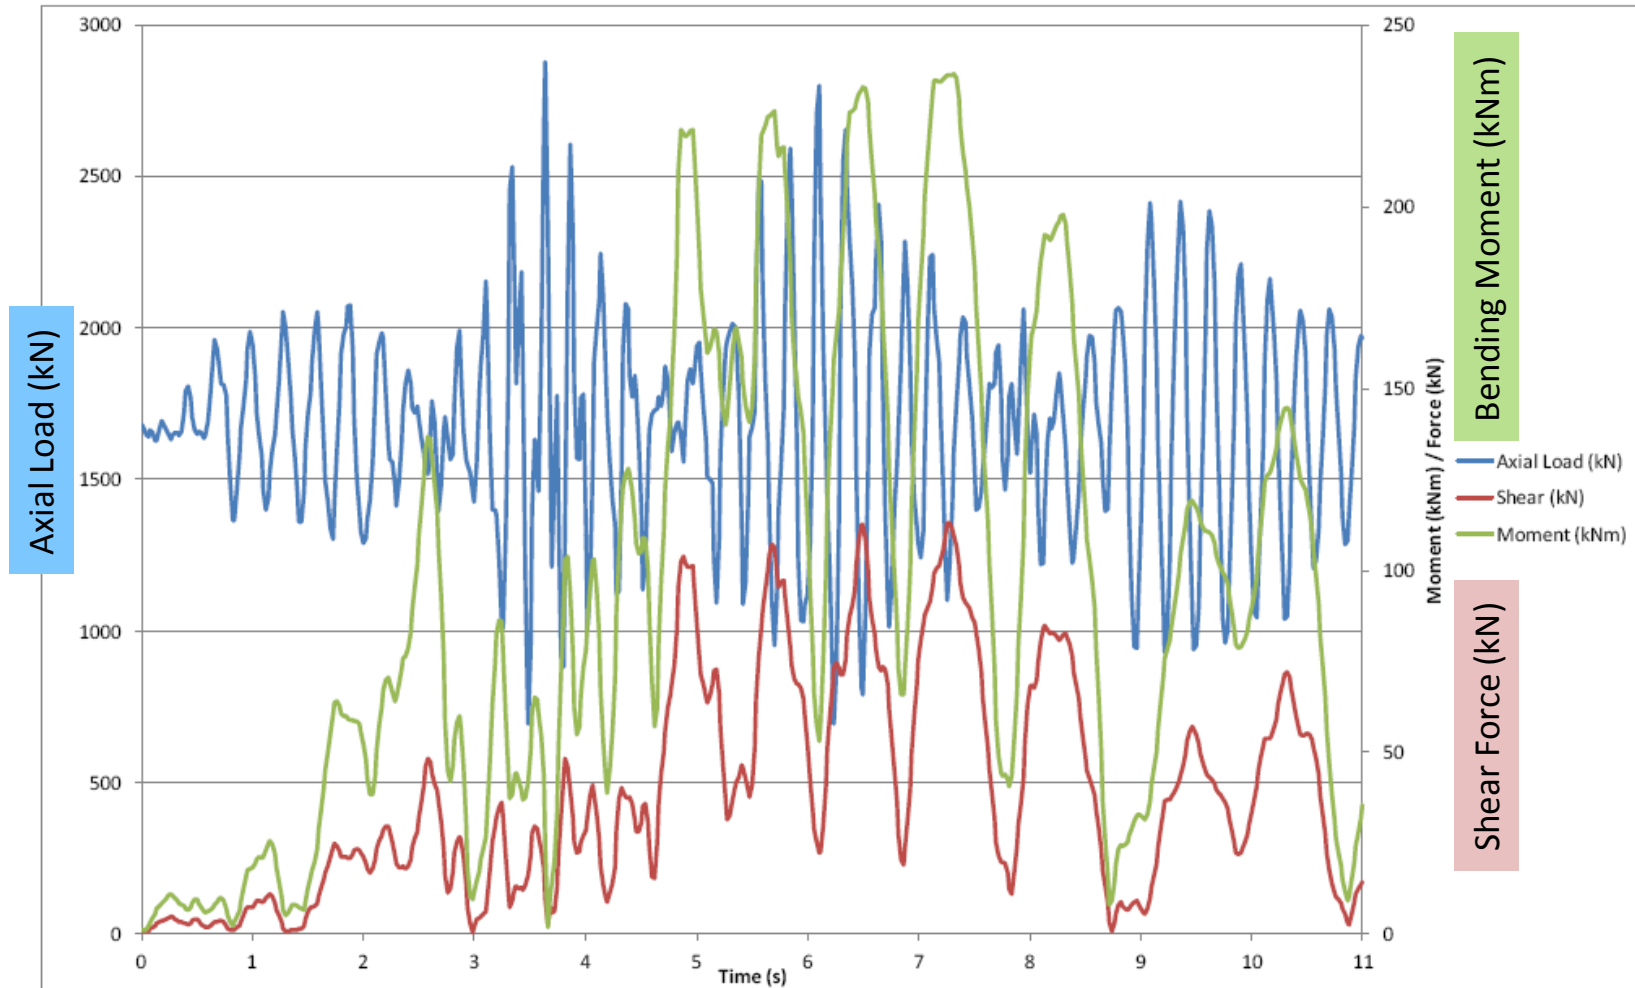
Column Actions Grid D2 Level 1 - 22 Feb 2011

Drift demand vs. capacity for column at grid D2

Level	Axial Load (kN)	Drift Capacity (% of storey height)			E/W Drift Demand 22 Feb CHHC (%)	Ratio <u>Demand</u> Capacity ($\epsilon_{cu}=0.004$)
		First Yield	Nominal Strength	$\epsilon_{cu}=0.004$		
5	324	0.71	0.85	1.31	1.65	1.26
4	681	0.85	0.90	1.20	1.85	1.54
3	1038	no yield	0.89	1.10	1.86	max. 1.69
2	1328	no yield	0.95	1.08	1.76	1.63
1	1682	no yield	0.90	0.96	1.46	1.52

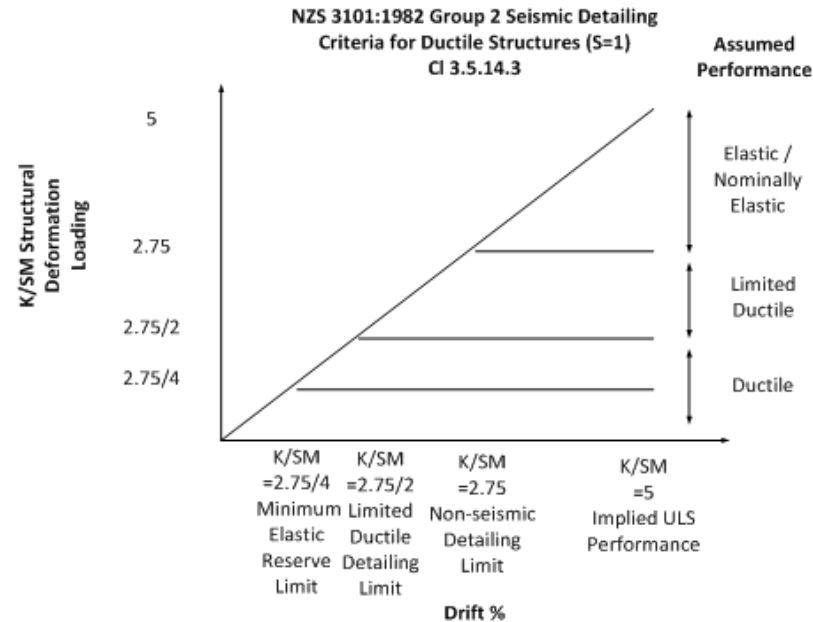
Column Drift Limits

- At $K/SM = 2.75$ loads ($2.75 \times S=1$ loads Fig 162)
 - Elastic behaviour required if no additional seismic reinforcing provided
 - 55% ULS drifts
 - Note NZS 3101:1982 Appendix B and ACI 318-71
 - Working Stress vs Strength Design
 - Additional seismic reinforcing required if elastic behaviour exceeded at or less than that demand
 - Stiff columns would require more reinforcing than more flexible columns to give safe performance
- 1.51% safe drift performance appeared to be expected by the Standards
 - Drift performance of 1.51% at $S=5$ loads
 - Principle of equivalent ductile displacement is basis of NZ seismic design standards

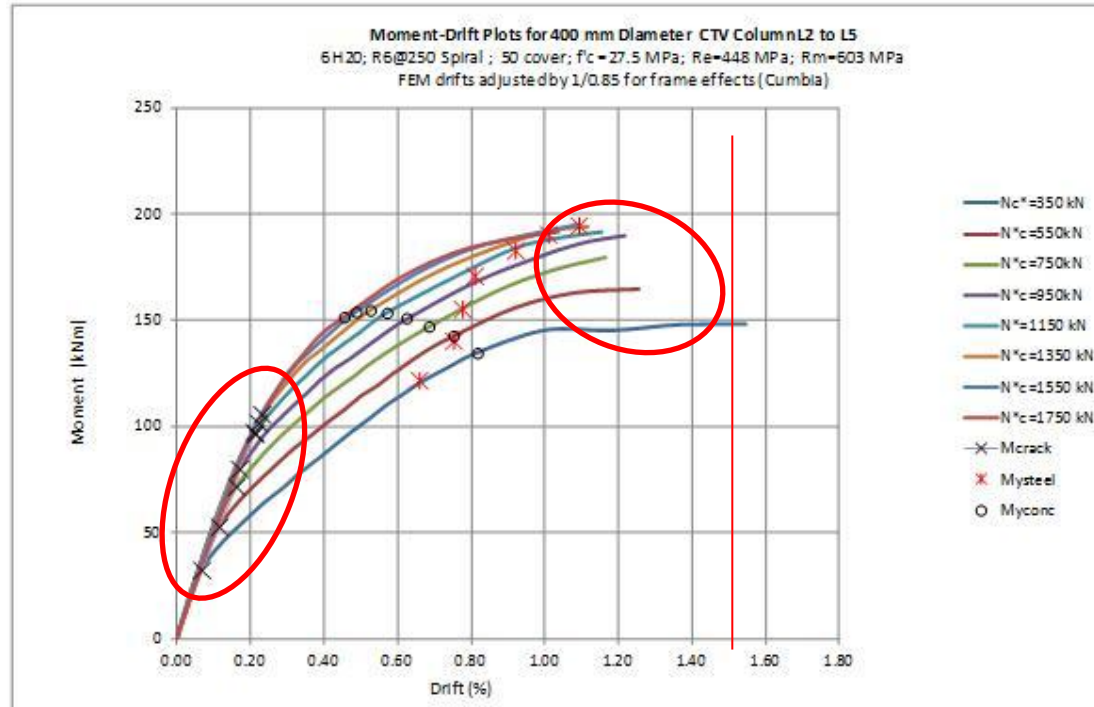
Column Drift Capacity

- At average tested concrete strength of 27.5 MPa (Fig 159)
 - Cracking at 0.10 to 0.35% drifts
- Level 2 to 4 columns North and East faces 1.15 to 1.45% drift capacity (Table 13 and 14)
 - Less than 1.51% safe drift performance expected by Standard

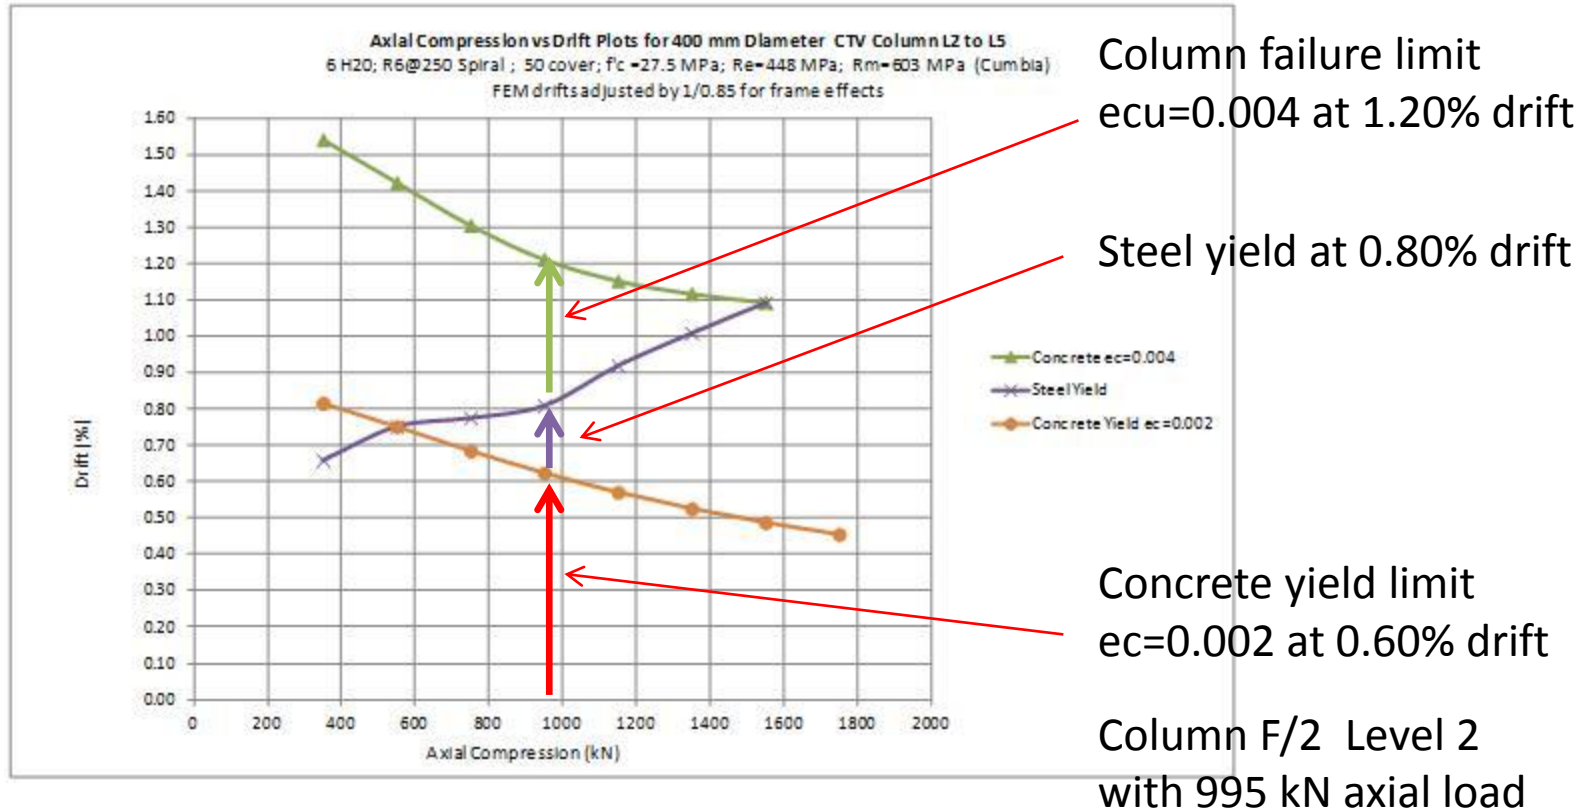
Column Drift Capacity

- At average tested concrete strength of 27.5 MPa
- Drift capacity reduces with increased axial load from vertical acceleration
 - Table 13 for C/1 and Table 14 for F/2 axial loads and drift limits

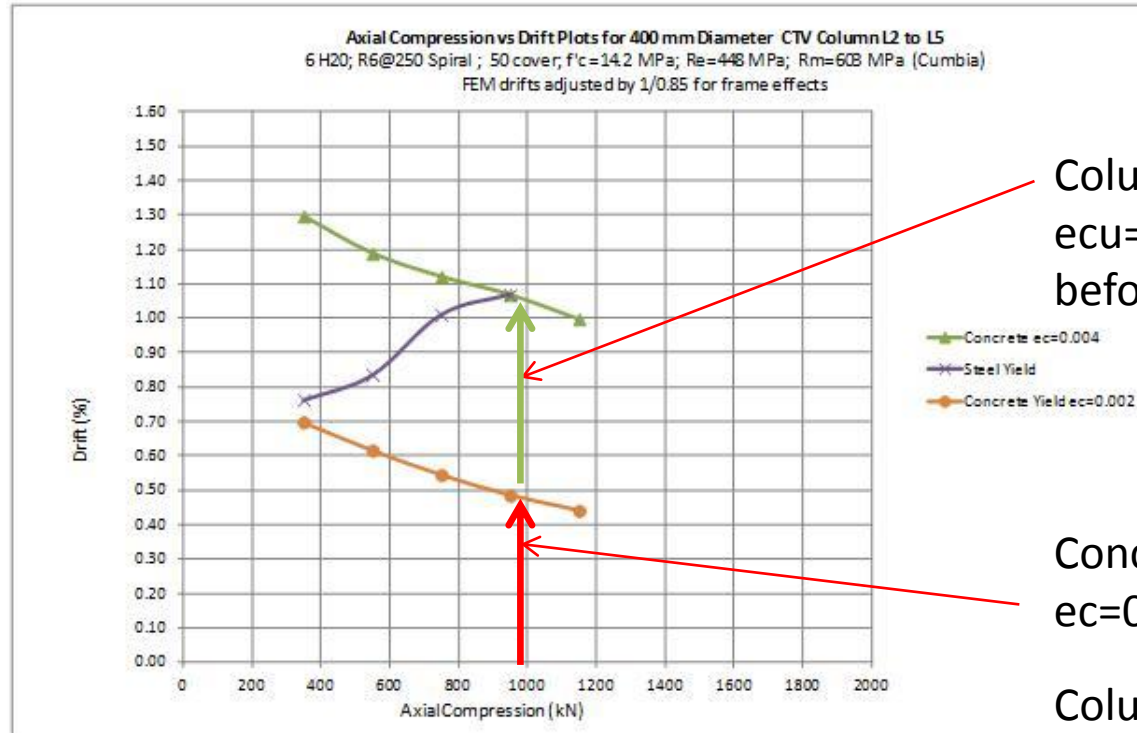
Column F/2 Level 2
with 995 kN axial load

Column failure limit
 $\epsilon_{cu}=0.004$ at 1.05% drift
before steel yields

Concrete yield limit
 $\epsilon_{cy}=0.002$ at 0.48% drift

- At lower 5%ile tested concrete strength of 14.2 MPa
- Drift capacity reduces with reduced concrete strength

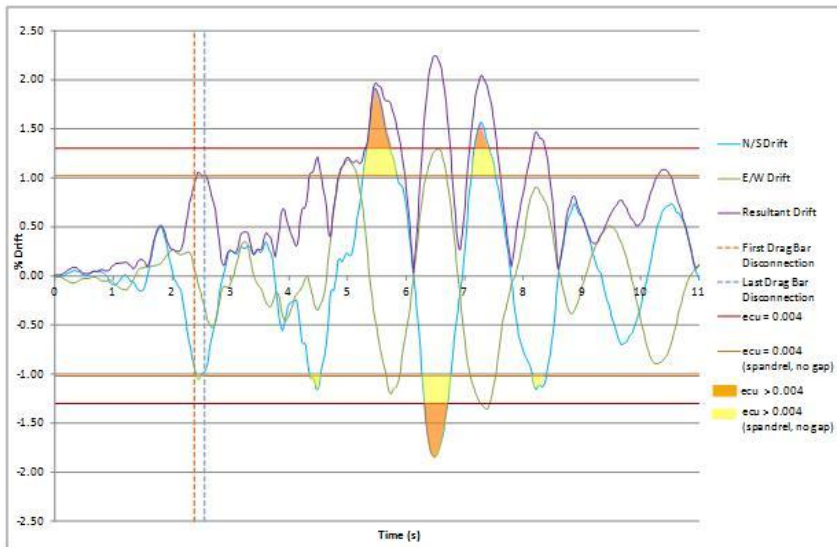
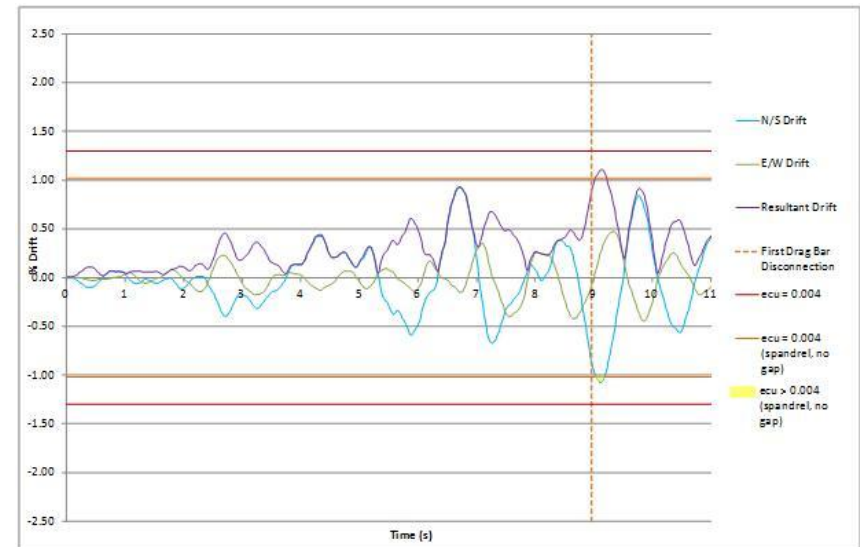
NTHA Drag Bar Failure Estimates

Column F2 Level 3 Drifts - CBGS, 22 February Lyttelton Aftershock, no masonry

Column F2 Level 3 Drifts - CBGS, 4 September Darfield Earthquake, no masonry

Drag Bar failure estimated to occur when 1% drift along Line F

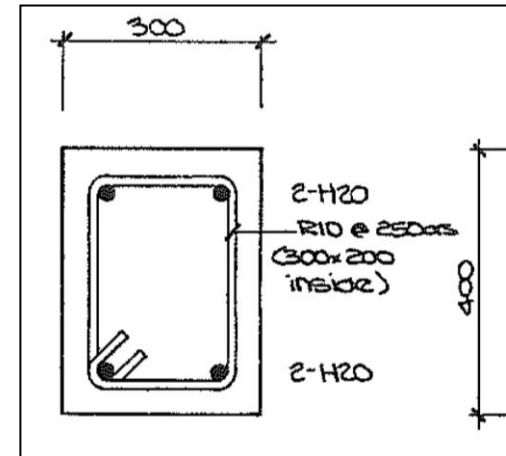
Concrete Columns

- Same reinforcing in all main building columns
- Light spiral binding R6 @ 250 centres
 - Non-compliant
- Rectangular columns on Line A only

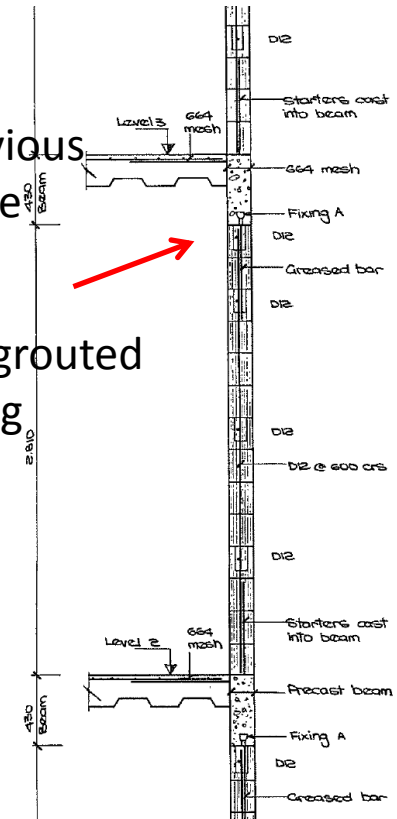
Section through wall from Drawings

- Drawings showed
 - Grouted top row of masonry at each floor
 - 25 mm gaps on sides at columns
- Workers outside just before collapse found
 - Top rows partially grout filled
 - No gaps on sides at columns on outer face
 - No obvious damage from September eq.
- Staff inside found
 - Sealant and gaps on sides at columns

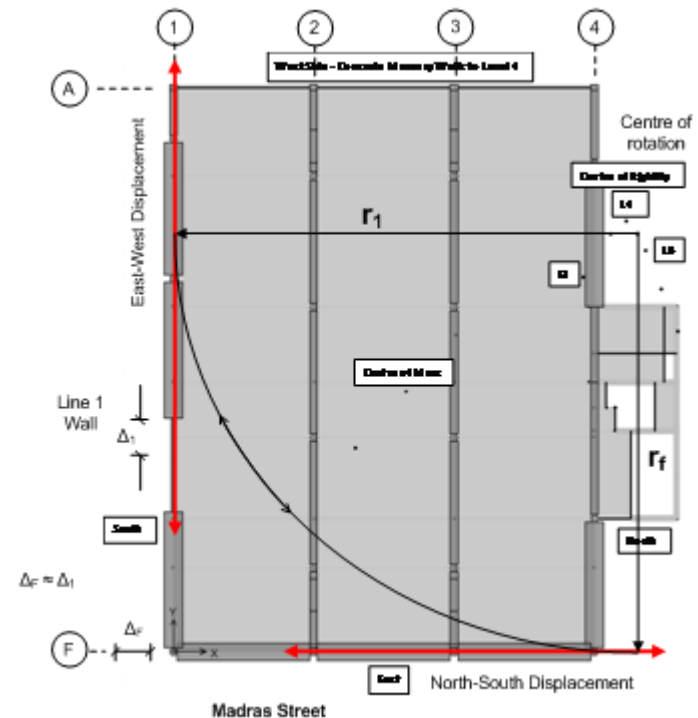
Effect of Masonry Infill on West Wall

- Increased torsional eccentricity
- Drifts on East face similar to drifts on South face
- May have reduced demand on South Wall

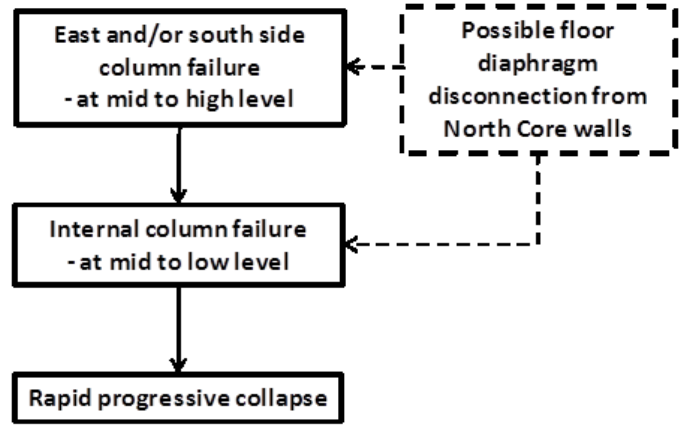
PROBABLE COLLAPSE SEQUENCE

Non ductile detailing of columns and beam-column joints

Insufficient gaps to Spandrel Panels

Low concrete strength

Lack of redundant load paths and interconnection of structural elements for robustness

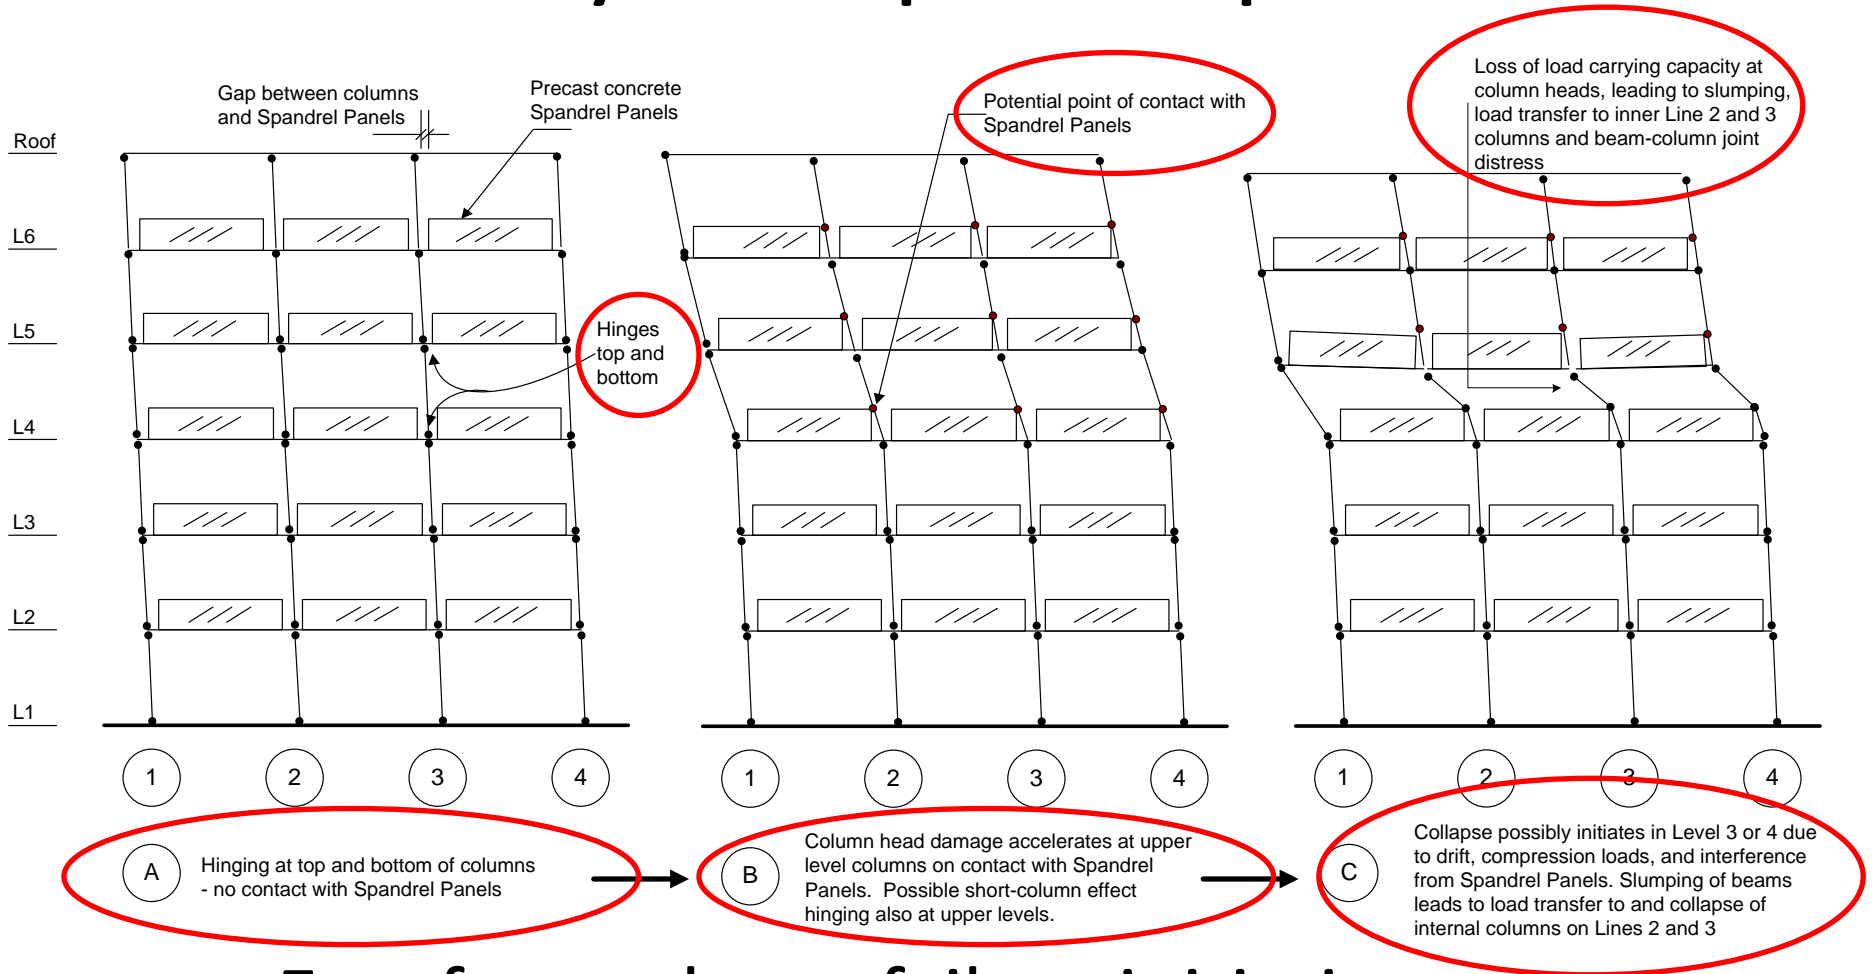
Likely Collapse Sequence

- East face column failure initiation

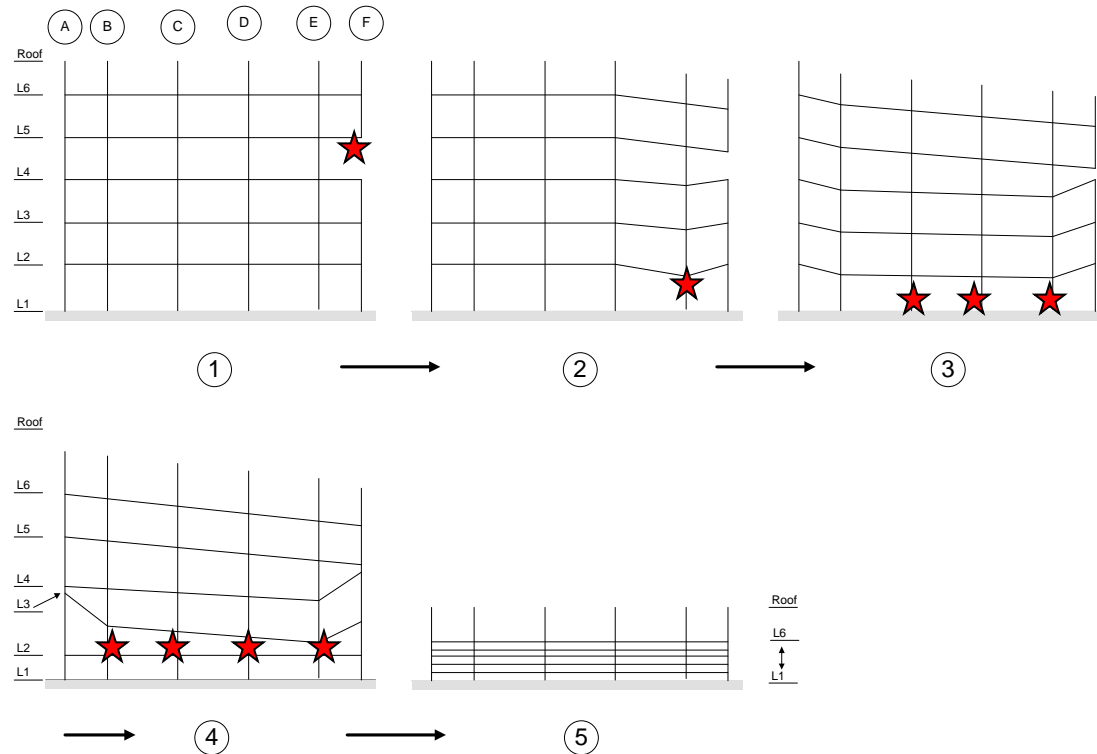
Likely Collapse Sequence

- Line 2 (east to west) column failure development

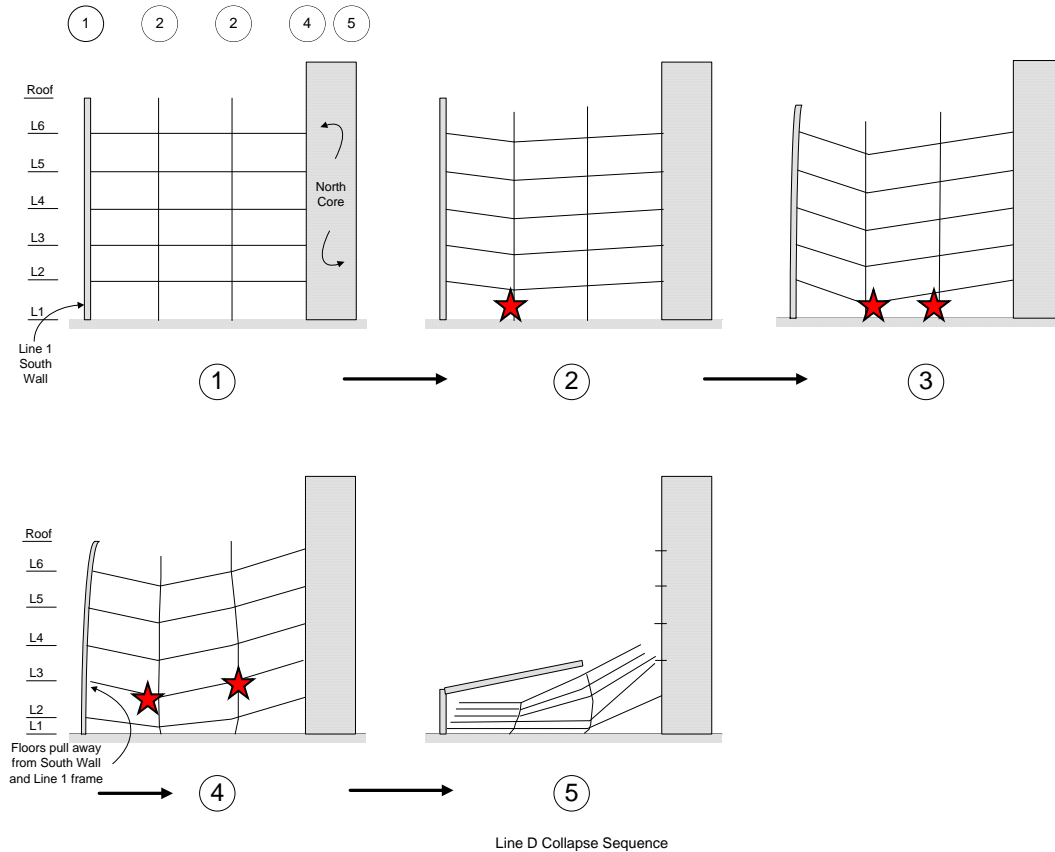
Likely Collapse Sequence

- Line C to D (south to north) column failure development
