# CTV Building Collapse Technical Investigation

Canterbury Earthquakes Royal Commission

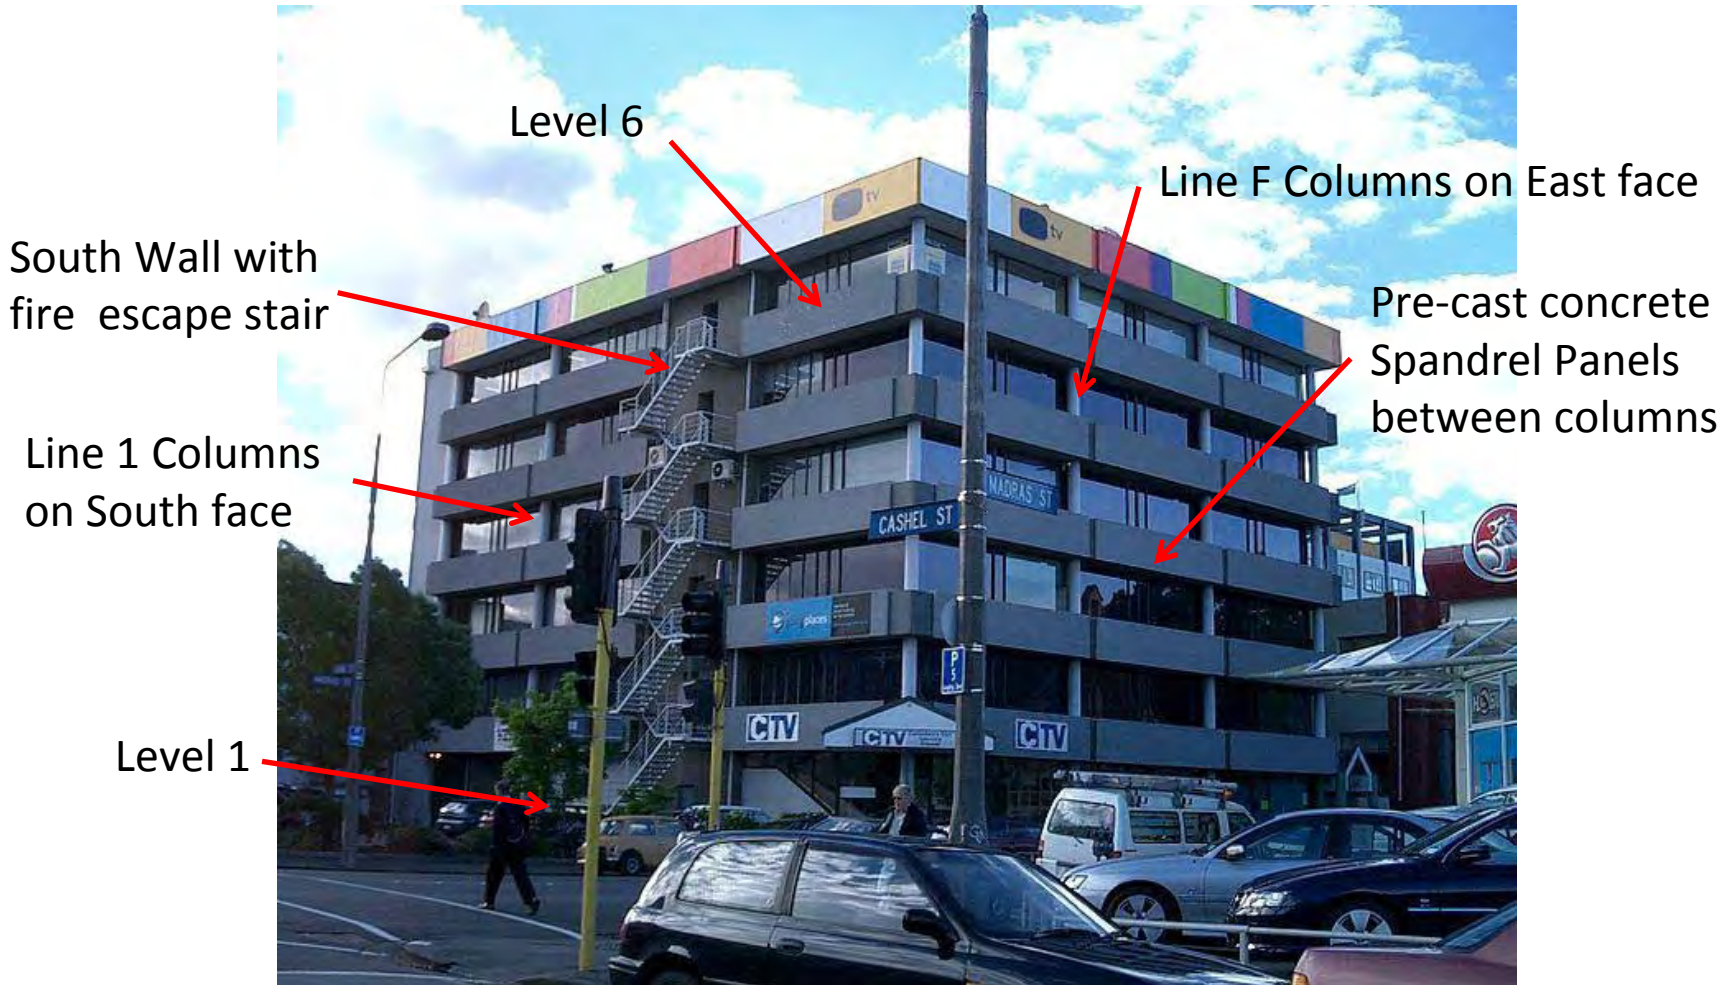
**CTV Building in 2004 (viewed from southeast)**

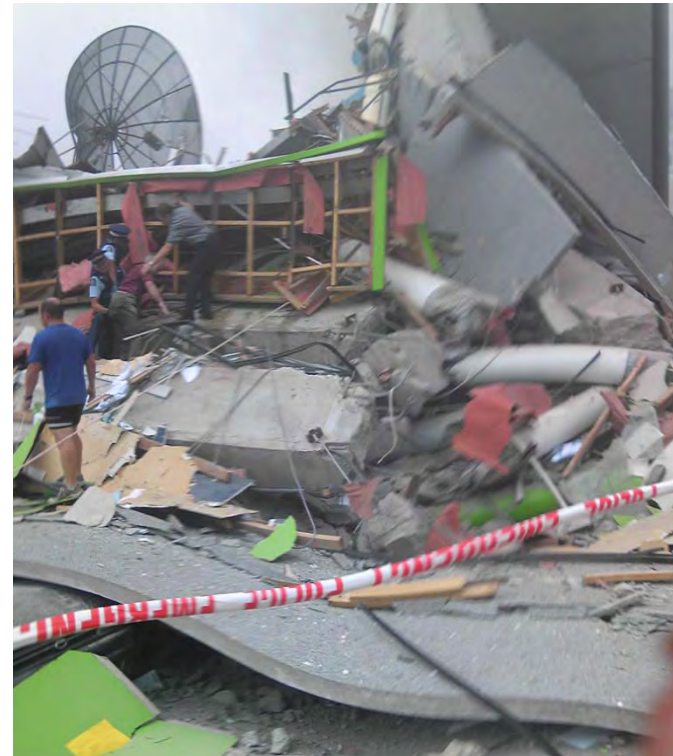
View from east at Line 4 North Core immediately after the collapse at 1:00 pm

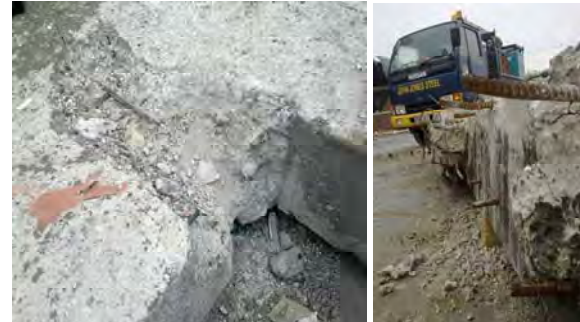
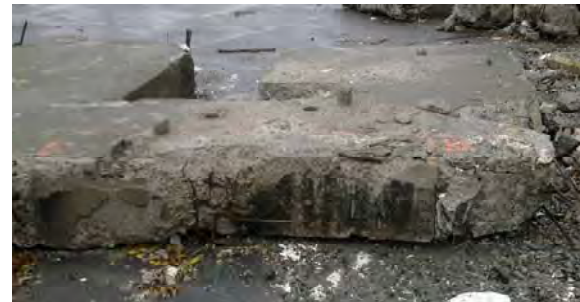
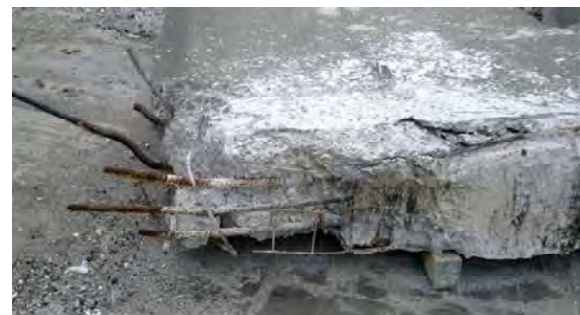
- South Wall Level 5 to 6
  - Soft concrete at door head
  - Smooth construction joints

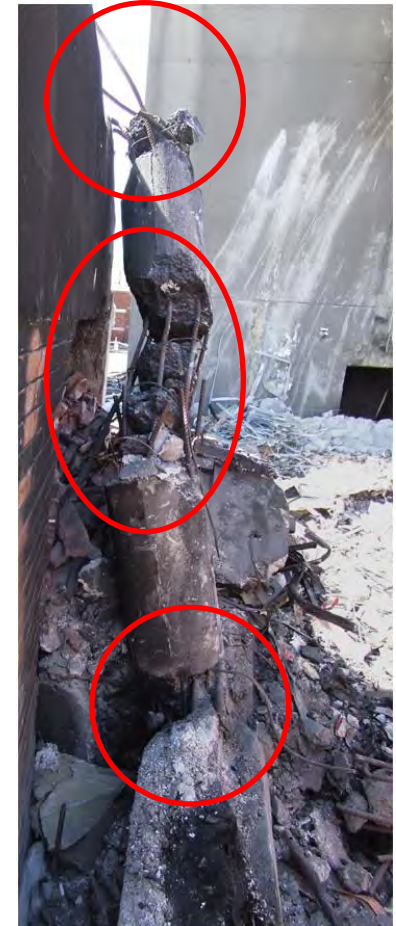
- Column Hinging
  - Base
  - Mid-height
    - Vertical reinforcing steel termination zone
    - Spandrel Panel contact?
  - Head

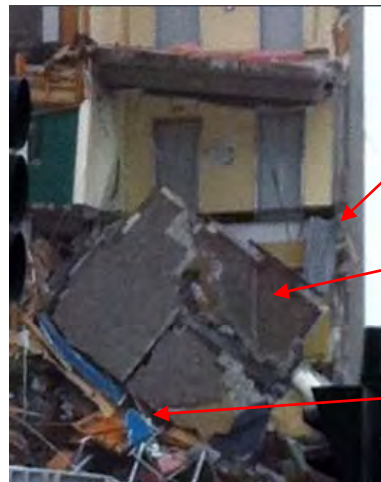
L5 Drag Bar

L5 slab from in front of lifts between  
Walls D/E and D

L5 slab failure surface 1200 mm out  
from Line 4 at end of H12 saddle  
bars

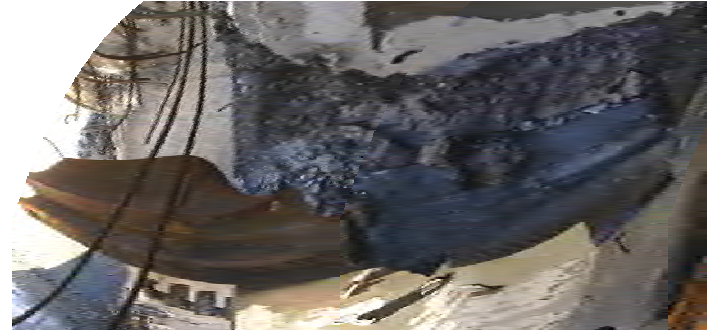
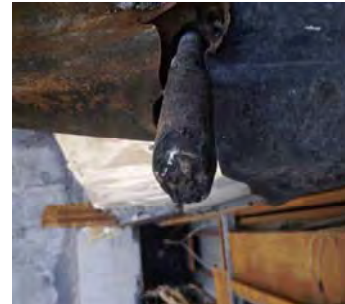
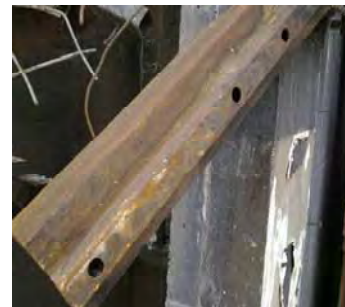
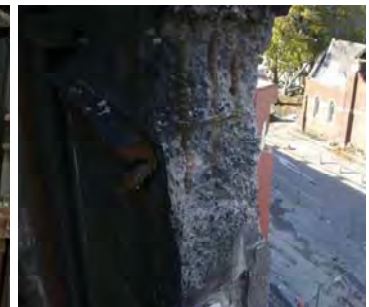
Level 4 Drag Bars

- Drag Bars slab anchors at Levels 4, 5 and 6 upright behind wall tips
  - Slab appeared to have rotated off after collapse further south in building
- Some Drag Bars had been cut off during recovery operations

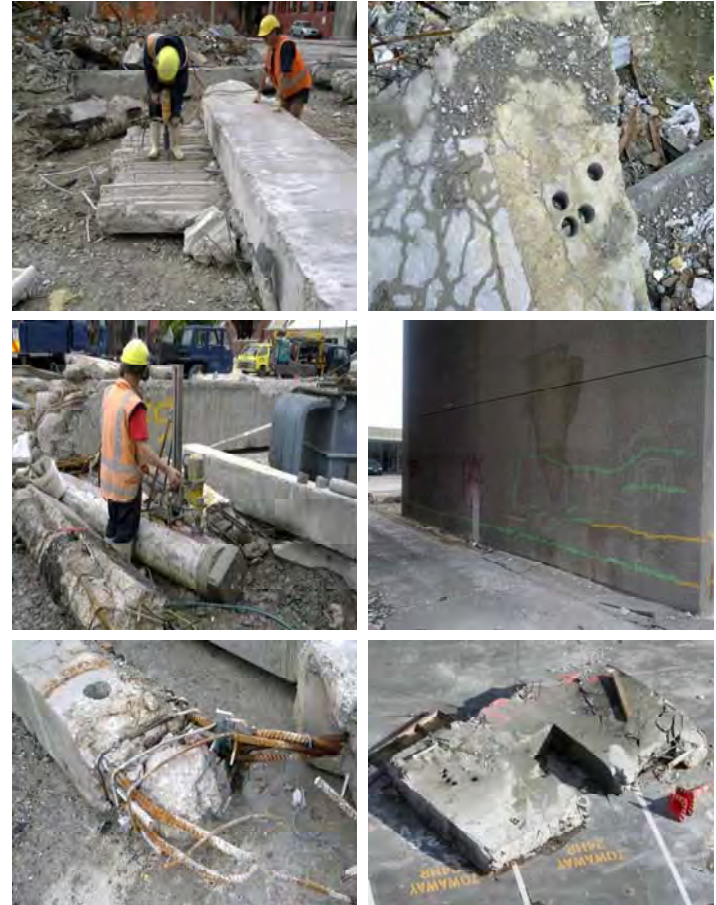
- Wall Concrete
  - Localised door head issue
- Slab Concrete
- Beam Concrete
- Column Concrete
  - Highly variable

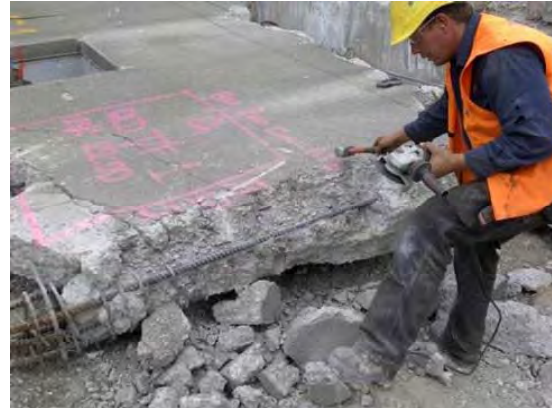
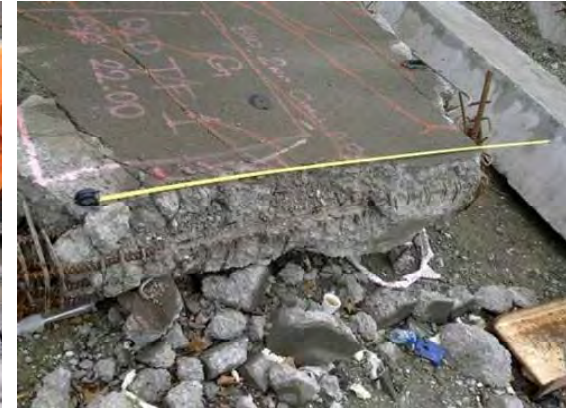
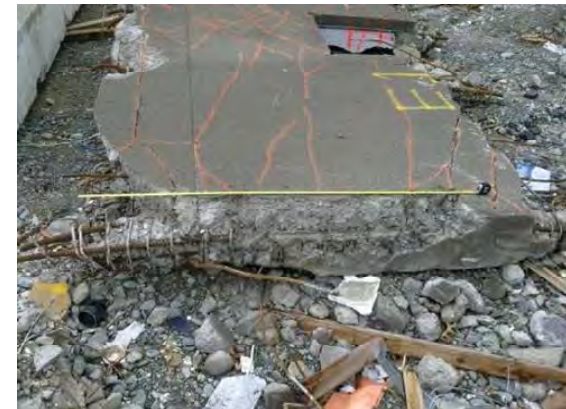
- South Wall
  - Some yielding at base only

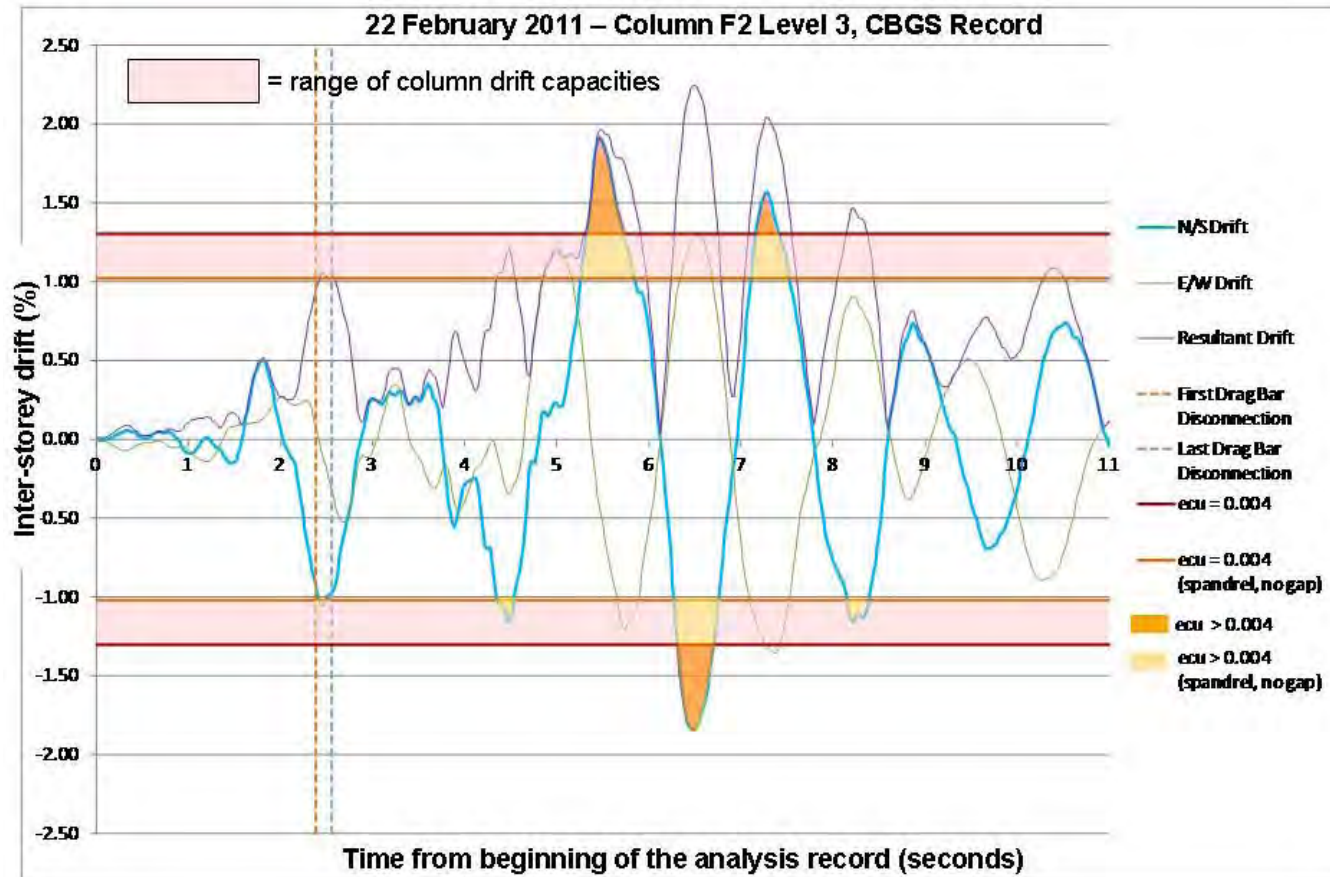
# Column F2 Level 3 – 22 Feb 2011 – CBGS Record

Comparison of drift demand and capacity

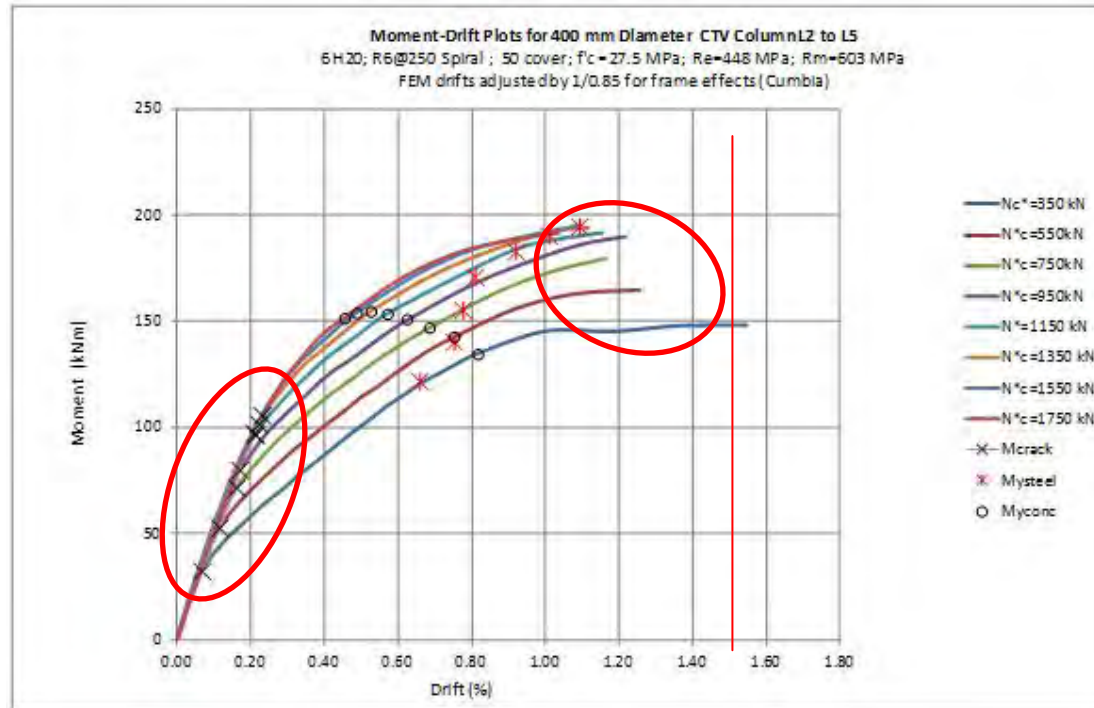
# Column Drift Capacity

- At average tested concrete strength of 27.5 MPa (Fig 159)
  - Cracking at 0.10 to 0.35% drifts
- Level 2 to 4 columns North and East faces 1.15 to 1.45% drift capacity (Table 13 and 14)
  - Less than 1.51% safe drift performance expected by Standard

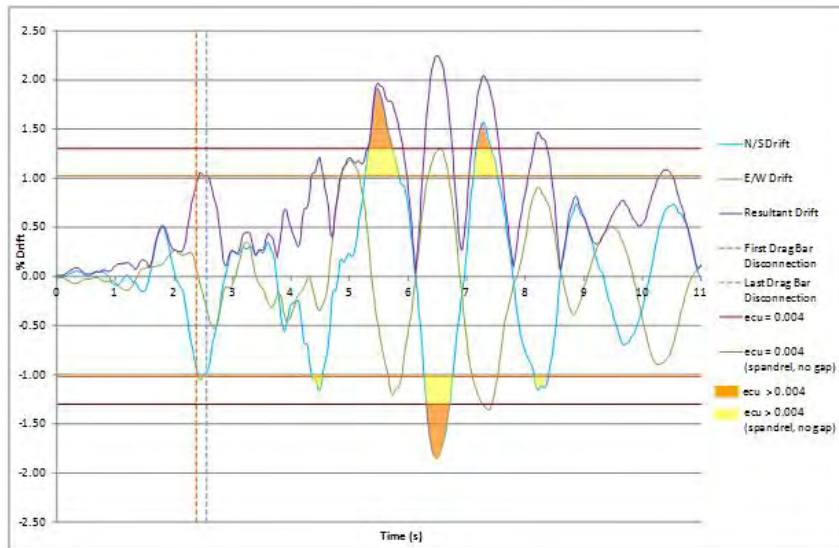
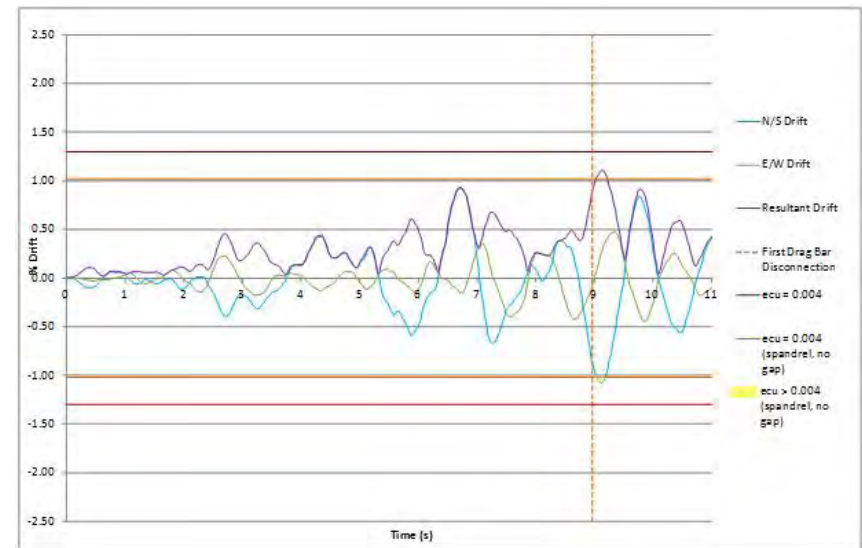
# NTHA Drag Bar Failure Estimates

Column F2 Level 3 Drifts - CBGS, 22 February Lyttelton Aftershock, no masonry

Column F2 Level 3 Drifts - CBGS, 4 September Darfield Earthquake, no masonry

Drag Bar failure estimated to occur when 1% drift along Line F

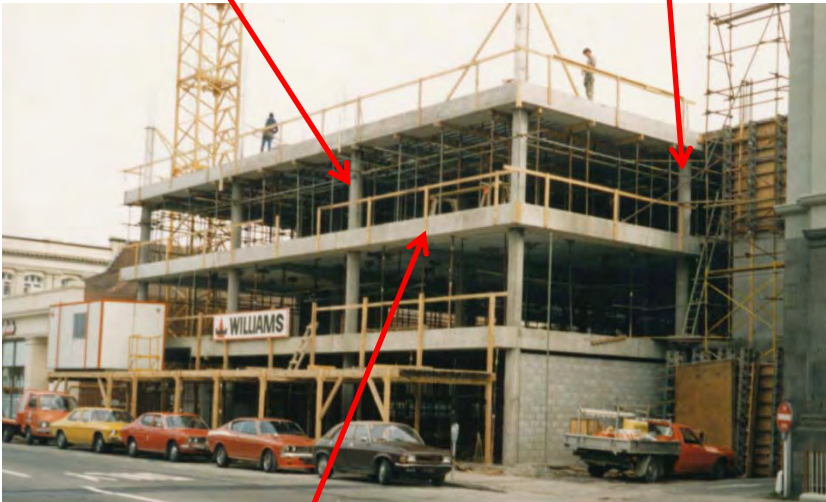
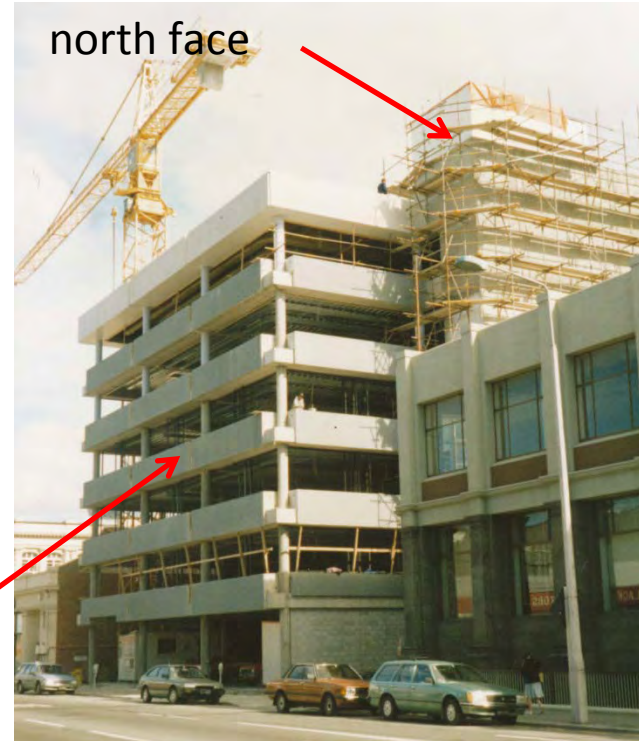
# Spandrel Panels and Columns

Line F columns on east face

Column C18

North Core on north face

Concrete edge beams

Pre-cast concrete Spandrel panels between columns on edge beams

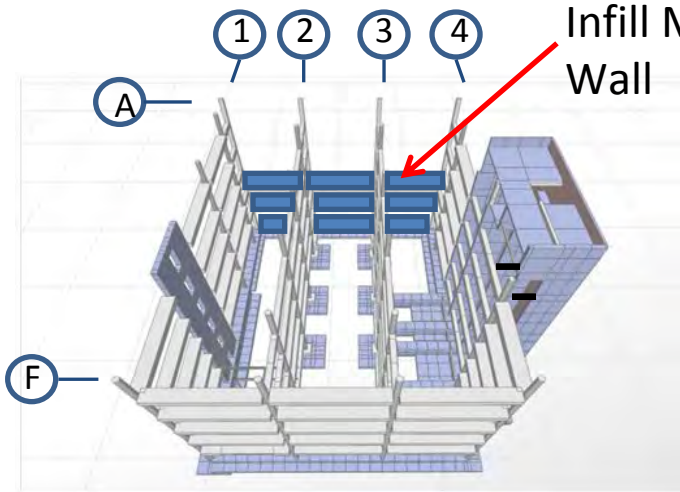
# Masonry Infill Wall on West Face

- Drawings showed
  - Grouted top row of masonry at each floor
  - 25 mm gaps on sides at columns
- Workers outside just before collapse found
  - Top rows partially grout filled
  - No gaps on sides at columns on outer face
  - No obvious damage from September eq.
- Staff inside found
  - Sealant and gaps on sides at columns

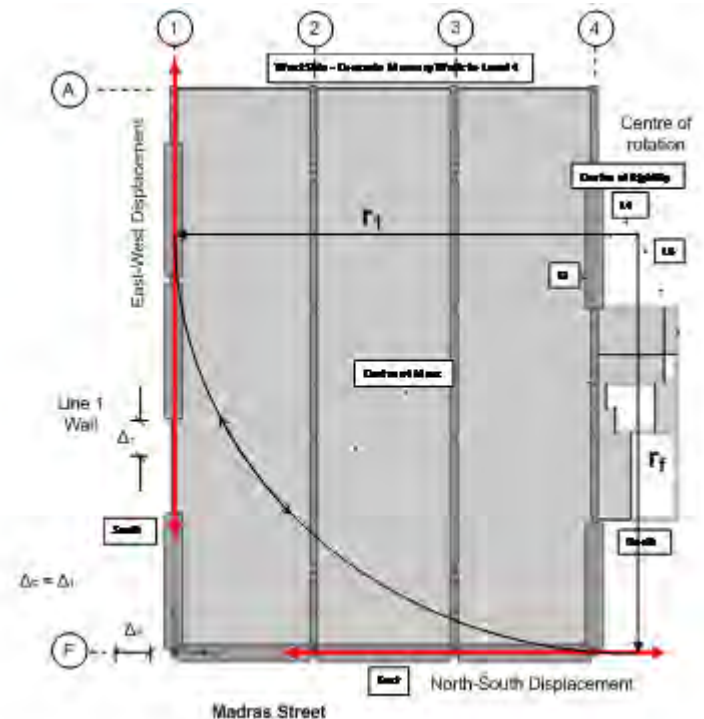
# Effect of Masonry Infill on West Wall

- Increased torsional eccentricity
- Drifts on East face similar to drifts on South face
- May have reduced demand on South Wall

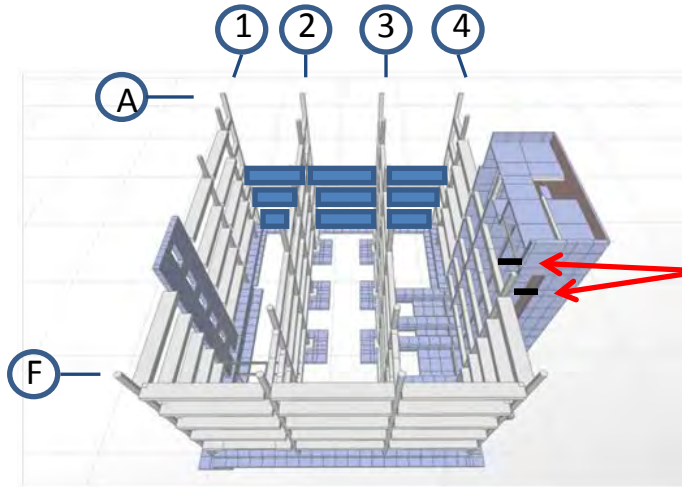
# Drag Bars Added after Completion

Drag Bars Level  
4, 5 and 6

- Construction of building 1986-1987
- Design defect found in 1990
  - Building could separate from North Core in an Eq.
- Remedial work using Drag Bars designed in 1991
  - Steel angles epoxy bolted into walls and underside of slabs
  - No Drag Bars designed or installed at Level 2 or 3
  - Unable to sustain full design response of the structure
- No Building Consent application on Council files

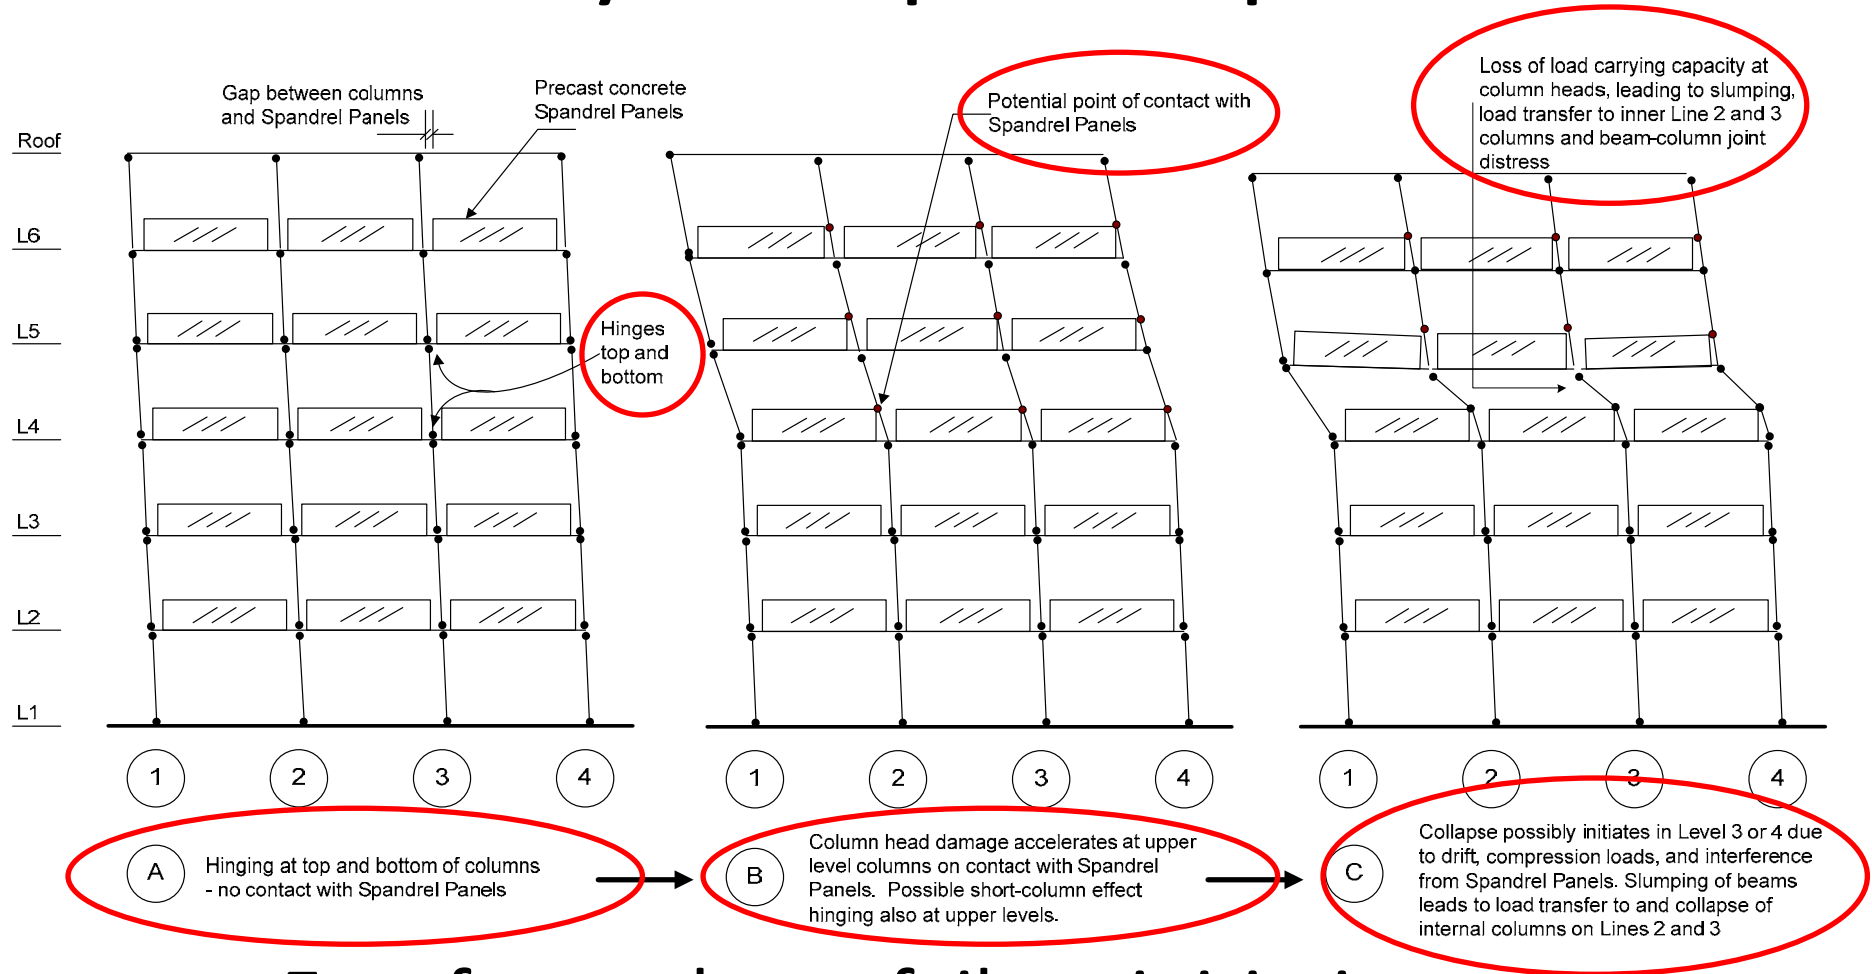
# Likely Collapse Sequence

## • East face column failure initiation

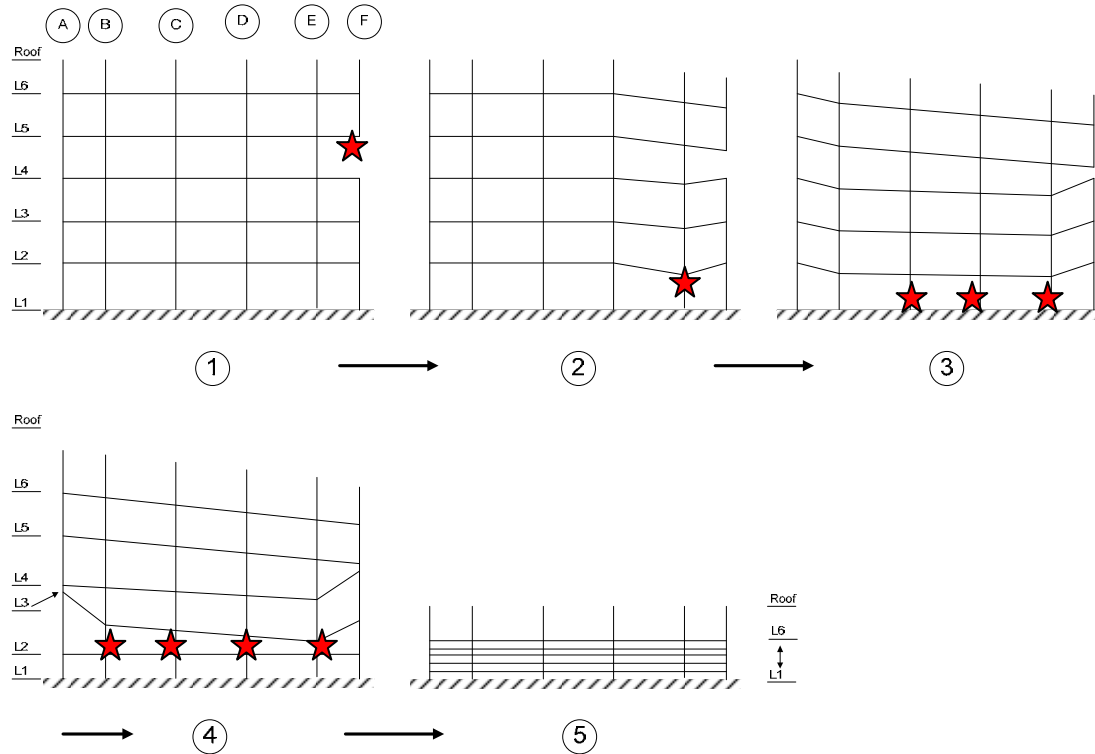
# Likely Collapse Sequence

- Line 2 (east to west) column failure development

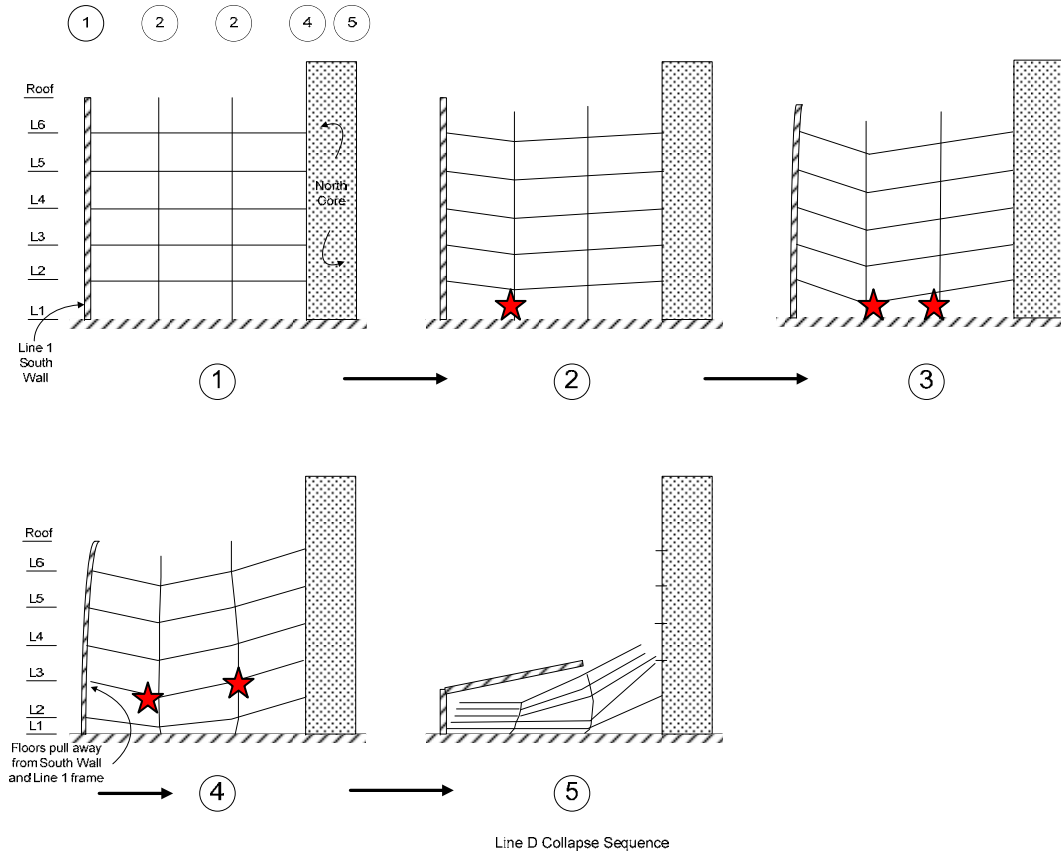
# Likely Collapse Sequence

- Line C to D (south to north) column failure development
