CTV Building - GF calculations relating to possible collapse scenarios

Further to Clark Hyland's DBH Report on the CTV Bldg collapse, I think the points below could have received a little more attention in that report - or offer alternative views to some of the report findings.

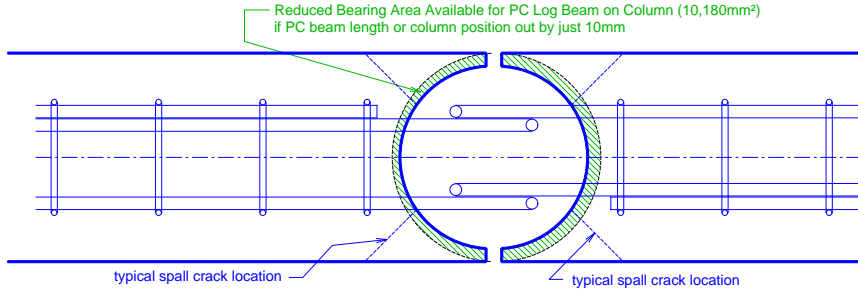
PLAN SECTION 2-2 - INTERIOR BEAM-COLUMN JOINT
 (ALLOWING 10mm CONSTRUCTION TOLERANCE)

Post collapse photos show that the ENDS of the precast units were made with a very smooth formed finish. Consider also that with very little inter-storey drift, the vertical joint between a beam end and the column core concrete would, on one side, be opening up below slab level (since the bottom longitudinal beam bars were inadequately anchored beyond that joint) - reducing any available friction on the curved vertical beam end face to zero AND reducing what was initially designed as a very narrow seating width (for the precast beam on the column cover concrete below). If all this single floor dead load is transferred through the 25mm wide (as designed) seating for the precast log beams on the 400Ø column, we would have a bearing stress of at least:

$$f_p := \frac{P_g}{\pi \cdot \left[(0.2\text{m})^2 - (0.175\text{m})^2 \right]} = 9.8 \cdot \text{MPa}$$

If the outer corners of the log beams have spalled off (all the POST-collapse specimens exhibited this situation - and there was no confining steel detailed to prevent this occurrence - see Point 3 below), the available bearing area reduces significantly. Many of the beam ends were left with less than 200mm width at the bottom after the corners had spalled off.

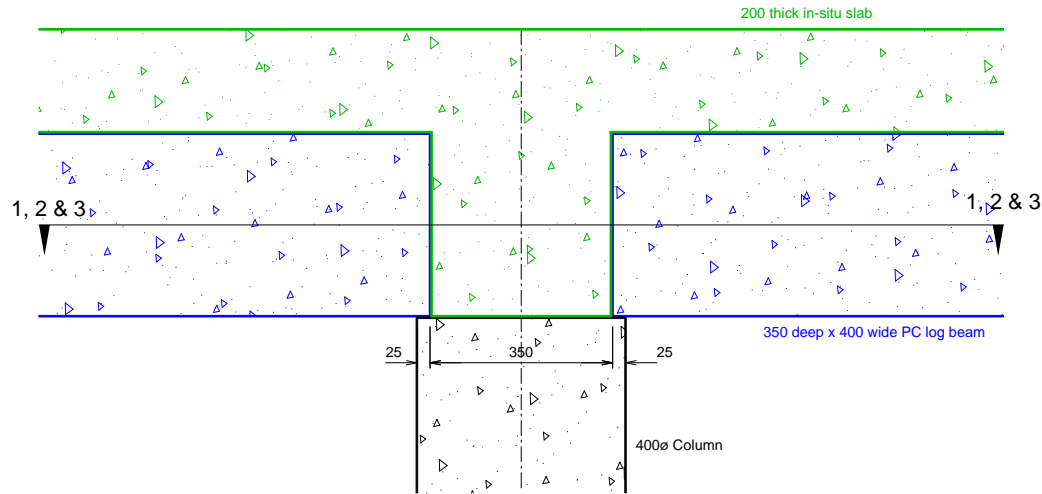
LONGITUDINAL SECTION - TYPICAL INTERIOR BEAM-COLUMN JOINT

End stirrups in precast log and shell beams were often not located close enough to the end of precast - i.e. too far away from column centreline. Some measured up to 300mm! (See photo DSCF 6888). This exacerbates the condition discussed in Point 1 above.
