~~SUBMISSION TO~~ THE ROYAL COMMISSION OF INQUIRY:

AN ALTERNATIVE COLLAPSE SCENARIO FOR THE CTV BUILDING

John B. Mander PhD, F.IPENZ

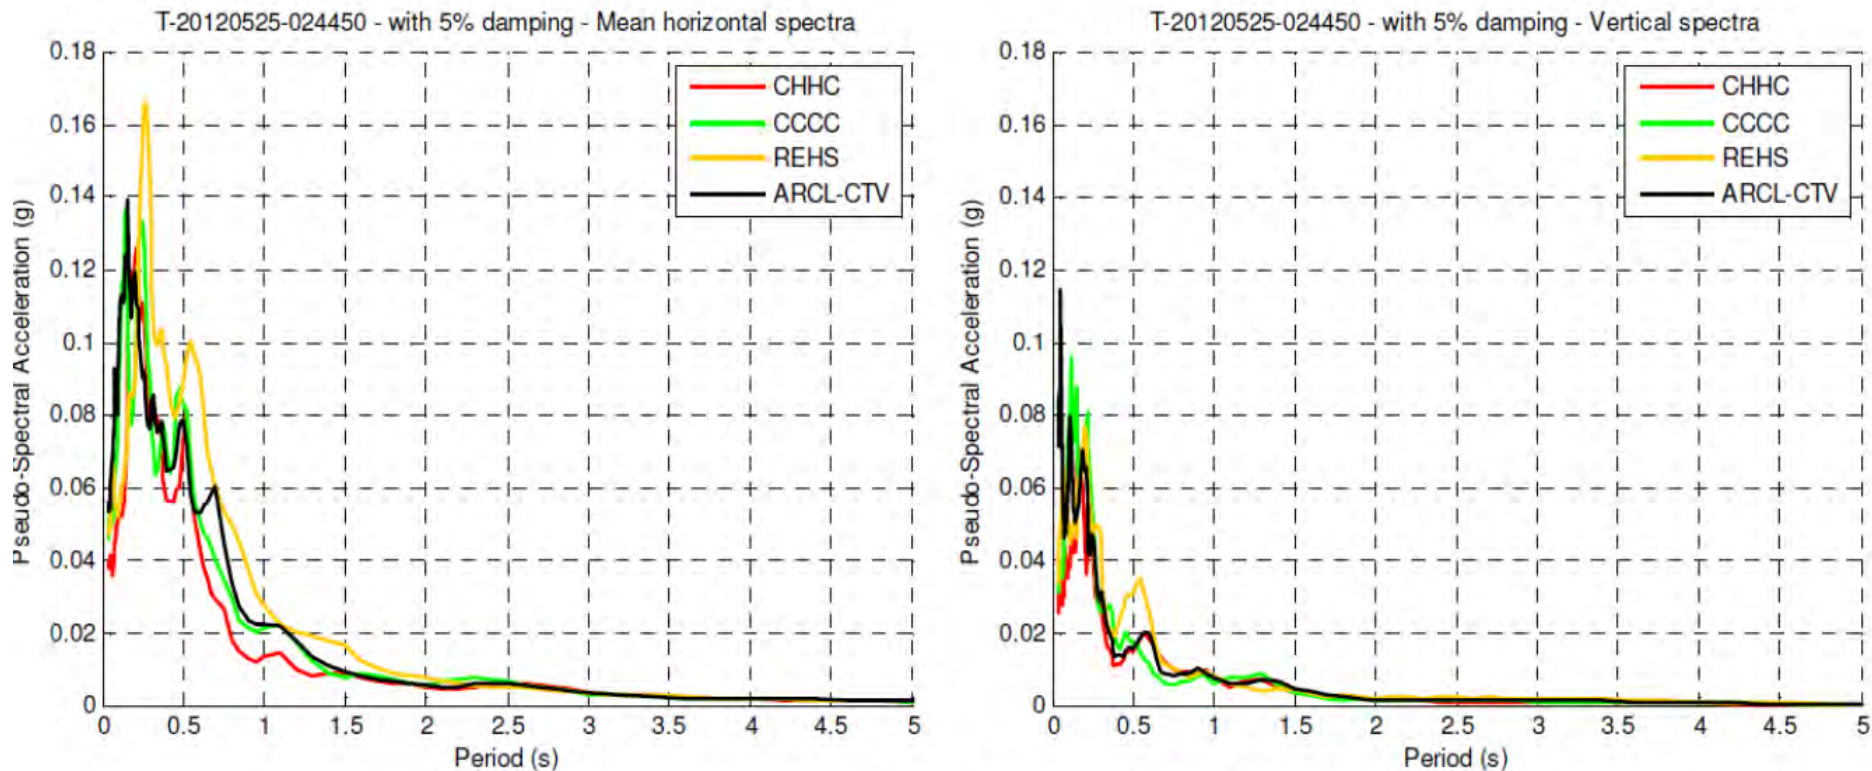
Fig 2.2. Acceleration response spectra comparison at the CTV Building site with the other Geonet recording stations within the Christchurch CBD (when actively recording).

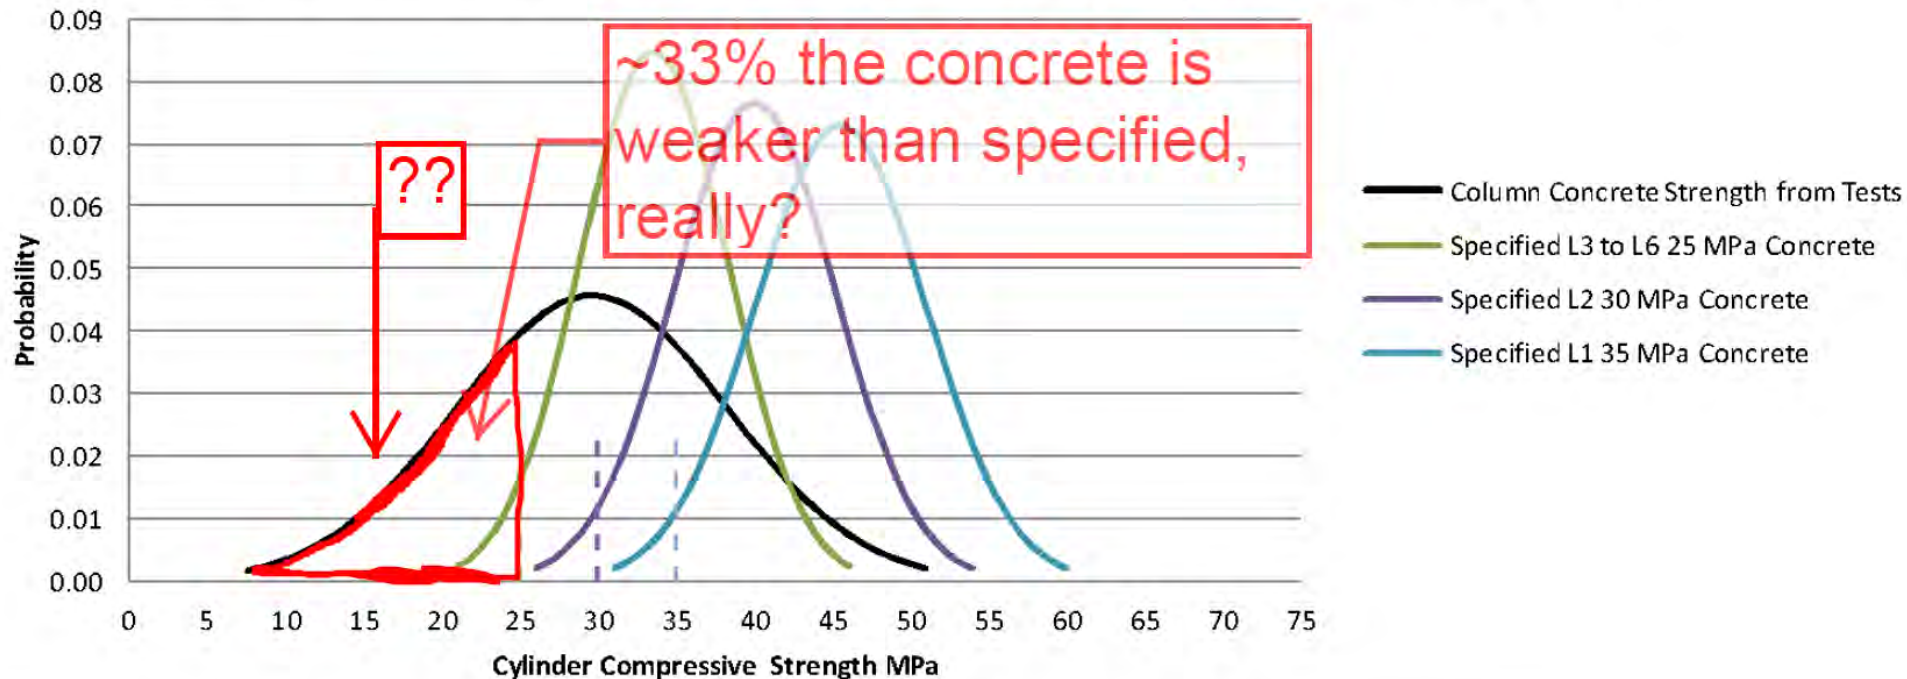
Column Concrete Strength from Tests vs Specified 28-day Strength Distribution NZS 3104:1983

Fig. 2.3. Cumulative distribution plot of the normalized concrete strength from the CTL test results.

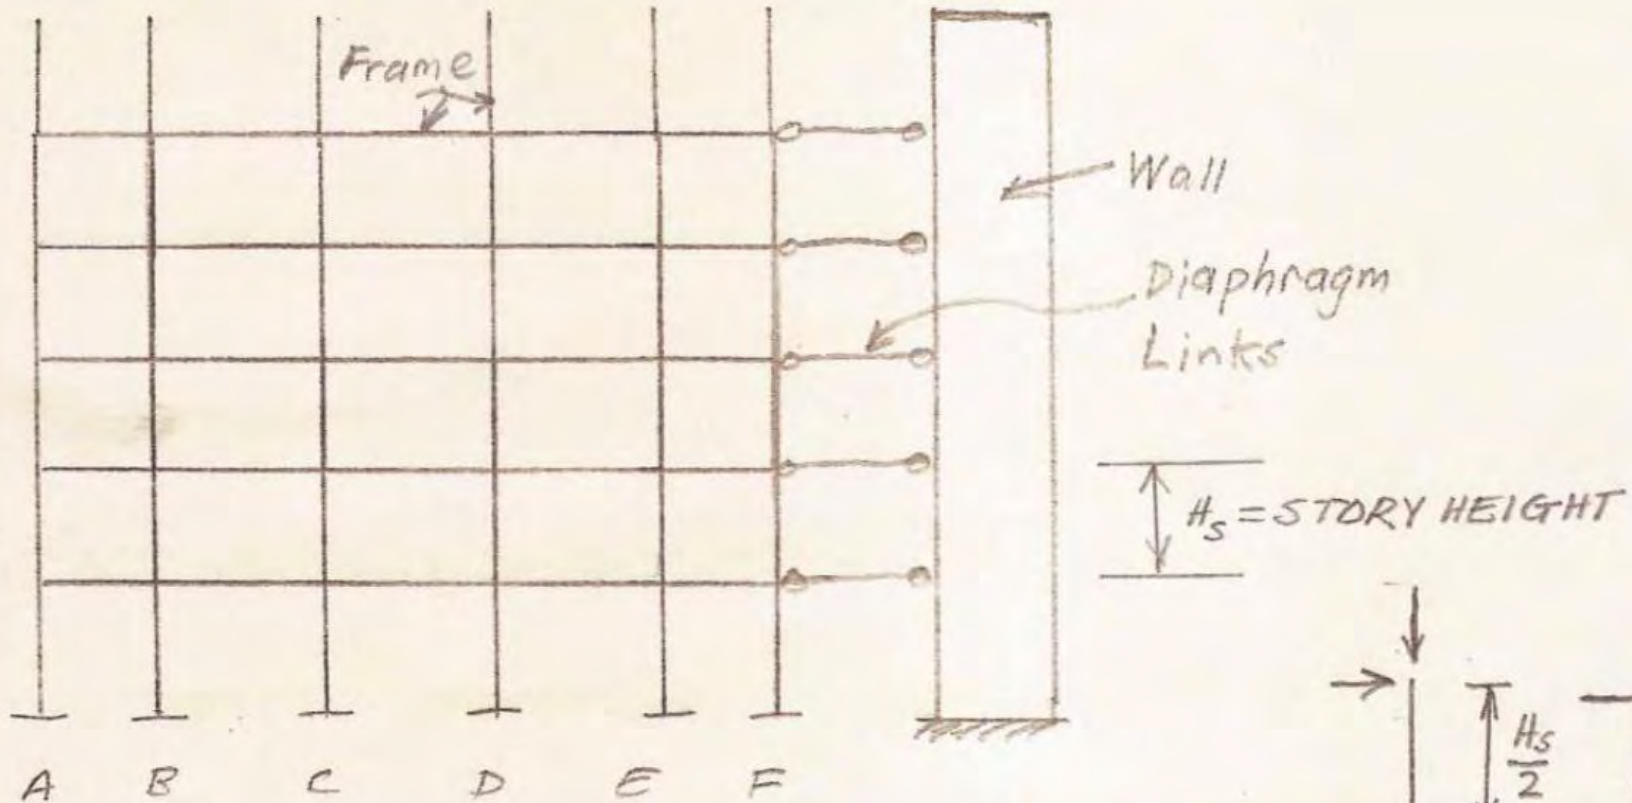
(a) CTV BUILDING - 2D SKELETON

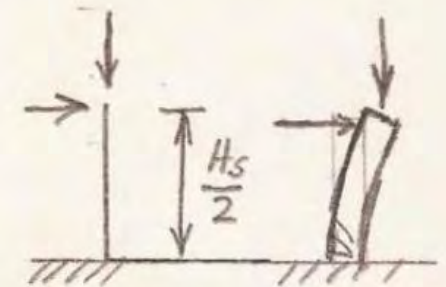
(b) MODELED COLUMN FOR 'PUSHOVER'

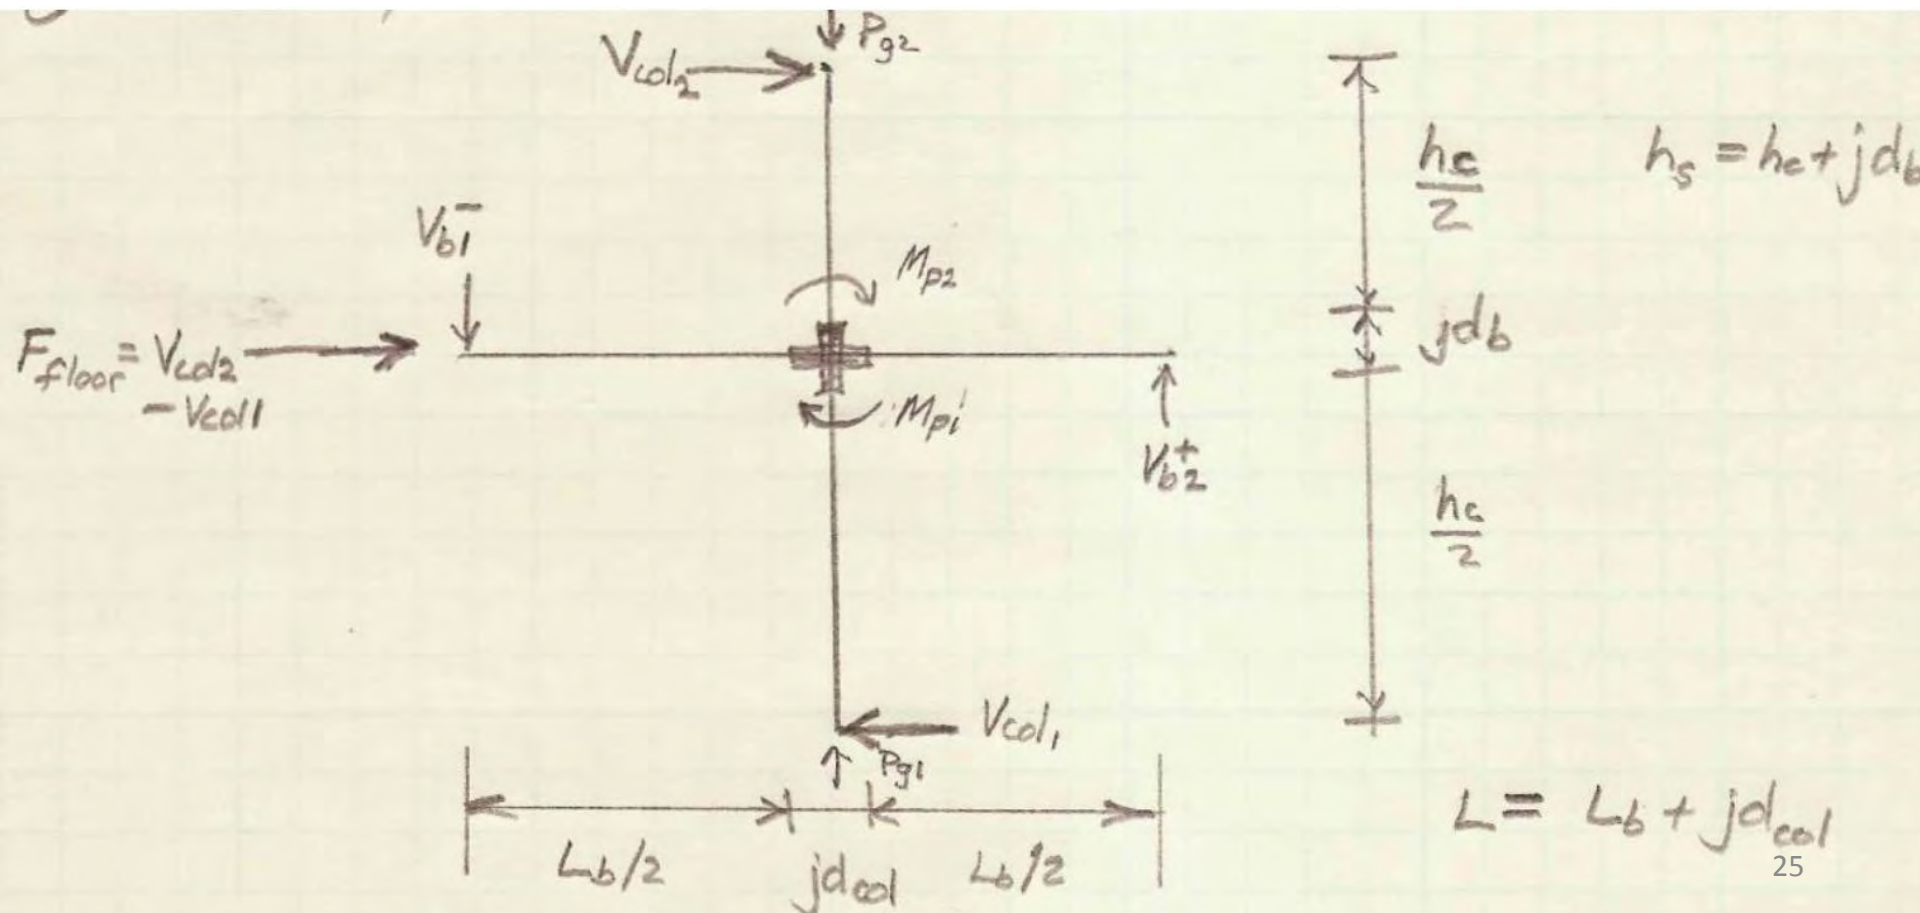
(a) *A typical interior beam column joint subassemblage showing the seismic loading actions under the frame, sidesway from left to right*

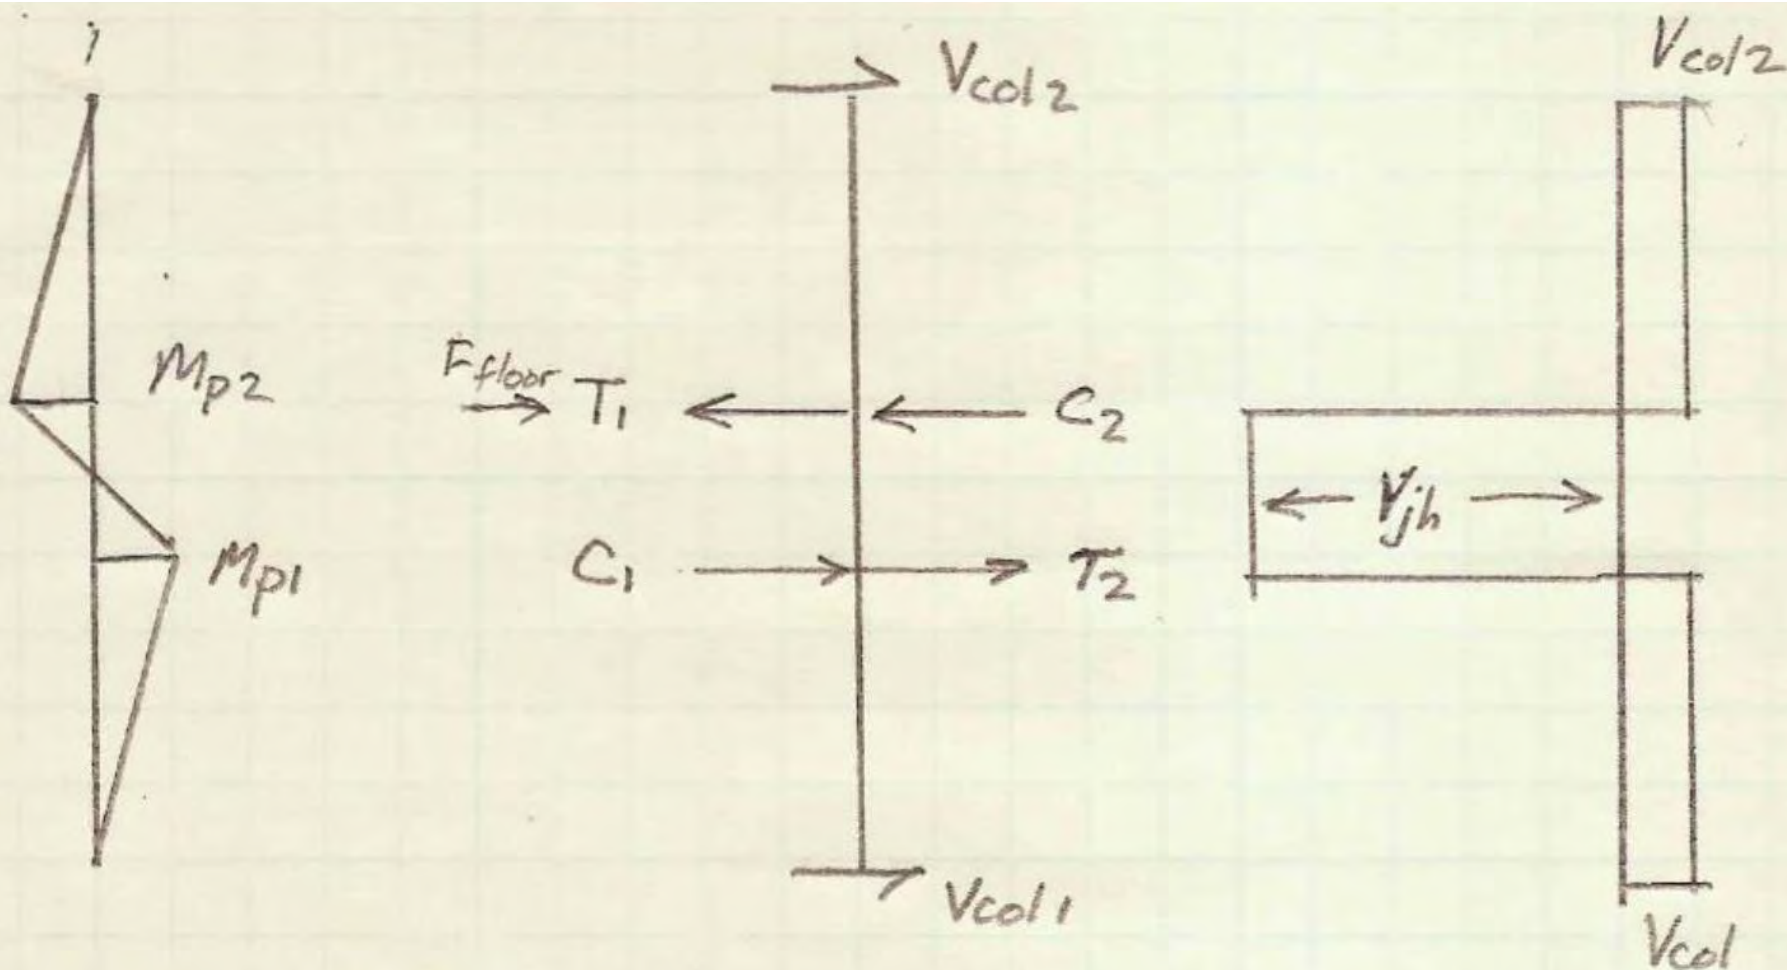
(b) The column extracted from the subassemblage

Note: the beams have been removed, but the incoming and outgoing forces provided by the beam reinforcement are shown instead

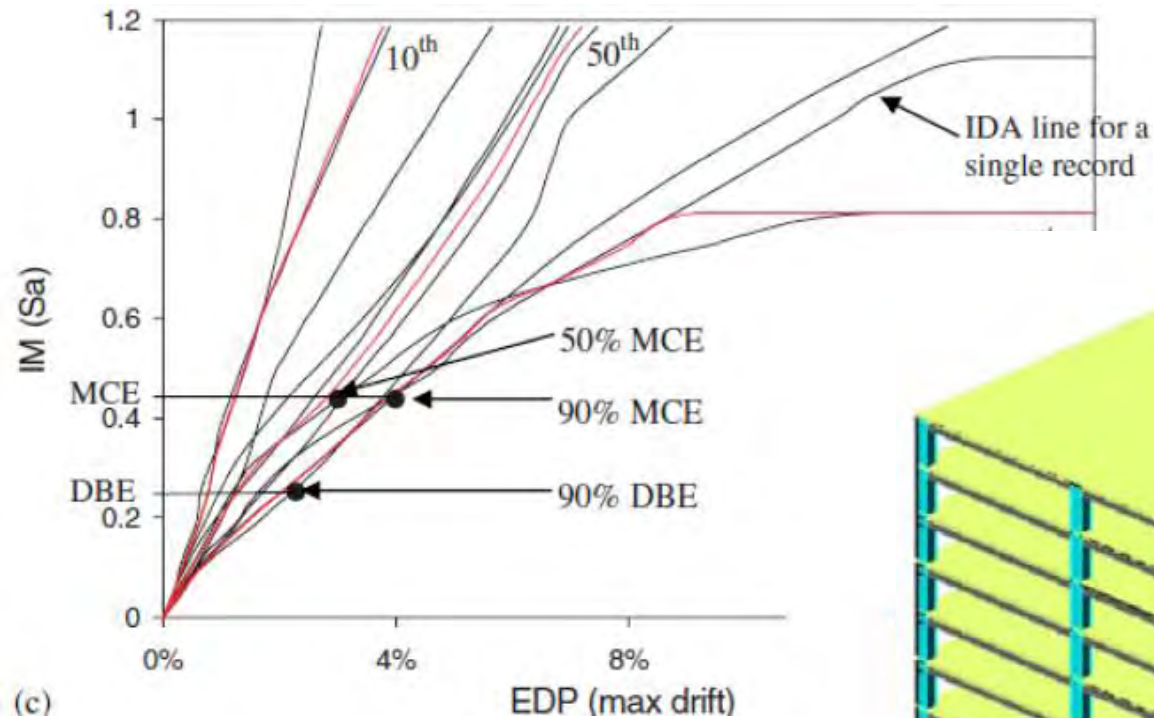
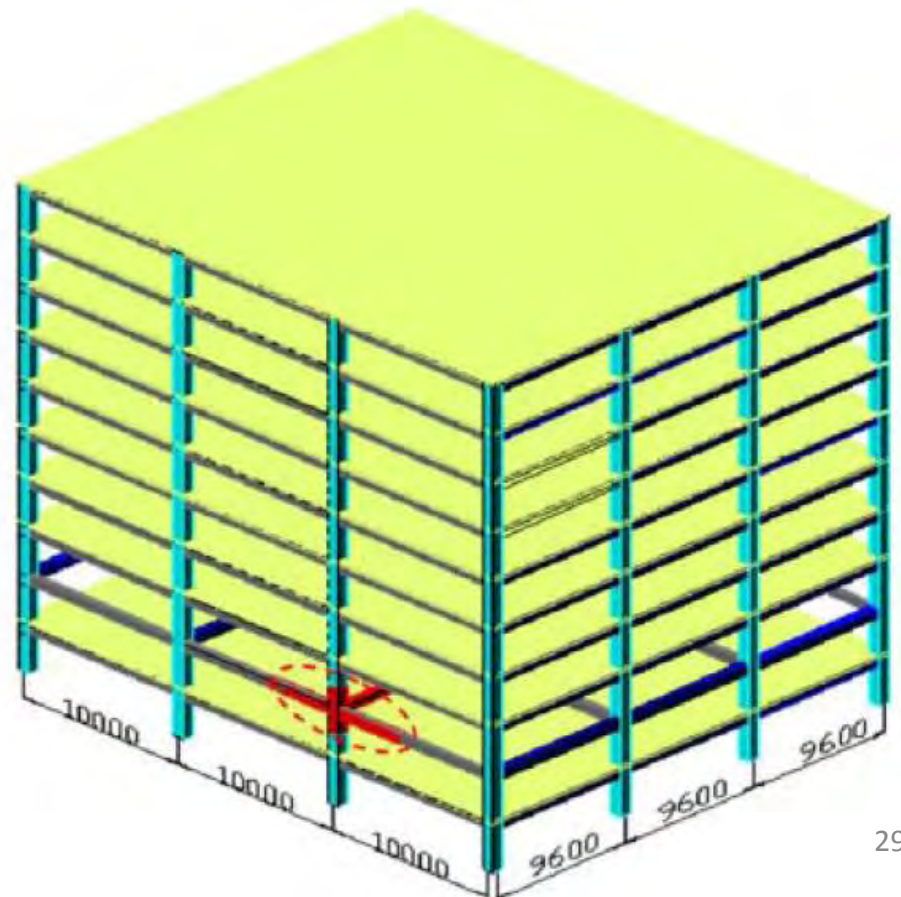
Fig. 2.11. Damage loss attenuation of the REDBOOK BUILDING for the Christchurch Earthquake.
