**ROYAL COMMISSION OF INQUIRY INTO  
BUILDING FAILURE CAUSED BY CANTERBURY  
EARTHQUAKES**

**THE CTV BUILDING COLLAPSE**

**SUBMISSIONS ON BEHALF OF BEREAVED FAMILIES AND THOSE INJURED**

**Dated: 4 September 2012**

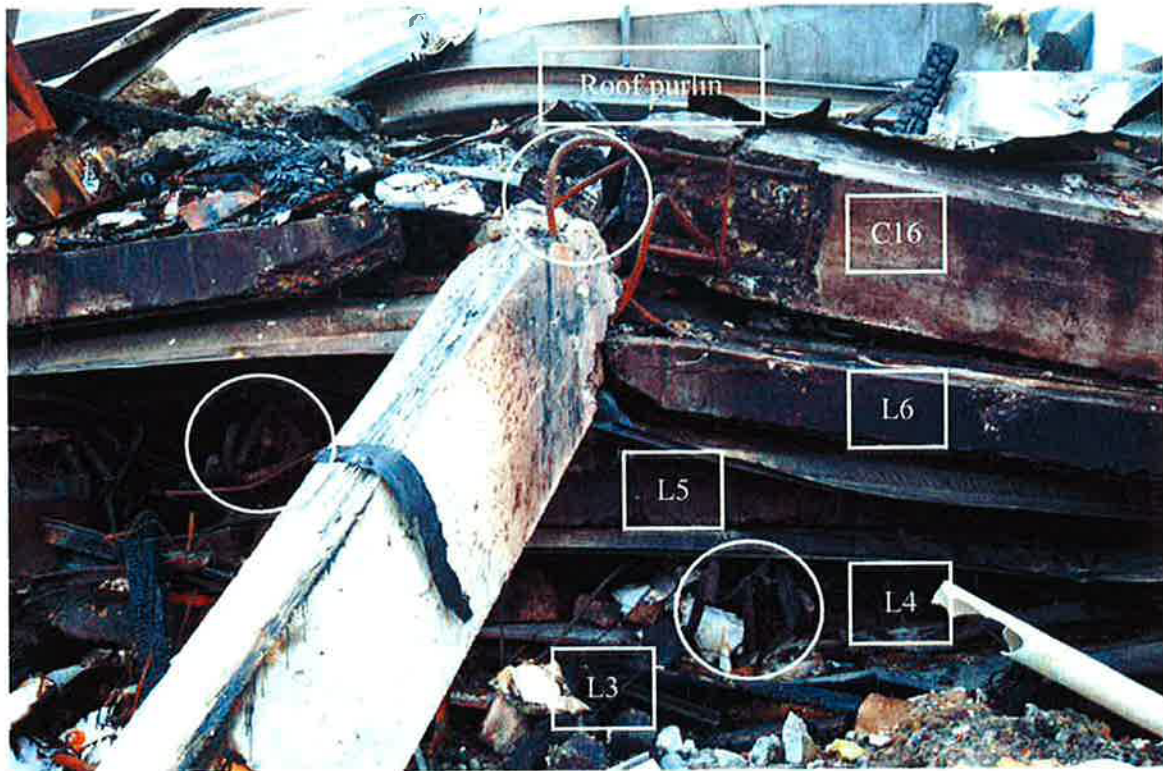
**Figure 15**

**Collapsed slabs lie on top of each along Line A. The ends of the Line 3 internal beam reinforcement have been circled and floor levels of the slabs labelled.**
