**BUILDING SAFETY EVALUATION AFTER THE
FEBRUARY 22, 2011 CHRISTCHURCH,
NEW ZEALAND EARTHQUAKE:
OBSERVATIONS BY THE ATC RECONNAISSANCE TEAM**

**Ronald Gallagher, SE
Bret Lizundia, SE, Team Leader
Jim C. Barnes, PE**

**APPLIED TECHNOLOGY COUNCIL
201 Redwood Shores, Parkway, Suite 240
Redwood City, California 94065
www.ATCouncil.org**

August 2012

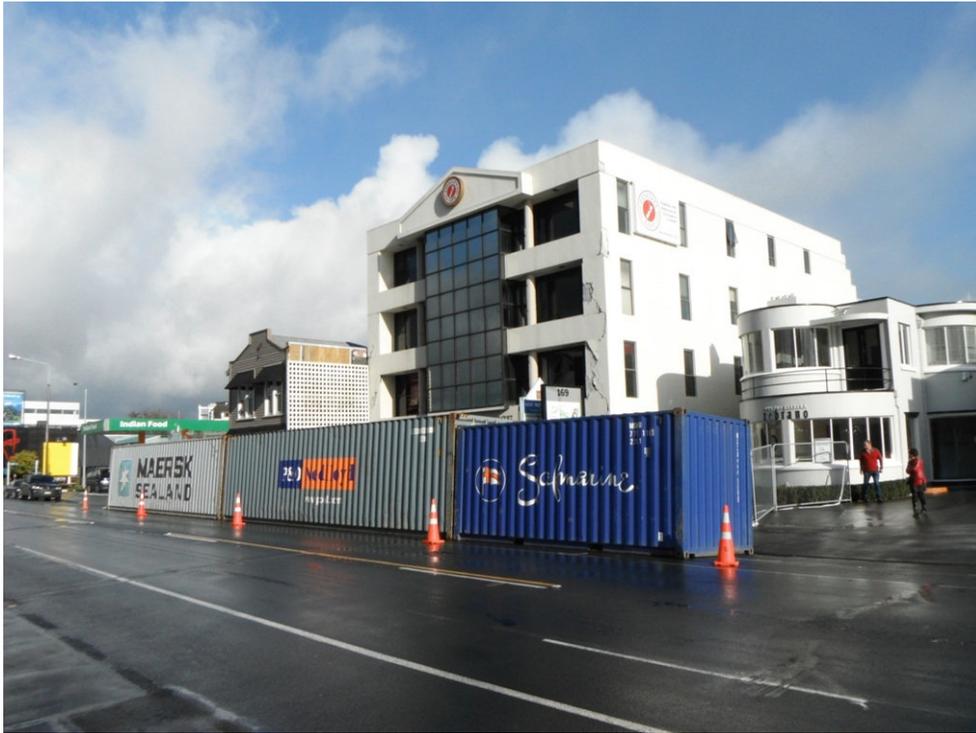
One innovation in Christchurch was the use of “indicator buildings.” Indicator buildings represented the unreinforced masonry, reinforced masonry, reinforced concrete, and precast concrete structures typical of Christchurch. One such building is shown in Figures 3-1 and 3-2. If an indicator building showed new damage after an aftershock, similar buildings nearby that likely experienced the shaking could then be re-examined for safety. This is better than the rather intuitive methods that have been used in the U.S.

Figure 3-1 This building was used as an “indicator building” by Christchurch officials. Note the shipping containers used as barricades at the front of the building.

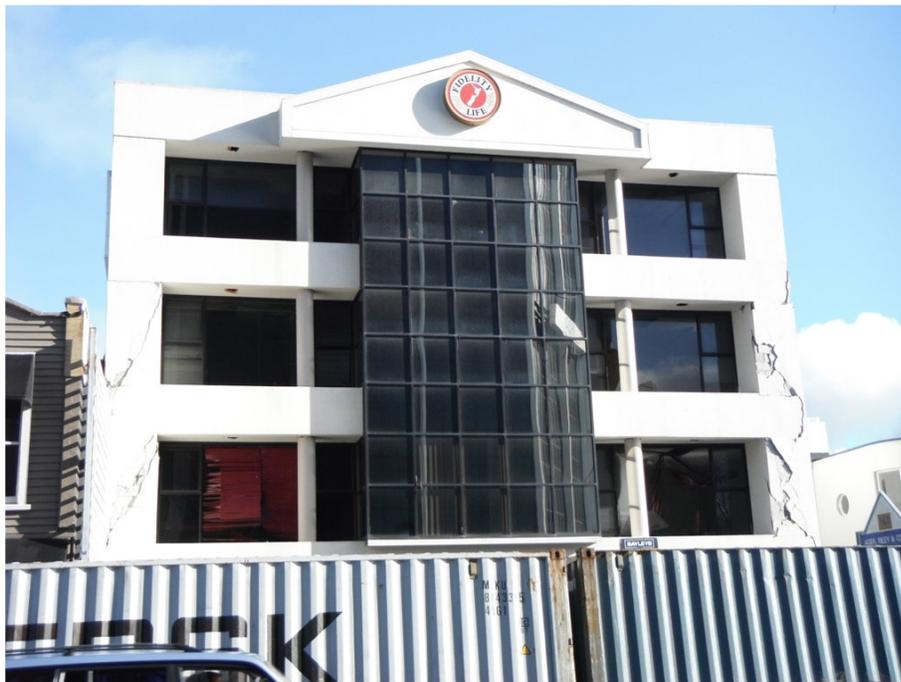
Figure 3-2 Close-up of the indicator building of Figure 3-1.

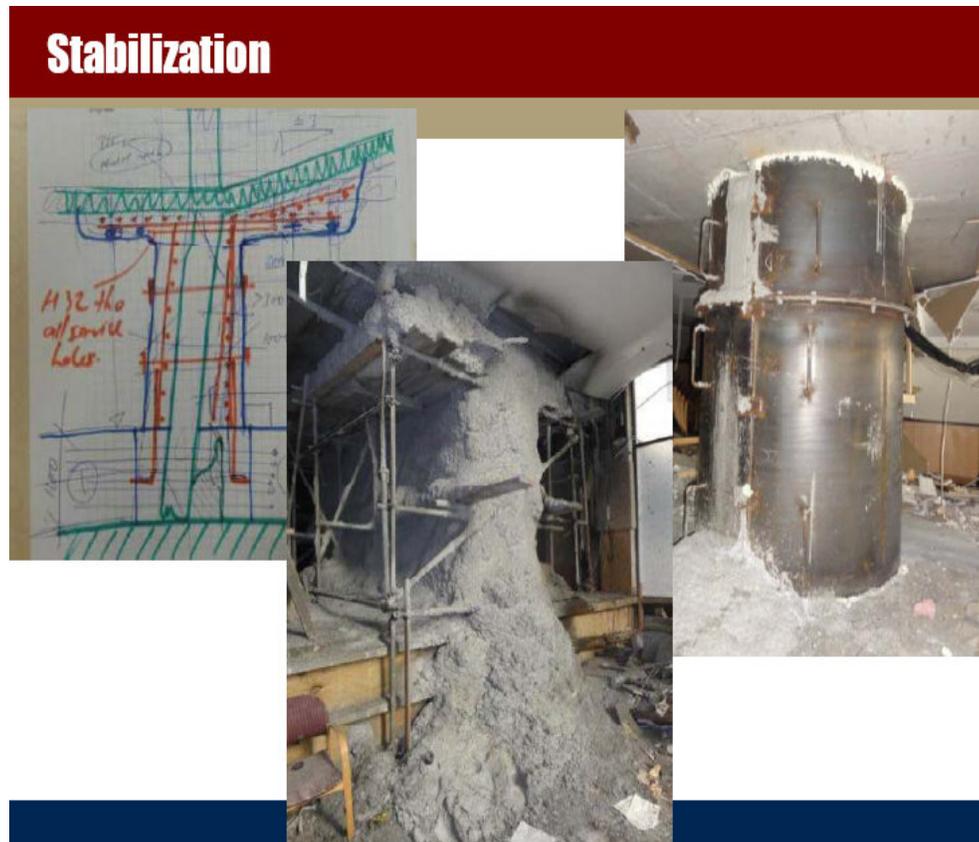
Examples of the emergency stabilization measures taken to keep “critical” structures from collapsing, especially collapsing on their neighbors, are shown in Figures 3-3 and 3-4.

Figure 3-3 Examples of emergency stabilization measures. (Source: Prof. Sri Sritharan, Iowa State University)

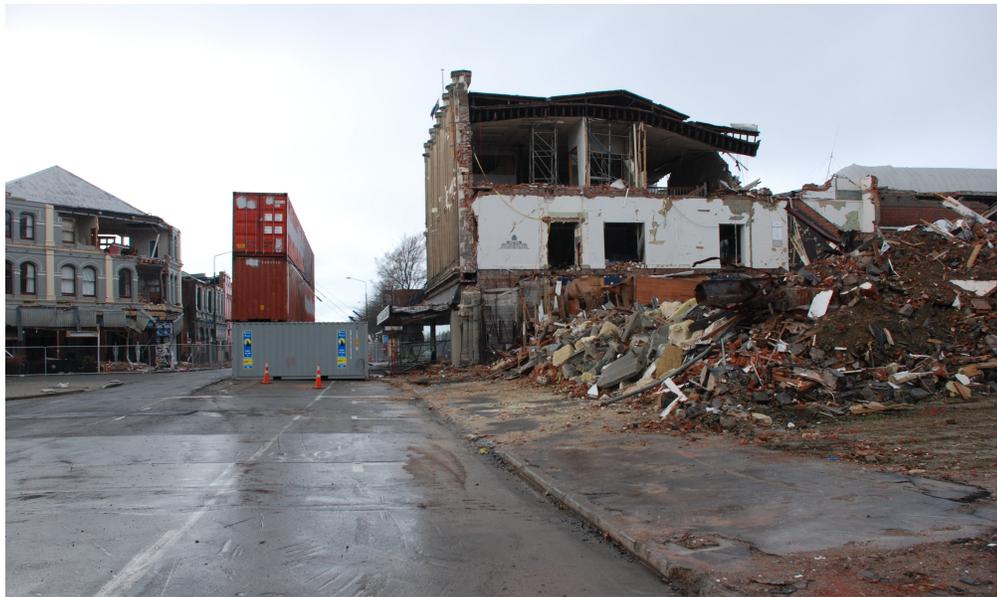
There was extensive use of shipping containers as barricades where falling hazards were severe (Figure 3-8 shows an example). These were placed against, or close to, buildings to keep parapets, walls and store fronts from falling into the street. This permitted street traffic to be relatively close to very damaged buildings.

Figure 3-8 Shipping containers were used to keep possible falling debris from damaged buildings from blocking streets. The red containers protect the building to the left and the portion of the street adjacent to it from the URM building on the right.

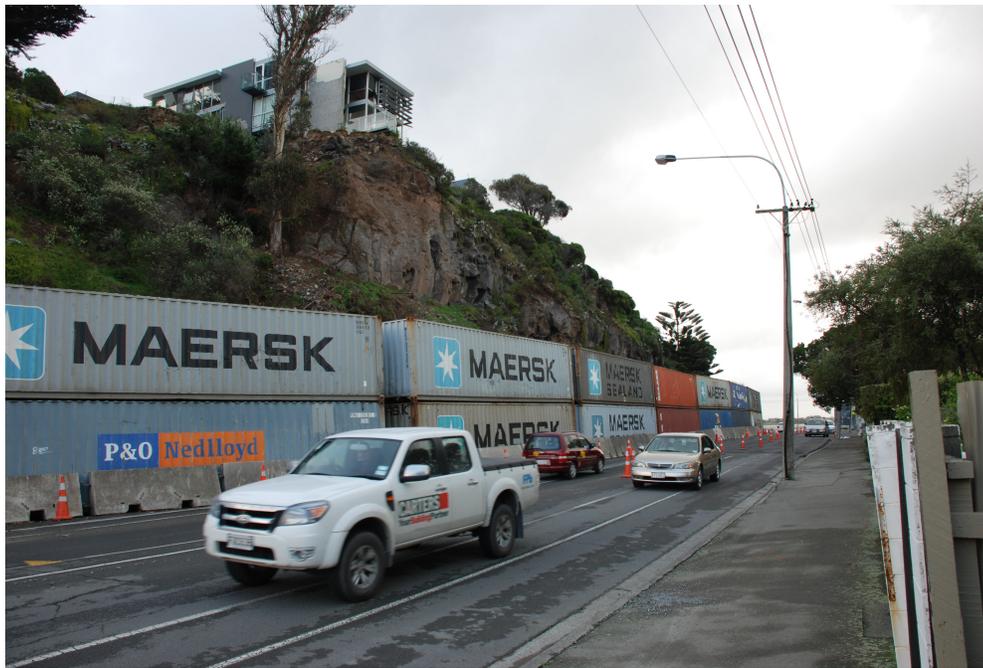
Figure 3-9 Shipping containers were frequently used to barricade roads from slides and rock falls.

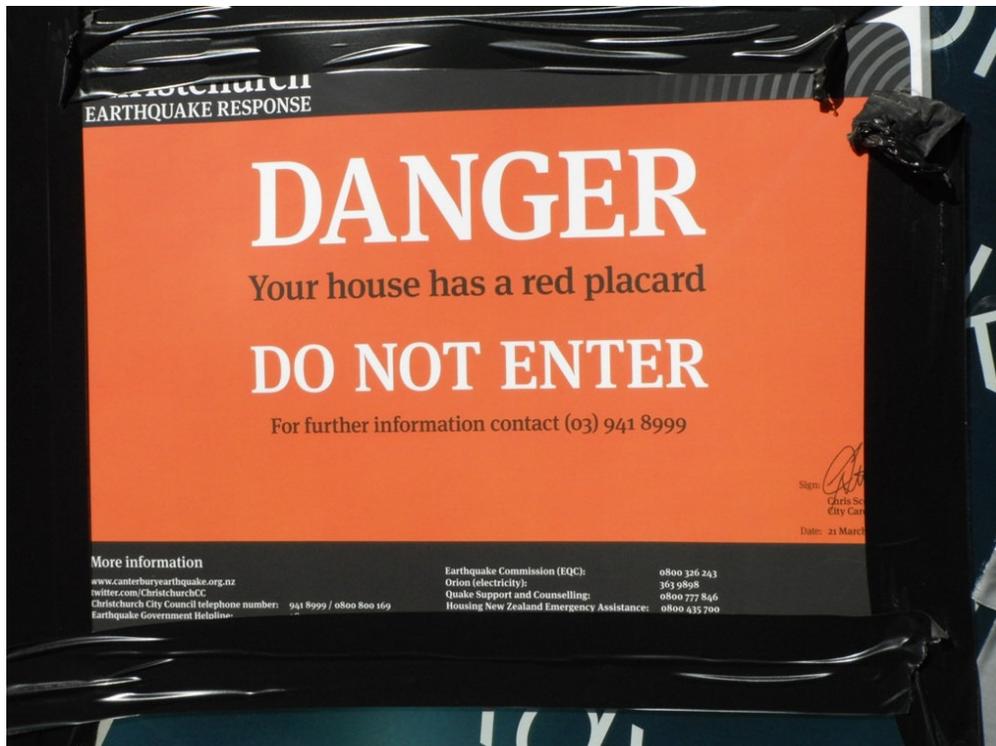
It was observed that a number of buildings had two placards. One placard was typically from the first inspection, and the second from a subsequent follow-up inspection. Both were often left in place. Often they had different postings (see Figure 4-1 for an example). This became confusing when the ink faded, and it was sometimes difficult to determine which was the latest placard. Some buildings had a different kind of placard (Figure 4-2).

Figure 4-2 Another kind of “Red Tag” observed in Christchurch.

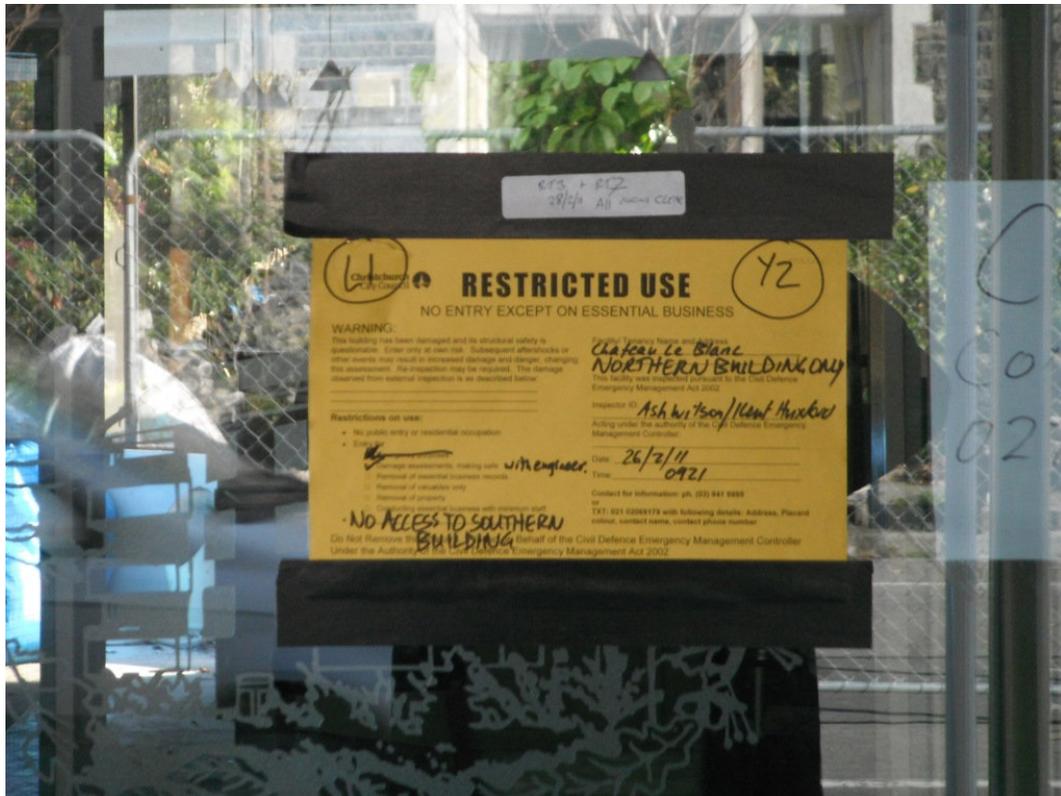
One problem the ATC team observed was that many placards used in Christchurch had the phrase “No Entry Except on Essential Business” under the RESTRICTED USE title (see Figure 4-3 and Appendix A for examples). This statement appears to be inconsistent with the general intent of the RESTRICTED USE posting which is to permit safe use of damaged buildings. In contrast, ATC-20 expressly allows for evaluators to select a variety of options for restricting the use of a building.

Figure 4-3 A RESTRICTED USE placard with the “Y2” Usability Category indicated in the upper right hand corner. The “L1” in the upper left hand corner probably refers to the fact that the building received a Level 1 Rapid Evaluation at the time of the posting.
