| C1 TOWER |

This Detailed Engineering Evaluation Report (Report) has been prepared in connection with damage suffered by the building at the address shown on the front of this report (Building) resulting from the earthquakes that occurred in the Canterbury region on Saturday 4 September 2010, on Tuesday 22 February 2011, Monday 13 June 2011 and Friday 23 December 2011 (NZDT) and subsequent aftershocks up to the date of inspection by CPG.

The Pacific Tower Body Corporate via Fortis Construction Ltd engaged CPG to prepare this assessment of damage caused by the 2010/2011 earthquakes and prepare repair specifications as detailed in the CPG proposal dated 7 July 2011.

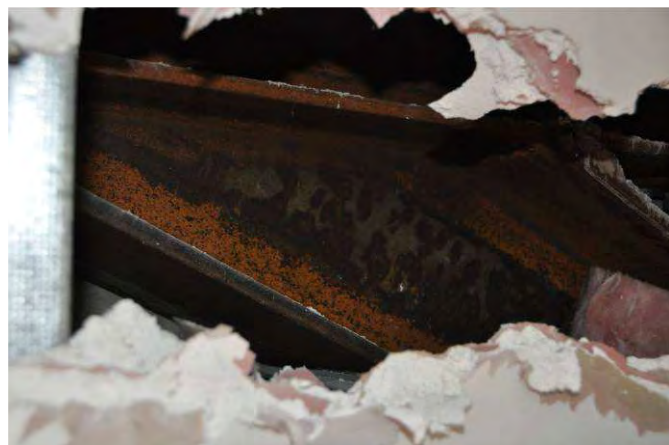
L7, Grid C2, brace connection

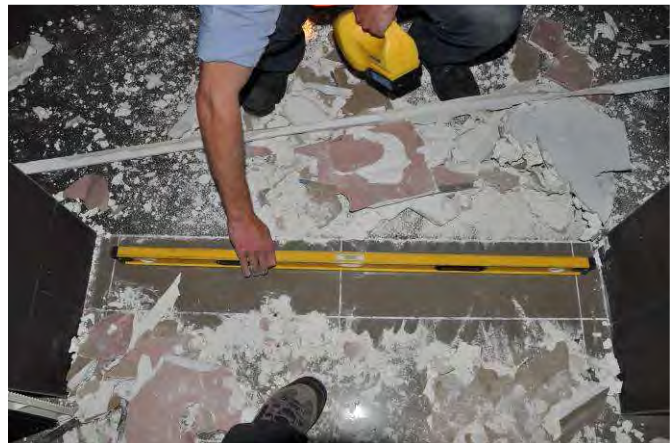
L7 floor at Grid C1/26, essentially level

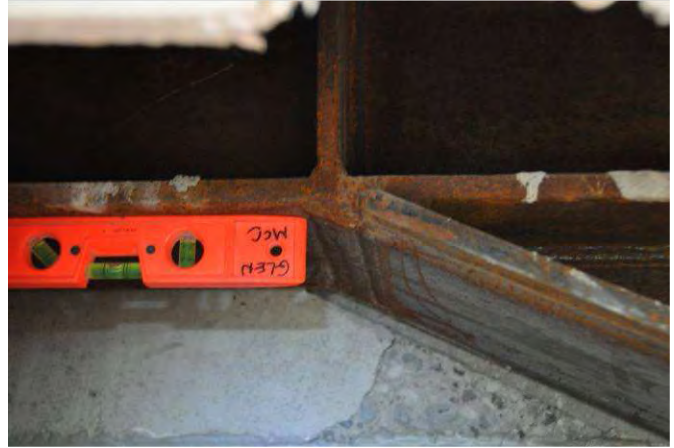
L7, Grid F5, active link and brace connection

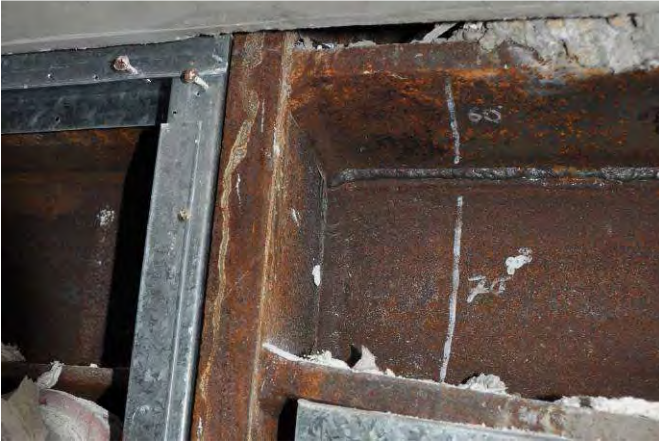
L16, Grid D4(east), active link

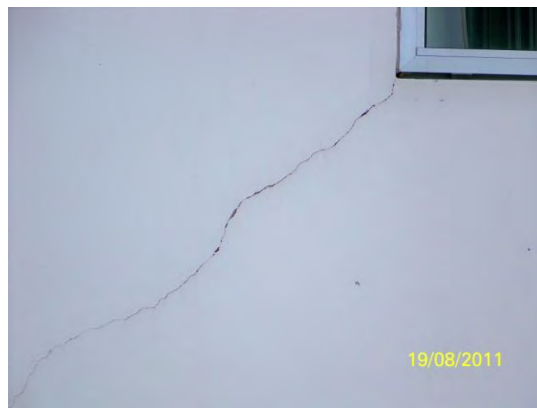
**Level 10 Left Side of Window, Rt Panel**

On the Southeast building corner, it appears that the concrete panels received even more of a beating.

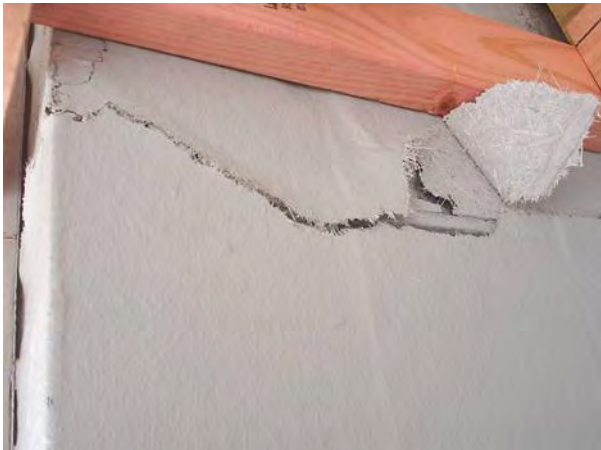
Level 6

Southwest corner internal wall

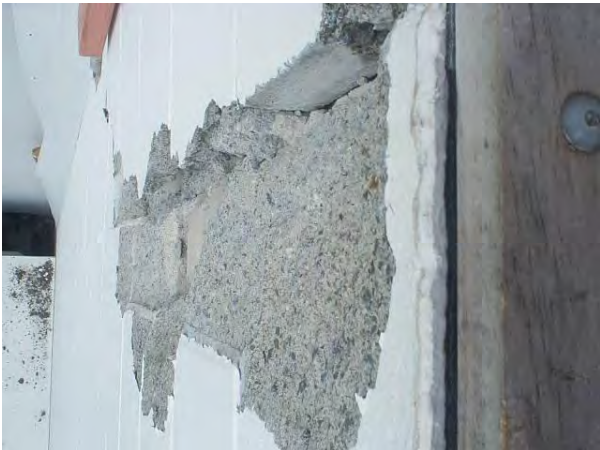
Southwest corner external wall

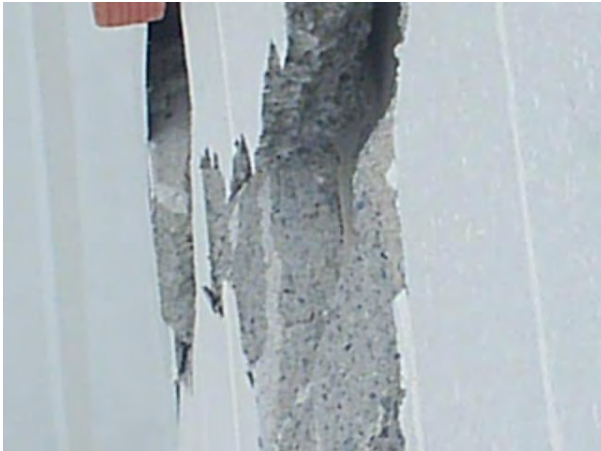
Southwest corner external Parapet wall

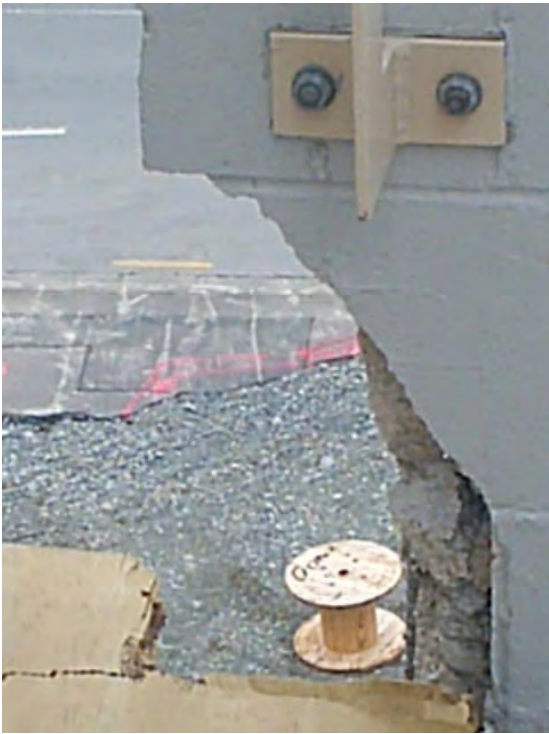
Southeast corner internal Parapet wall

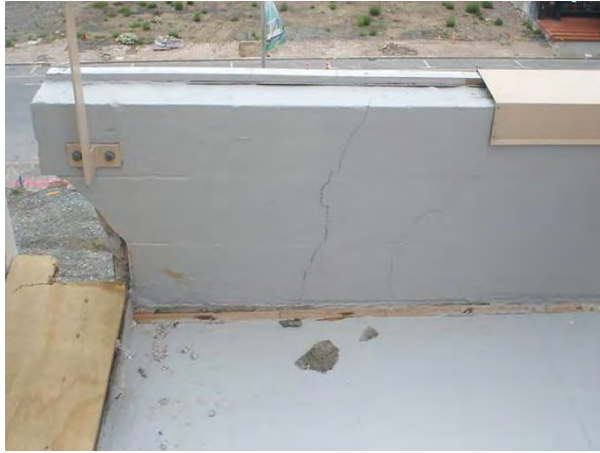
Southeast corner internal Parapet wall

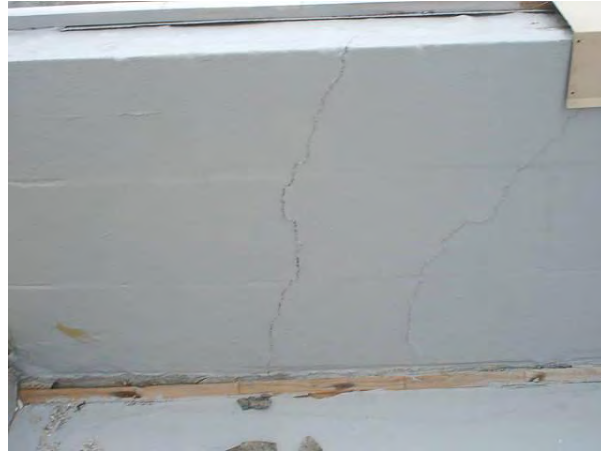
Southeast corner internal Parapet wall
