# Observed performance of unreinforced masonry buildings in the 2010/2011 Canterbury earthquake swarm

### 3.1 Damage to URM buildings from the 4 September 2010 earthquake

## The Performance of Unreinforced Masonry Buildings in the 2010/2011 Canterbury Earthquake Swarm

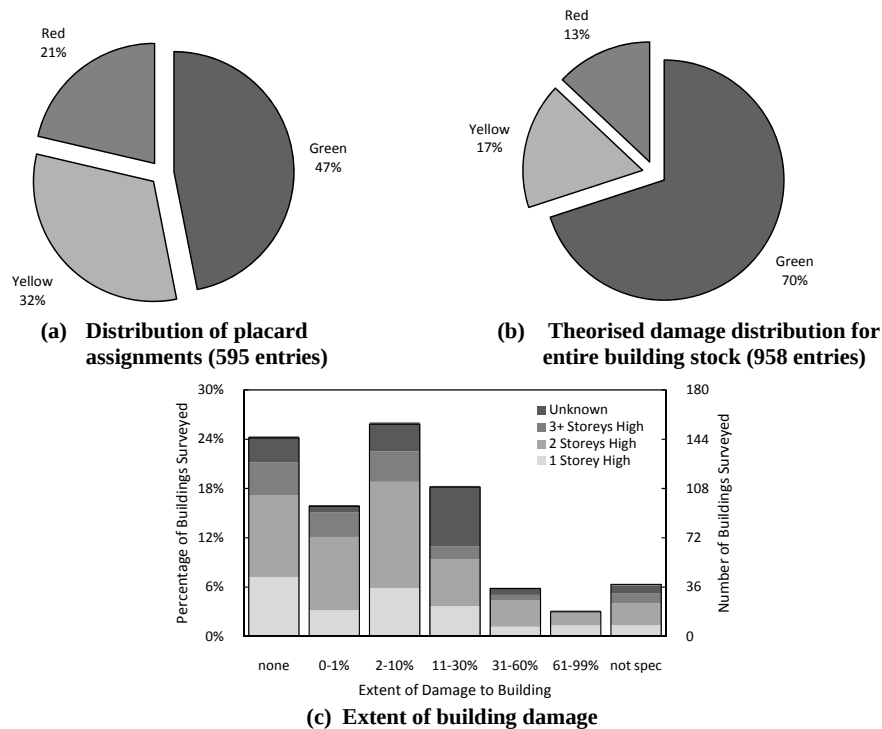
The results of the damage assessment are reported in Figure 3.5. Figure 3.5(a) reports the ‘useability’ assignment of the 595 URM buildings assessed. In consultation with staff of Christchurch City Council it was assumed that the remainder of the URM buildings thought to exist in Christchurch probably had a green tag usability rating, and so a theorised damage distribution for the entire URM building stock of Christchurch is shown in Figure 3.5(b).

Figure 3.5(c) reports the level of damage in percentage terms for the 595 buildings that were surveyed by the Rapid Building Assessment teams. The values recorded by the teams for each building surveyed were simply estimates (excluding contents damage). Despite the known vulnerability of URM buildings to earthquake loading, 395 of the 595 buildings (66%) were rated as having 10% damage or less, with only 162 (34%) of the buildings assessed as having more than 10% damage. It was also possible to study the distribution of damage dependent on storey height (Figure 3.5(c)), with the data indicating no definitive trend and a comparatively uniform level of damage assigned to buildings in each height category.

**Figure 3.5 Damage statistics for the 4 September 2010 earthquake**
