## The Performance of Unreinforced Masonry Buildings in the 2010/2011 Canterbury Earthquake Swarm

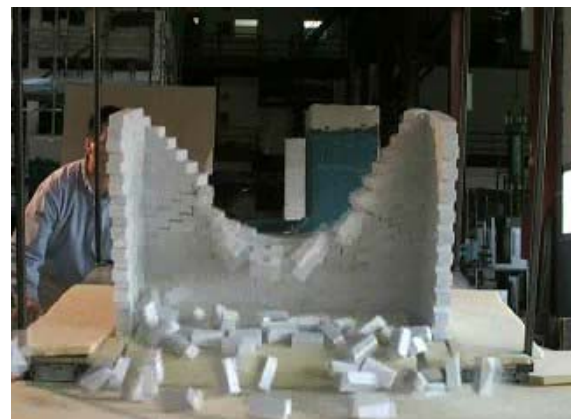
As shown in Figure 3.11, several examples of face load wall failure closely resembled observed damage in dry stack masonry experiments (Restrepo-Velez and Magenes, 2009), providing further support to the supposition that many of the wall failures were partly attributable to poor mortar strength.

(b) High speed photograph of a dry-stacked masonry wall failing during a tilt test

**Figure 3.11 Failure mechanism comparisons – observed earthquake damage versus experimental simulation**
