## The Performance of Unreinforced Masonry Buildings in the 2010/2011 Canterbury Earthquake Swarm

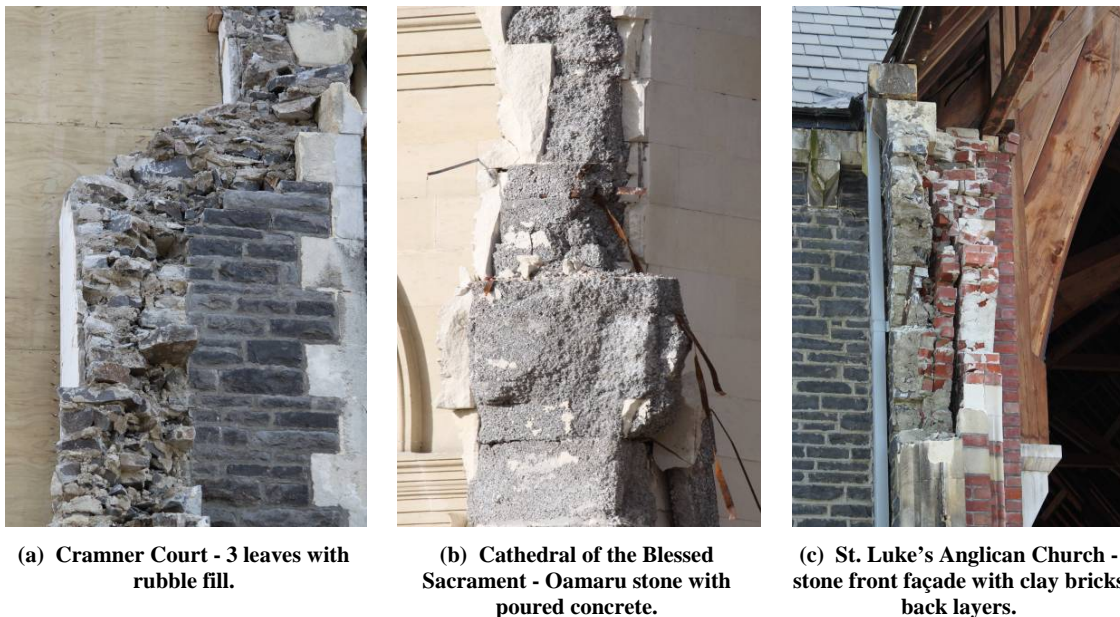
- Three leaf masonry walls, with dressed or undressed basalt or lava flow stone units on the outer leaves (wythes) while the internal core consists of rubble masonry fill (Figure 3.27(a));
- Three leaf masonry walls, with the outer layers in Oamaru sandstone and with a poured concrete core, such as for the Catholic Cathedral of the Blessed Sacrament (Figure 3.27(b) and section 5.1.2);
- Two leaf walls, with the front façade layer being of dressed stone, either dressed basalt or bluestone blocks, or undressed lava flow units, and the back leaf constituted by one or two layers of clay bricks, usually with a common bond pattern, with the possible presence of a cavity or of poured concrete between the inner and outer leaves (Figure 3.27(c)).

**Figure 3.27 Representative examples of wall cross-sections for Christchurch stone masonry buildings**

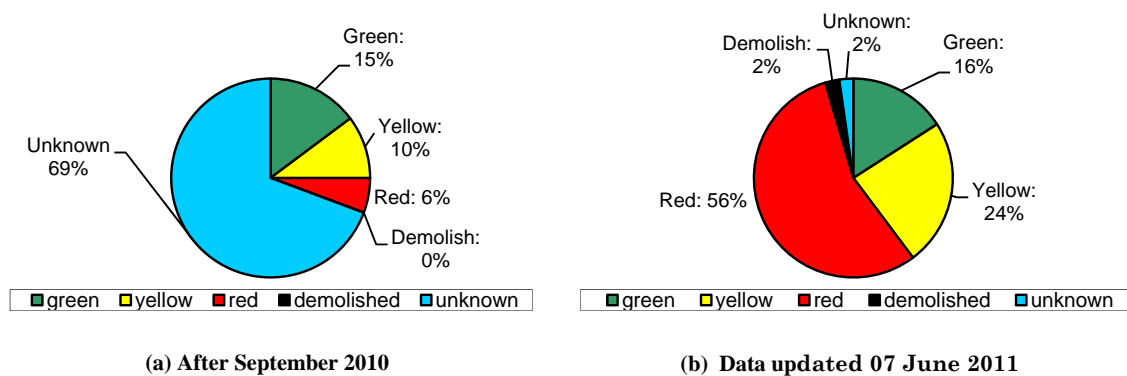
The seismic performance of stone masonry buildings was partially identified by considering the safety assessment data that was collected following the earthquakes that occurred in September 2010 and February 2011. Figure 3.28 shows the distribution of building safety assessments after the 4 September 2010 and 22 February 2011 earthquakes, respectively. From this figure it can be seen that there was a significant

escalation of damage due to the continuing earthquake activity in the Christchurch region. Figure 3.29 gives a further breakdown of this data for the two major earthquakes on the basis of building usage. As noted earlier, green placards were assigned to structures that were deemed to be safe to re-enter and required no further intervention; yellow placards were applied to buildings whose accessibility was restricted due to minor damage; and red placards were applied to buildings that were considered unsafe and likely to have a moderate to severe level of damage. At the time of the study reported here, several buildings had been demolished already because of the hazard associated with their damage state. As shown in Figure 3.28, only 16% of the stone masonry buildings surveyed were assigned a green placard after the 22 February 2011 earthquake whereas approximately 50% (15% green compared with 16% yellow and red) had green placards after the 4 September 2010 earthquake.

**Figure 3.28: Distribution of safety evaluation placarding applied to stone masonry buildings**

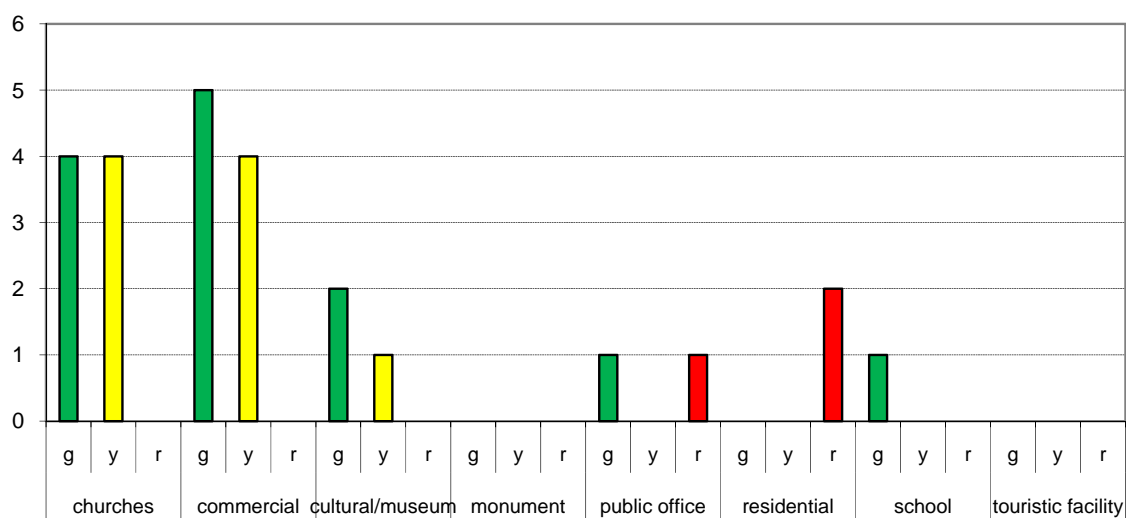
(a) after September 2010

**Figure 3.29 Distribution of safety evaluation placarding applied to stone masonry buildings differentiated by building usage**

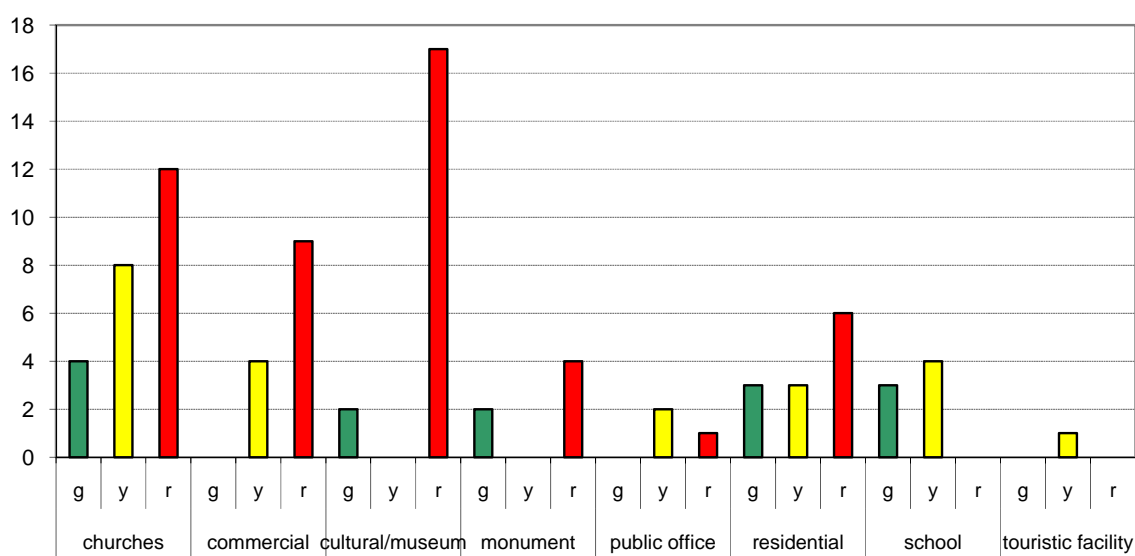
(b) after February 2011
