Section 5:

Set of representative buildings

The Performance of Unreinforced Masonry Buildings in the 2010/2011 Canterbury Earthquake Swarm

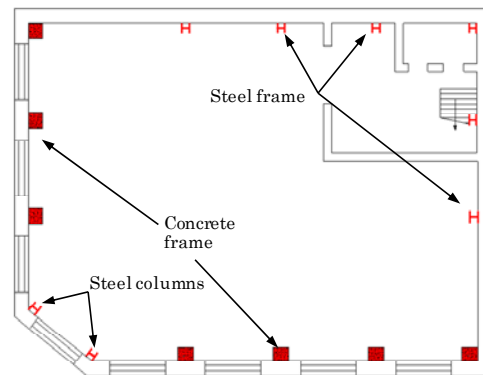
Figure 5.8 Floor plan of TSB Bank Building, showing retrofit

The building was seismically retrofitted by the new owner (TSB Bank) in 2009, which involved the introduction of secondary frames. The facade is strengthened by concrete columns and beams at the floor levels (forming a concrete frame) and the side walls are strengthened using steel frames with diagonal braces that are anchored into the masonry as shown in Figure 5.8 and Figure 5.7(b). The floor diaphragms on levels 2 and 3 were stiffened with plywood sheets and 'X' pattern steel plates, with screw fixings spaced at approximately 20 mm to connect the plates to the timber diaphragm as shown in Figure 5.7(c). Figure 5.7(d) shows strengthening of the gable, consisting of steel frames secured with adhesive anchor bolts, and Figure 5.7(e) shows the roof diaphragm strengthening using steel tie rods. The walls are supported by newly added concrete beams at the basement level, further resting over old concrete basement walls.

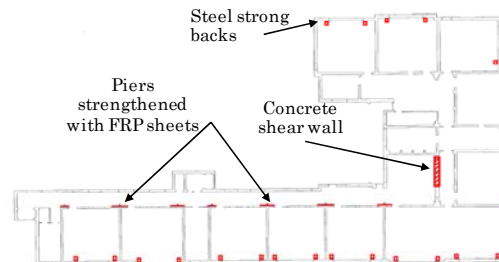
Figure 5.13 Floor plan of Shirley Community centre showing retrofit

Seven individual wall areas were strengthened with surface bonded FRP sheets using Sikawrap 100G (the application of FRP retrofit is shown in Figure 5.12(a)) in the locations shown in Figure 5.13. FRP rod anchors were installed to bond the applied

Sikawrap 100G sheet to the concrete foundation beams (BBR Contech, 2010). The out-of-plane stability to the perimeter wall was provided by using steel hollow sections as strong backs fixed to the URM walls. To ensure sufficient lateral load resistance in the North-South direction a concrete shear wall was also added at the location shown in Figure 5.13. The veneer brick layer was secured to the main wall using helical veneer ties at regular spacing.
