## The Performance of Unreinforced Masonry Buildings in the 2010/2011 Canterbury Earthquake Swarm

### 5.4 Clay brick URM building that have been partially or fully demolished

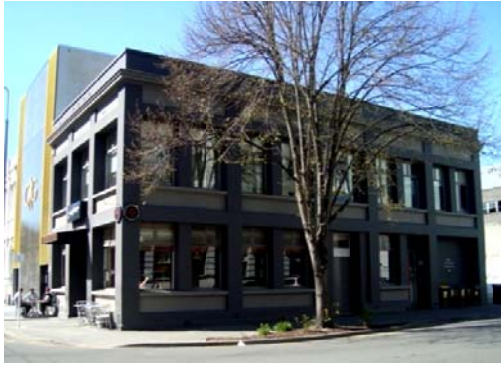
(a) Exterior view

At the time of construction in the 1920's, 194 Hereford Street was the end building in a row of two storey buildings. The building was a two storey isolated URM building most recently occupied by Joe's Garage Cafe and Miles Construction, and was isolated from the neighbouring building by a seismic gap (see Figure 5.17(d)). The original structural system consisted of load bearing external URM walls, with timber diaphragms and a concrete lintel beam running the full length of the building on the Hereford Street and Liverpool Street sides. The street-facing facade walls were perforated URM walls whereas the rear of the building consisted of stiff solid shear walls. The building had a sloping roof and the parapet height varied from zero to about 1 m at the side adjacent to the neighbouring building. From preliminary scratch tests it was established that a lime based weak mortar having coarse aggregate was used in the original construction.

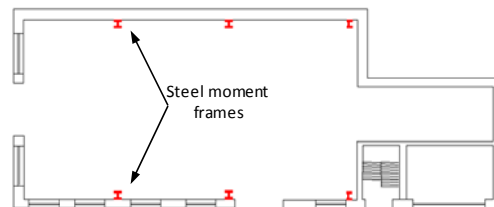
**Figure 5.18 Floor plan of Joe's Garage Cafe, showing retrofit**

The building was seismically retrofitted in 2004 using large steel portal frames oriented in the transverse direction of the building, spaced at approximately 4 m centres as shown in Figure 5.17(b). The building floor plan is shown in Figure 5.18. Diaphragm strengthening was not observed in the interior of the building.

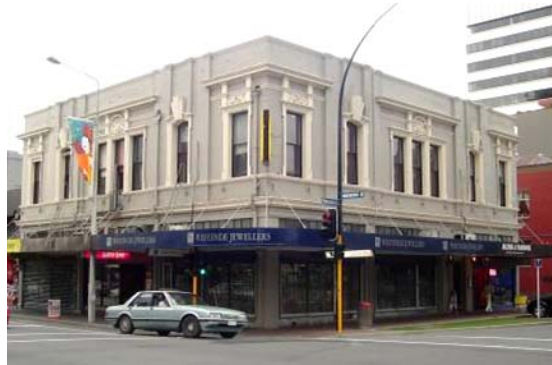
**Figure 5.19 Welstead House, 184-188 Manchester Street, before the 4 September 2010 earthquake**

standalone two storey clay brick URM building with a regular rectangular plan and no vertical irregularities. A photograph of the building prior to the 4 September 2010 earthquake is shown in Figure 5.19.
