FINAL REPORT

VOLUME 6  
CANTERBURY TELEVISION BUILDING (CTV)

The CTV building at 249 Madras Street collapsed during the earthquake at 12:51pm on 22 February 2011. One hundred and fifteen people lost their lives and others were injured.

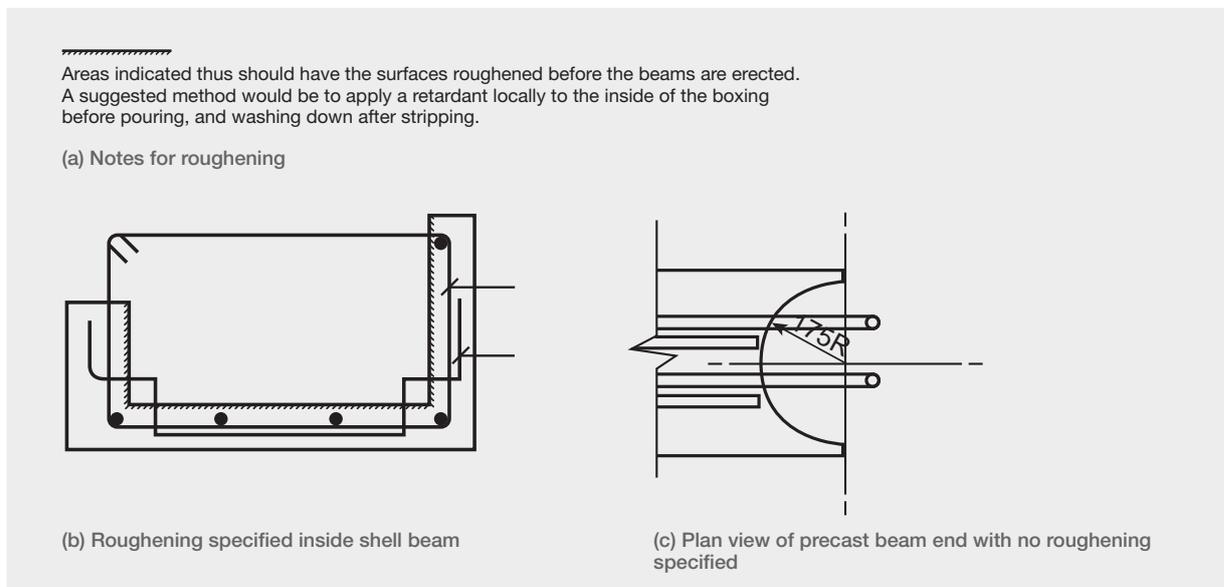
Figure 19: Details for roughening on structural drawings

As we have noted, the lack of roughening to the precast beam surfaces was both a design issue and a construction issue. There was inconsistency and a lack of detail in the way this requirement was detailed by Mr Harding on the drawings and in the specifications. The structural drawings included notes directing the roughening of surfaces (as shown in Figure 19(a)). Roughening was required on the inside of most shell beams (Figure 19(b)) but was not shown at the critical region where the precast beams met the in situ concrete of the circular columns (Figure 19(c)).

The specifications, on the other hand, stated, “all surfaces against which concrete is later to be cast shall be roughened by brooming while the concrete is still plastic”. They also specified that the surface of precast shell beams “shall be roughened to ensure good bond to the infill concrete”. There was evidence that this was not carried out, for example Figure 20. Dr Robert Heywood, a USAR and forensic engineer, observed a number of internal and edge beams in the rubble. He said that there was no surface roughening and no evidence of a substantial bond between a number of precast and in situ concrete interfaces.

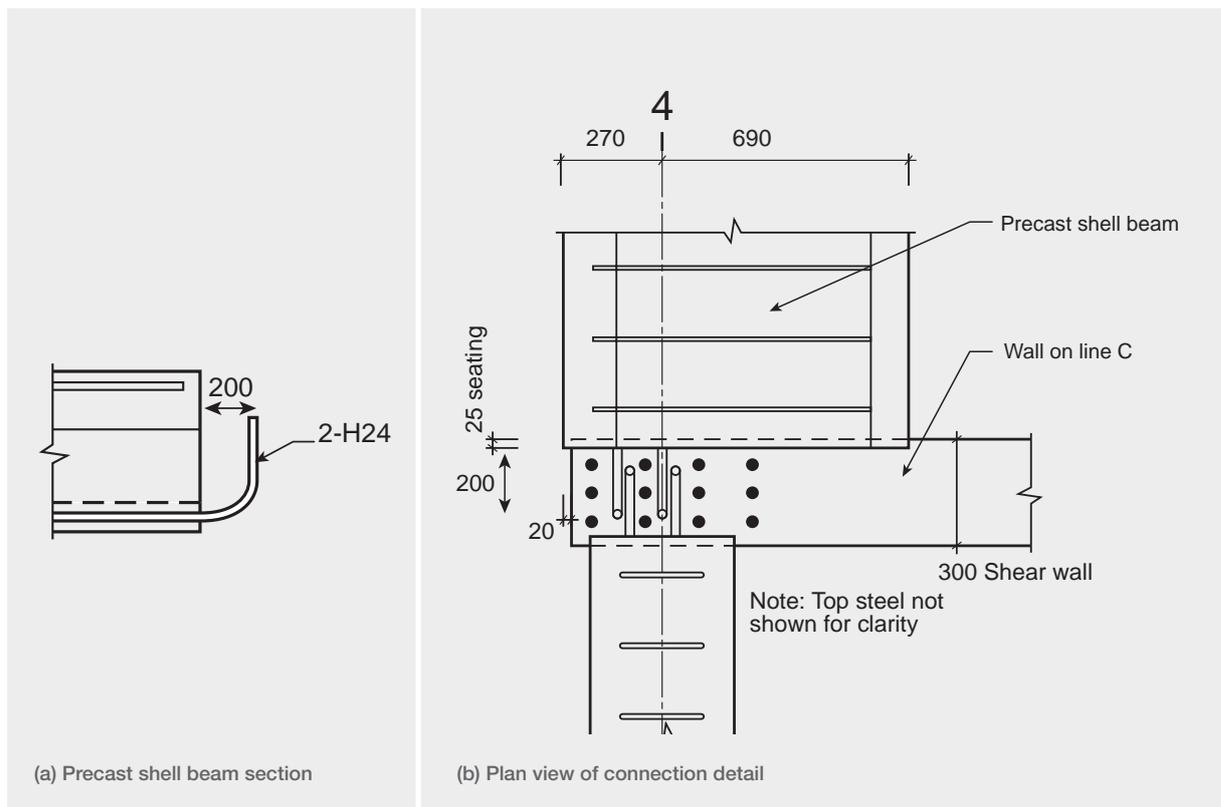
Figure 22: Structural drawing details of the beam-to-wall connection

The structural drawings show the bottom two H24 bars embedded 200mm into the wall on line C, as shown in Figure 22(a) and (b).

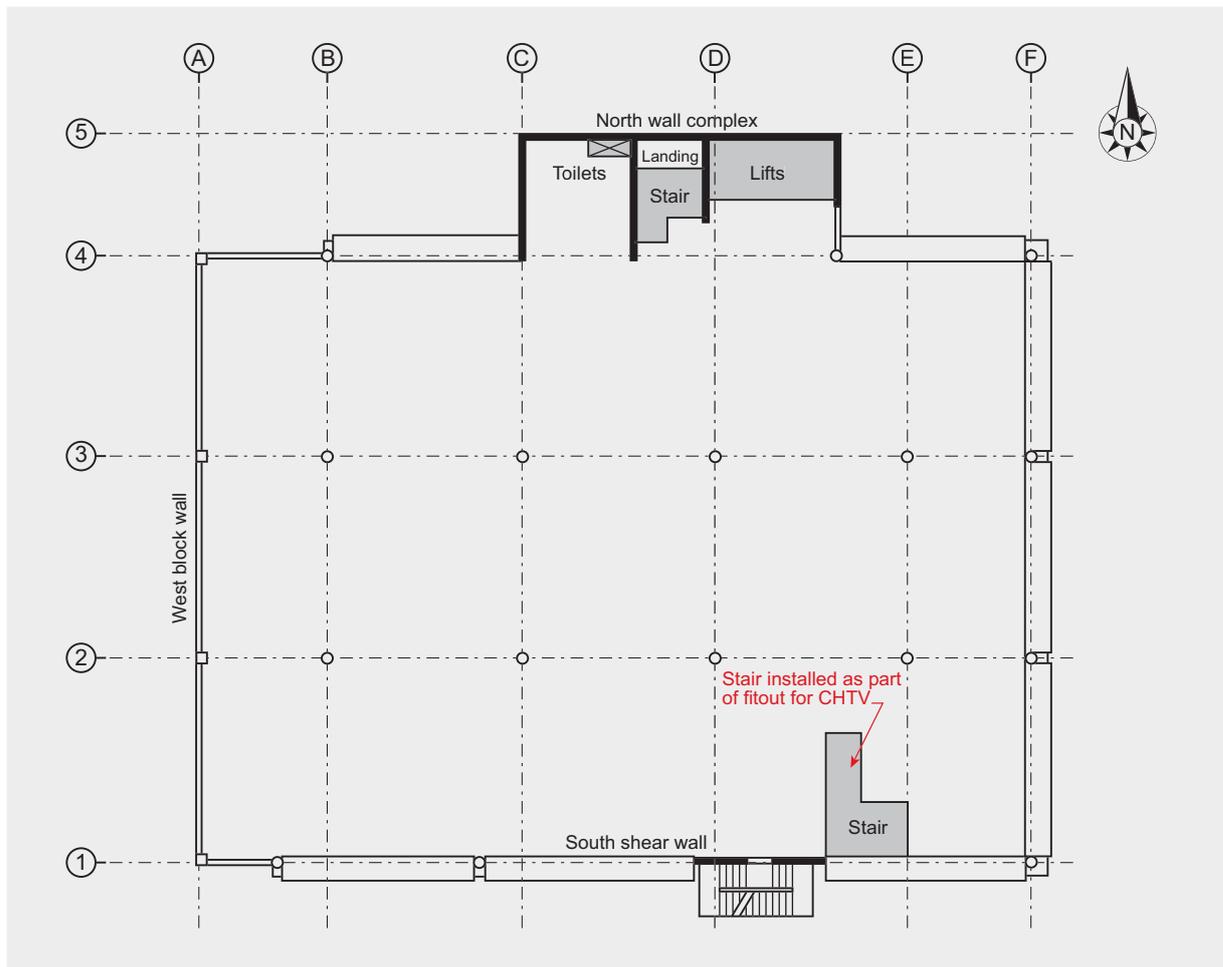
Figure 28: Level 2 showing location of stair installed for CHTV fit-out

The building consent application included cutting a penetration in the floor of level 2 so that an internal stairwell could be installed (see Figure 28). In addition, holes were to be drilled near the east end of the south shear wall. A building consent for the internal stairwell penetration was issued by the CCC on 10 May 2000. We have considered whether this work would have impaired the structural performance of the building in an earthquake.

An engineer from Falloon and Wilson Limited designed the floor penetration. Mr Falloon, who is principal of the company and was a Registered Engineer, checked the design and signed a producer statement. Mr Falloon gave evidence at the hearing that he carried out calculations to check the gravity loads but not the lateral loads. However he considered that the lateral load paths from the floor diaphragm would not be altered because the area cut out for the stair opening was only a small proportion of the total floor area. The rest of the floor diaphragm was available to transfer lateral loads to the shear walls. In his opinion, level 2 would not attract as much lateral action as the upper floors.

The Royal Commission asked Mr William Holmes to assess this design. Mr Holmes expressed the opinion that, “...the connection of a trimmer beam with drilled in dowels at the end of a major shear wall should have included a note to carefully monitor drilling and avoid cutting of bars”. Mr Falloon agreed with this in hindsight. He had no specific recollection of the observation of the project, so could not confirm if the drilling of the holes had been monitored.
