Section 3: From the September earthquake to the February earthquake

3.1 The Canterbury earthquakes

3.2 The September earthquake

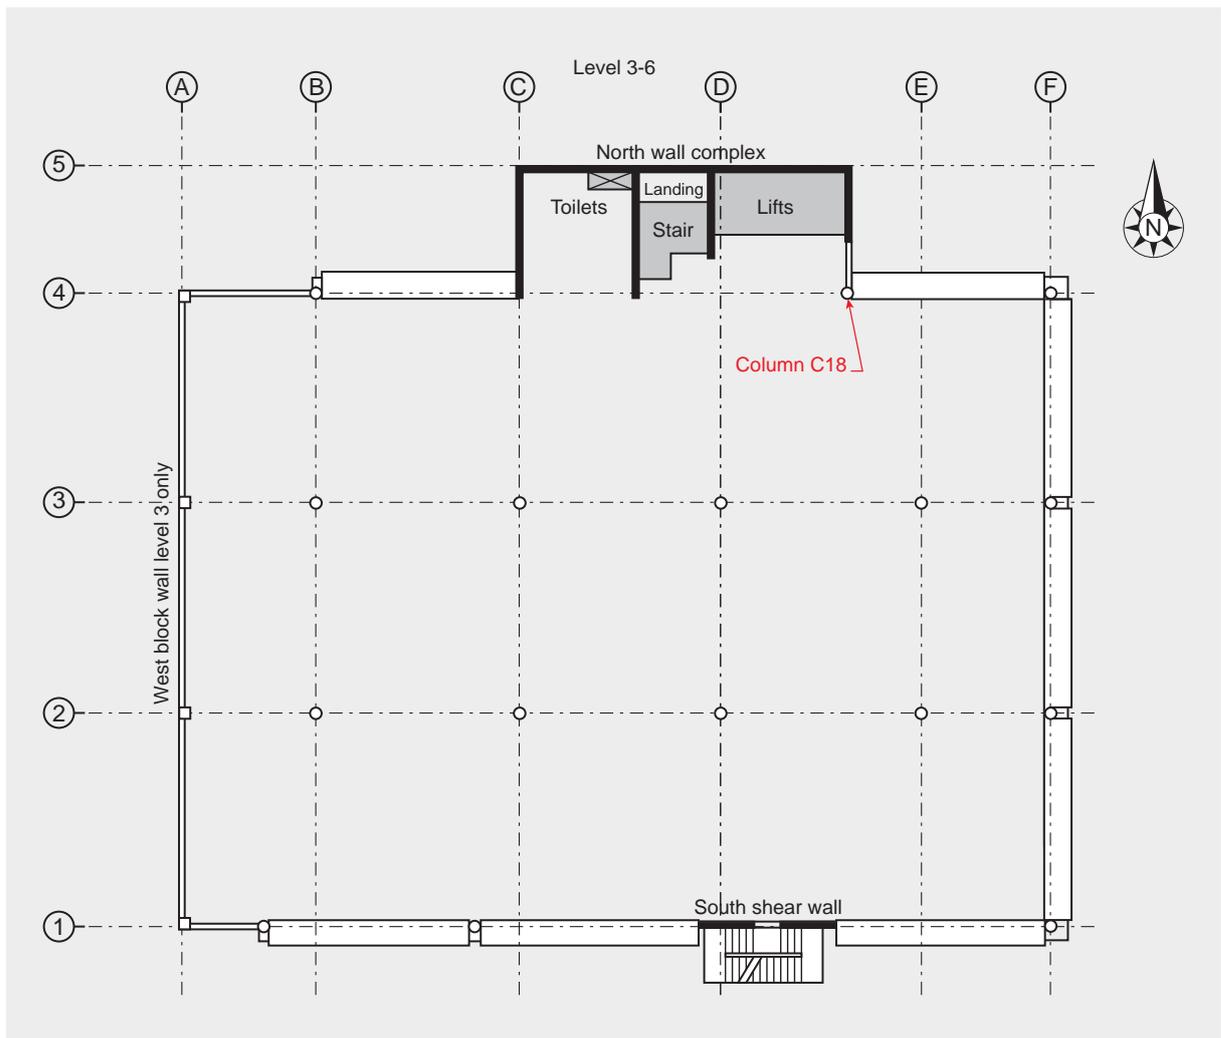
Figure 42: Location of column C18 on level 6

To assess the response of the columns and beams to the earthquake Mr Coatsworth looked for shear and/or flexural bending or cracking in the concrete at beam-column joints or in the columns and beams themselves. He said that the size of any cracking would indicate elastic or inelastic movement. He also looked for signs of compression failure in the columns as a result of vertical loading. He said he looked at every column on each floor. Although he observed some cracking to columns, he was of the view that none of it indicated structural damage. On level 6, the first column west of the north-east corner of the building exhibited some cracking, the appearance of which was accentuated because the paint had chipped off at the cracks. This column was referred to in the hearing as column C18 (see Figure 42). Mr Coatsworth's recollection was that the cracks were less than 0.2mm in width (see Figure 44).
