Building Evaluation Transition Team

Processes Used and Lessons Learnt following the Darfield Earthquake of 4 September 2010

Building Evaluation Transition Team (BET TEAM)

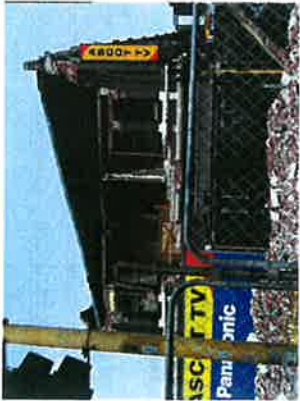
404 / 406 - ASCOT TV

Progress
404 owned by Kevin Thorne, 021 355 474.
406 owned by Mrs Bell, son Joe dealing with it, 03 5248146. 406 listed building, decision still to be made. Insurers considering options

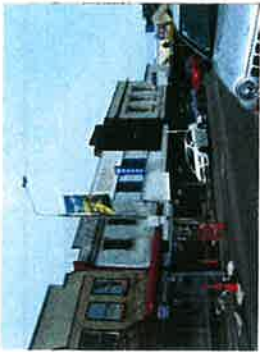
448 – MANSON ?

Progress
Unable to contact owners

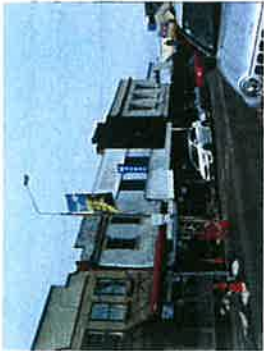
452 - DERELICT

Unable to contact owners.

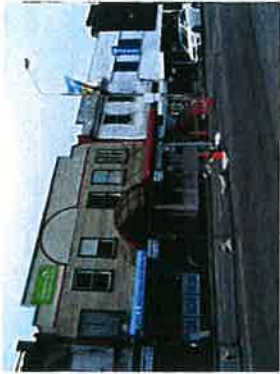
454 – OLD SYDENHAM TOWN

Murray Lapworth 021 105 8060. Owns 456 too. Resource consent being processed

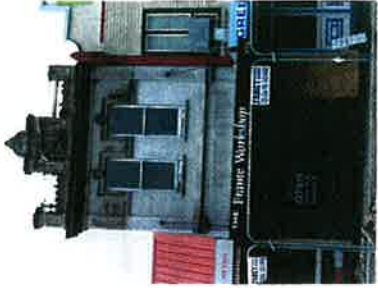
456 – THE FRAME WORKSHOP

Same as 454. Heritage building, Heritage reports being processed.

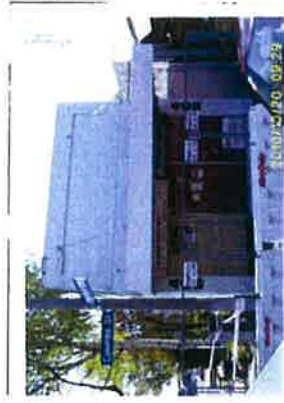
468 – SUPREME

Roger Wall 322 9443, liaising with insurance broker and 2 engineers. Insurance broker having meeting with insurance company on 8/11 to decide way forward. Owner informed that Notice 124 could be served and he will advise his insurers of that.

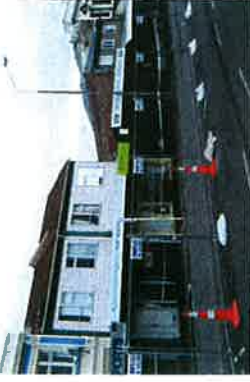
482 – EMPTY

Kim Jen Chang 348 2734, awaiting engineers report. Have had contact with Peter Mills, insurance broker 021 0499 184. Notice 124 served. Peter will forward report on receipt.

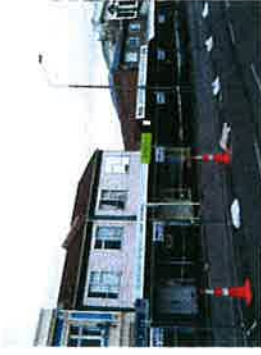
484 – MONUMENTAL MASONRY

Joan Nguyen 332 0895. Have spoken to Jeremy Noonan. Have received exemption consent BAE 35002040. Demolition dependent on adjoining buildings being made safe.

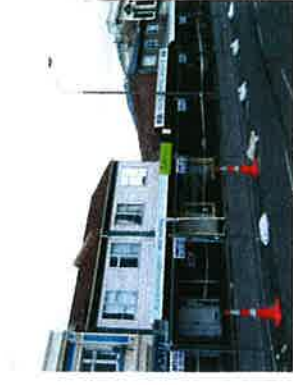
486 – 488 – KALEIDOSCOPE &
24 CARAT BEAUTY PARLOUR

Jeff Pipe 027 439 8991. Buildings 75% residential, dealing with EQC and insurance company. EQC have not been in contact yet. Notice 124 served.

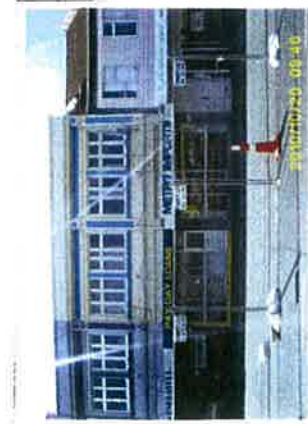
490 -- METRO IMPORTS & PAYDAY
LOANS

Progress
David Yang, son of owner. Still waiting to hear from insurance company. Robert Ling (acting as agent) liaising with Katie Smith. Also own 382 & 384. Notice 124 served.

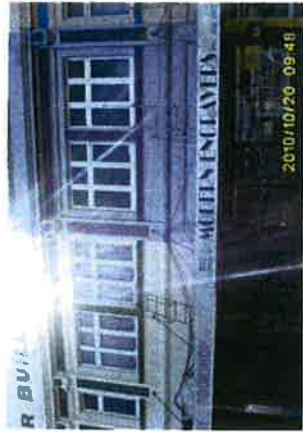
492 /1 -- MODERN ENGRAVERS

Progress
Michael Jones, 366 5633. Engineers report to be sent.

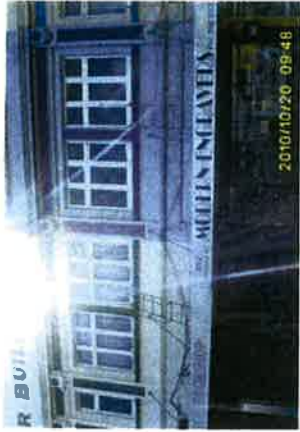
492/2 -- SPEEDWAY BOOKS

Progress
Tony De Rek, 03 312 8686. Unable to contact owner. No insurance.

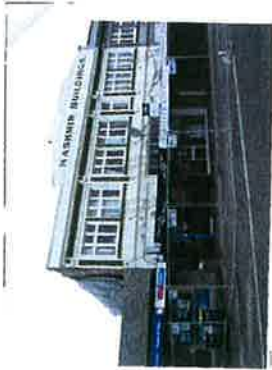
494 – SINISTER BOUTIQUE

Mike Drew, 021 372205, Loss Adjustor
Jason Knowles 027492 8628. Owns 494,
494A, 496. Jason contacting other property
owners from Kashmir building to make
collective decision re façade, will then
proceed with recommendation to owner.

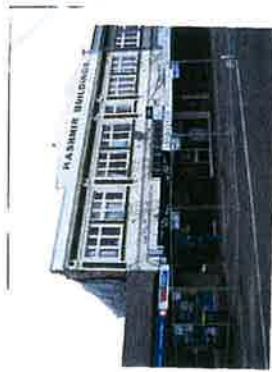
494A – GRAPHIC ADDICTION

See 494

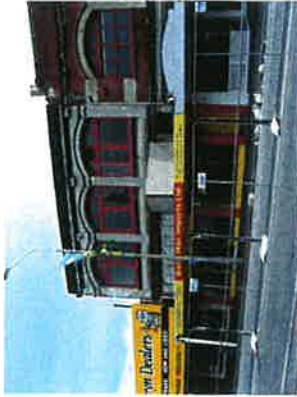
431 – BALI HAI

Chris Voisin, 027 436 7490. Negotiating with insurance company. Demolition team waiting. Can act very quickly.

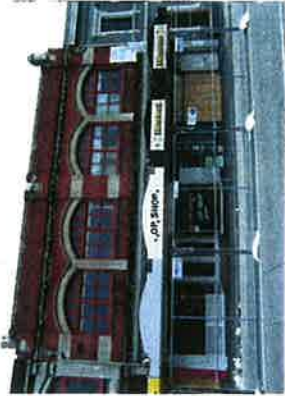
437 – 439 – OP SHOP & HERBAL HEAVEN

Terry Brown 0274 800876. Waiting to hear from insurance assessor, Greg? 021 41 774, unable to contact him. Owner wants buildings demolished.

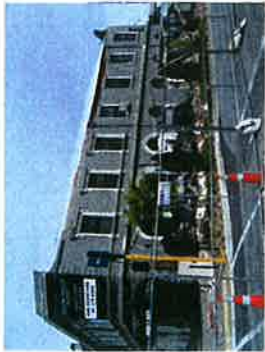
441 – CHURCHILLS

Progress
Jeff Harnett, 027 243 4234. Plans of building are with contractor for pricing for repair or demolition

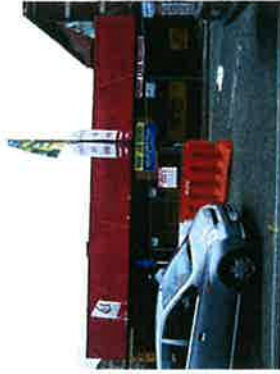
457 – 459 – LUX & PENNY LANE

Progress
See 455. Waiting for demolition of 461 - 469

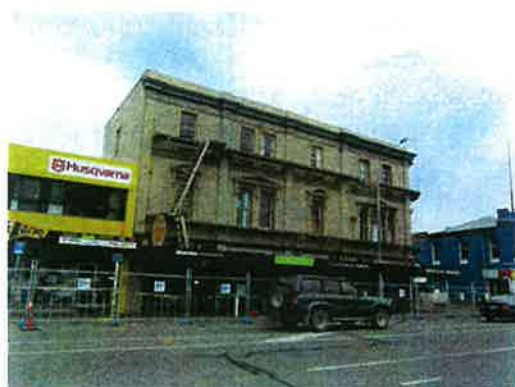
69-73 Manchester Street

Heritage. Central City Precinct 1a.

Cordon / Barrier Reduction: Reduce to parking bay on Welles St (both sides).

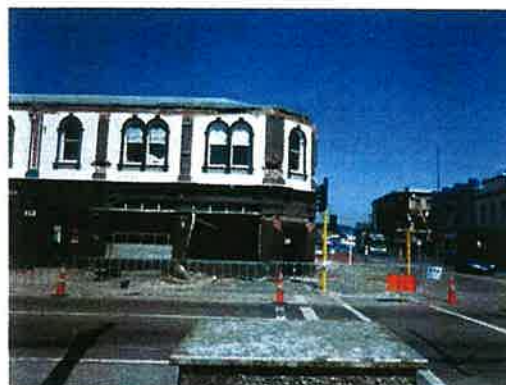
76 Manchester Street

Heritage. Central City Precinct 1a.

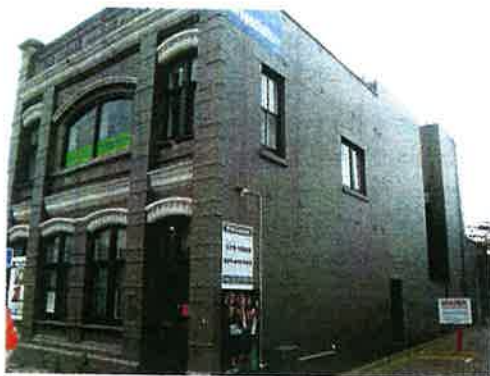
192 Madras Street

'Unsafe' (Red). s124 notice issued – date to respond 31/1/11. Owner denied request for s129.

Cordons: Remove container. Replace with fence lined with plywood.

Barrier Reduction: Props could be installed to stabilise/make safe this building, allowing for removal of cordons until negotiations with owner are completed.

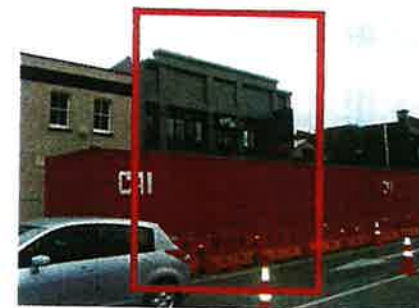
198 Madras Street

'Unsafe' (Red) building. s124 notice issued – date to respond 31/1/11.

Cordons: Remove container. Replace with fence lined with plywood.

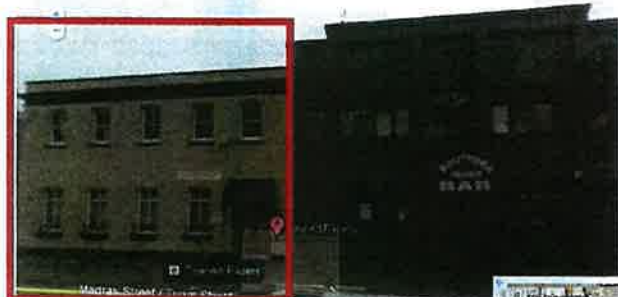
200 Madras Street

‘Restricted Use’ (Yellow) building. s124 notice issued – date to respond 31/1/11. OK for tenants to operate business, must repair southwest corner of parapet before use of south entrance is permitted.

Cordon / Barrier Reduction: Remove container. Replace with fence lined with plywood.

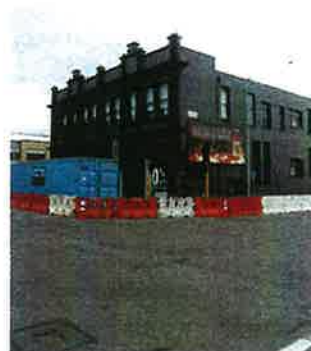
204 Madras Street

‘Unsafe’ (Red) building. s124 notice issued – date to respond 31/1/11. Building condition causing closure single lane on Tuam Street and Madras Street. Building is also preventing use of significant area of Wilson’s Carpark. Building is dangerous through collapse of façade and side wall (north).

Barrier Reduction: Props could be installed to stabilise/make safe this building, allowing for removal of cordons until negotiations with owner are completed.

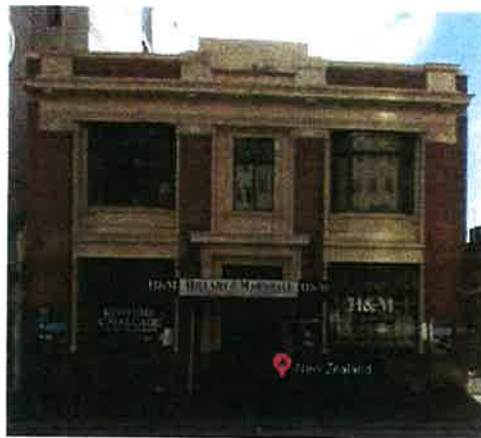
178 Manchester

'Restricted Use' (Yellow) Building. Currently inside the 160 Manchester Cordons. Structural front cracks existing.

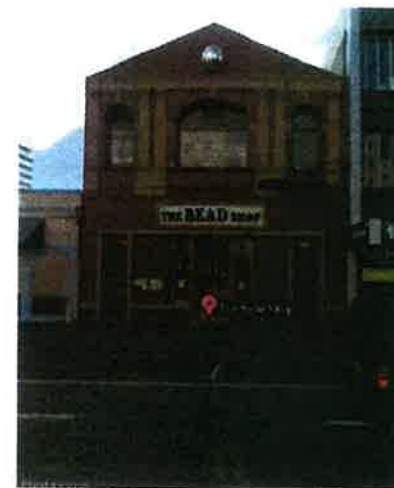
170-172 Manchester

'Unsafe' (Red) building. Side and back wall severe cracking and displacement. Collapse clearly evident on side wall.

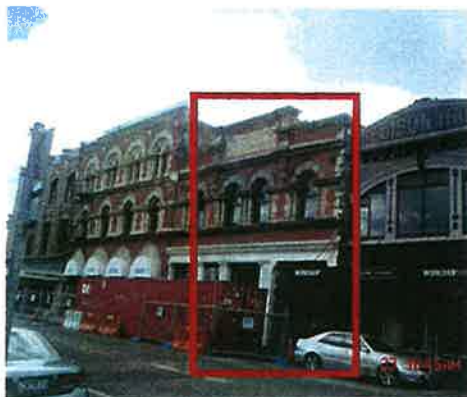
232 Tuam Street

'Unsafe' (Red) building. No notice sent. Cracking of brick walls loose and broken ornamental fractures partly collapsed parapet.

Containers to be removed and replaced with a barricade/fence. Securing work on buildings is underway. This will be completed between now – mid – Jan. A tight fit for scheduled tram & infrastructure development, but should work.

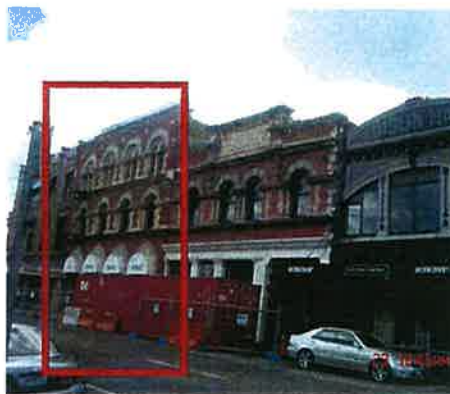
236 Tuam Street

'Unsafe' (Red). s124 notice issued – date to respond 31/1/11.

Broken parapets at L1, L2 and roof. Cracking through brick pier L3 & roof. Broken corbels & parapets, broken glazing L2

Containers to be removed and replaced with a barricade/fence. Securing work on buildings is underway. This will be completed between now – mid – Jan. A tight fit for scheduled tram & infrastructure development, but should work.

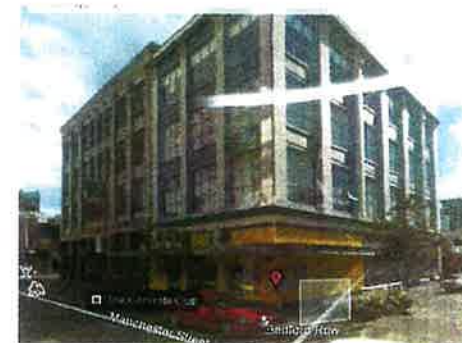
132 Manchester St

'Restricted Use' (Yellow) building. s124 notice issued – date to respond 31/1/11. Building has forced the closure of Bedford Row at Manchester St. Serious crack to south east corner of building. Crack to north west corner column. Possibility of parapet collapse.

Cordon / Barrier Reduction: Cordons removed to footpath. Bedford Row open to two-way traffic as of 29/11/10.

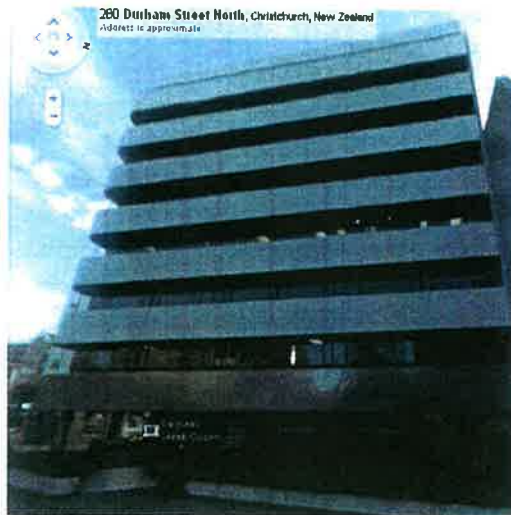
287 Durham Street North

'Restricted Use' (Yellow) building. Small part of the building flashing fell during the main earthquake, nothing has fallen since have fencing up on footpath. No repair work has been undertaken.

Secure two panels will allow for full barrier removal. Estimate cost \$500 - \$1000. BETT to contact Colliers International Property Mgmt to confirm proposal.

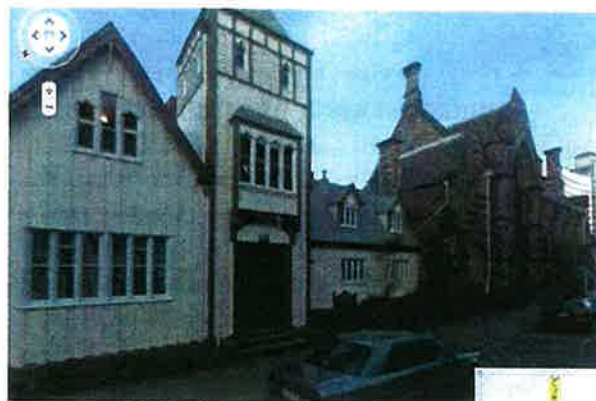
280 Durham Street North

'Restricted Use' (Yellow). Tenants can occupy building - access should be restricted to Armagh St, to avoid loose stonework around stone building.. Extensive cracking to plasterwork, stone dropped and displaced in entrance arch, restrict access until stonework stabilised.

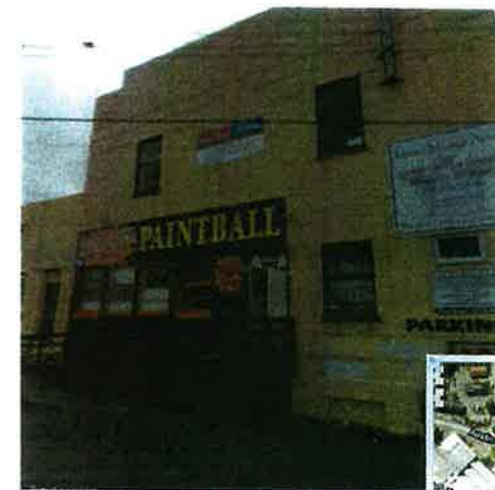
68 Waltham Road

'Unsafe' (Red). No notice has been sent. Damage to the building here is forcing pedestrians (including school children) onto the road on a corner.

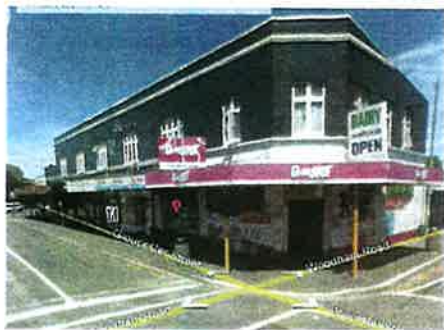
705-709 Gloucester Street

'Unsafe' (Yellow). No notice has been sent. Barricades are needed From 697 Gloucester Street to corner of Gloucester and Woodham. Parapet and façade instability.

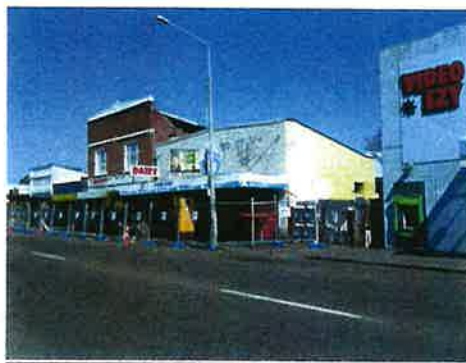
89-95 Stanmore Road

'Unsafe' (Red) building. Building at 93A Stanmore which is causing R3 status to 89, 89A and 95A.

Cordons: To remain in place.

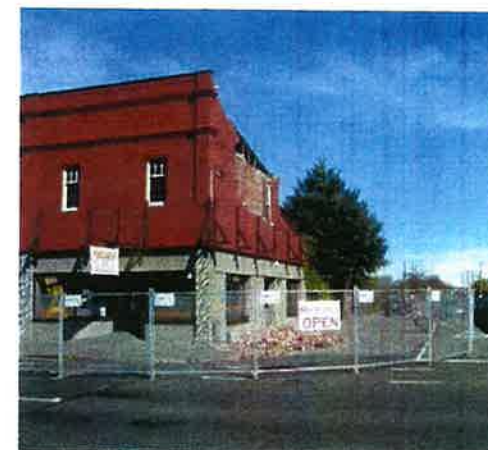
325 Stanmore Road

'Unsafe' (Red) building.

Significant damage to exterior walls.

More damage to building due to aftershocks.
