Report to the Royal Commission of Inquiry

The Performance of Unreinforced Masonry Buildings in the 2010/2011 Canterbury Earthquake Swarm

Associate Professor Jason M. Ingham The University of Auckland and

> > August, 2011

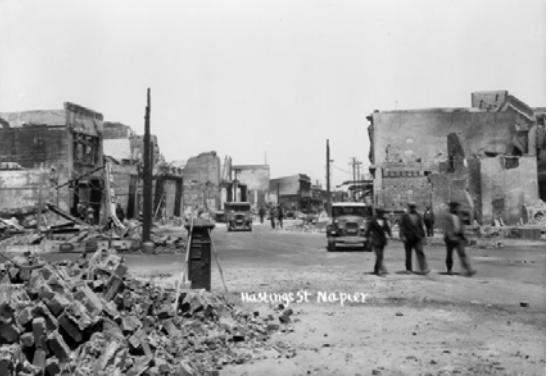
(d) View down Hastings Street, Napier after the earthquake 1931 [Alexander Turnbull Library]

Figure 2.6 Damage to masonry buildings in the 1931 Hawke's Bay earthquake

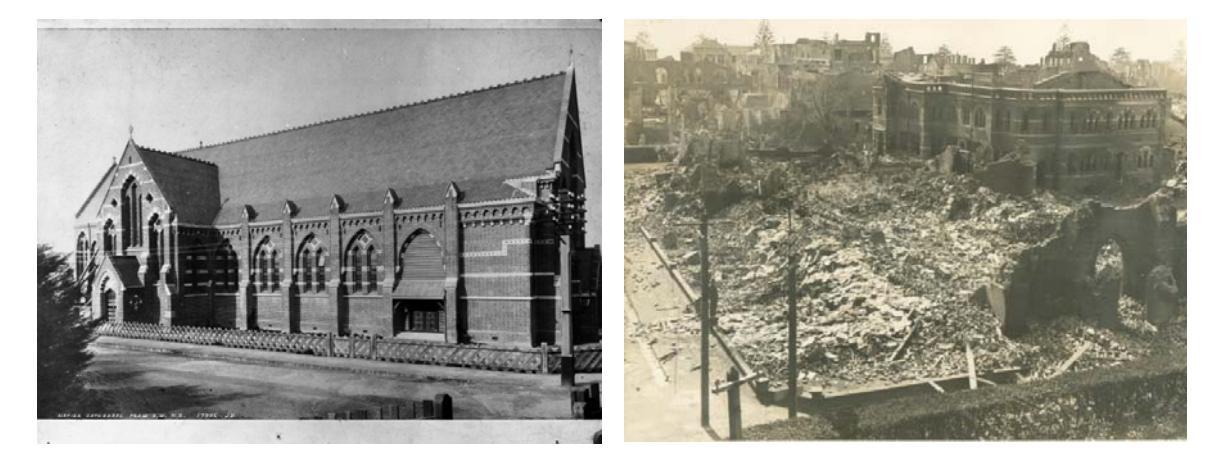
As reported above, it was the combustibility of timber buildings that prompted the focus in Auckland towards building in clay brick unreinforced masonry, and occasionally in stone masonry. Early earthquakes in the Wellington region resulted in a slower adoption of masonry construction. This caution proved to be well justified. On the morning of 3 February 1931 the Hawke's Bay region of the eastern North Island was struck by a M7.8 earthquake that destroyed much of the city of Napier (see Figure 2.6). Fires swept through the wreckage, destroying much of what was left. Perhaps the largest brick masonry building to collapse was the Napier Anglican Cathedral (see

(b) Ruins of the Napier Anglican Cathedral after the 1931 Hawke's Bay earthquake [Alexander Turnbull Library]

Figure 2.7 Napier Anglican Cathedral before and after the 1931 Hawke's Bay earthquake³

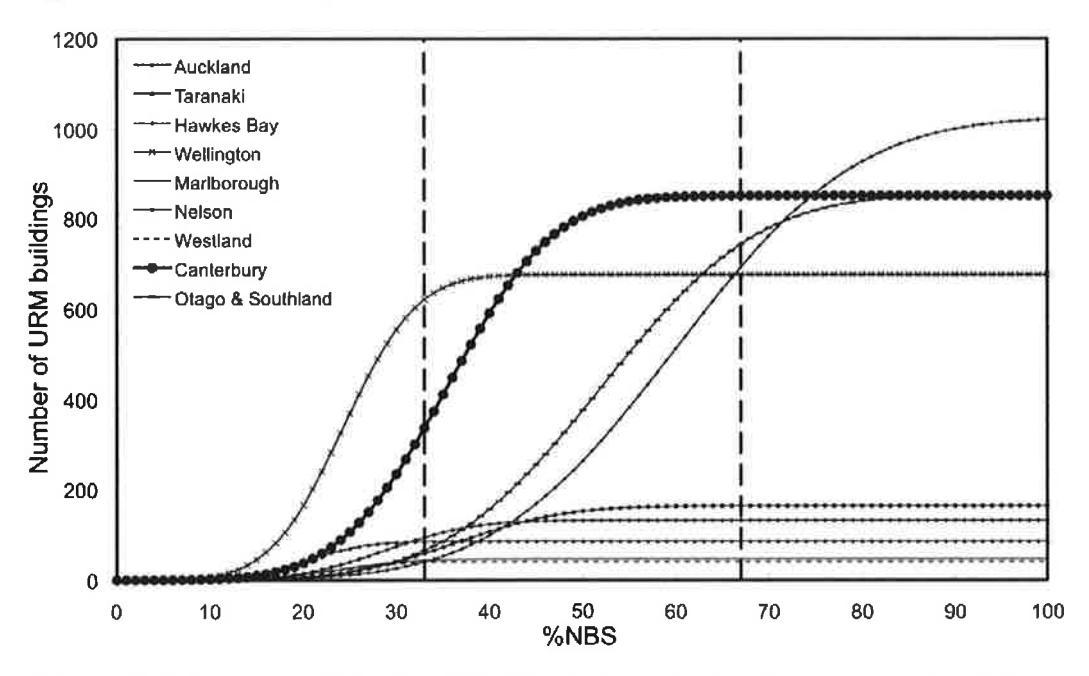
Figure 2.10 Estimated %NBS of URM buildings in Provinces throughout New Zealand

Applying the mean number of URM buildings estimated from both analysis methods discussed in section 27 (3750 URM buildings in total) to the normal distribution of %NBS scores, an estimate of all the %NBS scores for each of the provinces can be evaluated, as shown in Figure 2.10. From Figure 2.10 the number of URM buildings in each province with an estimated %NBS below 33, between 33 and 67, and above 67 can be evaluated. Thus the number of URM buildings in each province which are potentially earthquake prone, potentially earthquake risk and unlikely to be significant, respectively, can be estimated. This data is shown in Table 2.5 and aggregated to determine the estimated overall number of URM buildings in these categories throughout all New Zealand, as shown in Figure 2.11. From these results (Figure 2.10, Figure 2.11, and Table 2.5), it can be seen that up to 35% of URM buildings currently existing in New Zealand could be potentially earthquake prone, and additionally up to 52% could be potentially earthquake risk, such that approximately only 13% of existing URM buildings can be expected to not be a significant earthquake risk. Most of these buildings are in regions of higher seismicity, which is the most critical factor in the vulnerability of URM buildings. Bothara et al. (2008) noted from assessments conducted in Wellington, that "most unreinforced masonry buildings have been confirmed as potentially earthquake prone." This statement is in agreement with the results

presented here, in which 92% of URM buildings located in Wellington are estimated to be potentially earthquake prone.

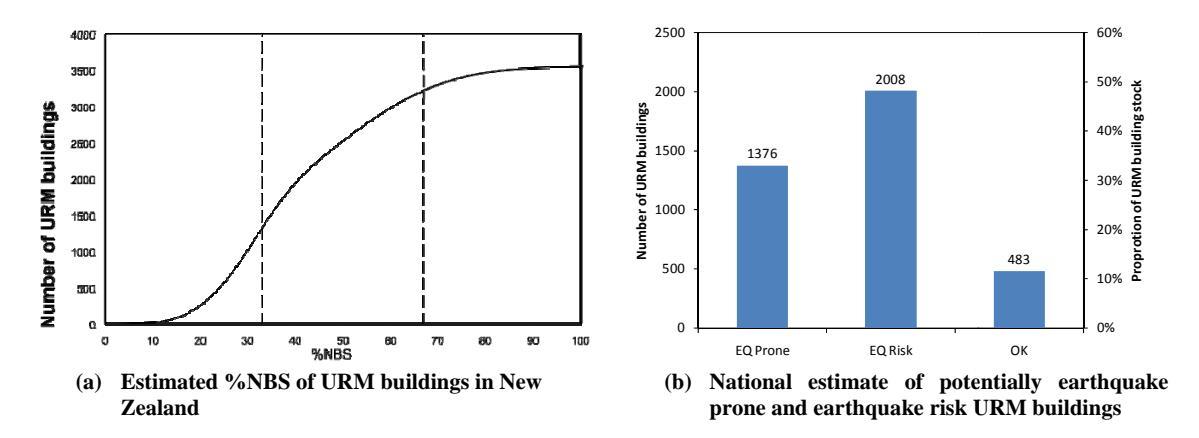
Figure 2.11 Estimated earthquake vulnerability of New Zealand's unreinforced masonry building stock

It must be recognised that the analysis presented here is essentially qualitative in nature and can be expected to overestimate the number of poorly performing URM buildings, primarily because of the conservative nature of the IEP. Nevertheless, as an informative estimate of the nature of the vulnerability of New Zealand's URM building stock, this analysis is considered robust. Additionally, this analysis does not take into account the number of buildings which have already been seismically improved, which Thornton (2010) notes is not insignificant.

Figure 2.11(b) shows that there are approximately 1376 URM buildings nationwide having a strength of less than 33% NBS and 2008 URM buildings nationwide having a strength of 34-67% NBS. It is recognised that there is uncertainty in these numbers and so therefore no attempt has been made to reduce the building count in accordance with the demolition data reported in section 6.1 and Appendix C. Section 2.4 reports that the URM buildings extracted from the QV database had a total floor area of 2,100,000 m². Consequently this data can be combined as shown in Table 6.2 to suggest an indicative cost of improving the national URM building stock to 67% NBS. In this analysis a typical cost of \$450/m² to elevate to 33%NBS is assumed in order to partially compensate for inflation during the period March 2010 to July 2011.

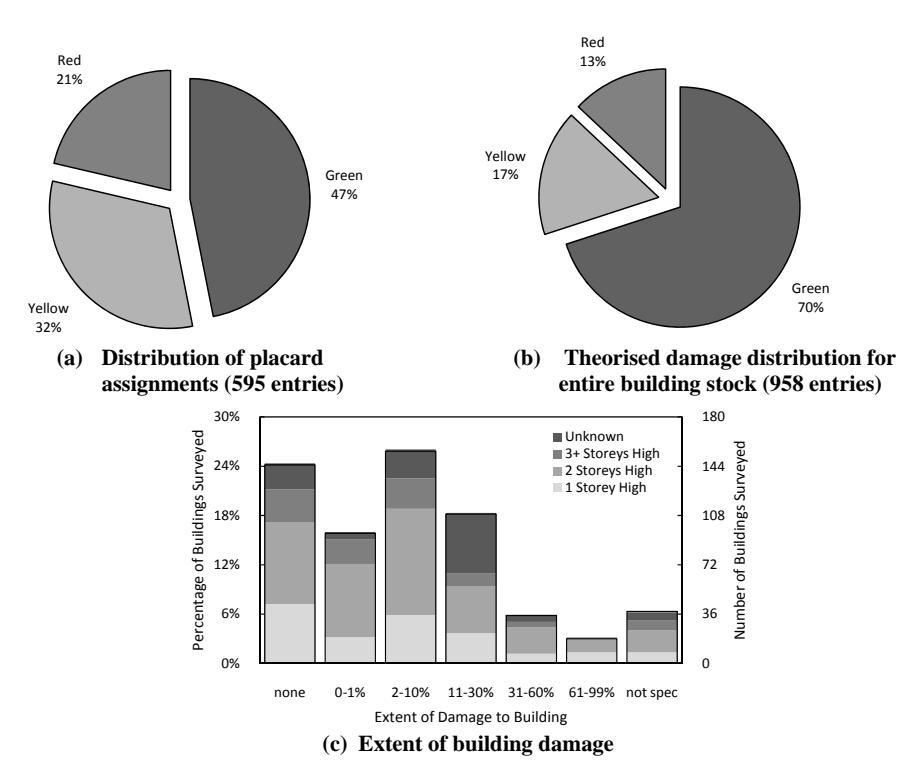
Figure 3.5 Damage statistics for the 4 September 2010 earthquake

The results of the damage assessment are reported in Figure 3.5. Figure 3.5(a) reports the 'useability' assignment of the 595 URM buildings assessed. In consultation with staff of Christchurch City Council it was assumed that the remainder of the URM buildings thought to exist in Christchurch probably had a green tag usability rating, and so a theorised damage distribution for the entire URM building stock of Christchurch is shown in Figure 3.5(b).

Figure 3.5(c) reports the level of damage in percentage terms for the 595 buildings that were surveyed by the Rapid Building Assessment teams. The values recorded by the teams for each building surveyed were simply estimates (excluding contents damage). Despite the known vulnerability of URM buildings to earthquake loading, 395 of the 595 buildings (66%) were rated as having 10% damage or less, with only 162 (34%) of the buildings assessed as having more than 10% damage. It was also possible to study the distribution of damage dependent on storey height (Figure 3.5(c)), with the data indicating no definitive trend and a comparatively uniform level of damage assigned to buildings in each height category.

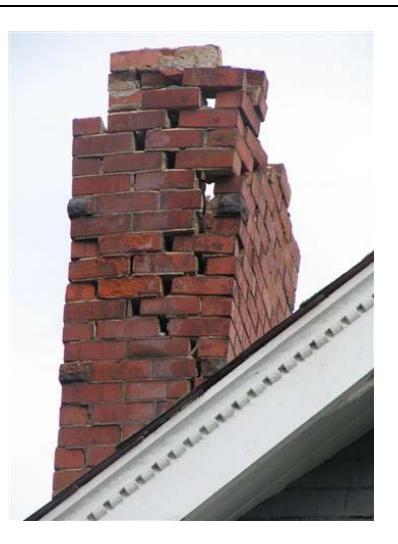
Unsupported or unreinforced brick chimneys performed poorly in the earthquake (Figure 3.6), with numerous chimney collapses occurring in domestic as well as small commercial buildings and some churches. Many examples of badly damaged chimneys that were precariously balanced on rooftops were also seen (Figure 3.6(b)) and it was reported that one week after the earthquake, 14,000 insurance claims involving chimney damage had been received, from a total of 50,000 claims (NewstalkZB, 2010). Emergency services personnel were in significant demand, being deployed to remove damaged chimneys in order to minimize further risk and eliminate these 'falling hazards' (Figure 3.6(c)). In contrast, Figure 3.6(d) shows an example of a braced chimney that performed well. Note that Figure 3.6(b) shows further evidence of the poor performance of mortar during the earthquake.

(b) Unstable damaged chimney

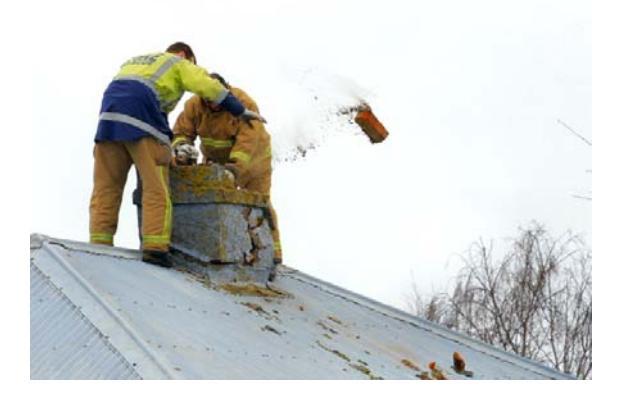
(c) Emergency service workers remove chimney

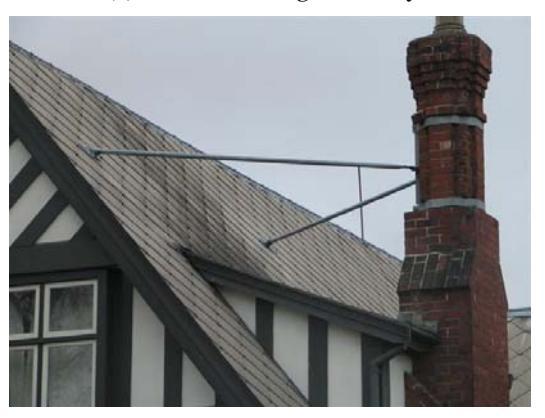
(d) Braced chimney performed well

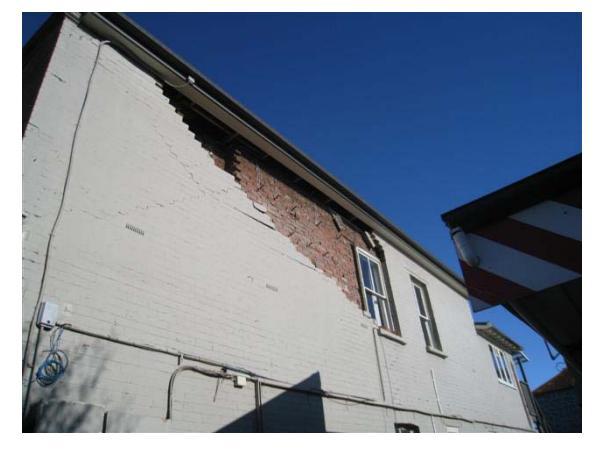
(b) 832 Columbo Street

Cavity wall construction is generally believed to be much less common in New Zealand than is solid multi-leaf (or multi-wythe) construction. However, cavity wall construction can be extremely vulnerable to out-of-plane failure in earthquakes in situations where the cavity ties were poorly installed, or more commonly have corroded over time, as the wall is then comparatively slender and less stable than for solid construction. Figure 3.12(a) and (b) show examples of cavity wall buildings that suffered out-of-plane wall failures.

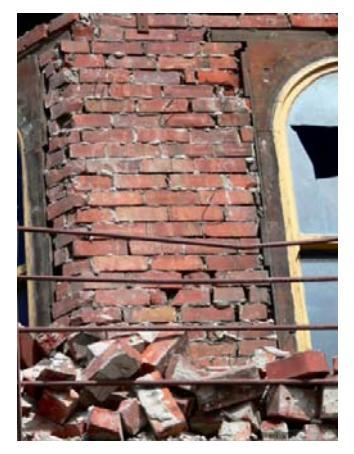
(d) Metal wall ties badly deformed.

Figure 3.12(c) and (d) show that cavity ties were present but were insufficient to prevent the outer leaf from failing.

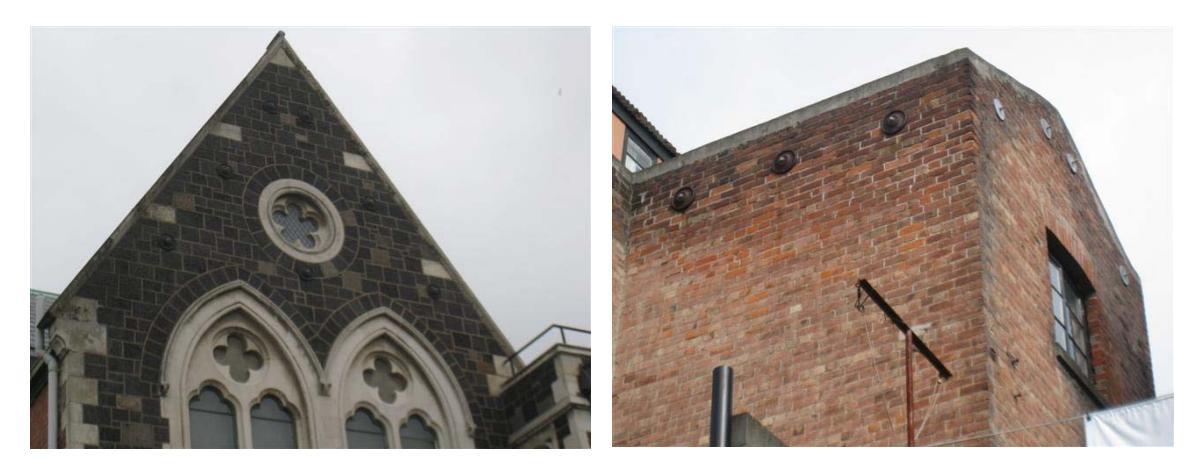
A significant feature of the earthquake was the number of occasions where anchored walls performed well during the earthquake. Photographs showing this are presented in Figure 3.14 and Figure 3.15. A typical wall-to-diaphragm (roof or floor) anchor typically consists of a long 20 mm bolt with a large circular disk of about 150-200 mm diameter between the wall exterior and nut that clamped the disk to the wall. This detail is shown quite clearly in Figure 3.13(a).

(a) Arts centre building (b) Arts centre building Figure 3.14 Successful gable end wall and side wall anchorages

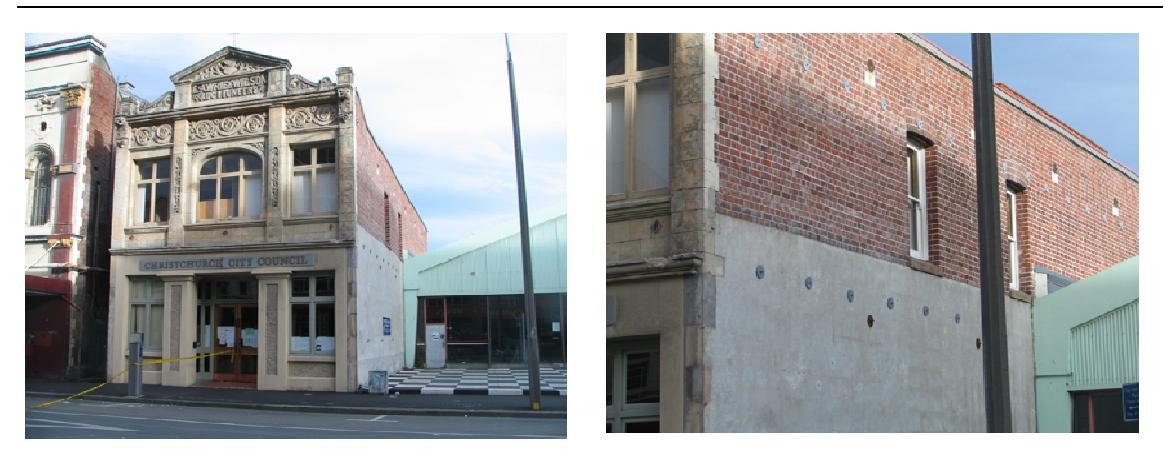
(a) Front elevation (b) Side elevation Figure 3.15 Successful wall-floor and wall-roof diaphragm anchorages

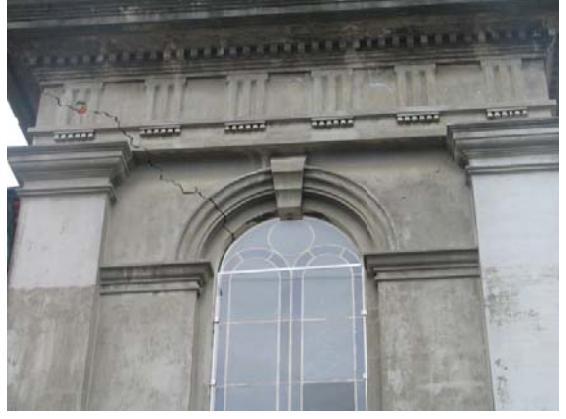
Where walls exhibited some damage to in-plane deformation the cracks were mostly seen to pass vertically through the lintels over door or window openings. Although this type of damage was not widely observed, examples are shown in Figure 3.16.

(d) Diagonal crack extending from window opening

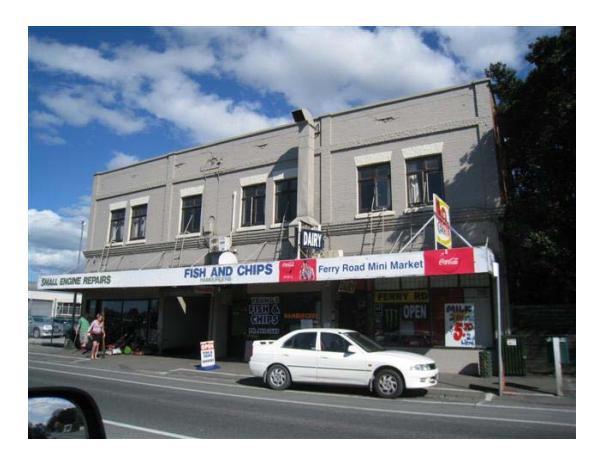
(a) Building overview

Another interesting feature of this earthquake is the observation of walls that only partly failed, allowing for identification of the specific failure mode at its onset. Several excellent examples are described below. The first of these is a 2-storey URM building on Ferry Road (see Figure 3.17) where the front, street facing, wall of the building had started to fail out-of-plane despite the presence of wall-roof diaphragm anchors. As is shown, the anchors were on the verge of pulling through the masonry wall. Internal inspection of the building revealed that the front wall had separated from the long side walls of the building and moved approximately 50 mm towards the road with respect to the ceiling/roof diaphragm (Figure 3.17(d)). It is believed that due to the nature of strength degradation of the brickwork at the onset of a punching shear failure, the anchorage has effectively failed and offers little residual resistance against further shaking. The only reason the wall did not completely collapse is probably due to the earthquake not imposing sufficient displacement on the wall after the anchorage failure.

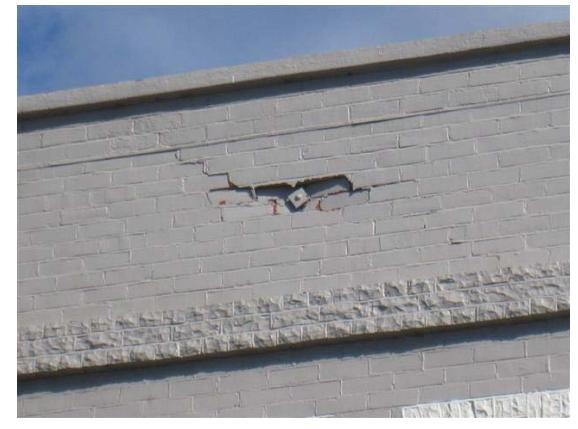
(b) Detail of partial anchorage failure

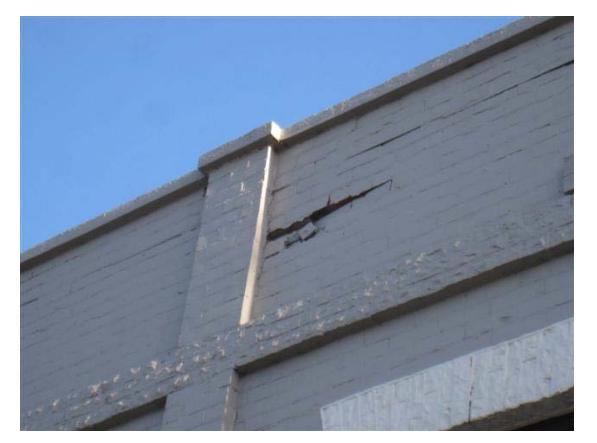
(c) Onset of anchorage failure

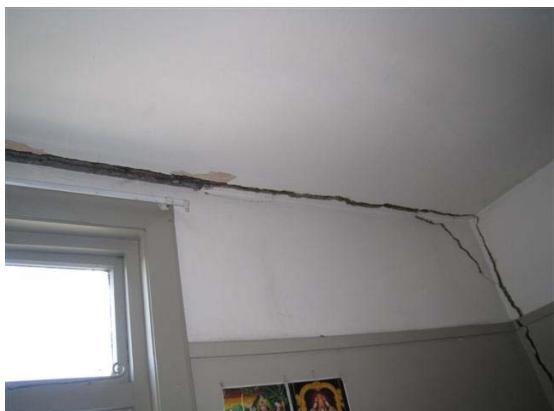
(d) Internal view showing wall separation

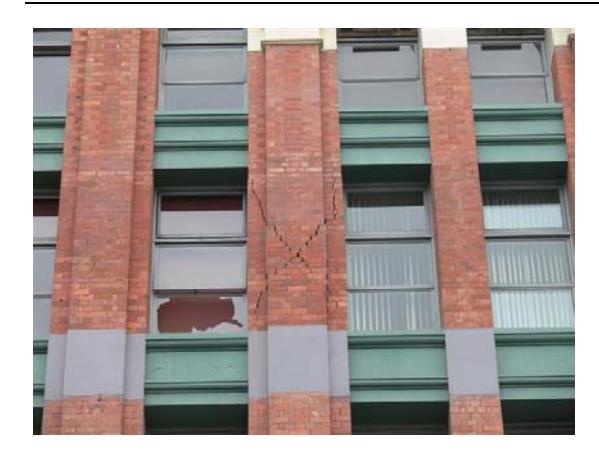
(a) North wall piers, levels 3-4

160 Manchester Street was a 7-storey office building that is reported to consist of load bearing masonry and was the most significant masonry building, at least in terms of height, in Christchurch (Figure 3.23). It is a registered heritage building and is a significant part of the fabric of the Christchurch city landscape. Unfortunately, the building suffered significant damage in the earthquake. The bottom two stories are reported to be reinforced concrete while the top five stories are reported to have load

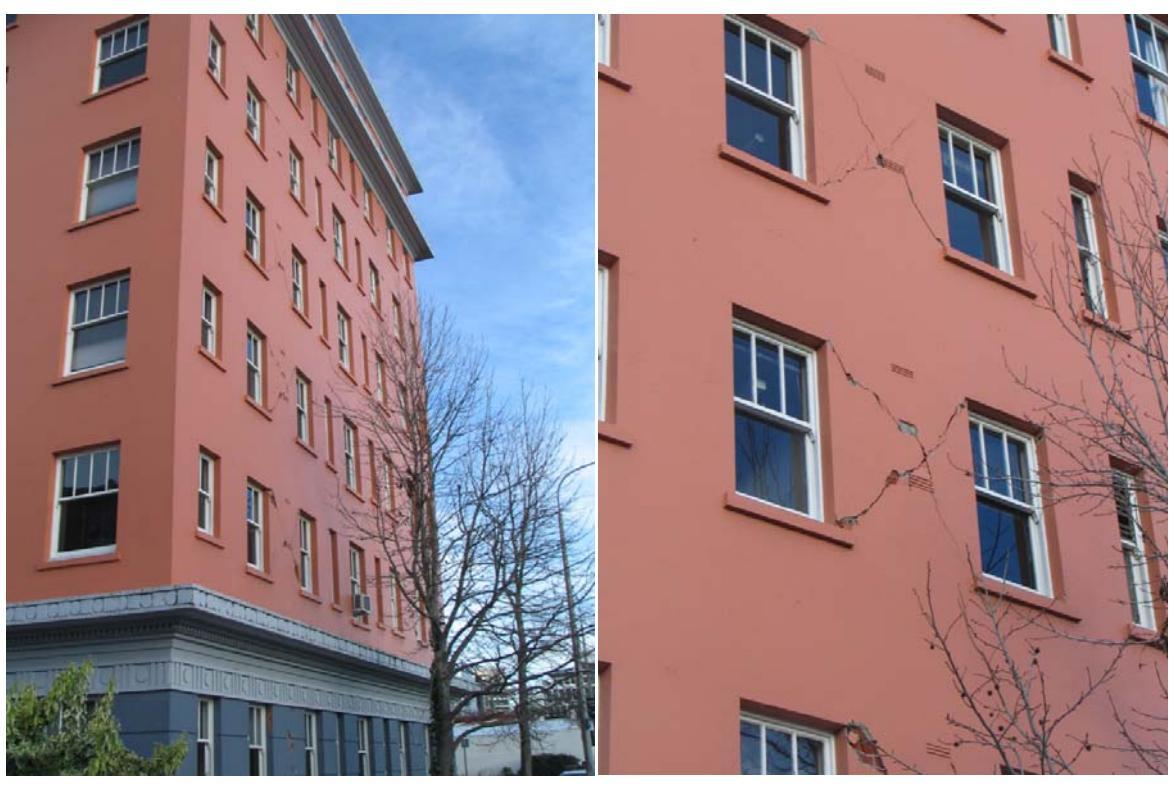
St Elmo Court was also a 7-storey building that was reported to be a reinforced concrete frame building with external clay brick masonry piers. Owing to the absence of control joints between the masonry and concrete frame, it appeared that the masonry piers attracted sufficient seismic in-plane forces to cause shear failure (refer Figure 3.25). However, once the masonry cracked the seismic loads were transferred to the concrete frame. Judging by the extent of cracking in the brickwork, it appeared that the storey drifts developed during the 4 September 2010 earthquake were less than 1%, implying that the concrete frame was not pushed to its maximum capacity (strength or drift). Following the 4 September 2010 earthquake the authors were not able to inspect the building from inside.

The building was demolished after the 22 February 2011 earthquake.

(a) Overview of building

(b) Close-up of damage to brickwork

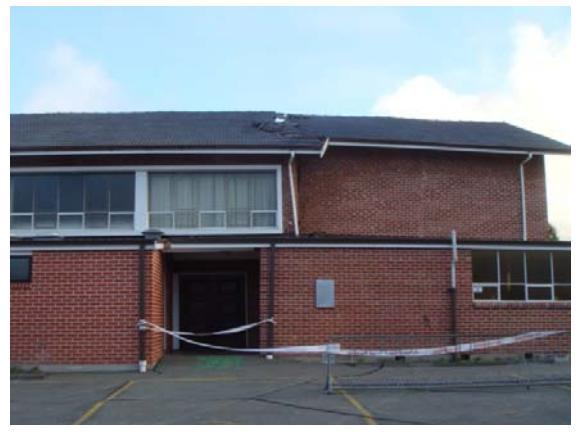
Perhaps the most striking aspect overall of the 2010/2011 Canterbury earthquake swarm was the extensive amount of liquefaction and ground deformation that occurred. These phenomena were not seen to a significant extent in the Christchurch CBD region containing the highest density of URM buildings, but did impact on a number of timber framed structures with masonry veneer. As shown in Figure 3.26, several cases of extreme ground deformation that affected URM buildings were observed outside of the CBD, and there were numerous cases where large crack widths formed in residential timber framed structures having a masonry veneer (Figure 3.26(c)). There were also cases where ground liquefaction had resulted in masonry structures having sunk into the ground (Figure 3.26(d)).

(b) Wide cracks due to ground deformation

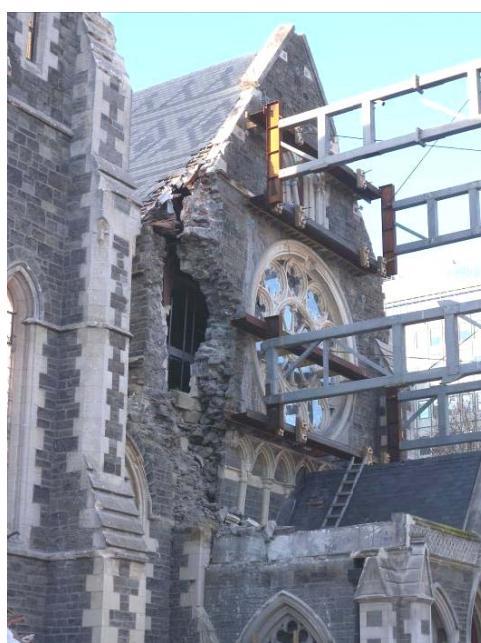
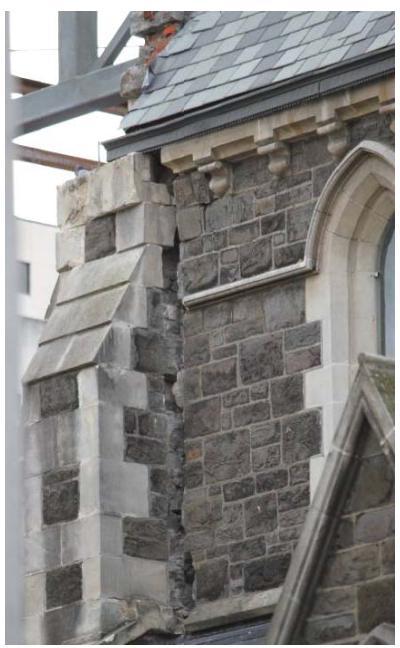
(a) unstable front wall (b) return wall separation Figure 3.30 Christchurch Anglican Cathedral – front façade damage

Because the predominate direction of the 22 February 2011 earthquake was in the eastwest direction, and because the buildings in the CBD are primarily oriented in the same direction, evidence of in-plane wall damage in the east-west running walls (see Figure 3.34 and Figure 3.35) was reported in conjunction with overturning of façades oriented in the orthogonal direction (see Figure 3.30).

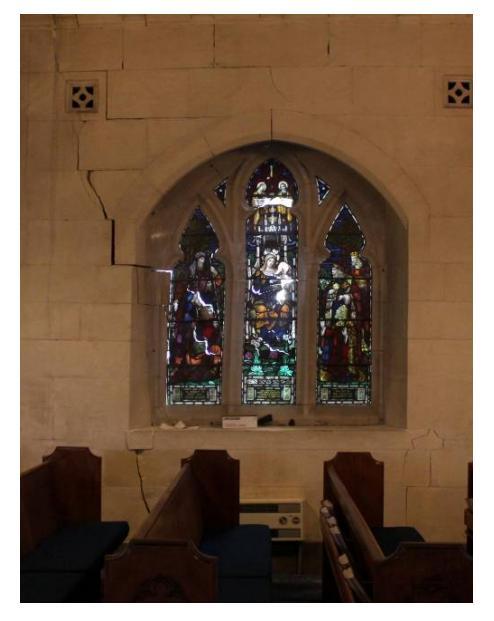
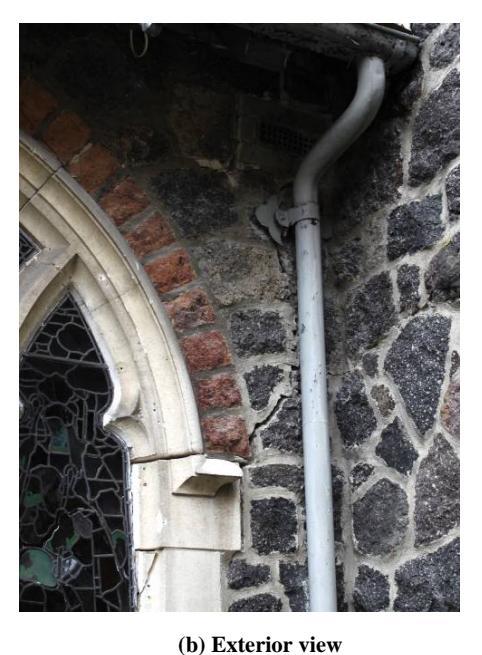
Damage that was attributable to plan irregularity was frequently observed, particularly for stone churches, due to interaction between adjacent structural elements at the intersections between walls. In most churches where the bell tower or low annexes are connected to the nave, damage developed at the intersection of the different structures (see Figure 3.36 and Figure 3.37).

Figure 3.36 St. Barnabas' Church, showing interaction between the nave and the bell tower

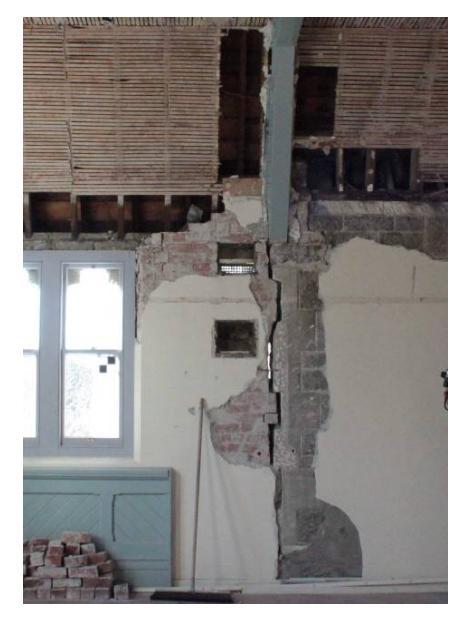
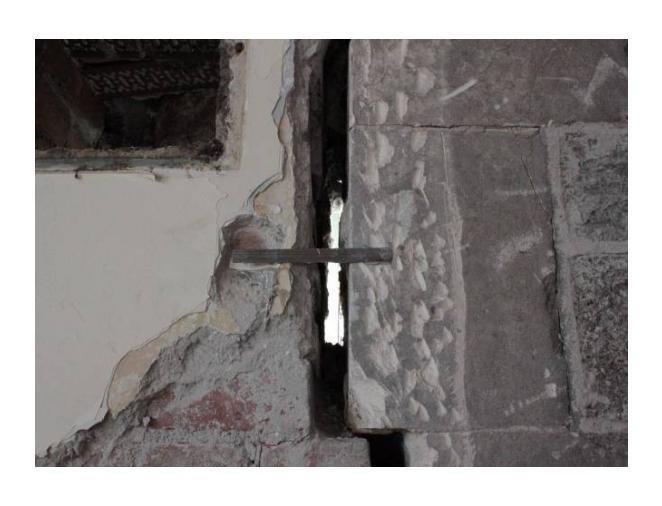
Another distinct example of damage due to plan irregularity in association with differential foundation settlement was observed at the former Old Boy's High building. Figure 3.38 shows the vertical crack that formed at the intersection between two buildings constructed in successive phases, attributable to the lack of connectivity between the structural walls and their separate foundations.

Figure 3.38 Interior views of Old Boy's High (part of the Arts Centre Complex, 2 Worcester St), showing interaction between adjacent buildings
Diaphragm and roof seismic response

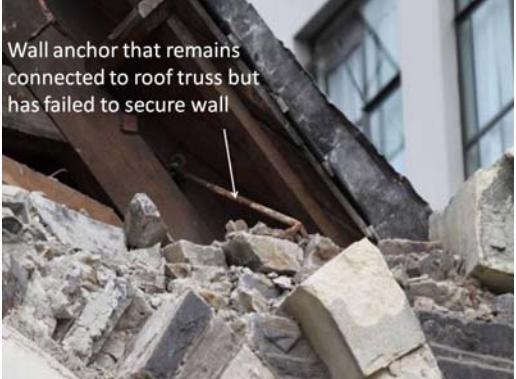
(b) detail of failed wall-to-roof anchorage

Two cases are presented to show the different behaviour induced by the presence and effectiveness of anchoring. Figure 3.39(a) shows the damage resulting from overturning of the gable of the main façade of the former Trinity Church in the Christchurch CBD while the detail in Figure 3.39(b) illustrates how the anchoring was insufficient in size and spacing to secure the wall in place. Figure 3.40 shows some examples of successful wall-to-roof anchoring in the Arts Centre building.

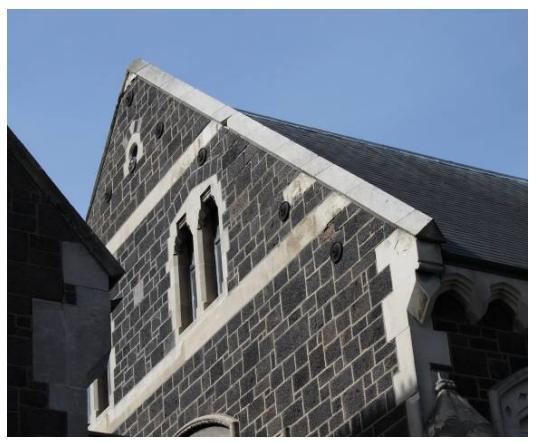
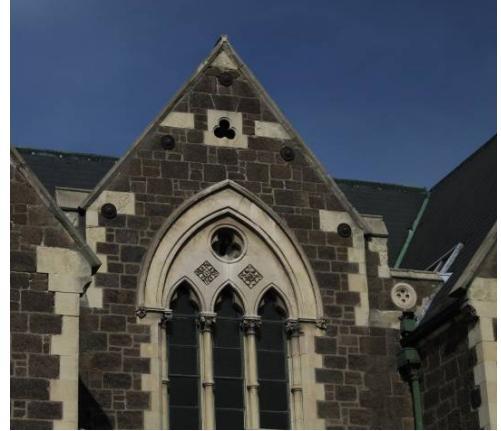
(a) former Old Girl's High (b) former Canterbury Engineering Department Figure 3.40 The Christchurch Arts Centre, showing successful use of walldiaphragm anchorages

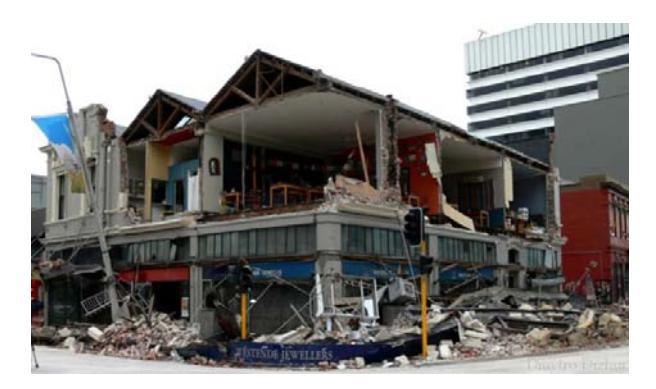
The most problematic deficiency in URM construction is inadequate connection of diaphragms to walls (FEMA, 2006), as failure of these connections can potentially lead to global collapse of the building. The addition of a network of small ties can substantially increase the strength of the building by fixing the walls to the floor and roof diaphragms (Robinson & Bowman, 2000). These ties need to resist two actions: shear from the diaphragms trying to slide across the walls; and tension from the diaphragm and wall trying to separate. If these ties are missing, the walls will be acting as a cantilever from the ground level under lateral loads, and floors and roofs are far more likely to be dislodged from their supports, which is the most common mode of failure for URM buildings in an earthquake. This failure mode is shown in Figure 4.10.

Figure 4.10 An extreme case in the 2010 Darfield earthquake where inadequate connections have resulted in wall collapse (Welstead House, 184-188 Manchester Street)

The use of simple metal anchors to connect the walls to the floor and roof diaphragms is relatively straight forward and was observed in many buildings that survived both earthquakes (see Figure 3.14 and Figure 3.15). Recently, some proprietary systems have become available that use steel reinforcement to connect walls to the floor and roof diaphragms, and to provide wall-to-wall connection at corners and other wall intersections. Typically, the reinforcement is placed in horizontally cored holes that pass through the entire building at each floor level and at the roof level. The reinforcement is then post-tensioned and grouted in order to clamp the walls to the floors and roof and to each other. In some applications, vertical reinforcement, sometimes with posttensioning, is also used to increase the compressive stress in the wall which results in an improvement to the walls earthquake strength when subjected to horizontal loads.

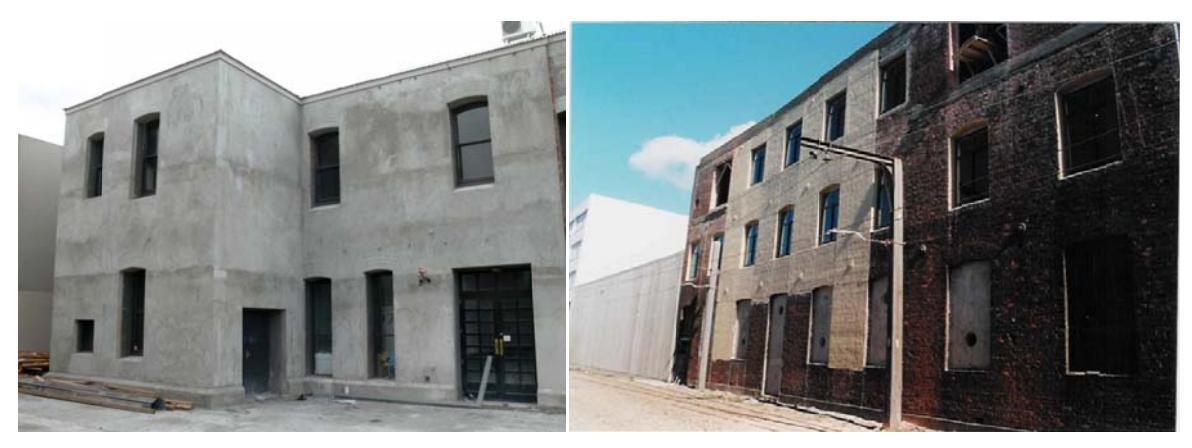
Figure 4.11 Examples of strengthened masonry shear walls

The shotcreting of shear walls was a common strengthening technique during the 1980s. This technique involves spraying concrete onto the surface of a URM wall to essentially cast a new wall against the existing wall, as shown in Figure 4.11(a). This technique provides plenty of additional strength to the wall, both in-plane and out-of-plane, but is now largely regarded as unacceptable unless absolutely necessary. The technique causes a significant increase in wall thickness and it is very difficult to remove the concrete, and even more so to restore the wall behind to any semblance of its character prior to concreting. Furthermore, the installation of shotcrete generally requires the building to be gutted, which results in the loss of much heritage material and creates an essentially new interior (Robinson & Bowman, 2000).

(a) Shotcrete applied to a former URM building

(b) Surface bonded FRP applied to the exterior of a URM wall

Another technique for forming strengthened shear walls is the addition of surface bonded fibre reinforced polymer sheets is in Figure 4.11(b). These sheets do not require the same invasive installation as shotcrete walls, but generally are equally permanent, and have potentially limited application, although new technology may soon change this. If it is possible to provide out-of-plane strength using FRP inserts, coupled with an FRP surface layer for shear, then this solution could be far superior to shotcrete from an architectural perspective. An important consideration with the use of sheets of FRP is that it is impermeable, which can lead to problems with water trapped within the building resulting in damp and mould issues, and potential de-bonding of the epoxy.

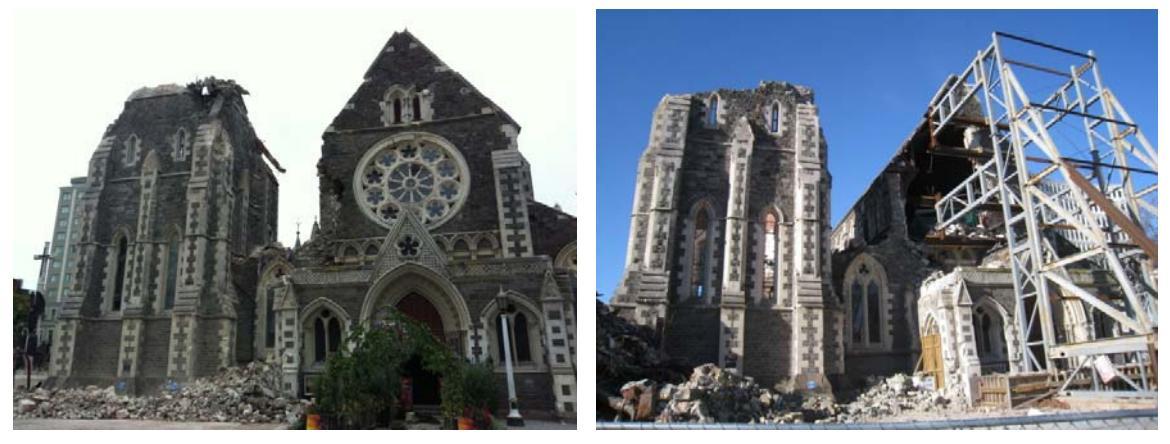
Figure 5.1 Damage to Christchurch Cathedral

construction began again. The nave and tower were consecrated on 1 November 1881, but other parts of the Cathedral were not finished until 1904. The Cathedral underwent major renovations during 2006–2007, including the replacement of the original slate roof tiles. The February 2011 Christchurch earthquake destroyed the spire and part of the tower – and severely damaged the structure of the remaining building. The Cathedral had been damaged previously by earthquakes in 1881, 1888, 1901 and 2010⁹.

(a) Condition after 22 February 2011

(b) Condition after 13 June 2011

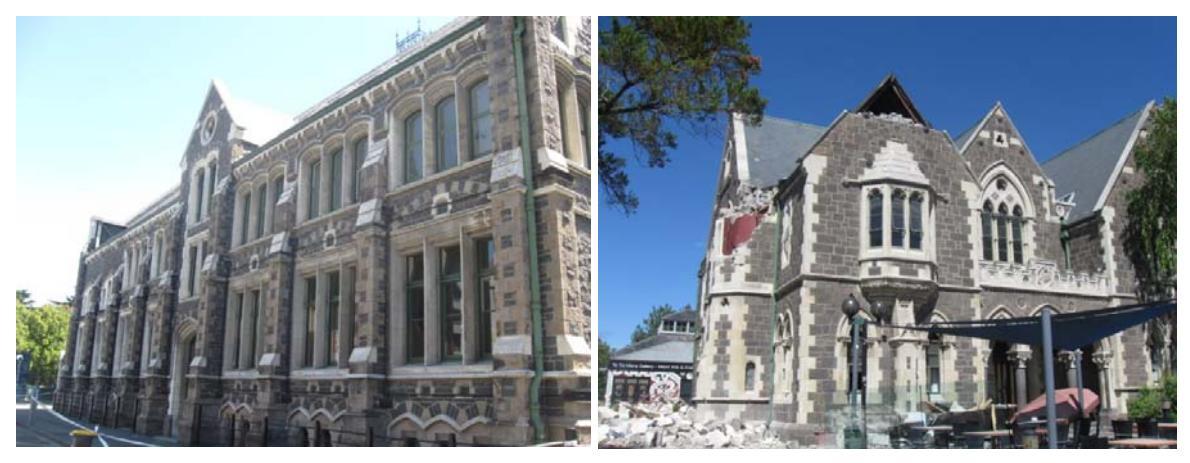
Figure 5.4 Mixed performance of the Christchurch Arts Centre (images taken post-February 2011)

The Christchurch Arts Centre complex is composed of stone masonry buildings that merit investigation because of the number of seismic retrofit technologies that have been previously installed within the complex. Three technologies in particular merit attention, being the innovative use of horizontal and vertical unbonded post-tensioning that appears from the exterior to have been highly successful in preventing damage (see Figure 5.4(a)), the use of wall-diaphragm anchor plates that in most cases have

effectively restrained the major part of gable end walls although some damage at the top of gables has occurred (see Figure 5.4(b)), and the use of surface bonded fibre reinforced polymers to the interior of the building. Documenting the successful performance (or otherwise) of these technologies will be useful when considering appropriate seismic improvement techniques for other iconic stone masonry buildings. See also Figure 3.32, Figure 3.38 and Figure 3.40.

(a) Good performance of stone masonry building with horizontal and vertical external posttensioning

(b) Poor performance of stone masonry tower and top of gable

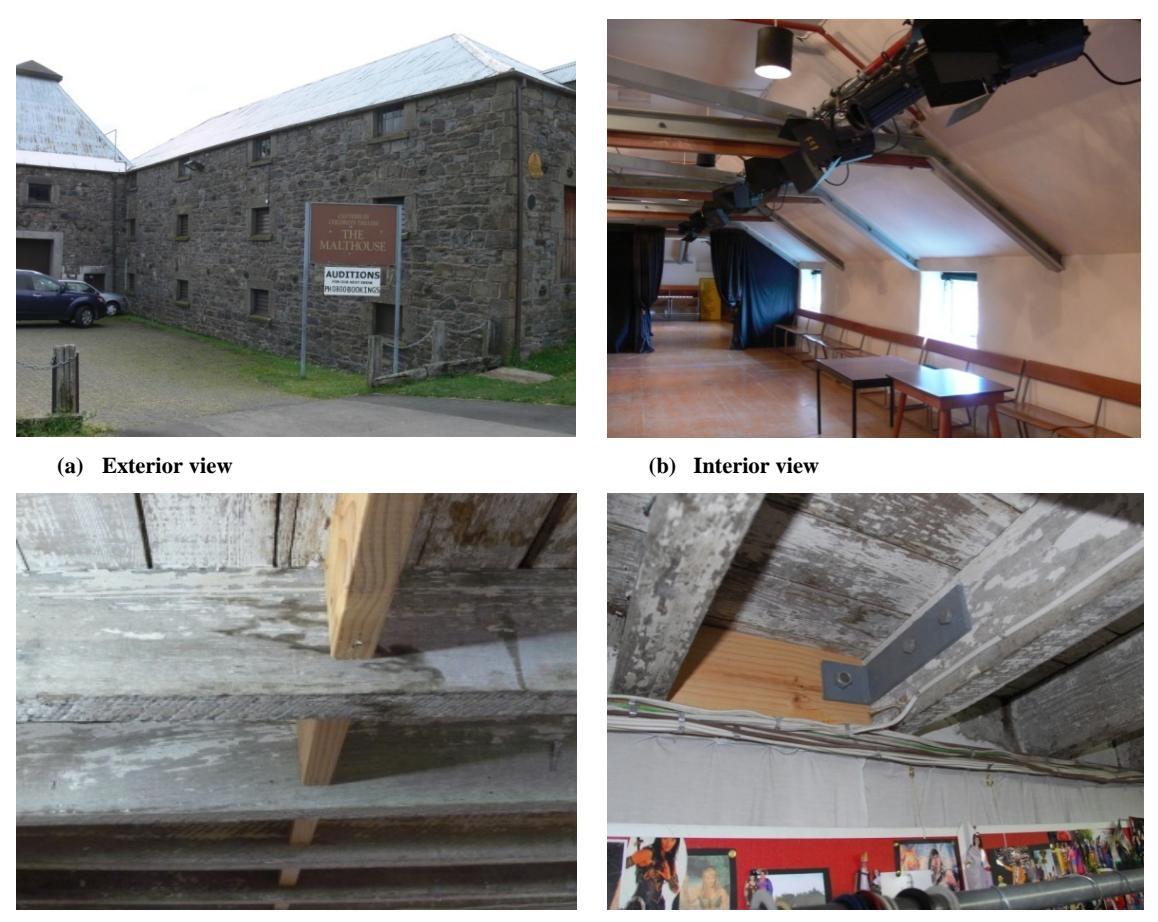
The Malthouse is a stone masonry building that was constructed in 1867-1872 (see Figure 5.5). The Malthouse is one of New Zealand's oldest buildings¹³ has three levels, with a half basement, timber floor and roof diaphragms and an irregular floor plan. The building was used as a Malthouse until 1955, when it was converted to the Canterbury Children's Theatre. Between 1972 and 1984 the Malthouse went through several architectural renovations that included seismic retrofit. The roof was raised in two stages: the first stage involved raising half of the roof in 1992 and the second stage involving raising the remainder of the roof in 2003. Seismic retrofit of the Malthouse in 2003 was found to be insufficient and consequently the building's lateral load resisting system was again updated in 2008. The seismic retrofit involved injecting grout into the rubble masonry walls, strengthening the roof by introducing new steel trusses (see Figure 5.5(b)), strengthening of the floor diaphragms by replacing the plywood and introducing additional timber blocking (see Figure 5.5(c)), and installing new wall-diaphragm anchors. It was established from discussions with the manager that the cost of retrofit was approximately \$NZ 750,000. The building appears to have performed well.

(c) Additional blocking at ground floor
(d) Wall-floor diaphragm connection
Figure 5.5 Former City Malthouse (images taken post-September 2010)

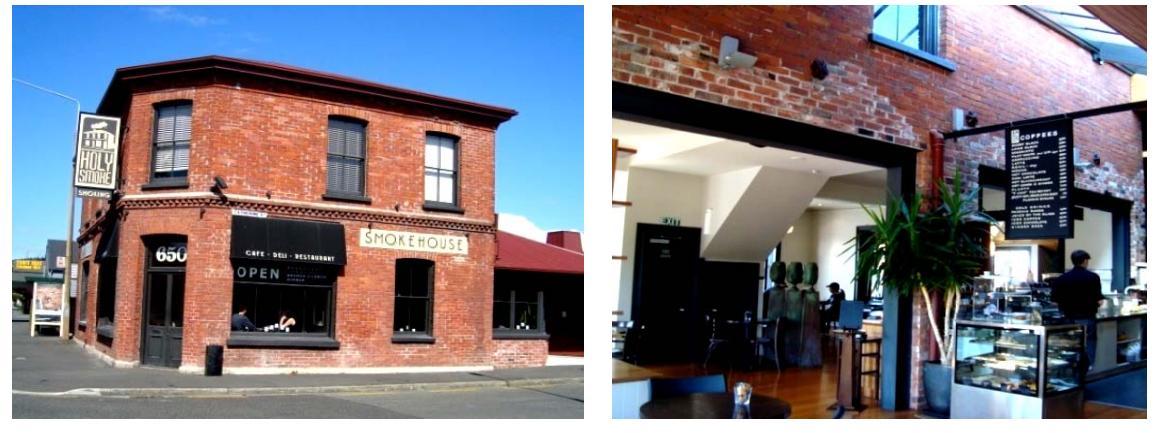
Figure 5.6 The Smokehouse, 650 Ferry Road (images taken post-September 2010)

(a) Exterior view

(b) Interior view showing added steel frames

The Smokehouse was seismically retrofitted in 2007 by introducing secondary moment resisting steel frames. This retrofit also included alterations to the internal layout, which involved partial removal of original external walls and replacement with moment resisting steel frames that created openings into the adjoining new section of the building (see Figure 5.6(b)), and also infilling one window at the second floor level. The retrofit design of the building won the New Zealand Architectural Award in 2008 for initiative in retention, restoration and extension of a significant building and its adaption to new uses¹⁴. The building appears to have performed well, with no significant signs of earthquake damage observed.

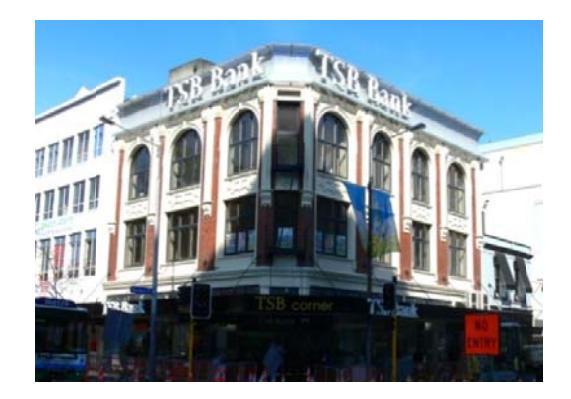
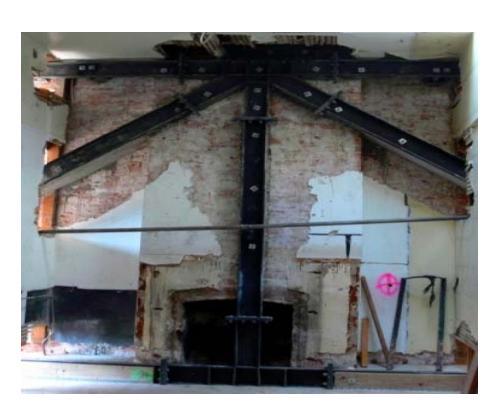
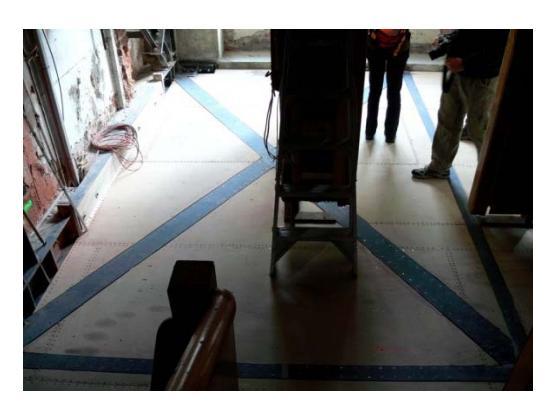
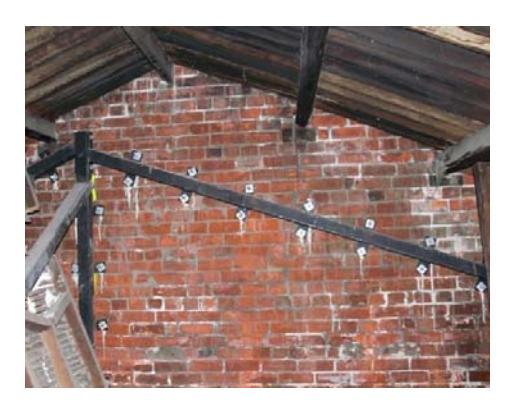
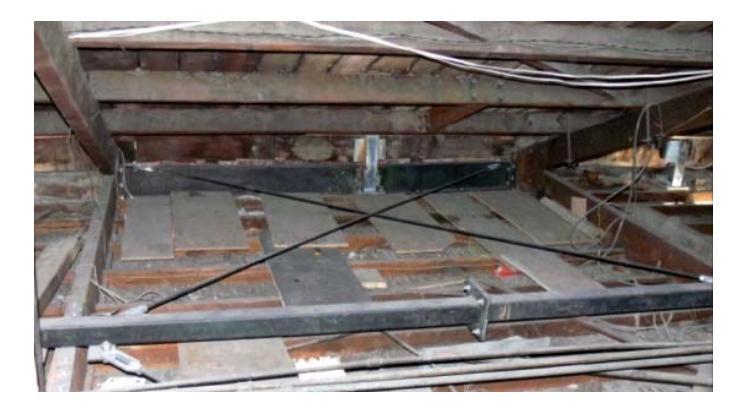
Figure 5.7 130 Hereford Street (images taken post-September 2010)

(a) Exterior view

(b) steel brace frame

(c) floor diaphragm strengthening

(d) gable strengthening

(e) roof diaphragm strengthening

The building was seismically retrofitted by the new owner (TSB Bank) in 2009, which involved the introduction of secondary frames. The facade is strengthened by concrete columns and beams at the floor levels (forming a concrete frame) and the side walls are strengthened using steel frames with diagonal braces that are anchored into the masonry as shown in Figure 5.8 and Figure 5.7(b). The floor diaphragms on levels 2 and 3 were stiffened with plywood sheets and 'X' pattern steel plates, with screw fixings spaced at approximately 20 mm to connect the plates to the timber diaphragm as show in Figure 5.7(c). Figure 5.7(d) shows strengthening of the gable, consisting of steel frames secured with adhesive anchor bolts, and Figure 5.7(e) shows the roof diaphragm strengthening using steel tie rods. The walls are supported by newly added concrete beams at the basement level, further resting over old concrete basement walls.

Building and	Assessed earthquake performance				
address					
The Smokehouse,	All: No significant damage. See Figure 5.6.				
650 Ferry Road					
TSB Bank,	September: Some cracks in the basement walls. Retrofit				
130 Hereford Street	appeared to perform well. See Figure 5.7.				
	December: Unknown.				
	February: Gable failure on the east side, but again the retrofit				
	appeared to have performed well.				
	June: No further significant damage.				
X Base Backpackers,	September: Some cracking at top of front facade. Timber				
56 Cathedral Square	shoring placed at top of parapet (visible in Figure 5.9(a)).				
	December: Unknown.				
	February: Front facade was in process of being repaired, and				
	was covered in scaffolding. Observed damage includes failure of				
	the north east corner at top floor (rear of the building), extensive				
	cracking of front facade (particularly in spandrels). Parapet

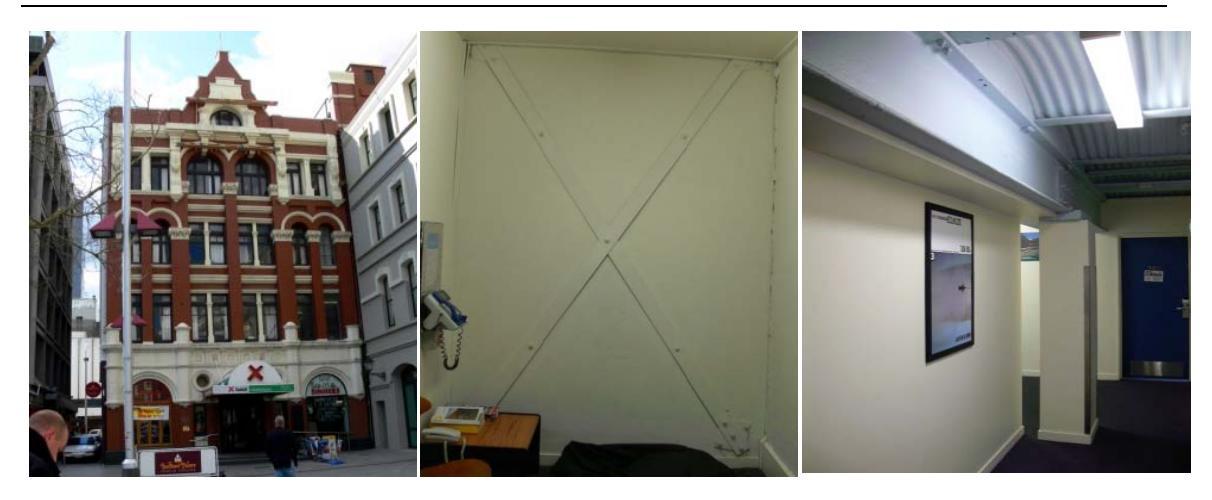
Figure 5.9 X Base Backpackers, 56 Cathedral Square (images taken post-September 2010)

- (a) Exterior view
- (b) 'X' steel brace fixed into wall
- (c) Interior steel frames

The X Base Backpackers building was seismically retrofitted in 2001 using steel moment resisting frames. The moment frames, as seen from the fourth floor of the building, are shown in Figure 5.9(c). As part of the seismic retrofit scheme, the parapets were tied back to the roof structure using hollow steel circular sections (see Figure 5.9(d)). In a recent inspection of the building, steel straps anchored to the side walls in an X pattern were also observed (shown in Figure 5.9(b)) and were possibly part of an earlier retrofit scheme.

strengthening appeared to work well, apart from where walls				
	failed. Diagonal shear cracking and failure of some walls of top				
	storey rooms, not visible from the street. X steel straps appear				
	to have kept the walls from collapsing.				
	June: Unknown.				
	This building has recently been demolished.				
Vast Furniture,	September: Partial punching shear of wall-diaphragm anchor,				
242 Moorhouse Ave	parapet collapse. See Figure 5.10.				
	December: Unknown.				
-----------------------	---	--	--	--	--
	February: Wall-diaphragm anchors punched through further,				
	but no collapse.				
	June: No further significant damage externally visible.				
Environmental Court,	September: No apparent damage. See Figure 5.11.				
282-286 Durham	December: Unknown.				
Street North	February: Although the retrofit behaved well the building has				
	suffered some damage, particularly around the entrance.				
	June: No further damage.
