Report to the Royal Commission of Inquiry

The Performance of Unreinforced Masonry Buildings in the 2010/2011 Canterbury Earthquake Swarm

Associate Professor Jason M. Ingham The University of Auckland and

> > August, 2011

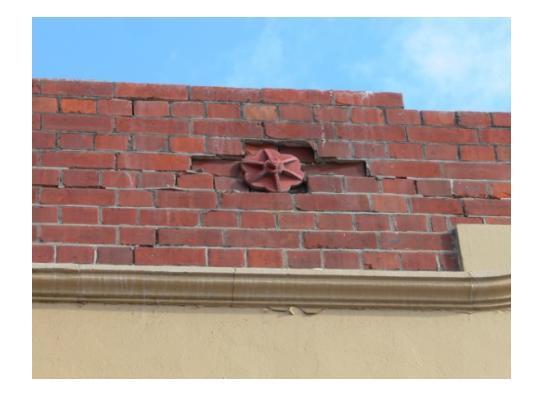
(a) wall-diaphragm anchor punching

During the 4 September 2010 earthquake the parapets collapsed out-of-plane and the wall-diaphragm anchors pulled out from the wall, with the anchors punching through the brickwork and creating localized wall damage (refer to Figure 5.10(a)). The building was cordoned off as falling hazards had been identified during post-earthquake evaluation but the internal retail area remained open.

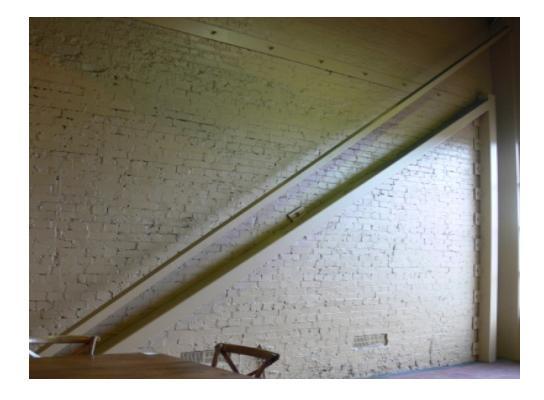
(b) wall strengthening using steel sections

The trusses are further supported on steel portal frames, but the frames had more modern welded joints than the old fashioned riveted joints used in trusses, which suggests that the portal frames were added later to the building as a seismic retrofit solution (see Figure 5.10(b) and (c)).

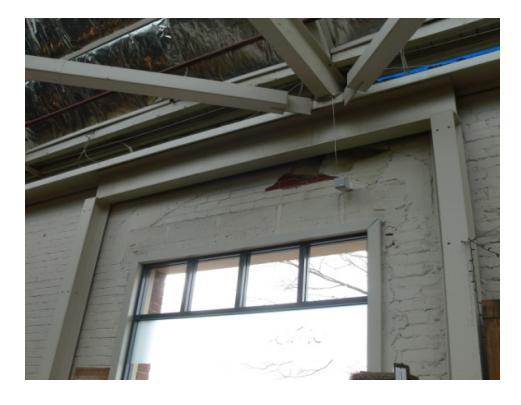
(c) interior of the building (location where anchor plate pull out occurred)

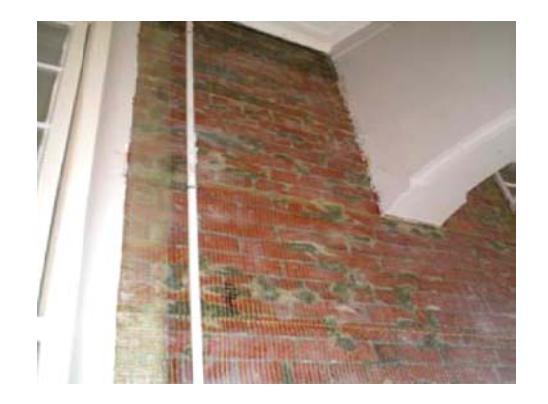
(a) FRP sheet strengthening, image taken 2009 (BBR Contech, 2010)

Seven individual wall areas were strengthened with surface bonded FRP sheets using Sikawrap 100G (the application of FRP retrofit is shown in Figure 5.12(a)) in the locations shown in Figure 5.13. FRP rod anchors were installed to bond the applied Sikawrap 100G sheet to the concrete foundation beams (BBR Contech, 2010). The outof-plane stability to the perimeter wall was provided by using steel hollow sections as strong backs fixed to the URM walls. To ensure sufficient lateral load resistance in the North-South direction a concrete shear wall was also added at the location shown in Figure 5.13. The veneer brick layer was secured to the main wall using helical veneer ties at regular spacing.

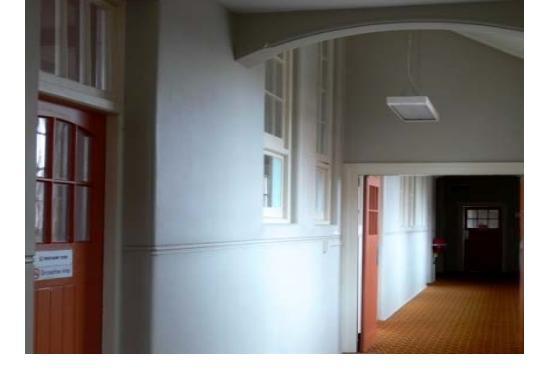
(b) FRP strengthening after 4 September 2010 earthquake, no visible cracking

Shirley Community	September: No visible damage. See Figure 5.12.				
Centre, 10 Shirley Rd	December: Unknown.				
	February: Differential movement between cavity wall layers				
	causing veneer ties to become visible. Liquefaction and				
	differential movement around the grounds. Some cracks				
	extended from ground into the building. Movement of the roof				
	diaphragm visible. In-plane cracking of external walls.				
	June: Out-of-plane collapse of external veneer layer.

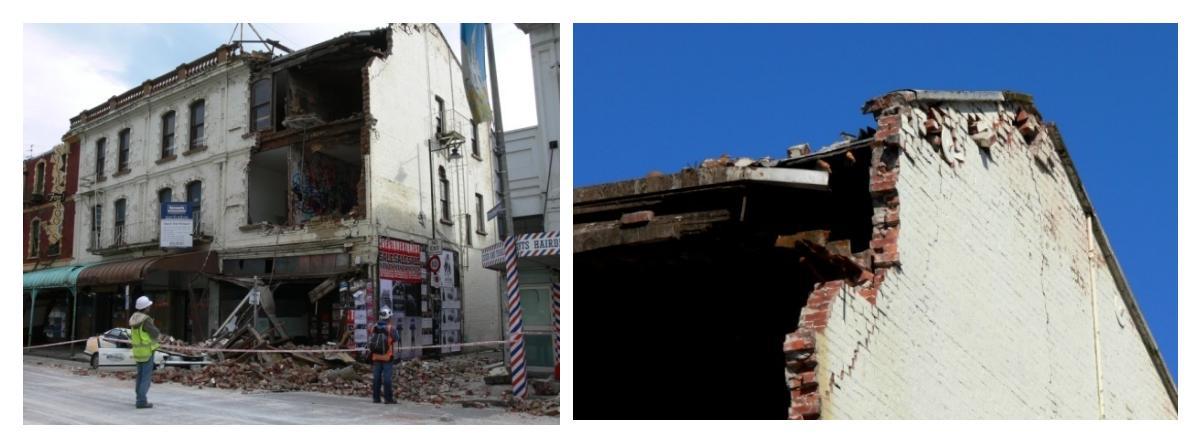
Figure 5.14 Damage to clay brick URM building at 135-139 Manchester Street (images taken post-September 2010)

(a) 135-139 Manchester Street, out-of-plane facade collapse

(b) 139 Manchester Street, through steel anchors and rotten timber roof diaphragm

The corner bay of the building (139 Manchester Street) was in a deteriorated condition and had been poorly maintained, with visible water damage and rot of the timber floor and roof diaphragms being evident. The floor joists and roof rafters were oriented in the North-South direction for the building portion along Manchester Street. The end gable was connected to the roof structure using only two through anchors with round end plates.

The building sustained considerable damage during the 4 September 2010 earthquake, mainly concentrated at the end bay (139 Manchester Street) where the front facade entirely collapsed out-of-plane (see Figure 5.14). The entire building sustained damage from collapsed parapets, apart from two bays (135 and 137 Manchester Street) where the parapets remained on the building. From visual observations and physical assessment of the collapsed masonry the mortar was found to be in a moist condition and the mortar that was adhered to the bricks readily crumbled when subjected to finger pressure (see Figure 3.3), suggesting that the mortar compression strength was low (<2 MPa). The collapsed facade wall revealed extensive water damage to the timber structure, with rotten floor joists and roof rafters. Also, it was observed that there were large patches of moist masonry on the interior surface of the building, especially around the roof area (there was no precipitation during the period following the earthquake and prior to building inspection).

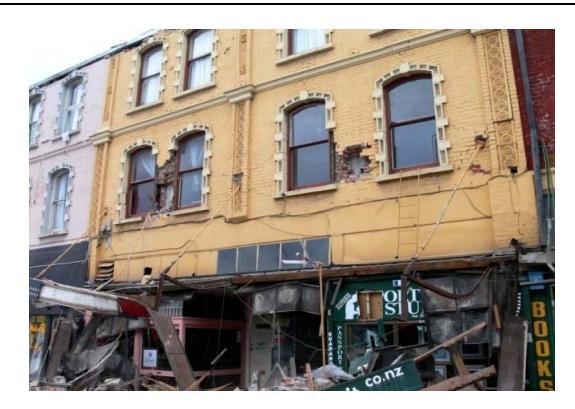
It appears that the through steel anchors at the gable did not provide sufficient restraint to the masonry, with the brickwork being pulled around the steel anchor plates. Furthermore, from images prior to the earthquake it is evident that there were significant cracks through the spandrel and the parapet over the top corner window of 139 Manchester Street. Falling parapets landed on the canopies, resulting in an overloading of the supporting tension braces that led to canopy collapse. The connections appeared to consist of a long, roughly 25 mm diameter rod, with a rectangular steel plate (approximately 5 mm thick) at the wall end that was approximately 50 mm wide x 450 mm long and fastened to the rod, and was anchored either on the interior surface or within the centre of the masonry pier or wall. The force on the rod exceeded the capacity of the masonry, causing a punching shear failure in the masonry wall (see Figure 5.15).

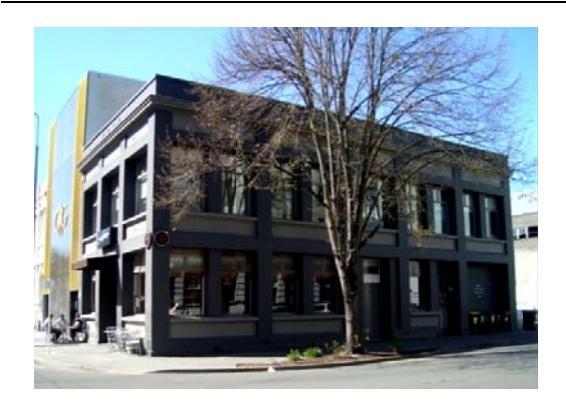
At the time of construction in the 1920's, 194 Hereford Street was the end building in a row of two storey buildings. The building was a two storey isolated URM building most recently occupied by Joe's Garage Cafe and Miles Construction, and was isolated from the neighbouring building by a seismic gap (see Figure 5.17(d)). The original structural system consisted of load bearing external URM walls, with timber diaphragms and a concrete lintel beam running the full length of the building on the Hereford Street and Liverpool Street sides. The street-facing facade walls were perforated URM walls whereas the rear of the building consisted of stiff solid shear walls. The building had a sloping roof and the parapet height varied from zero to about 1 m at the side adjacent to the neighbouring building. From preliminary scratch tests it was established that a lime based weak mortar having coarse aggregate was used in the original construction.

(a) Exterior view

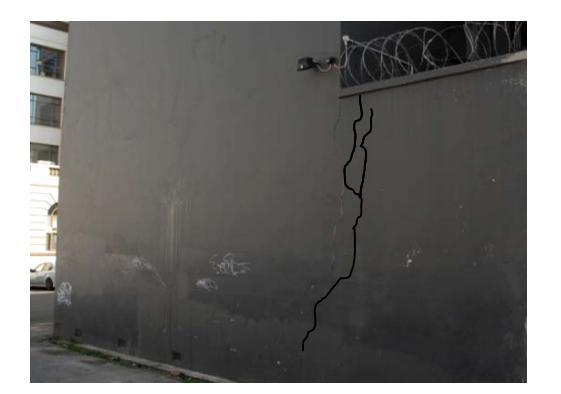
(c) Highlighted crack location at the rear of building

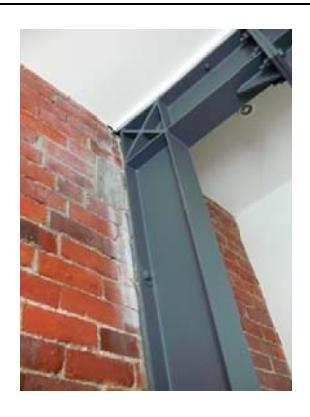
(b) Steel moment frame

The building was seismically retrofitted in 2004 using large steel portal frames oriented in the transverse direction of the building, spaced at approximately 4 m centres as shown in Figure 5.17(b). The building floor plan is shown in Figure 5.18. Diaphragm strengthening was not observed in the interior of the building.

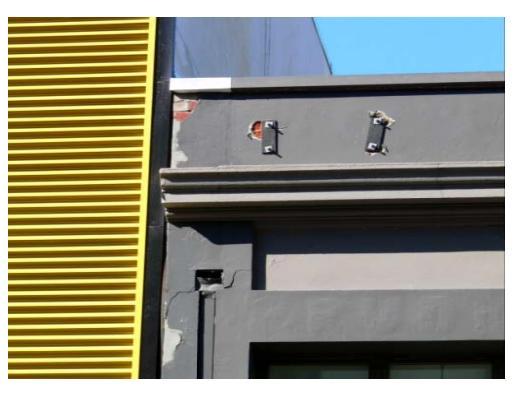
(d) Reduction of seismic gap

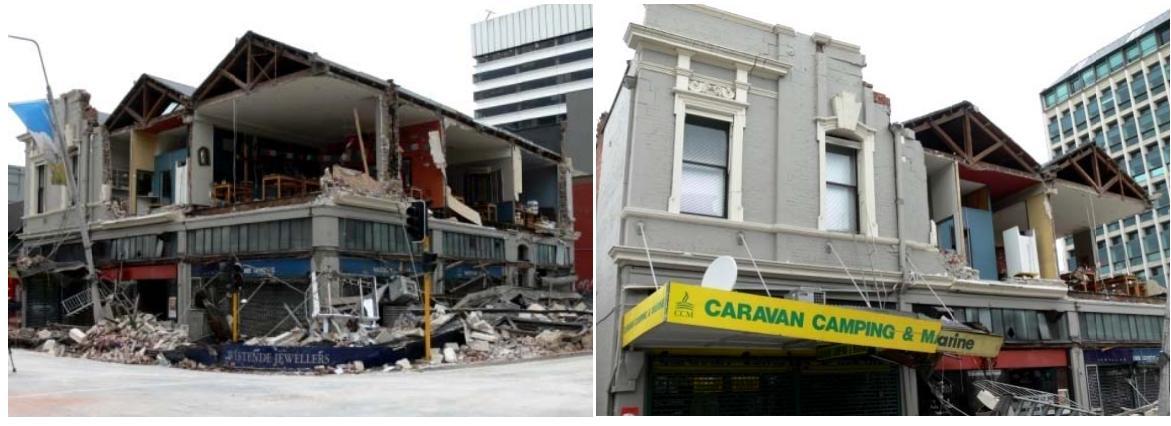
(a) Corner view

(b) Side view, showing steel anchors

The building experienced a complete out-of-plane collapse of the street front corner facade walls (see Figure 5.20(a)). Anchors in the gables did not provide sufficient restraint, as they remained in the timber roof structure following the earthquake as shown in Figure 5.20(b). Steel anchor plates which were observed along the Worcester Street roof were positioned between the masonry leaves. These anchors remained in the timber roof structure, indicating that insufficient out-of-plane restraint was provided. Due to excessive damage and safety considerations the building was demolished following the 4 September 2010 earthquake.

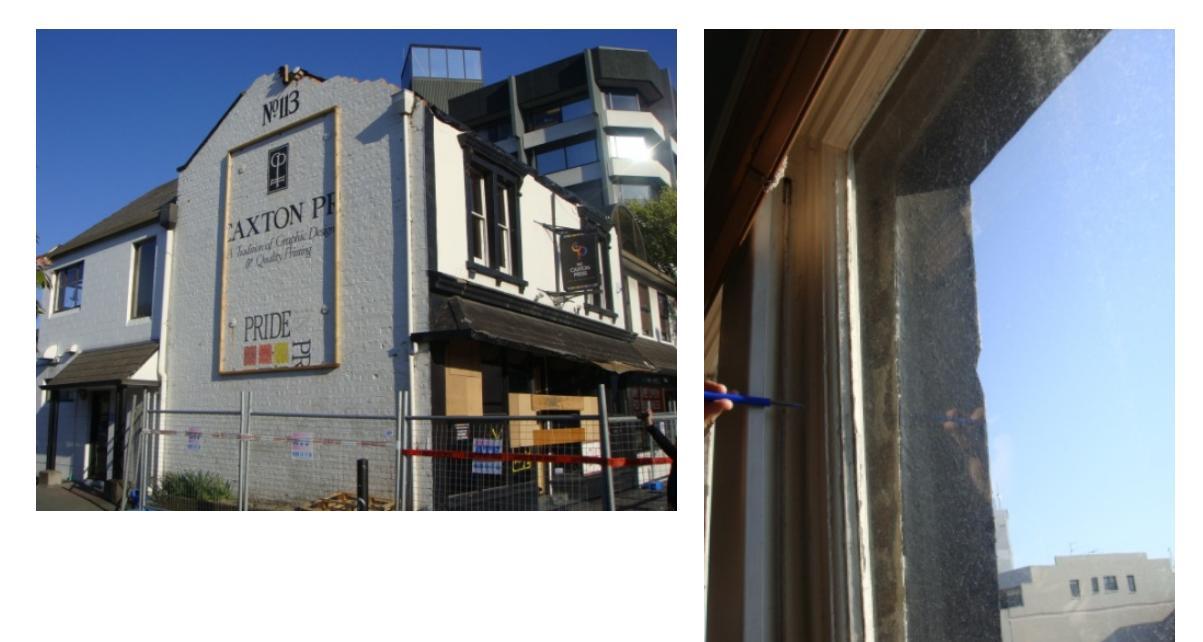
Figure 5.21 Caxton Press building at 113 Victoria Street (images taken post-September 2010)

(b) facade wall pulled away from the side walls

The Caxton Press building was extensively damaged during the Darfield earthquake and the subsequent aftershocks. From external observation, the parapets on the facade wall had collapsed, the top of the gabled side walls had failed due to out-of-plane loading seen in Figure 5.21(a), the perforated facade wall had developed extensive shear cracks through the spandrel over the openings, and the facade wall had pulled away from the side walls due to insufficient anchorage, as shown in Figure 5.21(b). Furthermore, pounding was evident from cracking on the side walls adjacent to where the new concrete block building butted up to the URM building. On internal inspection, evidence of diaphragm movement was apparent as indicated by displacement of the floor boards and the 15 mm displacement of the bricks in the side walls. The building owner, who was standing outside the building at the time of the first major aftershock, recalls seeing the brick wall move in a wave pattern, which indicates possible diaphragm movement and weak cohesion between the bricks and mortar. The building was demolished following the 4 September 2010 earthquake.

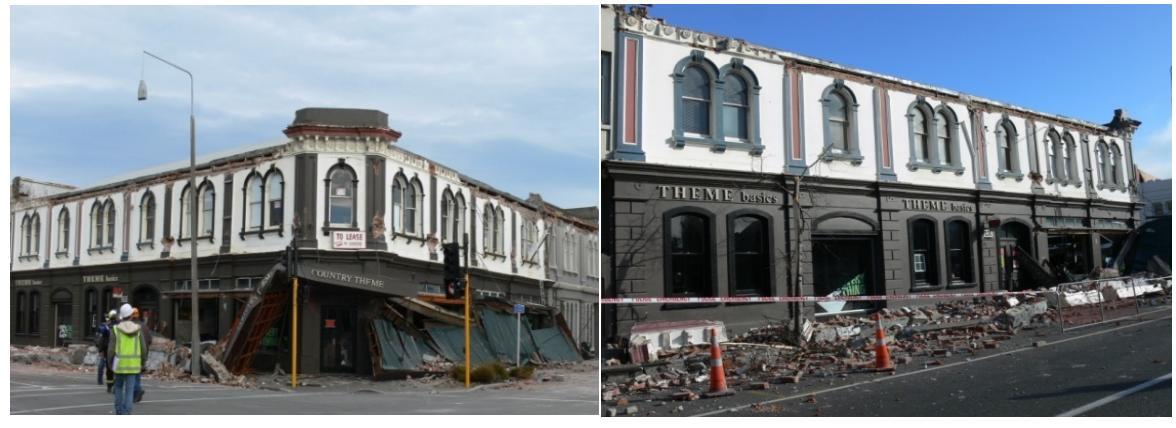
Figure 5.22 Cecil House / Country Theme Building, 68-76 Manchester Street (images taken post-September 2010)

(b) concrete beam on the ground

The most apparent earthquake damage was the toppled parapets around the street frontage as illustrated in Figure 5.22(b), with a lightly reinforced concrete beam on top of the parapet providing insufficient restraint. Falling parapets landed on the canopies below, overloading the supporting tension braces that caused a punching shear failure in the masonry wall and subsequent canopy collapse. The connections appeared to consist of a long, roughly 25 mm diameter rod, with a round steel plate (about 10 mm thick) at the wall end that was approximately 150 mm in diameter.

No evidence of through anchors connecting the roof diaphragm to the wall structure was observed. Some in-plane damage to the far end of the building along Manchester Street was evident, mostly consisting of cracking through the spandrel and some horizontal cracking through the piers.
