Landmark Tower
Robert Jones House
Selected Drawings

Forsyth Barr House - Level 2 Seismic Assessment

FORSYTH BARR TOWER POST-EARTHQUAKE ASSESSMENT AND REPAIR REPORT

Investigation into the Collapse of the Forsyth Barr Building Stairs on 22nd February 2011

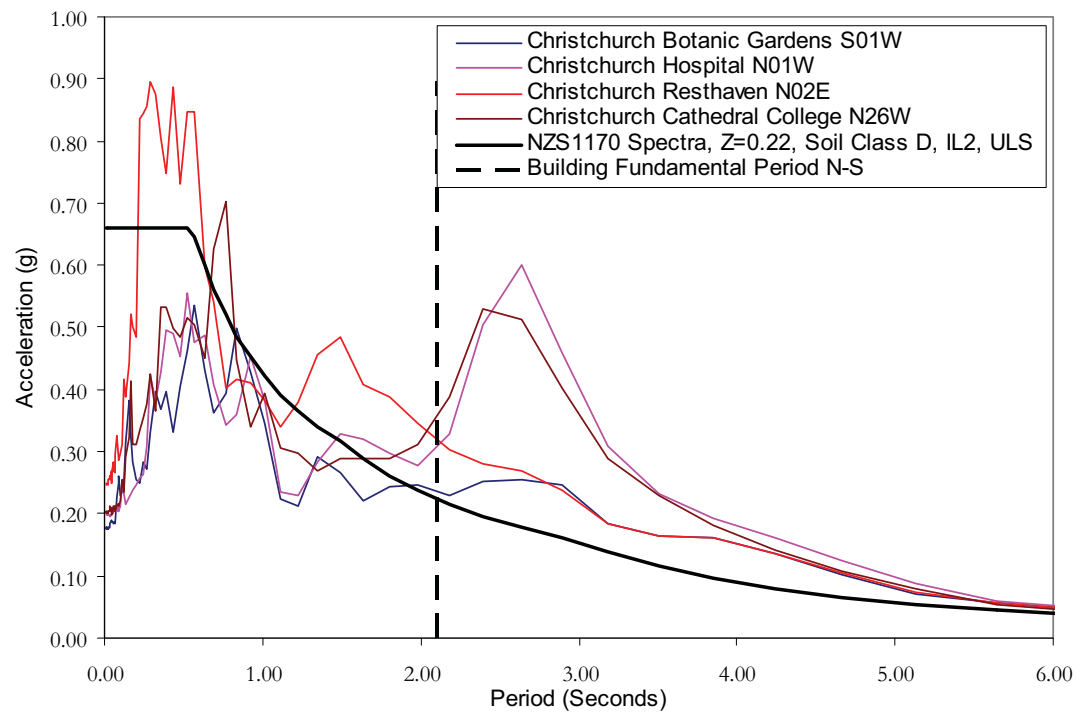
Figure 4-2: 5% Damped Spectra – North-South

It is apparent that in the North-South direction, there is significant variation in the shaking experienced at the different monitoring sites, particularly in the 2 second to 3 second period range. This is due to the highly variable ground conditions around Christchurch.

Previous analyses of the Forsyth Barr Tower have determined the buildings fundamental periods to be between 2.0 and 2.2 seconds for the primary directions. Based on the strong motion data downloaded, it is possible that the earthquake produced accelerations in the north-south direction significantly in excess of the design spectra for this building.

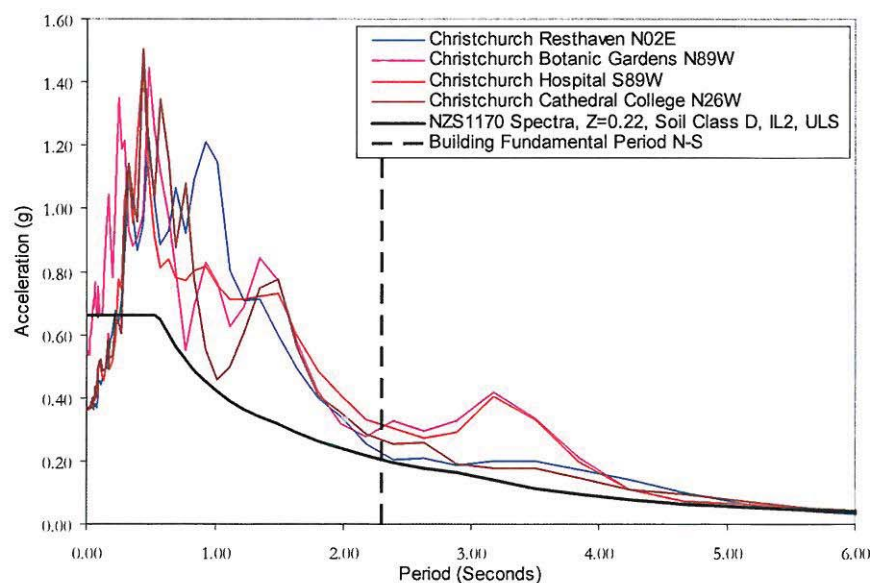
Figure 3: 5% Damped Spectra (North South Direction)

It is apparent that the shaking experienced by the Forsyth Barr Building was most likely well above the current design code level for this building.

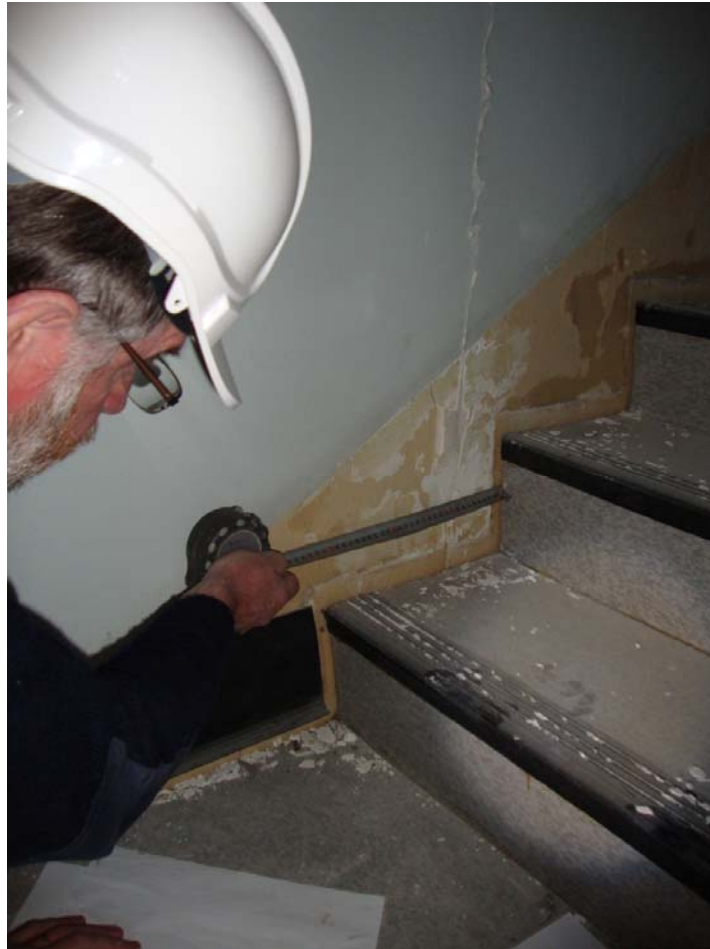
Figure A2.6.5: Level 16 : North-West Unit, South-West Landing – Relative Movement between Stair and North-West Wall (19 mm horizontally, 30 mm vertically)

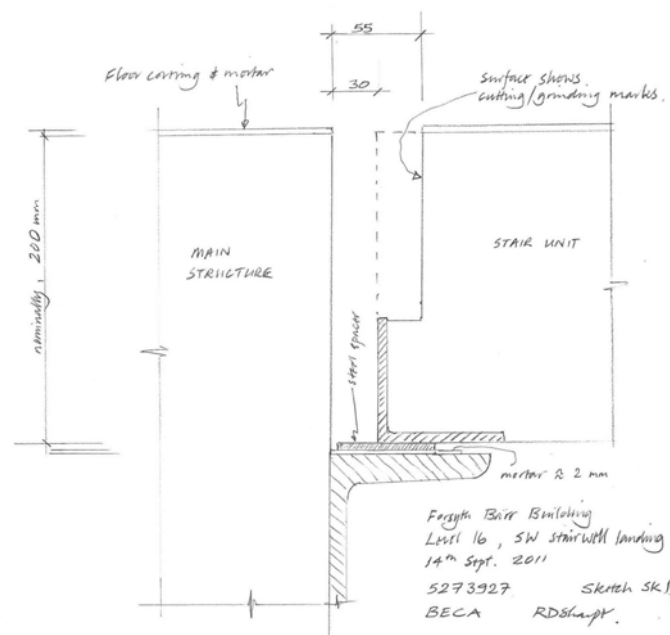
Figure A2.6.6: Level 16, South-West Lobby, North-West Unit, Seismic Gap Measurements

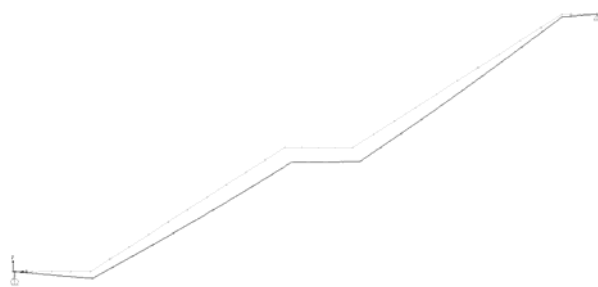
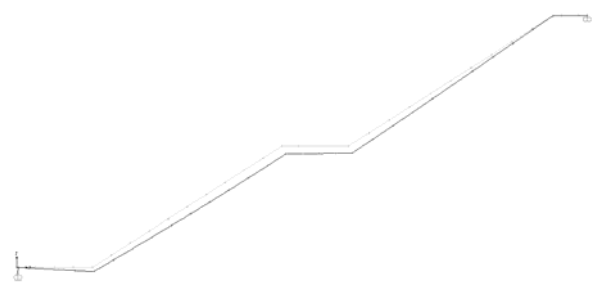
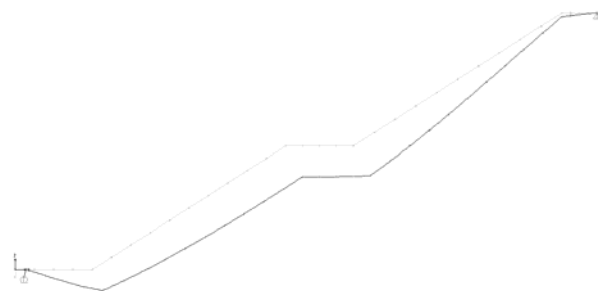
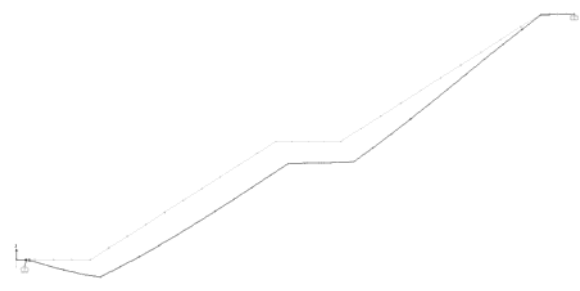
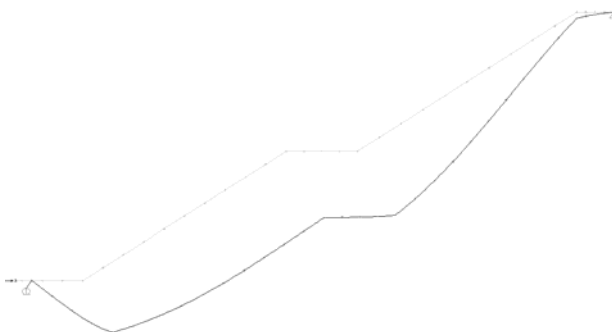
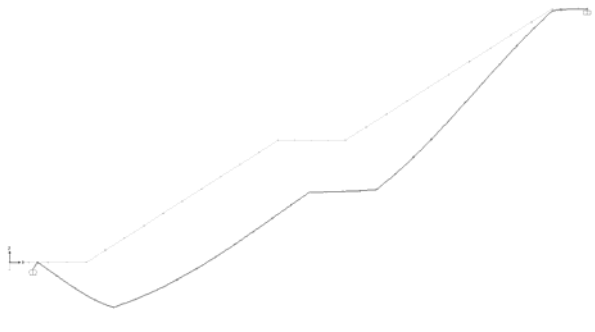
Figure A3.4 : Deflected Shapes from the Forced Displacement Analyses (

The deflected shapes are shown in Figure A3.4.

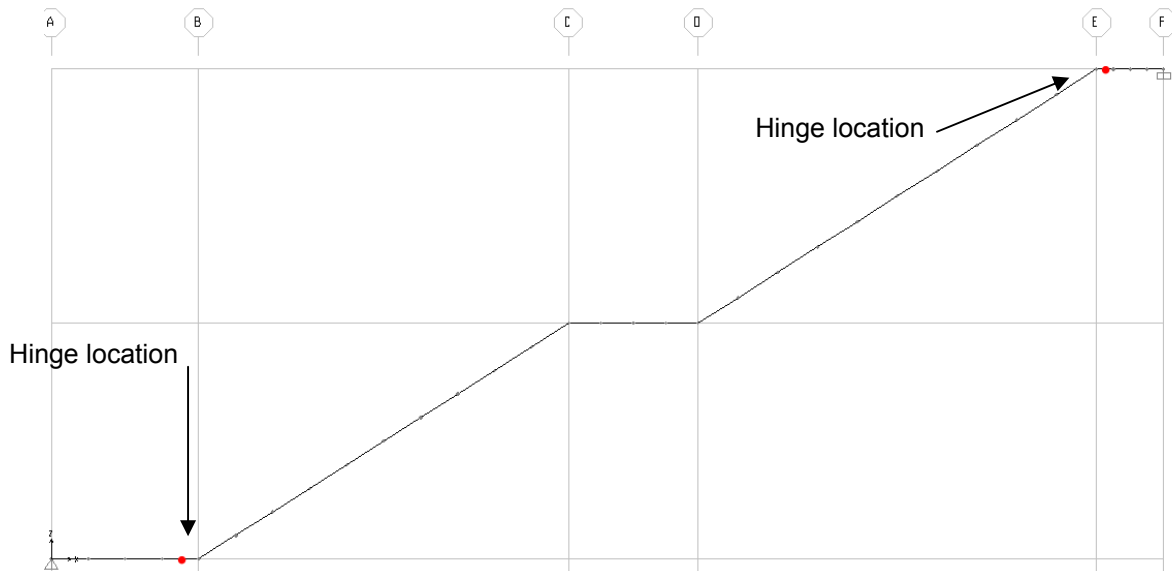
Figure A3.12 : Location of Hinges in the Non-linear Stair Flight Analysis

A non-linear pushover analysis was carried out on the stair unit to confirm the potential permanent horizontal shortening and vertical displacement of the stair unit. Moment-curvature hinges were added adjacent to joints 2 and 5, in the 900 mm x 200 mm stair section as noted below.

A displacement was applied to the lower landing joint until the first hinge failure.

The assumptions made were similar to those for the linear case. Other assumptions include hinge lengths assumed as 0.2 m (the same as the depth of the section), and the location of the hinge located at a distance of 130 mm from the end of the member. Flexural stiffness modifiers of 0.5 were assumed.

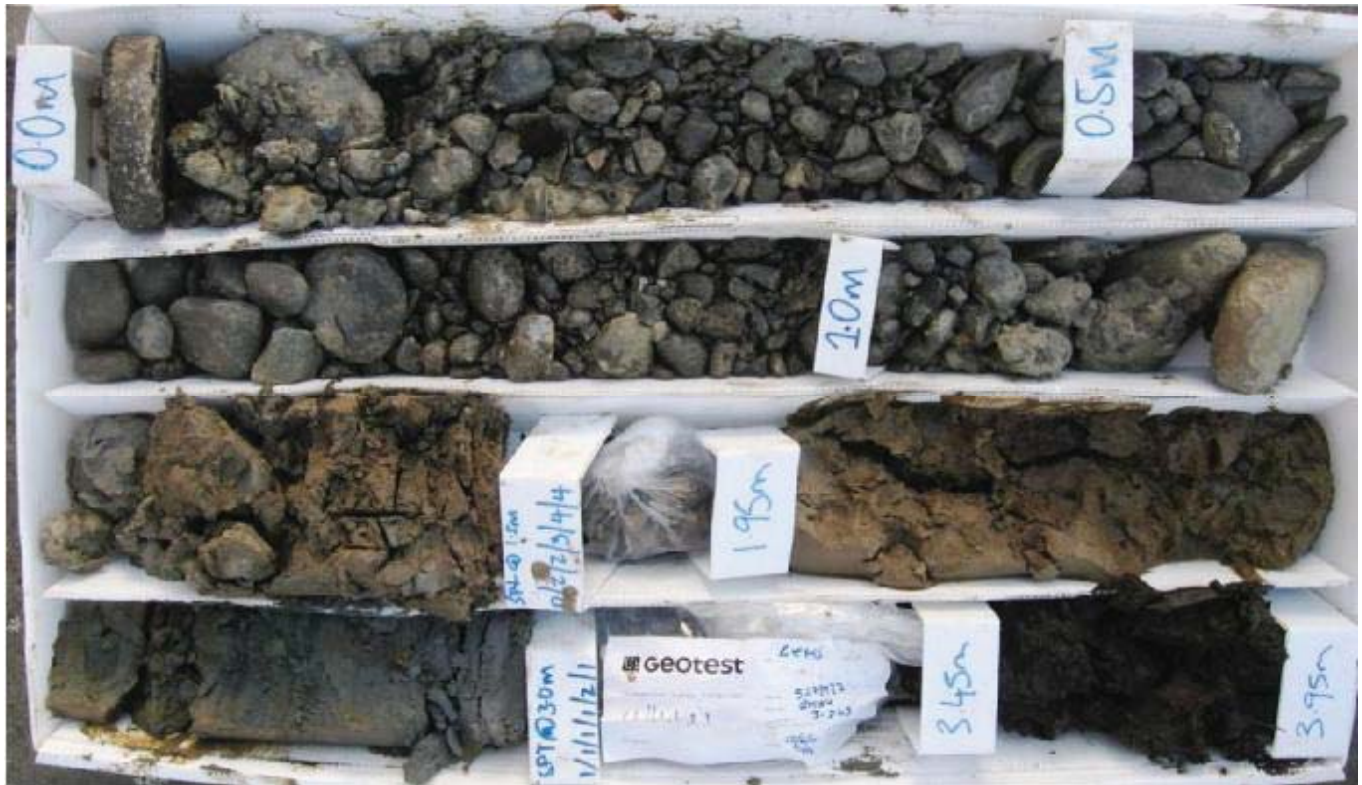
BOX: 1

DEPTH: 0.0 to 3.95m

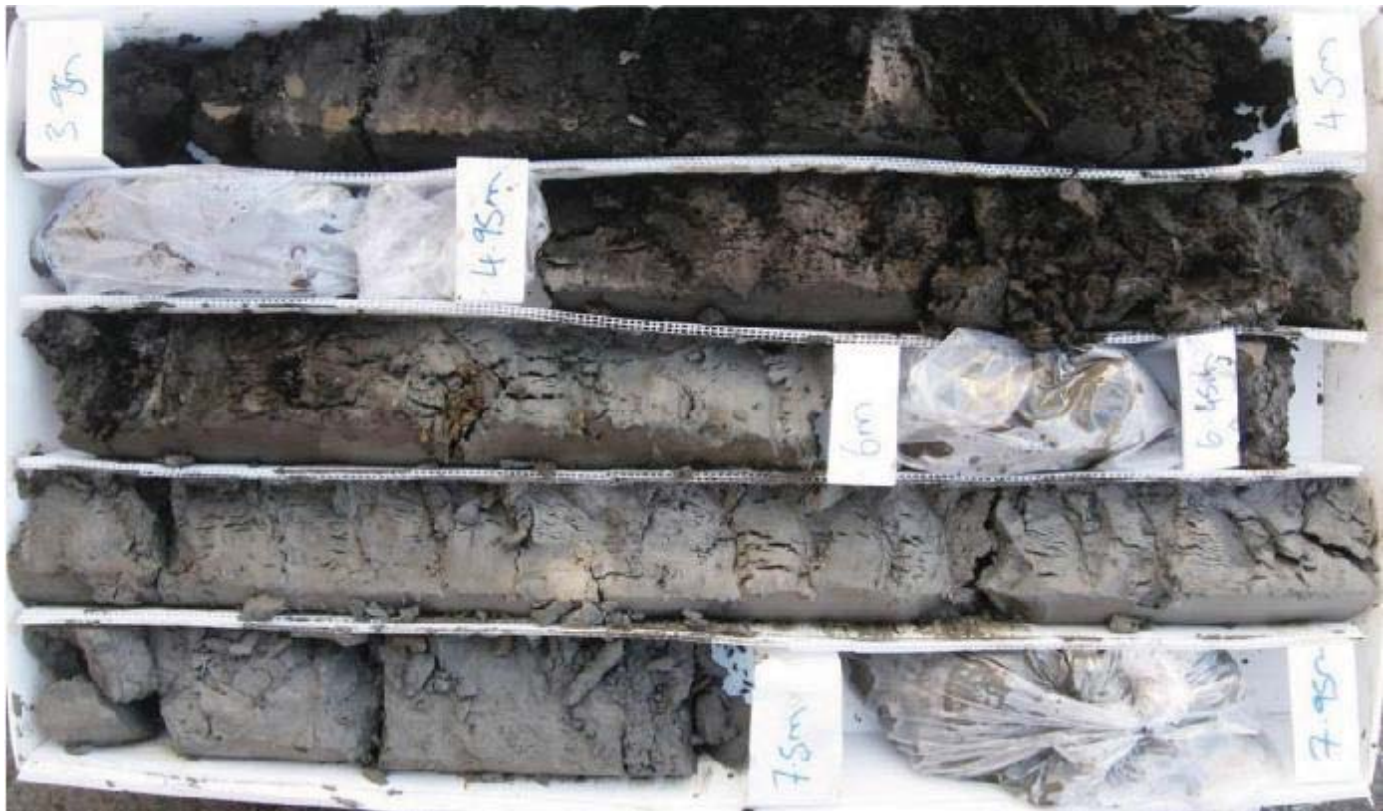
BOX: 2

DEPTH: 3.95 to 7.95m

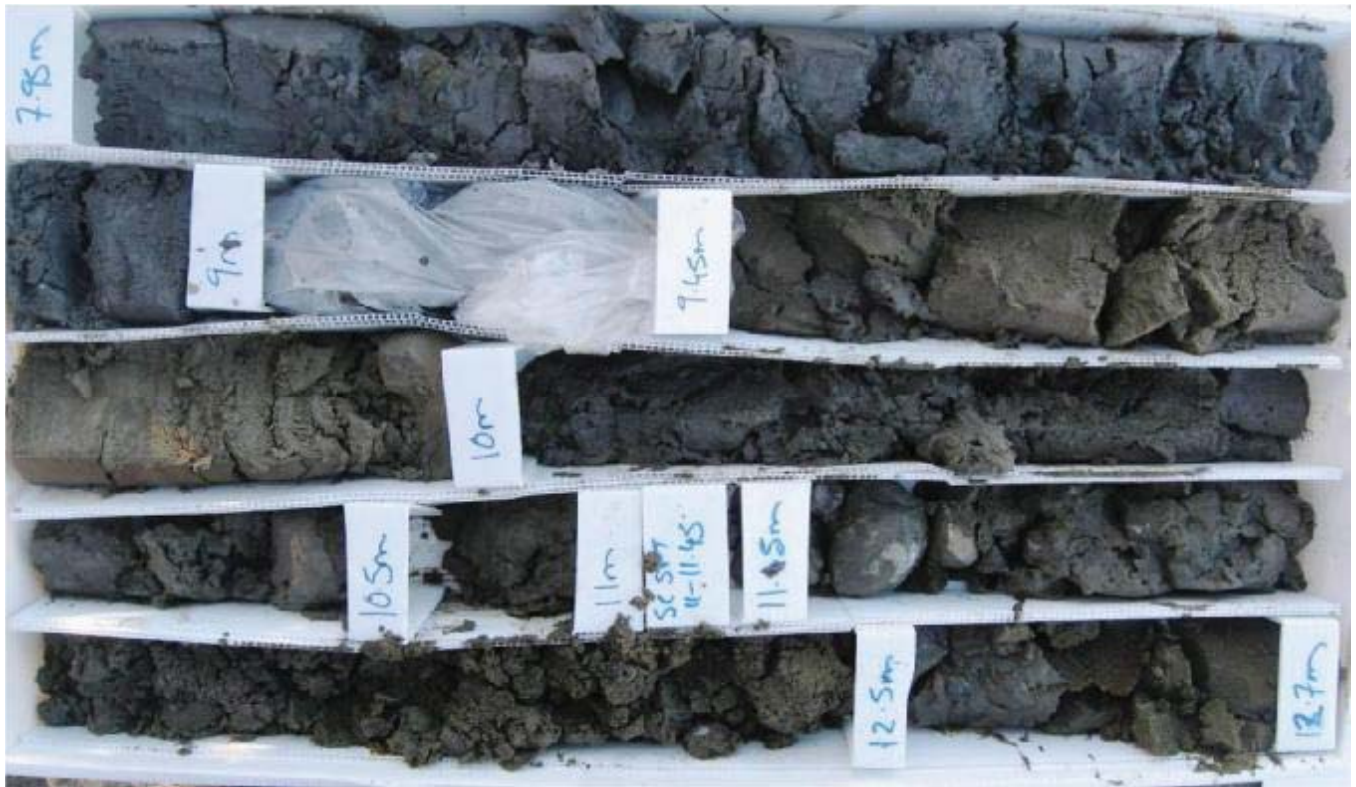
BOX: 3

DEPTH: 7.95 to 12.7m

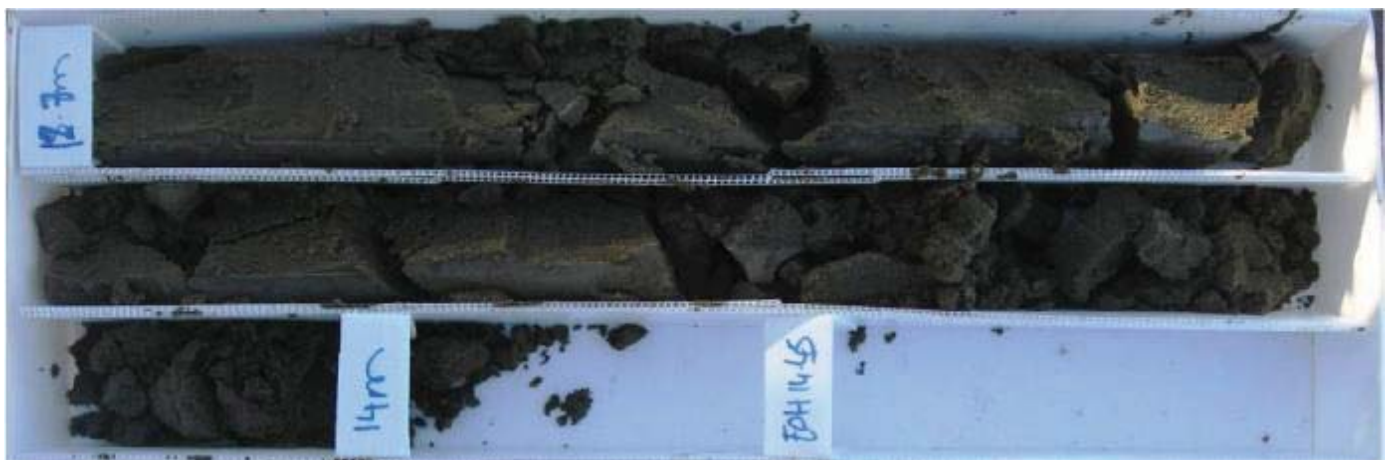
BOX: 4

DEPTH: 12.7 to 14.45m
