# FORSYTH BARR

FORSYTH BARR BUILDING STAIRS  
SITE EXAMINATION AND MATERIALS TESTS  
FOR DEPARTMENT OF BUILDING AND HOUSING  
22ND SEPTEMBER 2011

Report Issue Date: 22 September 2011

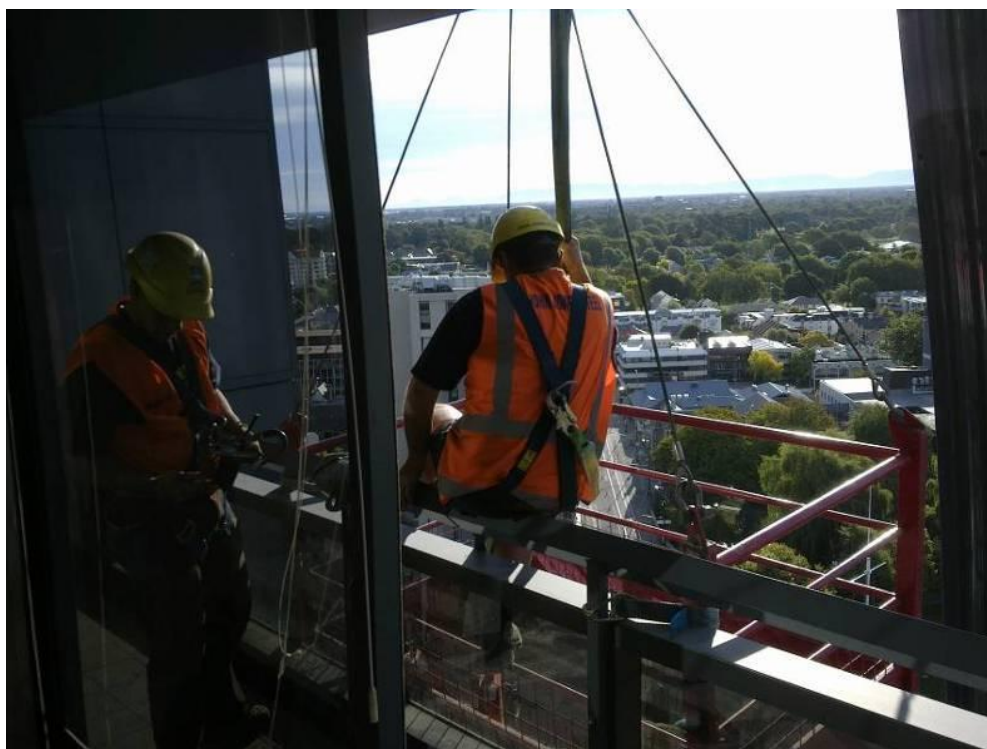
Figure 5 –Crane access into building

Access was gained externally by crane (Figure 5) consecutively into Levels 15, 16, and 17, then up to the roof internally using the remaining stairs.

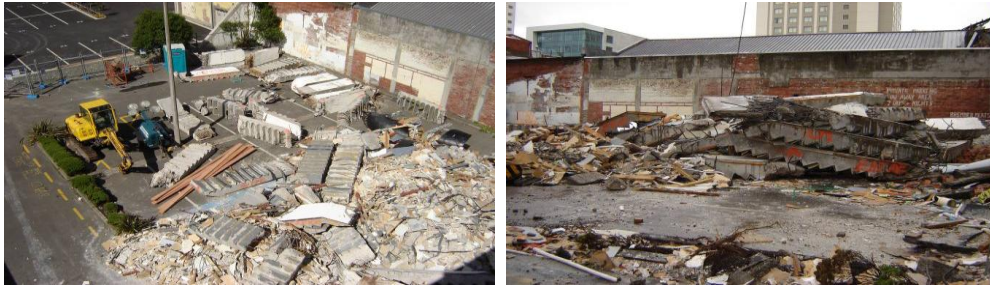
The collapsed stair remnants had been removed from the stairwell at Level 1 and 2 (Figure 13) by other parties and placed in the car park behind the Forsyth Barr building prior to the Stair Remnants Examination (Figure 12).

Figure 12 - Stair remnant debris in car park behind Forsyth Barr building after their removal from the stairwell.

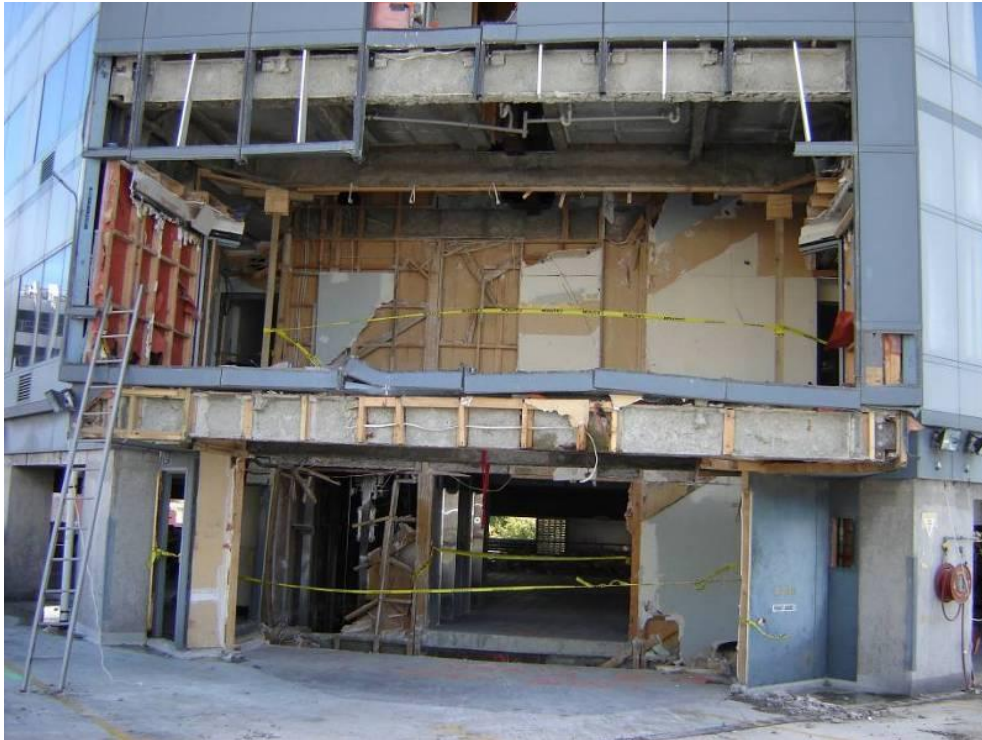
Figure 13 - Access into stairwell from Level 1 and 2 used for removal of stair remnants

The stair remnants had been retrieved by other parties from Level 1 and 2 of the stair well (Figure 13 and Figure 14).

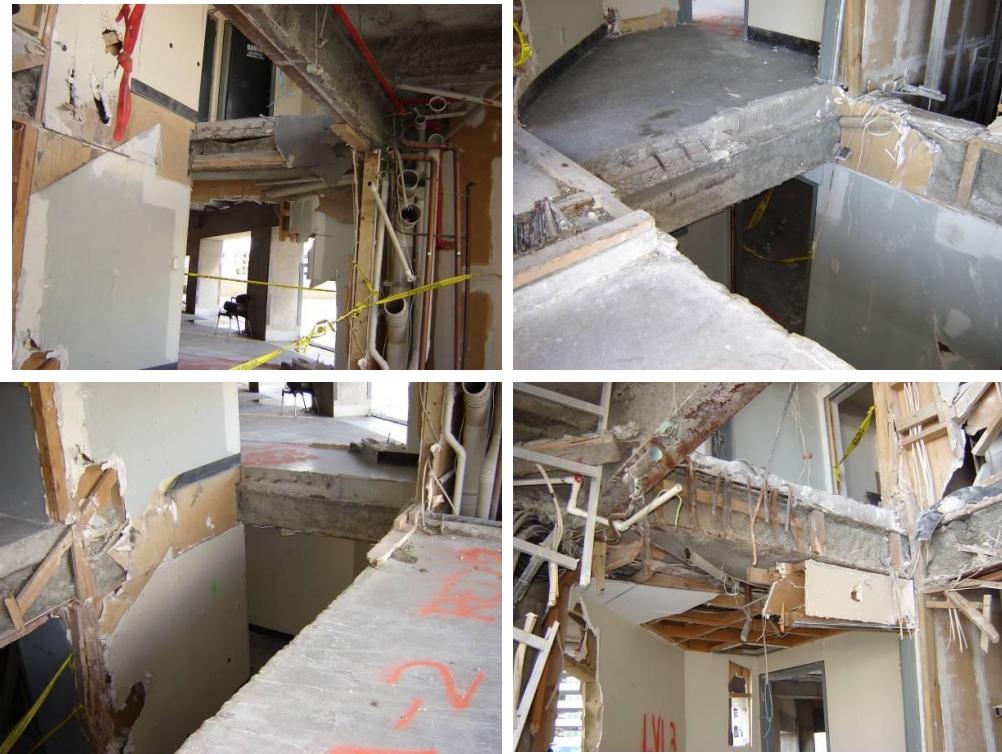
Figure 14 – Level 2 to 3 Stairwell in the access area used for remnant retrieval

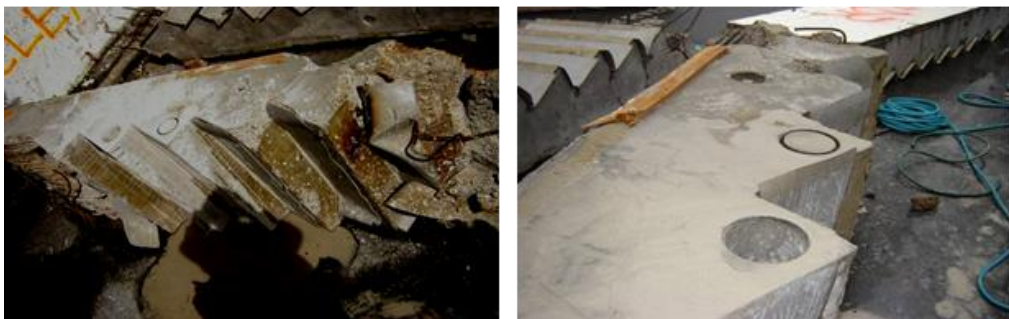
Figure 17 - Unit 2 showing concrete core test locations on the sides of treads

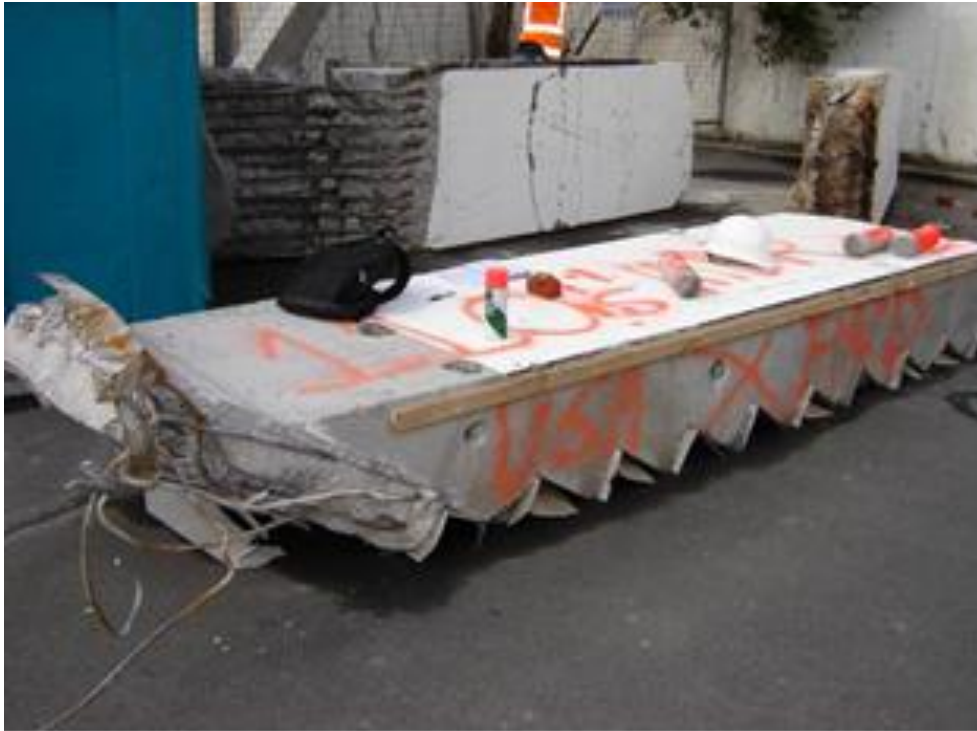
Figure 18 - Unit 3 with upper landing; Unit 1 to left behind; Unit 2 to right behind

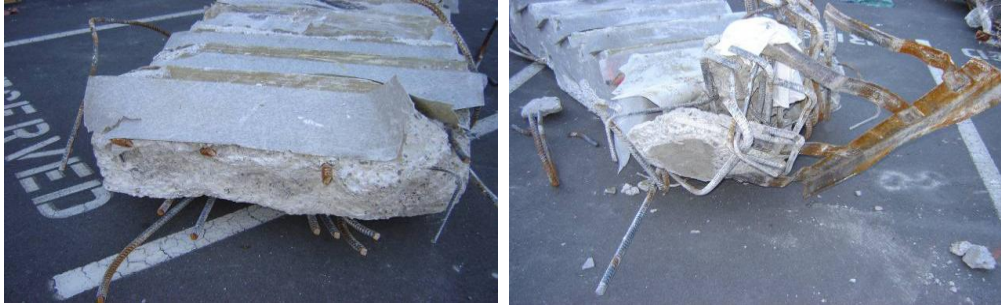
Figure 27 - Unit 12 (left to right): (a) Mid-height landing; (b) Lower landing.

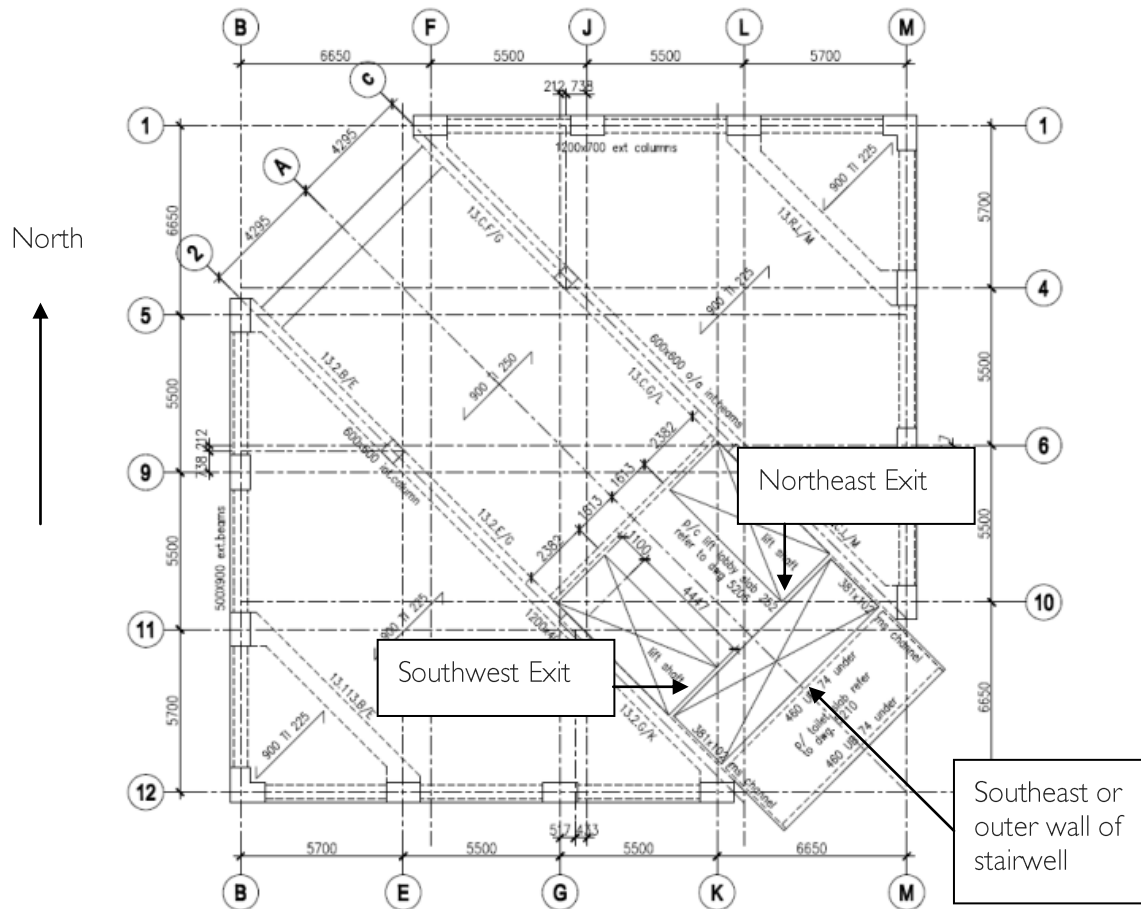
Figure 35 – Typical floor layout and stairwell orientation

The building permit drawings stamped by the Council with the date 26 April, 1988 ("the Drawings") for the Forsyth Barr Building show an 18 level perimeter frame reinforced concrete building with pre-stressed concrete rib floors with in-fill timber permanent formwork (Figure 35 Appendix E). There was no shear wall core.

For the purposes of this report the stair exits on each floor level are designated as “the Northeast Exit” or “the Southwest Exit” (Figure 35 Appendix E). For example the Level 9 Southwest Exit occurs on Level 9 at the southwest end of the stair well.

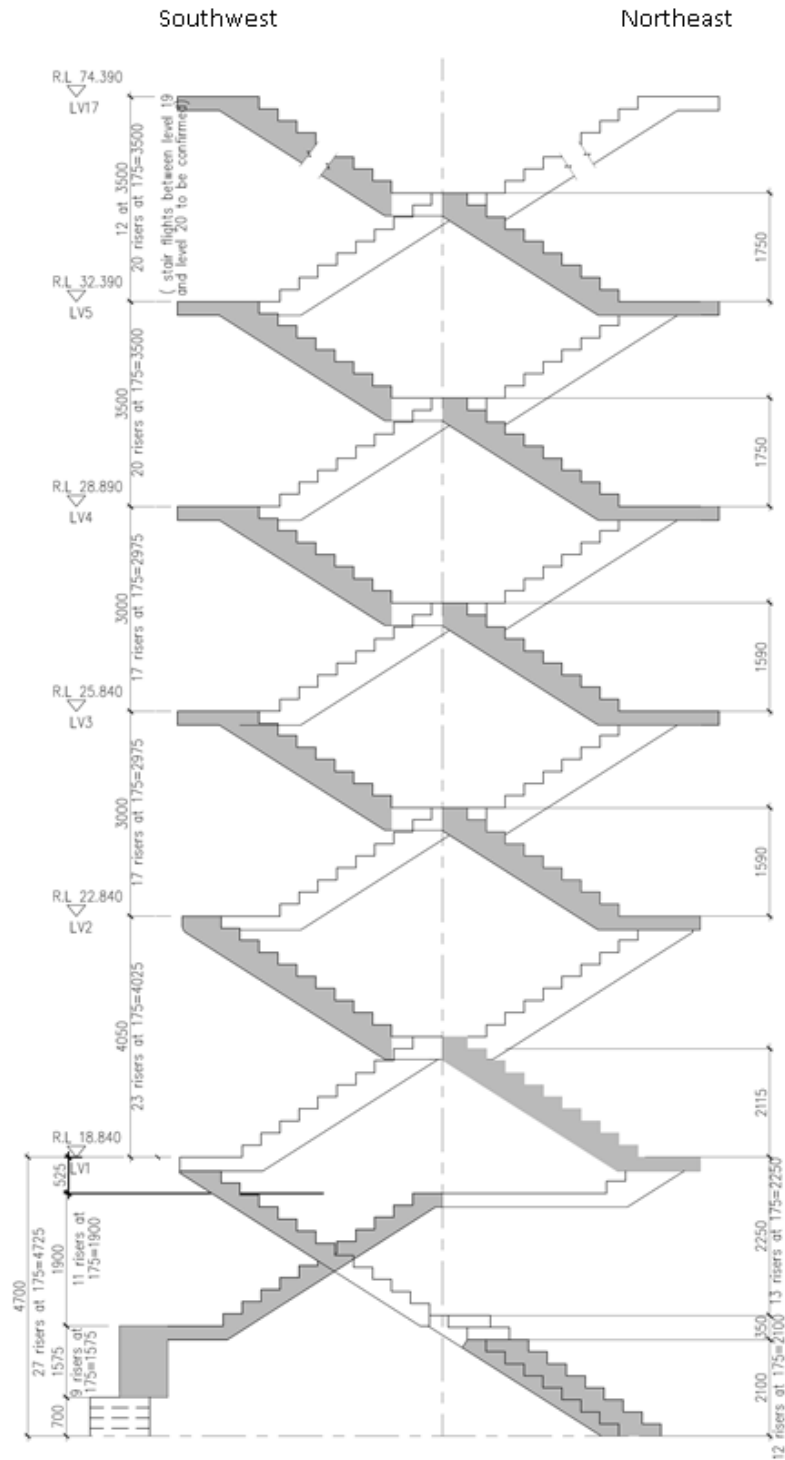
Figure 36 – Stair Elevation

- c. Each flight of stairs was shown on the Drawings as consisting of two precast half flights with a mid-height in-situ landing (Figure 36; Figure 37). However it appears that the stair flights were precast as one continuous unit as no construction joint could be seen in Units 8, 14 and 18 at the mid-height landing (Figure 23; Figure 29; Figure 33). The top end of the flight rested on a 381 mm x 102 mm RSC (rolled steel channel) and was cast into the building floor concrete (Figure 39). The bottom end of the precast flight sat on a 381 x 102 RSC steel channel with nominally 75 mm seating and detailed to allow 30 mm of horizontal compression movement between the stair and the lower floor (Figure 38). The typical design floor to floor height between Level 4 and 18 was documented as 3500 mm.

The stairwell is located at the rear of the lift shaft on the southeast corner of the building and consists of two sets of stairs arranged in scissor fashion aligned southwest to northeast, that were separated by light-weight fire rated walls (Figure 36 Appendix E).

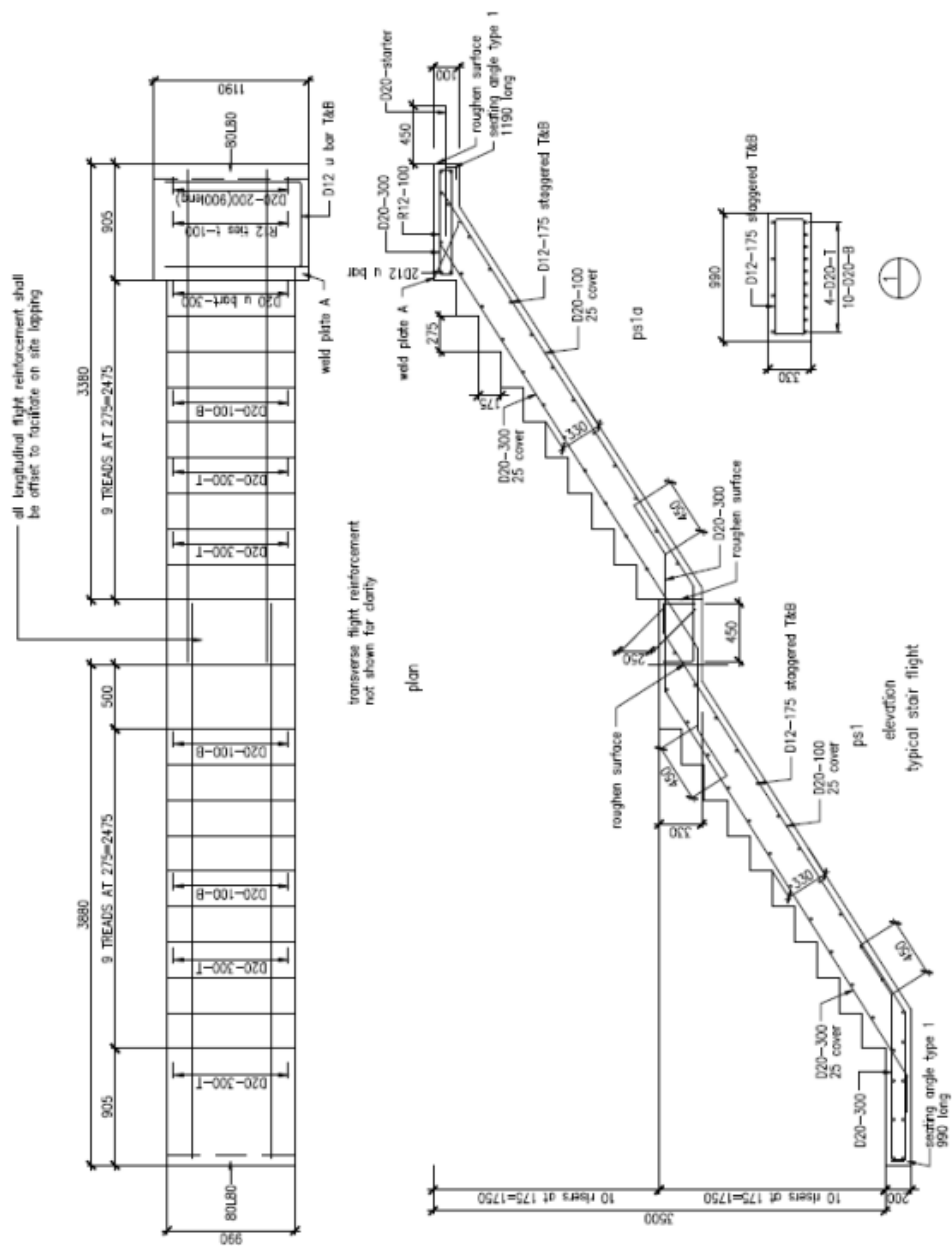
Figure 37 – Typical stair details

The Drawings show that the stairs flights were permitted to consist of two precast concrete units joined by in-situ concrete at a mid-height landing (Figure 37 Appendix E). The upper portion of each stair flight was seated on a 381x102 mm RSC steel channel section and had six D20 reinforcing bars cast into the upper concrete support beam (Figure 39 Appendix E). The lower portion of each stair flight sat on a 381x102 mm RSC steel channel section.

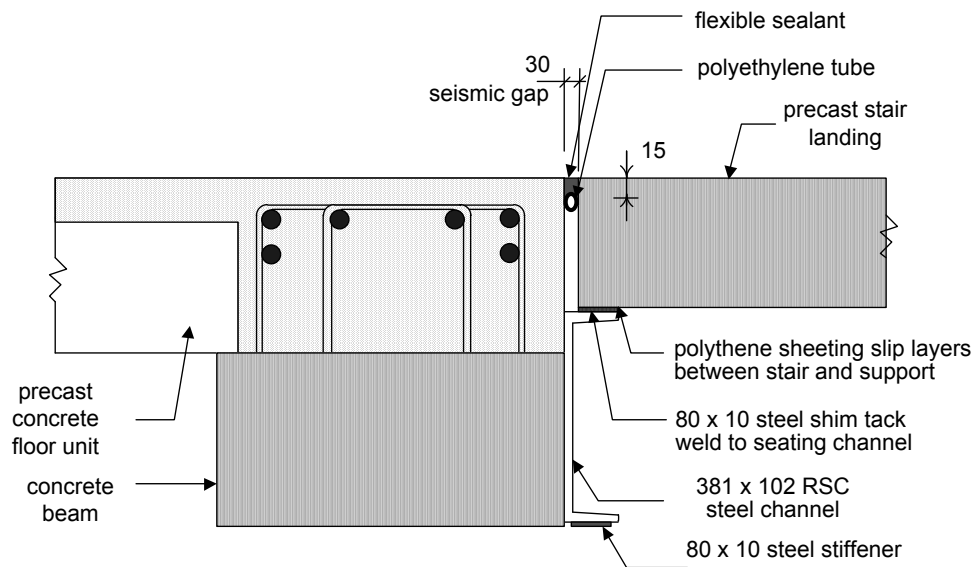
Figure 38 - Typical lower landing detail with seismic joint.

A 30 mm seismic gap was specified on the Drawings at the lower landings of the stair flights to allow the stair flights to slide freely back and forth and take up any inter-storey drift movements induced by an earthquake without damaging the stair or falling off the lower landings supports (Figure 38 Appendix E).
