# Addendum Report to the Royal Commission of Inquiry

## The Performance of Earthquake Strengthened URM Buildings in the Christchurch CBD in the 22 February 2011 Earthquake

Associate Professor Jason M. Ingham

Professor Michael C. Griffith

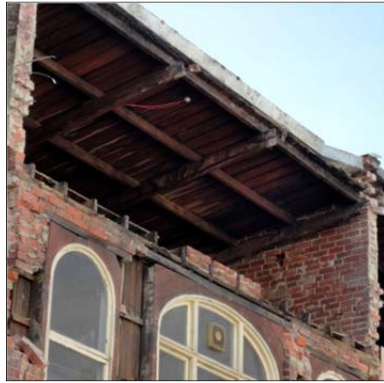
(a) Example of fair roof diaphragm condition

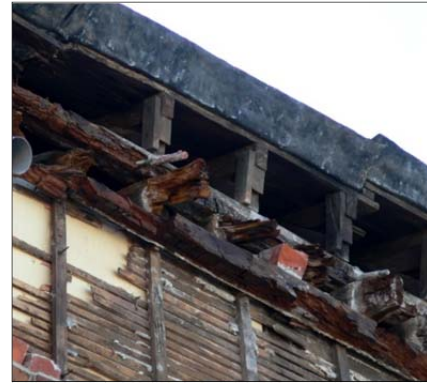
(b) Example of poor roof diaphragm condition

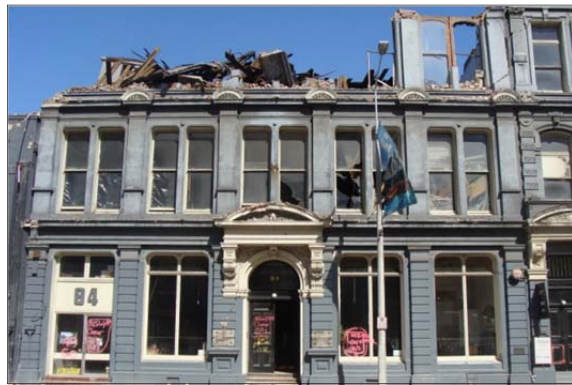
(d) Complete collapse of top storey due to weak piers, 84 Lichfield Street

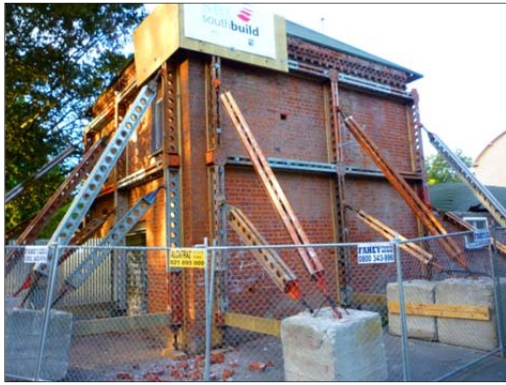
(a) Extensive steel temporary shoring of a URM building following 4 Sept. 2010 Darfield earthquake, (building located outside CBD)

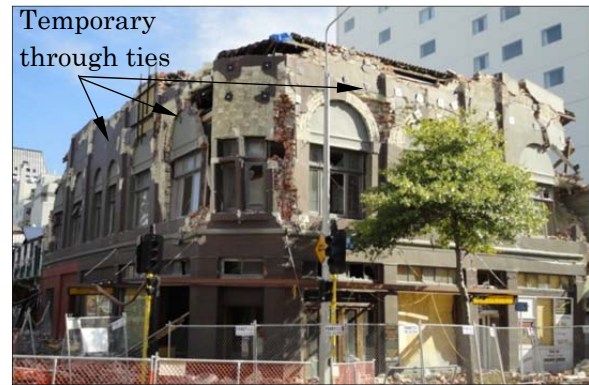
(b) Temporary securing work on a URM building following 4 Sept. 2010 Darfield earthquake, corner of Gloucester and Manchester Street

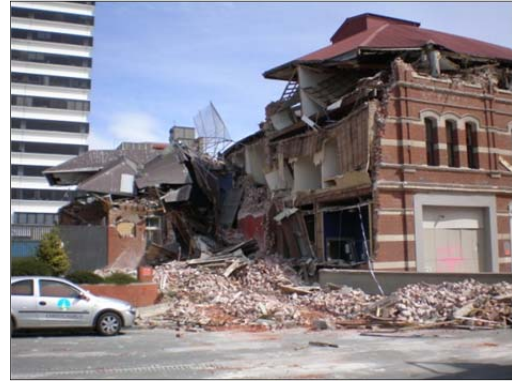
(b) Partially collapsed building poses a near certain risk to building occupants and to public space, 194 Gloucester Street

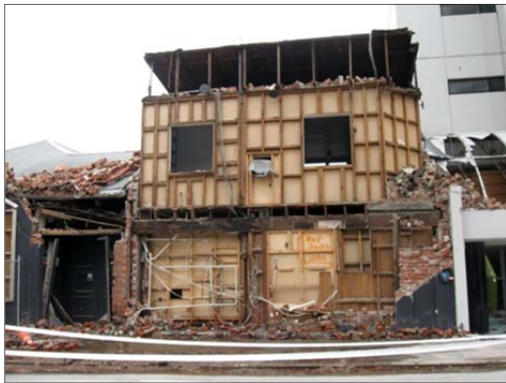
(c) Partially collapsed building poses a unlikely risk to building occupants and near certain risk to public space, 195 Armagh Street

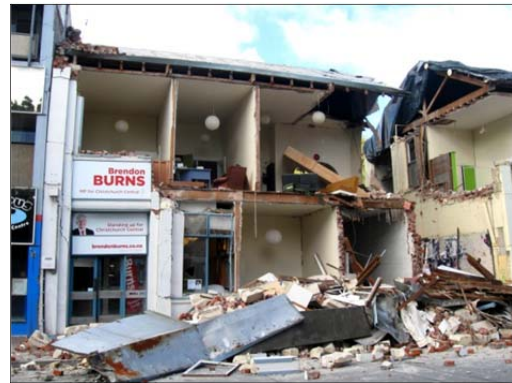
(d) Partially collapsed building poses a likely risk to building occupants and near certain risk to public space, 202 Hereford Street

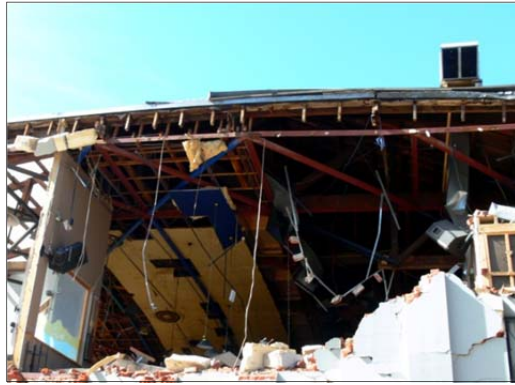
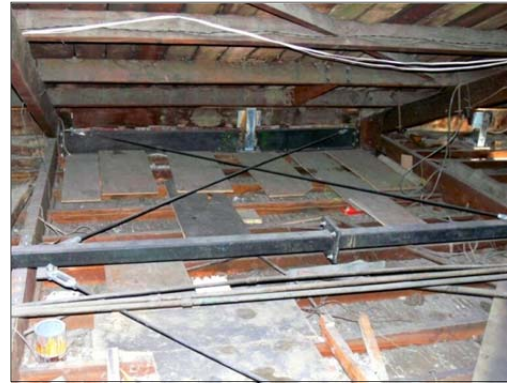
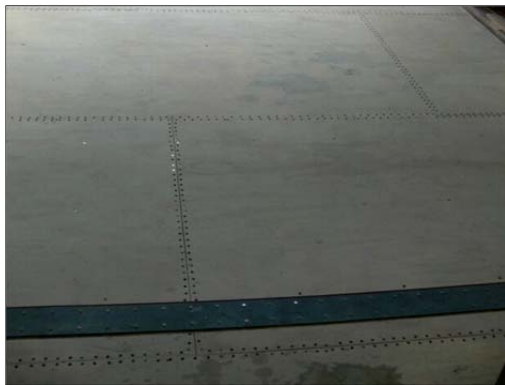
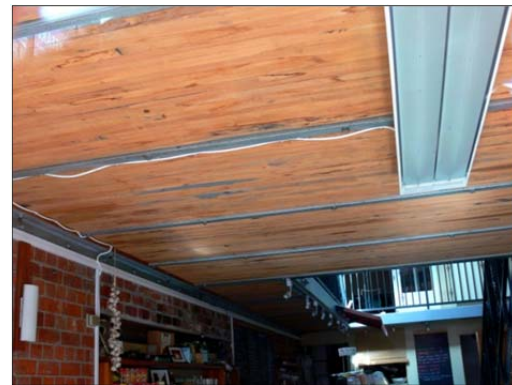
**Figure 3.18 Example of diaphragm improvement techniques**

(a) Roof diaphragm improvement using steel brace frames

(b) Roof diaphragm improvement using steel braces

(c) Floor diaphragm improvement using plywood overlays

(d) Floor diaphragm improvement using overlays and steel framing

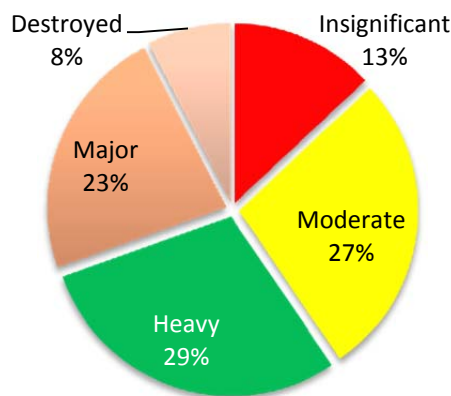
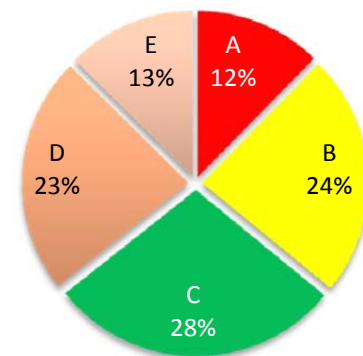
**Figure 4.2 Damage level using two different classifications schemes**

As can be seen in Table 4.8 and Figure 4.2(a), the ATC scale reported damage in excess of moderate for 219 (60%) of all surveyed buildings, and damage in excess of insignificant for 320 (87%) of all surveyed buildings.

As noted above, it was determined that when using the ATC 38/13 damage classification there were 320 (87%) surveyed buildings that suffered damage in excess of insignificant, and when using the Wailes and Horner damage scale there were 322 (88%) surveyed buildings that suffered significant structural damage (Level B, C, D or E). Clearly this comparison indicates a high level of correlation between the two survey methods. This high correlation can be further identified by considering the two charts in Figure 4.2, where it can be seen that comparable numbers of buildings were assigned for each of the incremental damage levels within the two scales.

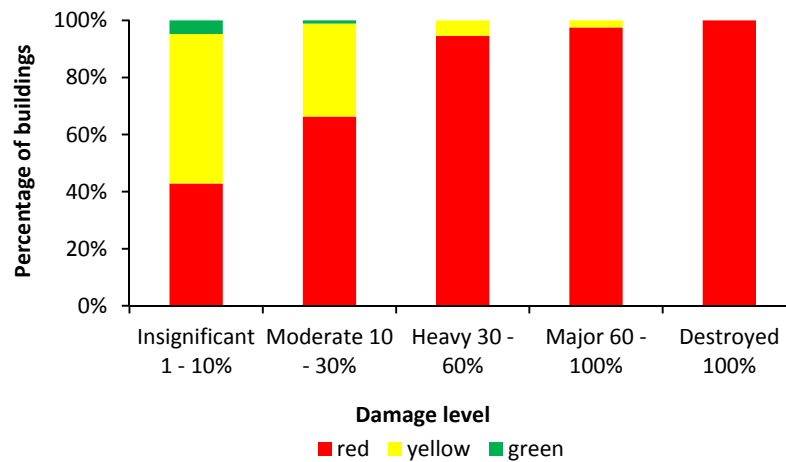
**Figure 4.3 Plot of damage levels vs. placard data (level 1)**

A plot of overall building damage against available placard data (from level 1 inspections as reported in section 4.2.1) is shown in Figure 4.3. The prevalence of the red placard assignments to URM buildings having insignificant or moderate damage shows that assigned placard levels tended to be a conservative estimate of structural damage. Note that both the building damage assessments and the level 1 inspections for placards were primarily based on external inspections only.

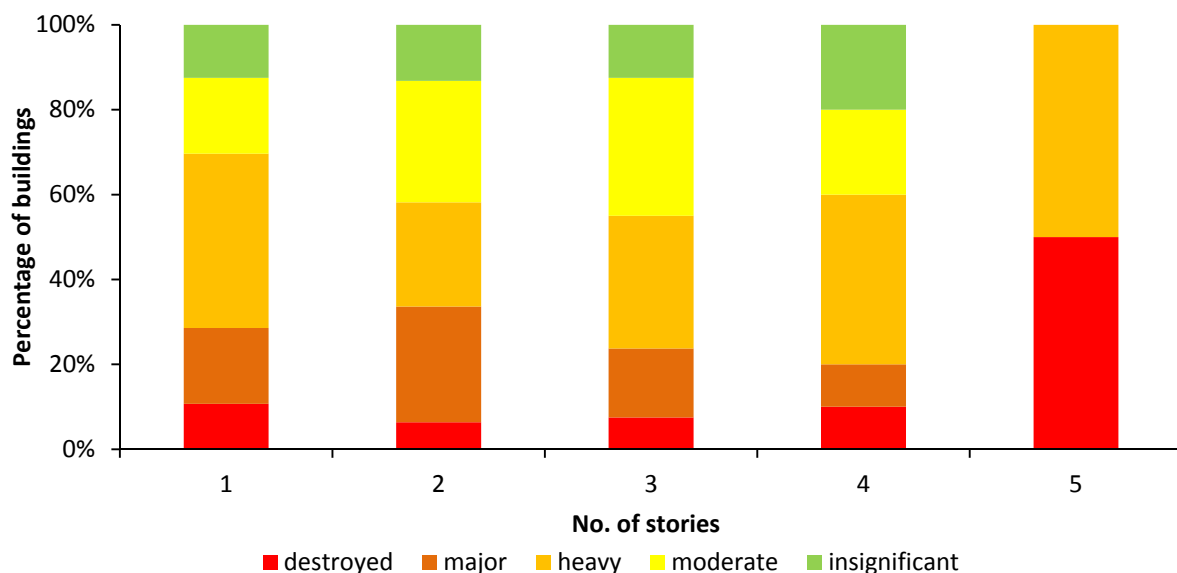
**Figure 4.4 ATC 38/13 damage classification for number of stories**

The ATC 38/13 damage classification was used to investigate any possible relationship between the number of stories and the level of damage (see also Figure 4.1(a) for the distribution of storey heights for the entire URM building population). As shown in Figure 4.4, and specifically neglecting the case for 5 storey buildings due to this category representing only 1% of the building population, it was concluded that there was no distinct relationship between overall building height and the level of sustained building damage. Notably the same conclusion was reached following the 4 September 2010 Darfield earthquake (see Figure 3.5(c) of Report No. 1).

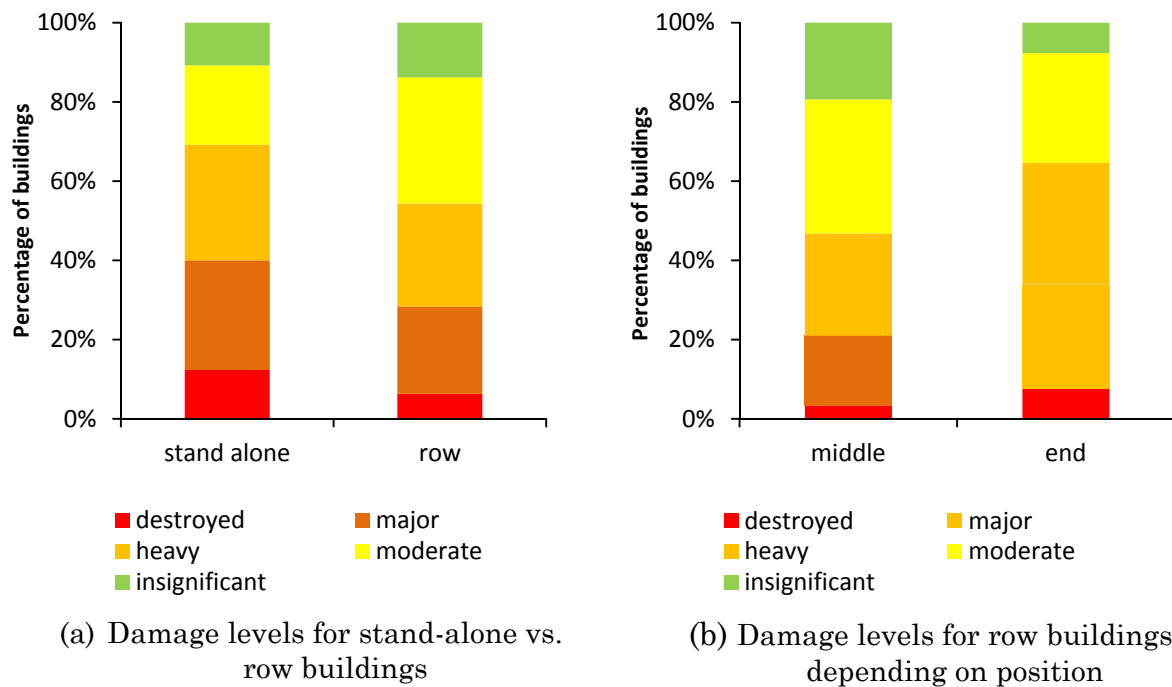
**Figure 4.5 ATC 38/13 damage classification for stand-alone and row buildings**

greater degree of damage to stand-alone buildings than to row buildings. Similarly, the performance of row buildings was considered based upon damage correlated to whether the building was located mid-row or end-of-row (see Figure 4.5(b)), where it was found that greater damage was sustained to end-of-row buildings. These findings are consistent with the generally held view that mid-row buildings are somewhat protected from damage by the end-of-row buildings (occasionally referred to as ‘bookend’ behaviour) and similarly that the practice of constructing multiple URM buildings connected together provides additional robustness when compared to the earthquake performance of stand-alone URM buildings.

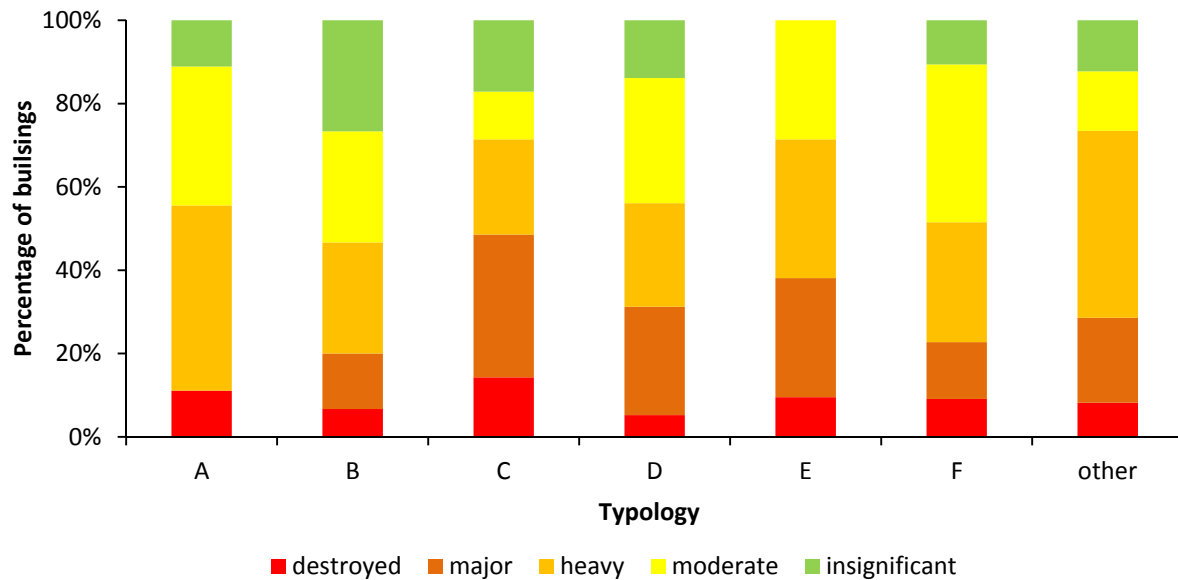
Figure 4.6 ATC 38/13 damage classification for building typology

Finally, the two analyses discussed above were amalgamated to identify the associated damage levels for different building typologies (see Figure 4.6). Recalling that Typology A and C are 1 and 2 storey stand-alone buildings and that Typology B and D are 1 and 2 storey row buildings (see section 2.2 of Report No. 1 for a full description), the damage trends discussed above lead to the conclusion that Typology B and D buildings should exhibit less damage than for other typologies. This trend is shown in Figure 4.6.

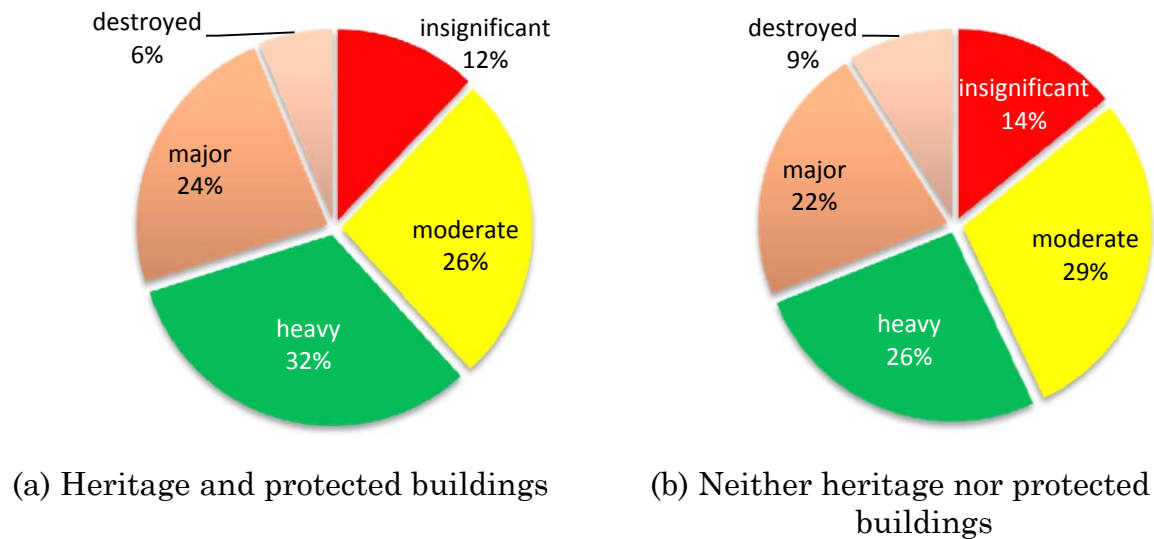
**Figure 4.7 Damage classifications for heritage and non-heritage buildings**

Of the 370 surveyed URM buildings, 192 (52%) buildings were either heritage buildings registered with the New Zealand Historic Places Trust (NZHPT) and/or were recognised as a protected building by CCC (note that of the two buildings for which no damage data was acquired, one building was ‘Heritage and protected’, resulting in 191 data entries). The damage data reported in Table 4.8 was further analysed to identify the assessed level of damage for those buildings that were either heritage listed or were protected by CCC, compared with those buildings that had no special classification. As shown in Table 4.11 and Figure 4.7 there was little difference between the damage distributions for the two groups of buildings.

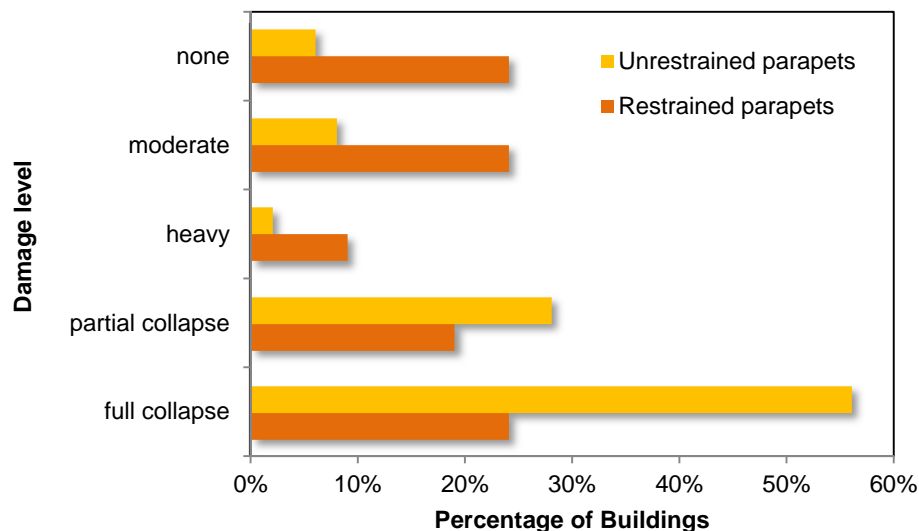
**Figure 5.3 Performance of unrestrained and restrained parapets**

As expected (see Table 5.4 and Figure 5.3), restrained parapets performed significantly better than parapets having no restraint, with 75 (84%) unrestrained parapets suffering full or partial collapse while only 65 (44%) restrained parapets suffered similar damage. Furthermore, 71 (48%) restrained parapets suffered no or moderate damage while only 12 (13%) unrestrained parapets achieved such good response, such that 86% (71/83) of those parapets that performed satisfactorily were restrained.

Overall it may be concluded that unrestrained parapets were twice as likely to collapse as were restrained parapets. It would seem that this is a disappointing finding as it would have been sensible to assume that the majority of restrained parapets would have

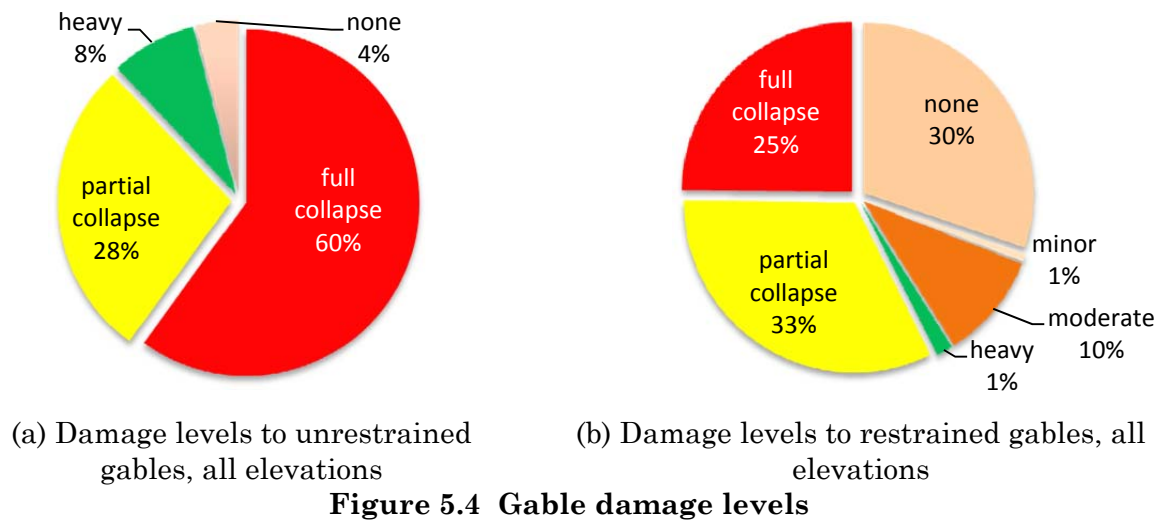
As can be seen in Figure 5.4, restrained gables performed better than for situations where no gable restraint was identified. However, 74 (57%) restrained gables suffered partial or full collapse.

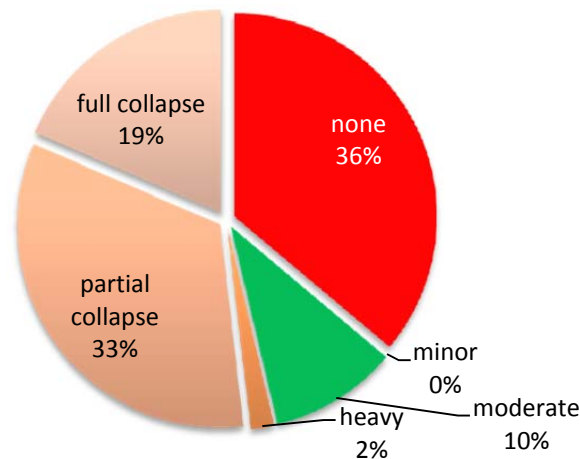
**Figure 5.5 Damage distribution for gables restrained using through ties**

As discussed above, Table 5.8 shows that there were 108 gable elevations where ‘through ties’ were used to provide restraint. This data population allowed the specific performance of through ties to be further analysed, as shown in Table 5.9 and Figure 5.5. From this analysis it may be determined that this securing technique resulted in mixed success, with 58 (54%) gable elevations suffering in excess of moderate damage. Further correlation between damage levels and the spacing of through tie anchors would assist in determining future recommendations for earthquake strengthening procedures, but is beyond the scope of the study reported here. Nevertheless, the finding that approximately half of all restrained gables sustained either heavy damage or collapse suggests that further investigation of appropriate procedures for the earthquake protection of unreinforced masonry gable end walls is merited.

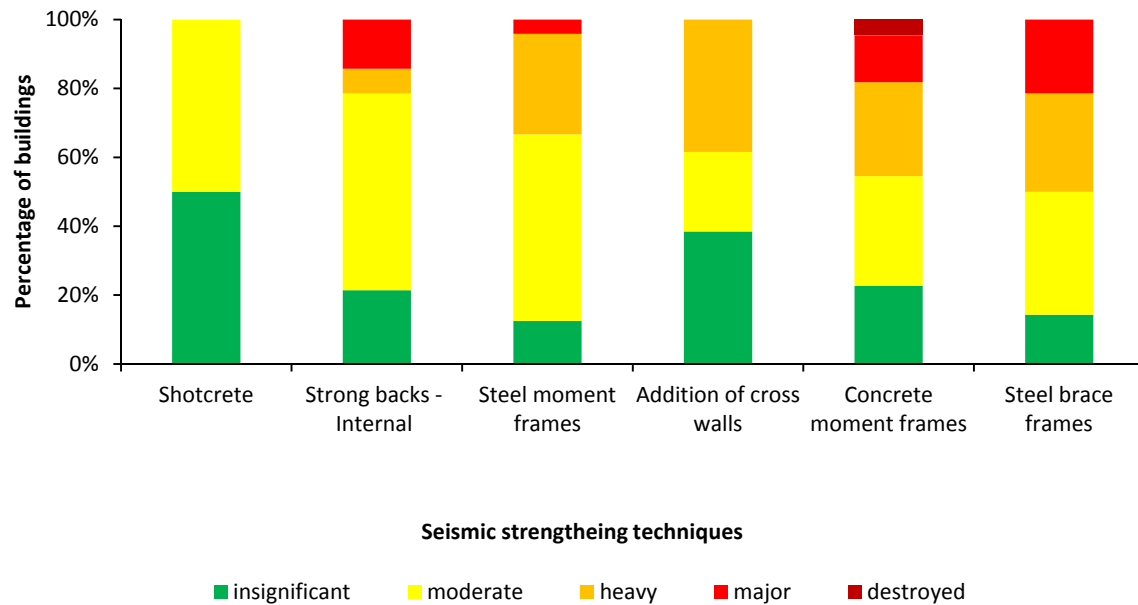
**Figure 5.6 Building damage distribution for various Type B earthquake strengthening techniques**

The overall building damage levels for 97 (89%) of the 109 identified cases of Type B earthquake strengthening were considered, with the damage distribution shown in Table 5.14 and Figure 5.6. The Type B strengthening methods of Fibre Reinforced Polymer (FRP), post-tensioning, and external strong-backs were not included in Table 5.14 as the number of surveyed cases of implementation was small. Note that buildings having more than one form of Type B seismic strengthening (eg. steel moment frames and internal strong backs) are represented twice in Table 5.14 and Figure 5.6 such that the 97 entries do not represent 97 different buildings.

As might be expected, the data presented in Table 5.14 and Figure 5.6 shows that the two Type B earthquake strengthening methods that resulted in the least damage were shotcrete and the addition of cross walls. The two methods are somewhat analogous as the former involves the application of new reinforced concrete walls adhered to the exterior of existing URM walls and the latter involves the installation of new walls. The data also shows that the damage statistics for buildings having internal strong backs, steel moment frames and concrete moment frames was comparable.

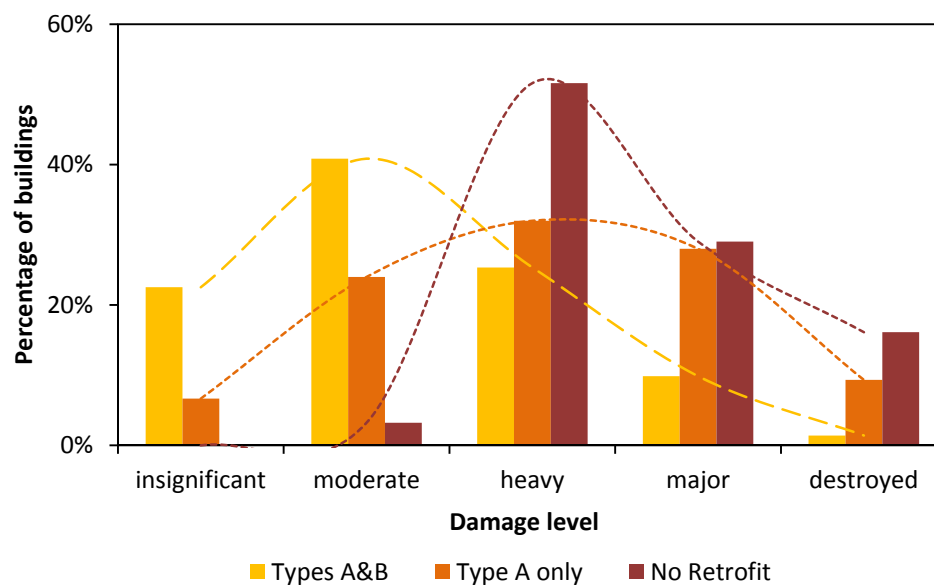
**Figure 5.7 Plot of damage level against seismic strengthening types**

In this section the building damage data for 368 URM buildings in the Christchurch CBD is correlated against earthquake strengthening schemes, recalling that building damage information was not available for two URM buildings. As shown in Table 5.15, URM buildings having no earthquake strengthening suffered greater damage than those buildings that had received some form of earthquake strengthening. Of the 31 URM building confirmed to have no earthquake strengthening, 30 (97%) suffered heavy, major or severe damage (see Table 5.15 and Figure 5.7). Similarly, of the 149 buildings that had a Type A earthquake strengthening scheme installed, 104 (70%) suffered heavy, major, or severe damage whereas for combined Type A&B strengthening only 29 (35%) buildings suffered this level of damage.

From this data it is clear that Type B earthquake strengthening was more successful at minimising building damage than were Type A earthquake strengthening improvements. This observation is to be expected, recognising that the aim of Type B earthquake strengthening improvements is to increase the global earthquake capacity of the building, and consequently reduce the expected overall building damage level.

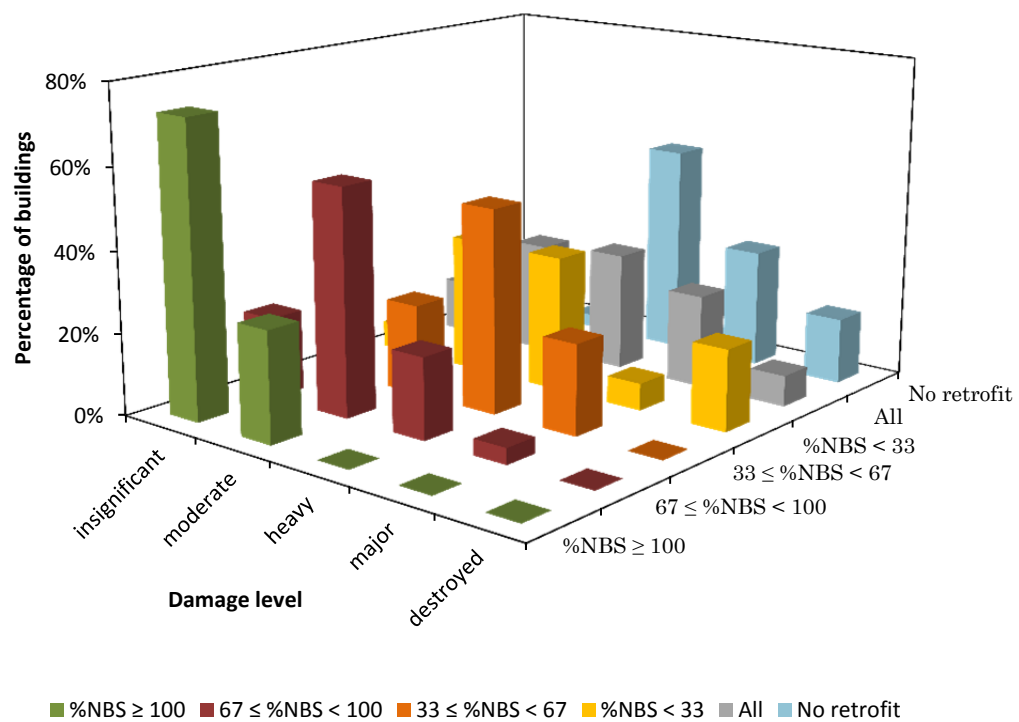
**Figure 6.1 Damage levels for different levels of %NBS earthquake strengthening**

The data plotted in Figure 6.1 is reproduced in a different format in Figure 6.2. From Table 6.2, Figure 6.1, and Figure 6.2 it can be determined that those URM buildings strengthened to 100%NBS performed well, that buildings strengthened to 67%NBS performed moderately well, but that buildings strengthened to less than 33%NBS collectively exhibited no significant improvement in performance when compared with buildings that had received no earthquake strengthening.

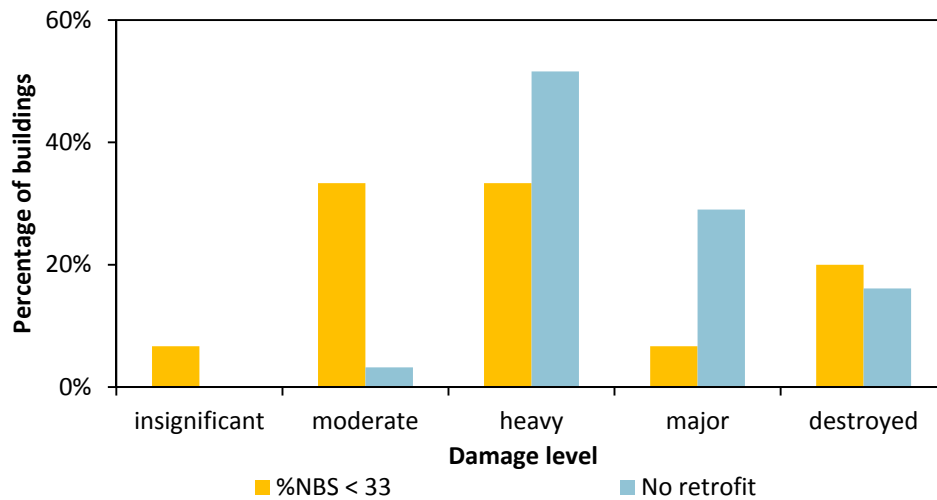
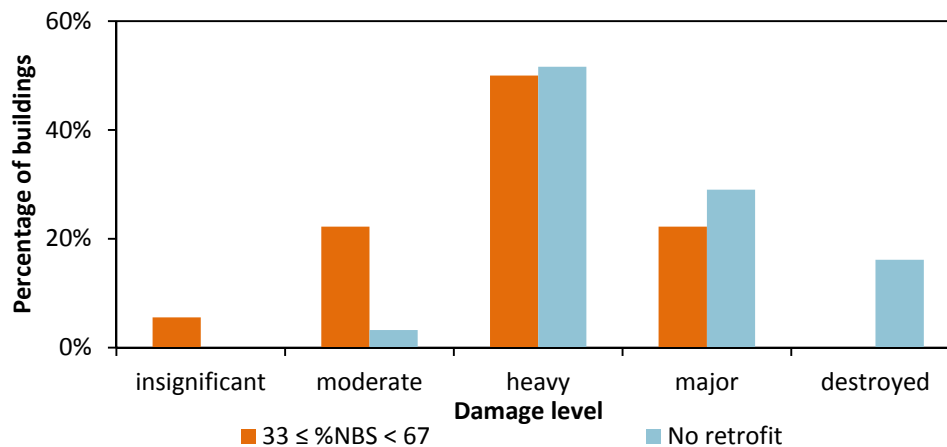
Figure 6.3, Figure 6.4 and Figure 6.5 show earthquake performance for buildings strengthened to increasing levels of %NBS, plotted against the performance of buildings that received no earthquake strengthening. As anticipated, the three plots show that an increase in the level of %NBS earthquake strengthening resulted in reduced levels of damage.

**Figure 6.3 Damage comparison between URM buildings strengthened to 33%NBS and no retrofit**

**Figure 6.4 Damage comparison between URM buildings strengthened to 33-67%NBS and no retrofit**

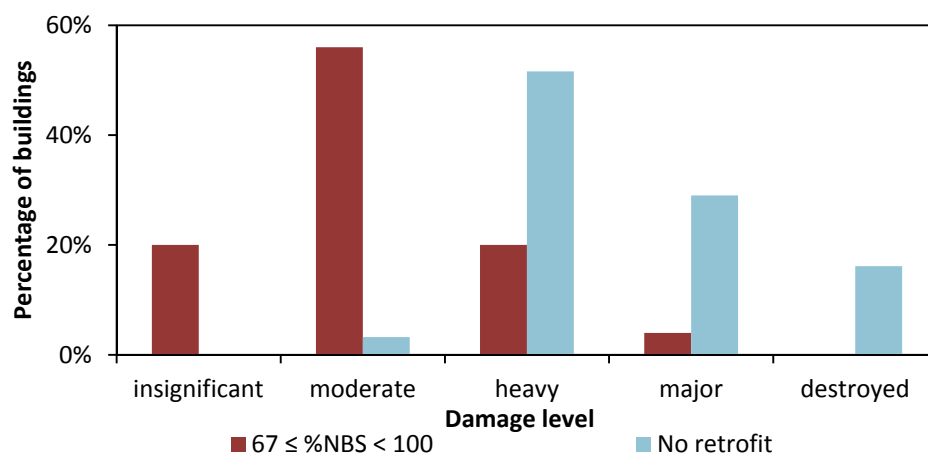
**Figure 6.5 Damage comparison between URM buildings strengthened to 67-100%NBS and no retrofit**

3. Figure 6.5 and Figure 6.7 both show that URM buildings strengthened to 67-100%NBS performed much better than both URM buildings having no strengthening and URM buildings strengthened to lower levels of earthquake resistance. This significant improvement in performance is also reflected in the

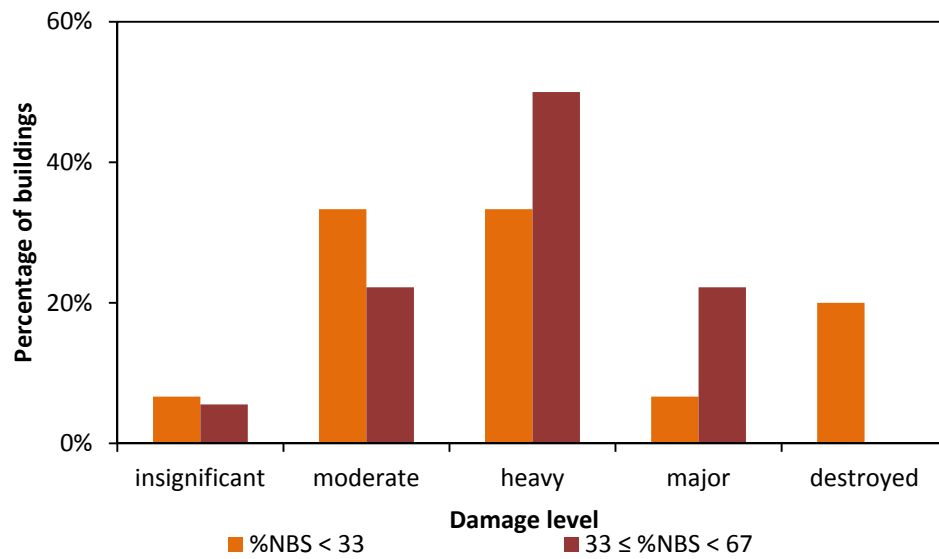
**Figure 6.6 Damage comparison between URM buildings strengthened to 0-33%NBS or to 33-67%NBS**

Figure 6.6 and Figure 6.7 extend the analysis reported above, by comparing damage levels for different levels of earthquake strengthening.

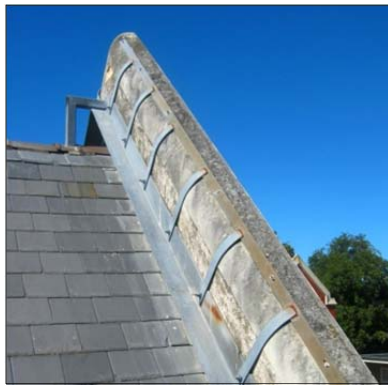
(c) Well restrained parapet

**Figure B.1 Performance of parapet restraint types**

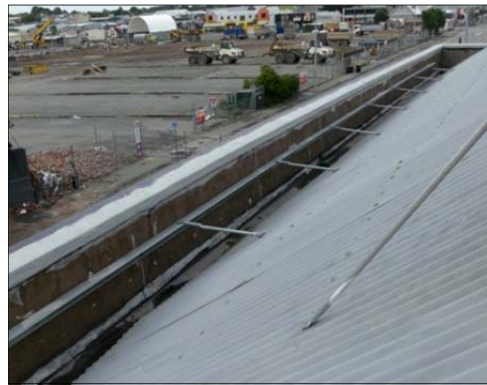
(d) Parapet restraint using rigid steel braces connected to a continuous steel section

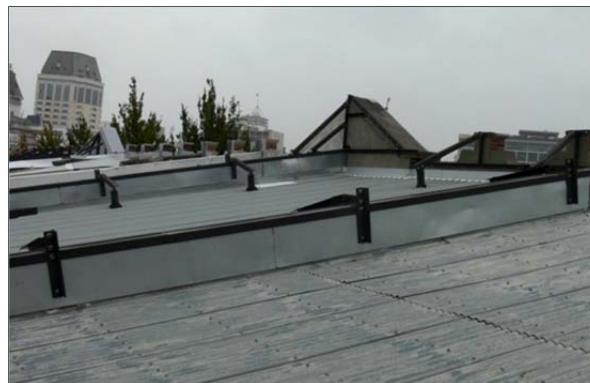
(e) Steel angels 'confining' the parapet and securing it back to the roof via rigid braces
